MINERALS PROGRAM INSPECTION REPORT
PHONE: (303) 866-3567

MINE NAME: Sievers Pit	MINE/PROSPECTING ID#: M-1977-098	MINERAL: Sand and gravel	COUNTY: Garfield
INSPECTION TYPE: Monitoring	WEATHER: Clear	INSP. DATE: May 27, 2025	INSP. TIME: 11:00
OPERATOR: Oldcastle SW Group, Inc. dba United Comp County	OPERATOR REPRESENTATIVE: Jesse Farmer	TYPE OF OPERATION: 112c - Construction Regular Operation	
REASON FOR INSPECTION: Normal I&E Program	BOND CALCULATION TYPE: None	BOND AMOUNT: \$962,447.00	
DATE OF COMPLAINT: NA	POST INSP. CONTACTS: None	JOINT INSP. AGENCY: None	
INSPECTOR(S): Todd Jesse	INSPECTOR'S SIGNATURE:

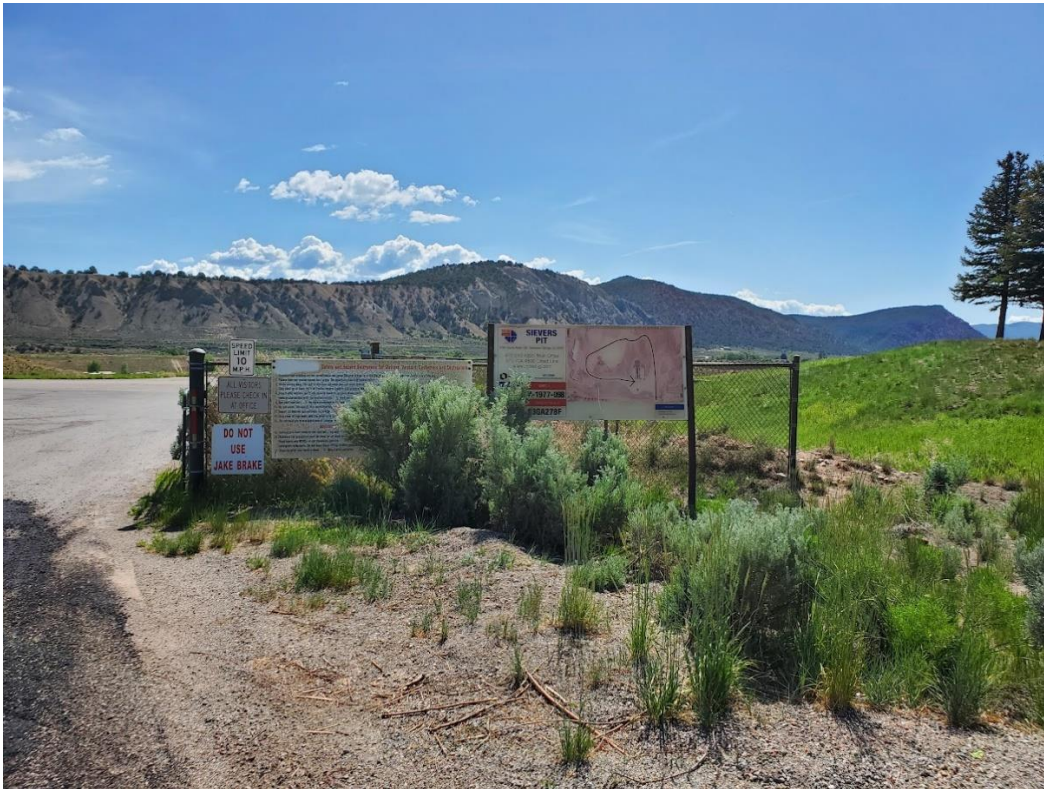
The mine identification sign and boundary markers are in place and in compliance with Rule 3.1.12. The sign is posted by the entrance to site. The permit boundary is marked with fence line that is easily identifiable as well as earthen berms.

Photo 1: View to the east of mine ID sign at entrance to site.

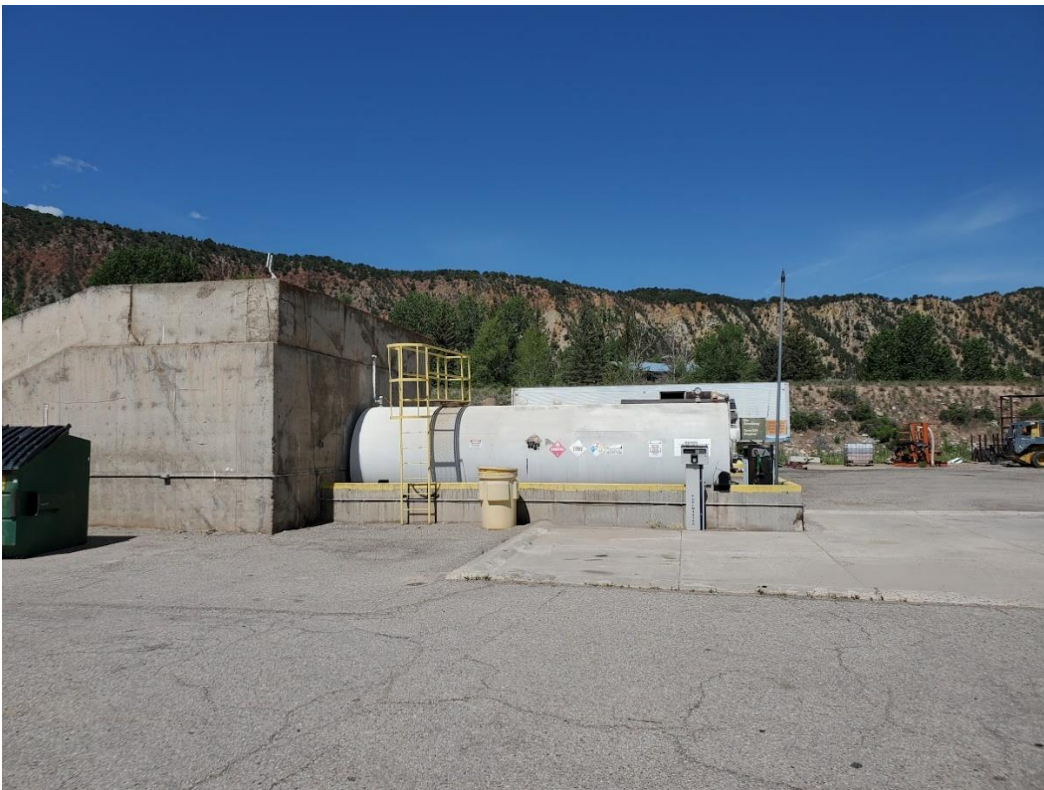
The office building, shop and hot plant were observed during the inspection. The office building is located near the entrance to the site and has a scale. The shop is located in the north portion of the permit area and contains fuel storage. The hot plant is leased out and not operated by Oldcastle.

Photo 2: View to the west of fuel storage on site.

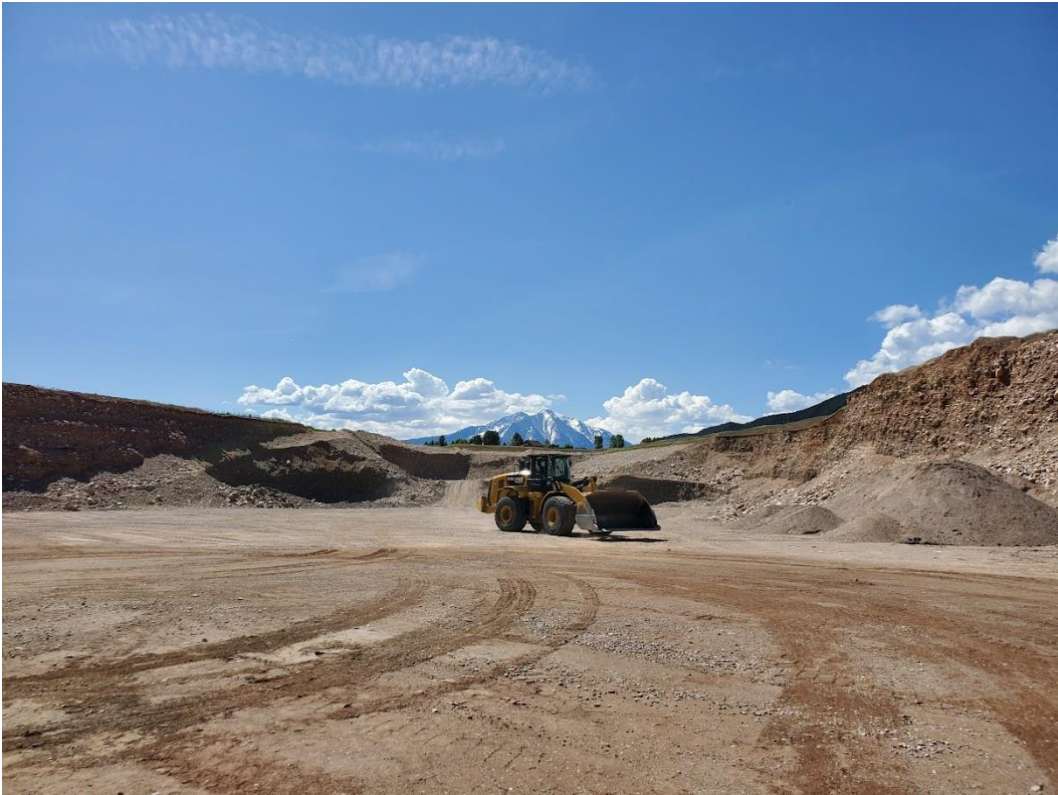
Mining is occurring in the southern portion of the permit area. The highwall is approximately 40 feet. Stockpiles are located on the pit floor. A wash plant and processing area are also on the pit floor. The operator regularly runs a water truck to suppress dust.

Photo 3: View to the south of mining area.

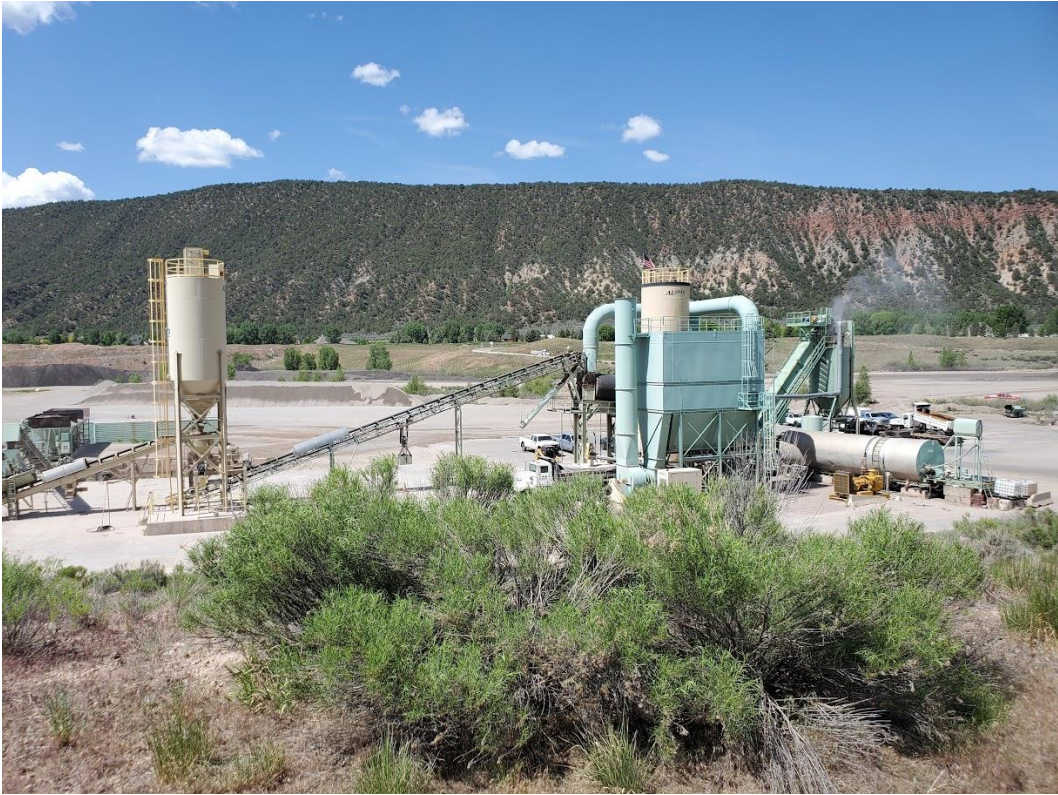
Photo 4: View to the west of hot plant on site.

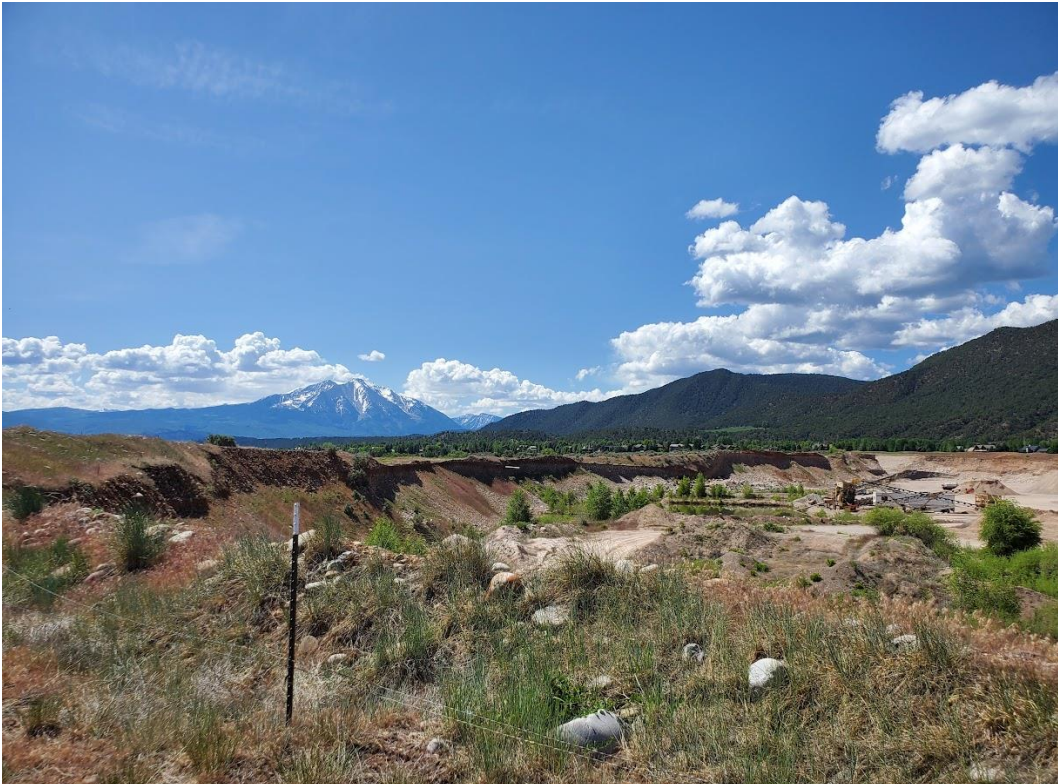
Photo 5: Overview of the pit – view to the south.

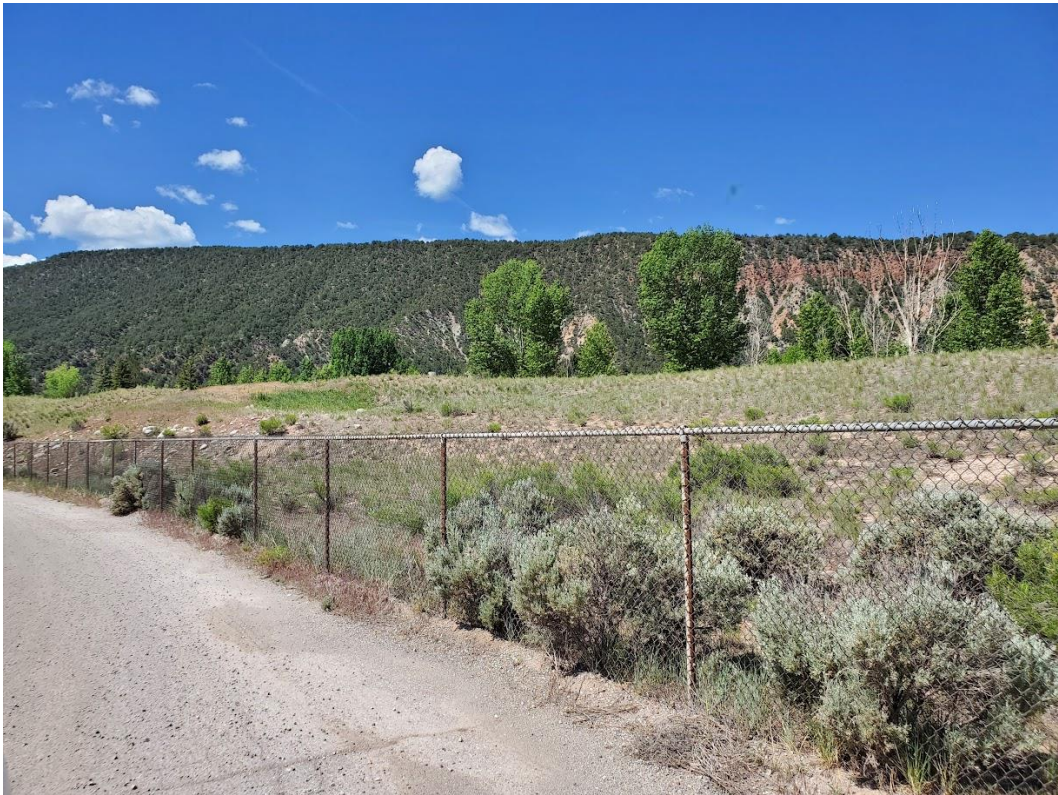
Photo 6: View to the west of fence and berm that mark boundary.
