Division of Reclamation,
Mining and Safety

PERMIT INFORMATION

Permit Number: C-1996-084 Mine Name: Lorencito Canyon Mine Operator: New Elk Coal Company, LLC Operator Address: 12250 Highway 12 Weston, CO 81091	County: Las Animas Operation Type: Surface Permit Status: Suspended Ownership: Private
	Operator Representative Present: None
Operator Representative Signature: (Field Issuance Only)

INSPECTION INFORMATION

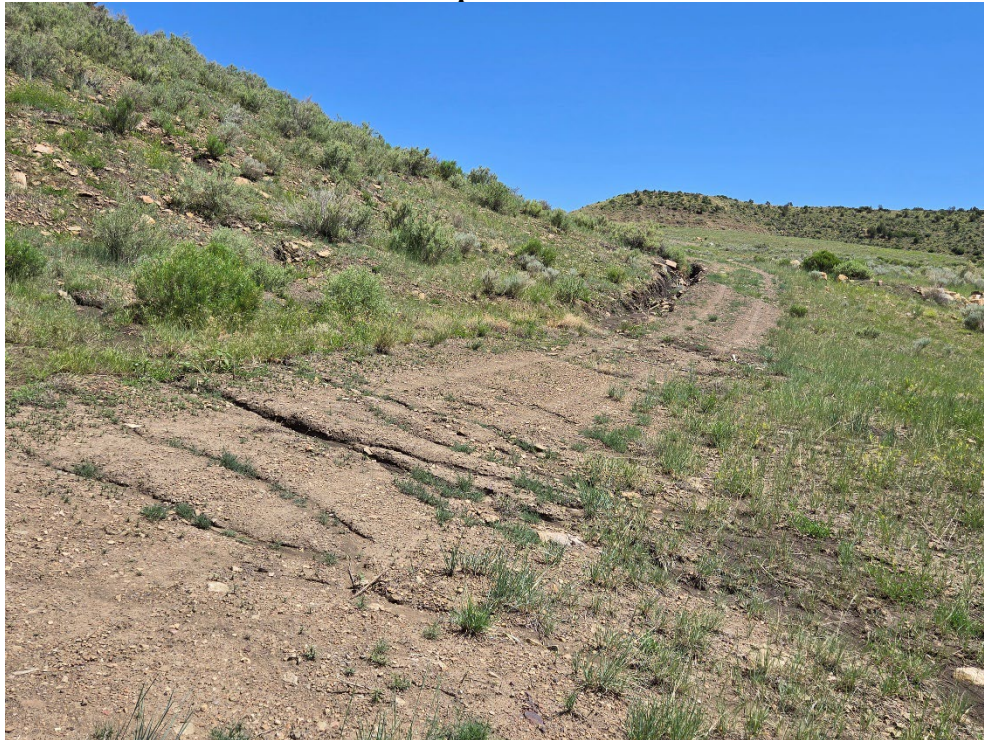
3. The following items pertain to ongoing maintenance issues, cited in previous reports for the area in and around the reclaimed area above Pond 006a:
 - a. The ditch along the road leading to Pond 006a is eroding and nearly full of sediment. The overloaded ditch is contributing to the build-up of sediment in the check dams of ditches D8 and D64. **Pursuant to Rule 4.03.2(4), the ditch along the west side of the road leading to Pond 006a needs to be cleaned out and repaired.**

Photo 1: Sediment in ditch on the west side of the road leading down to Pond 006A has cut across the road and enters into ditch D64 leading to Pond 006A.

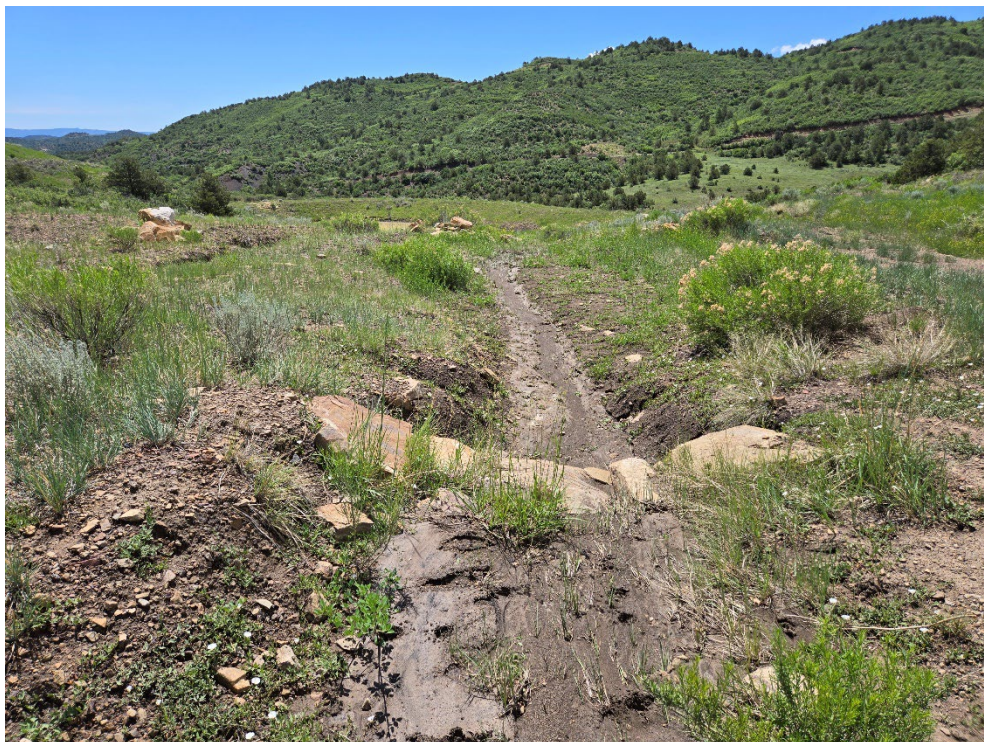
- b. The check dams leading to Pond 006a, within ditches D8 and D64, are nearly full of sediment. **Pursuant to Rules 4.05.3(1)(c)-(e) and 4.05.5, the Operator shall clean out the sediment from the check dams to prevent excess sediment from entering the pond.**

Photo 2: Full check dam within D8.

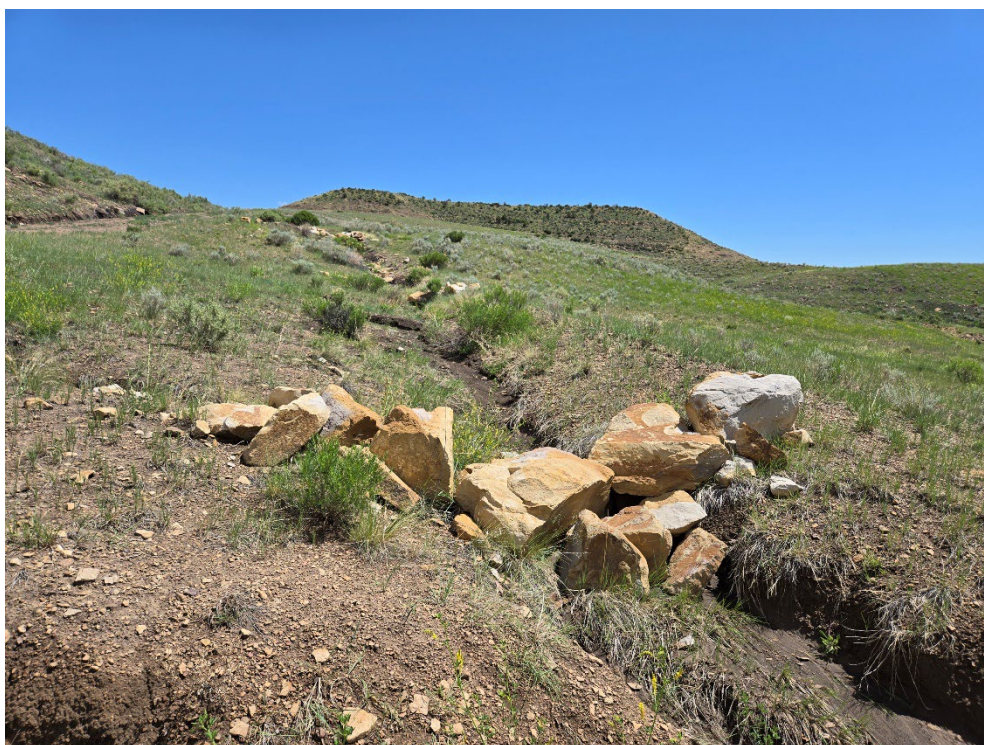
Photo 3: Check dams in ditch D8.

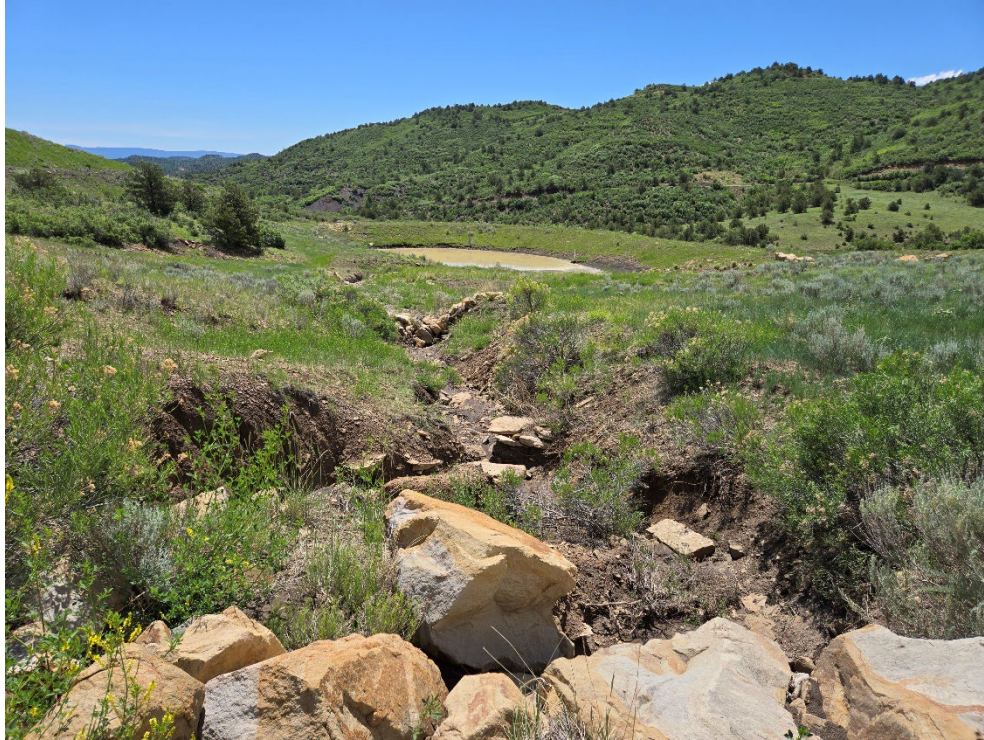
Photo 4: Full and damaged check dams leading to Pond 006A.

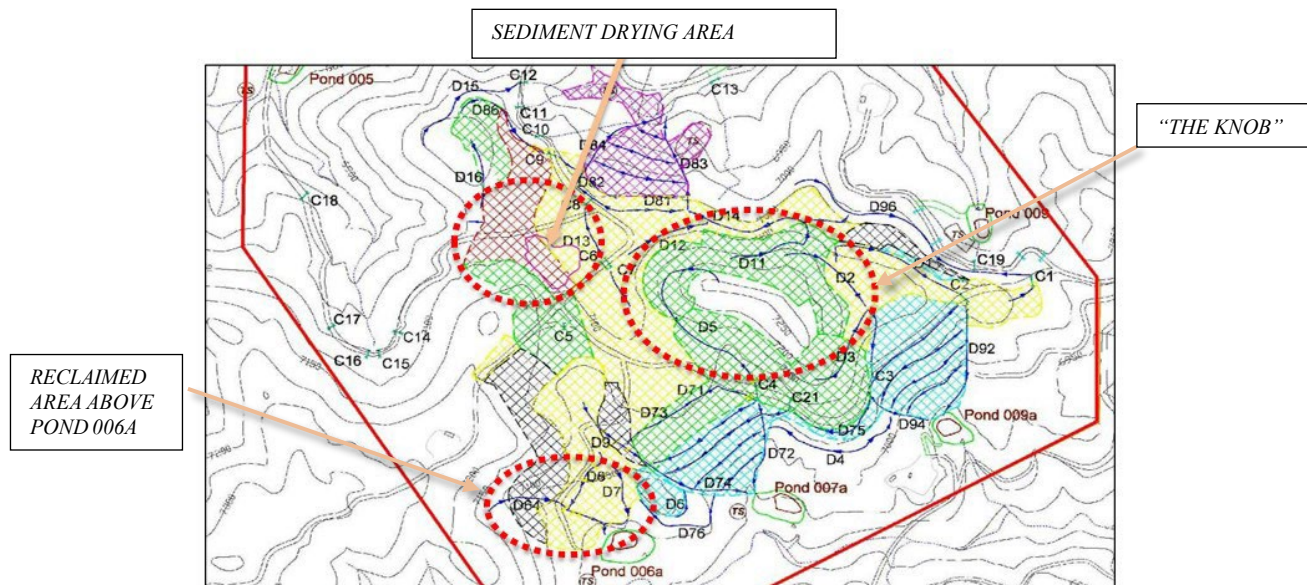
4. The following items pertain to ongoing erosional issues in the areas shown in Figure 1, that pursuant to Rule 4.14.6 need to be addressed. A Technical Revision will be required to expand on the current Rill and Gully plan in the PAP. **The Operator shall submit the technical revision, obtain approval, repair the erosion, and stabilize the slopes pursuant to the approved plan.**

FIGURE 1. AREAS WHERE RILLS, GULLIES AND SPARSE VEGETATION HAS BEEN FOUND TO BE A PERSISTENT PROBLEM AT THE SITE ARE WITHIN THE DOTTED CIRCLE AREAS. BACKGROUND IMAGE IS THE 2020 ANNUAL REPORT MAP.

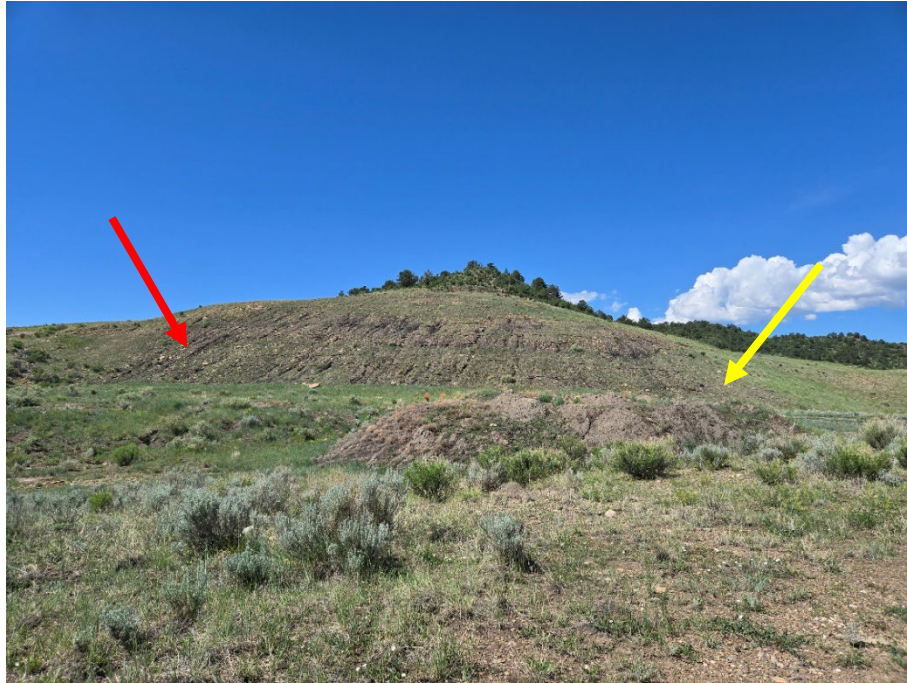
Photo 5: Erosion on the north-facing slope of the reclaimed area (red arrow) above the sediment drying area (yellow arrow).

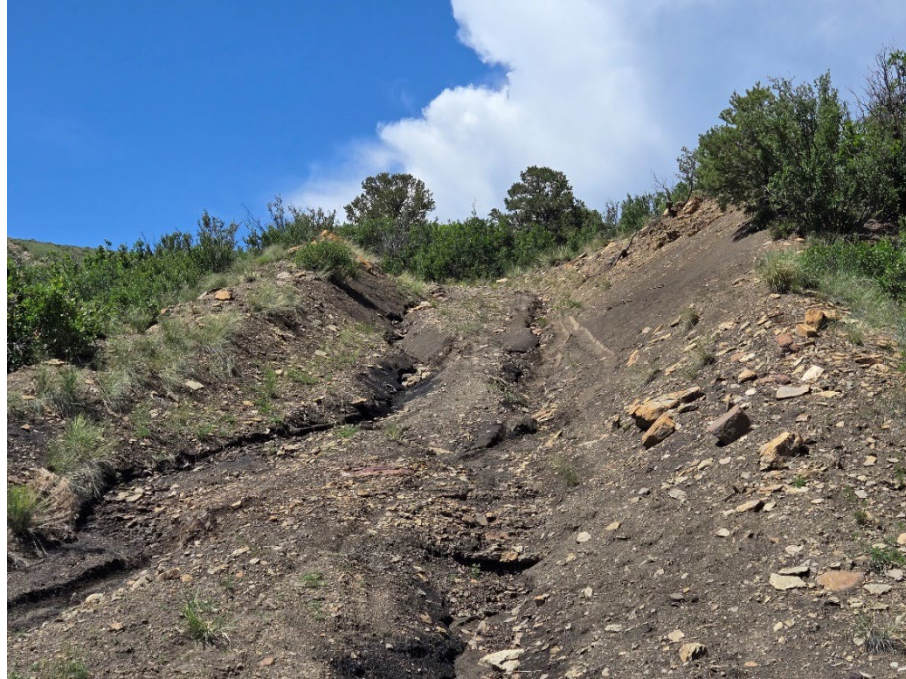
- a. The road leading down into Pond 008 has deep ruts and driving on it is not advised without a high clearance 4WD vehicle. The **Operator shall repair and stabilize the road leading to Pond 008.**

Photo 6: Road leading down to Pond 008.

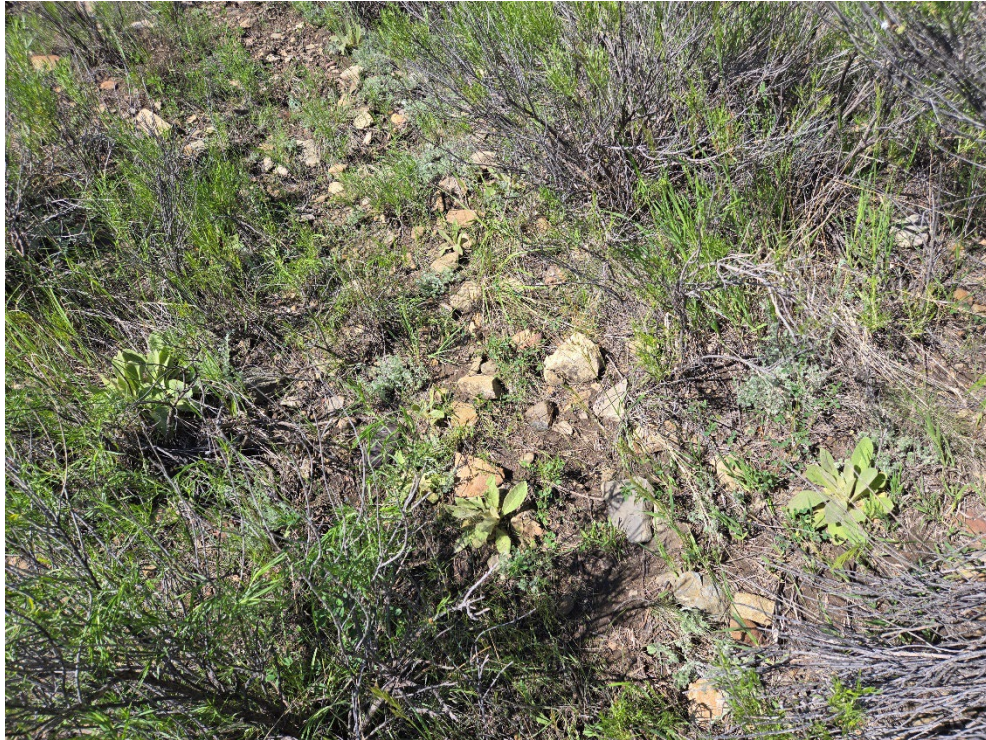
6. (August 2024 report) The state listed noxious weed, Mullein, was observed:
- by the Pond 005 spillway. **The Operator shall treat and/or remove Mullein in this area.**

Photo 7: Mullein near flume at Pond 005

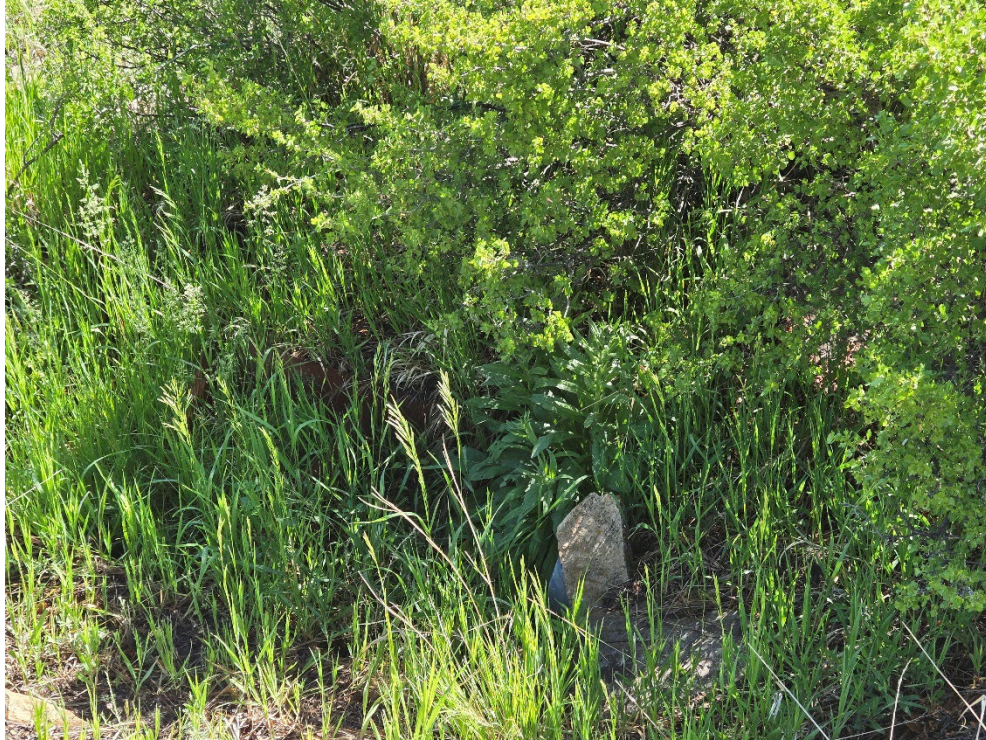
- (November 2024 report) Some vegetation has grown over and into the flume. The **Operator shall clear the excess plant material in the flume.**

Photo 8: Flume for Pond 009 covered with vegetation.

- The flume held some water at the time of the inspection but was not discharging. Vegetation has overgrown the flume (**see outstanding maintenance item #8b**).

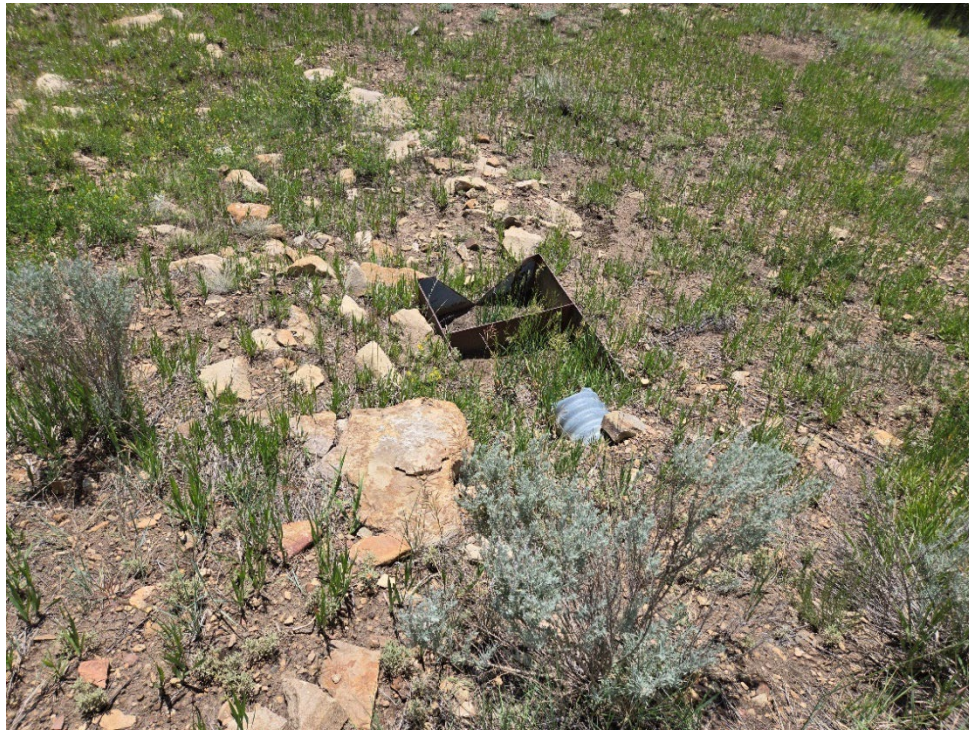
9. (October 2024 report) Pond 006a - Sediment has built up within the upper portion of the flume. **The Operator shall clean the flume of sediment and vegetation to ensure it functions properly.**

Photo 9: Flume filled with sediment at Pond 006A.

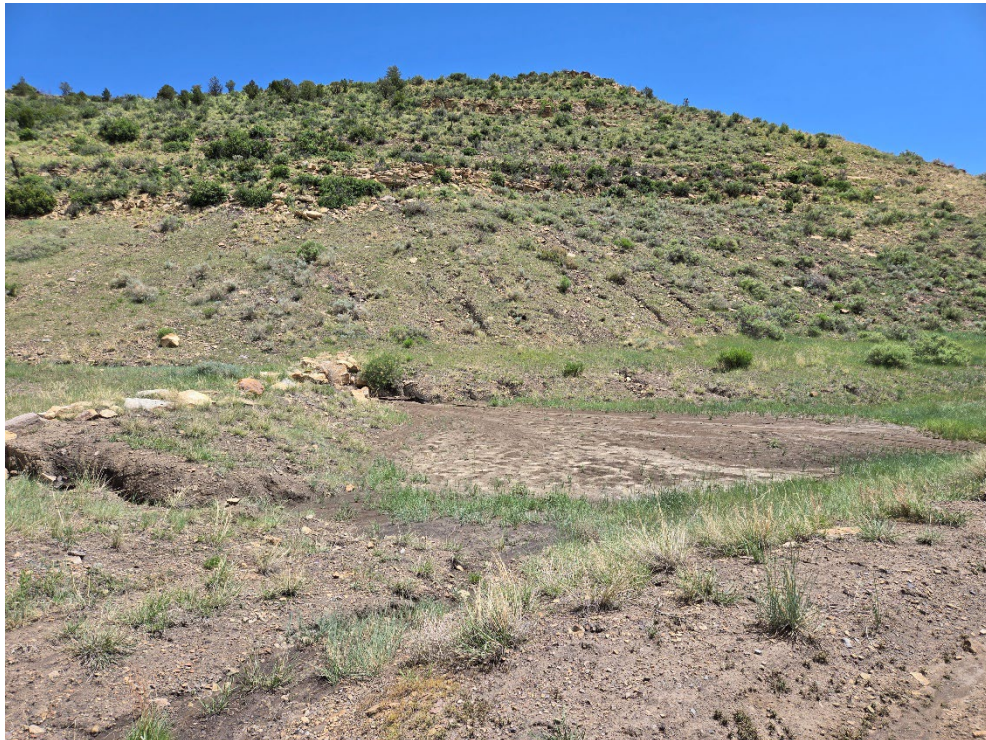
- a. Ditch D5 is located on the southside of a previously disturbed area referred to as “The Knob”. The Knob is north of Fill 7 and north of the road. Check dams are located throughout D5, and a small sediment catchment area is located at the base of the ditch that leads to culvert C4. The check dams are full and need to be cleaned, and a few need to be repaired. The catchment basin also has an increased sediment load, however C4 appears to still be clear at this time. Still, the Operator **shall clean the sediment out of the check dams and the catchment basin located within D5, north of C4.**

Photo 10: Looking northwest at the sediment catchment basin on the north side of the road, on the south side of “The Knob”.

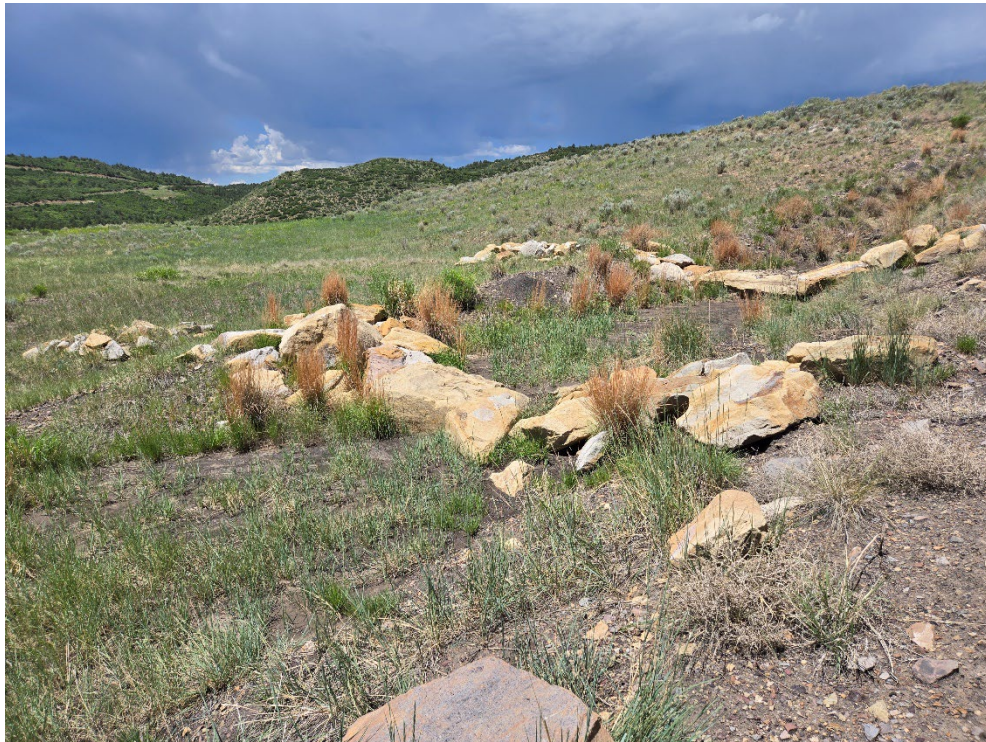
- d. D71, located along the southside of the road and north side of Fill 7, empties at the west side of the outlet for C4. The check dams within D71 are nearly full of sediment. **The Operator shall clean the sediment from the check dams within D71 and ensure the dams are functioning appropriately.**

Photo 11: Sediment built up in the check dams within ditch D71.

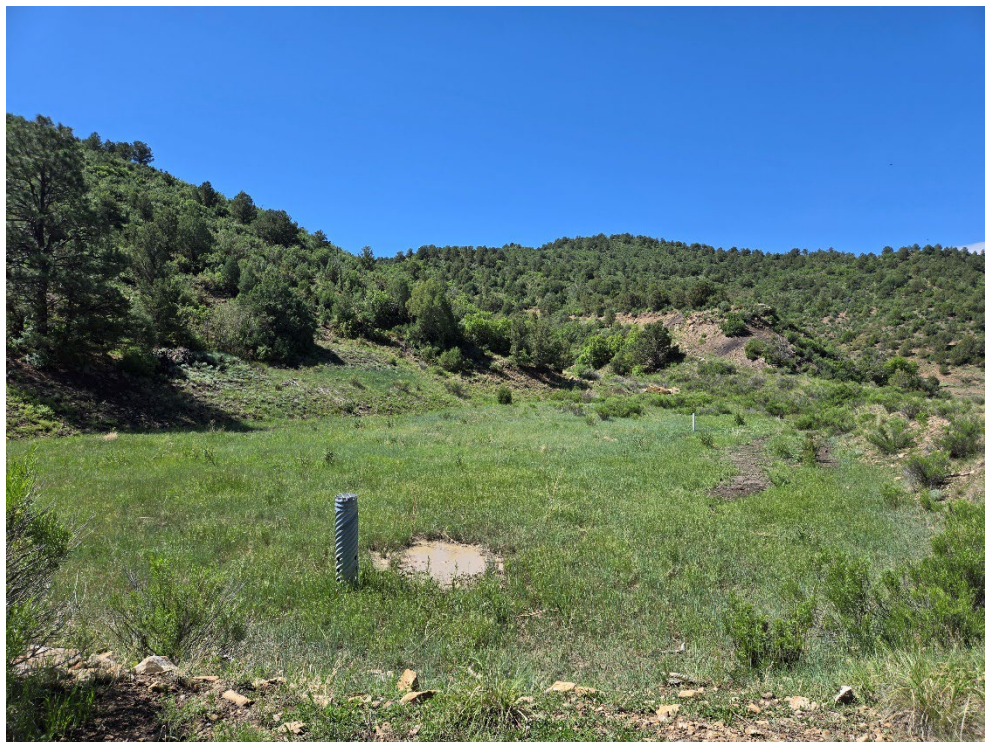
Photo 12: Pond 005

- Pond 005:
 - Pond 005 contained a small amount of water at the time of the inspection (Photo 12).
 - The flume contained water and was discharging from a leak on the bottom (Photo 13).
 - The primary and emergency spillways appeared to be clear and functional.
- Pond 006a:
 - The pond held water at the time of the inspection (Photo 14).
 - The pond embankment appeared to be stable and vegetated. **See outstanding maintenance Item # 1.**
 - The primary and emergency spillways appeared clear and functional.

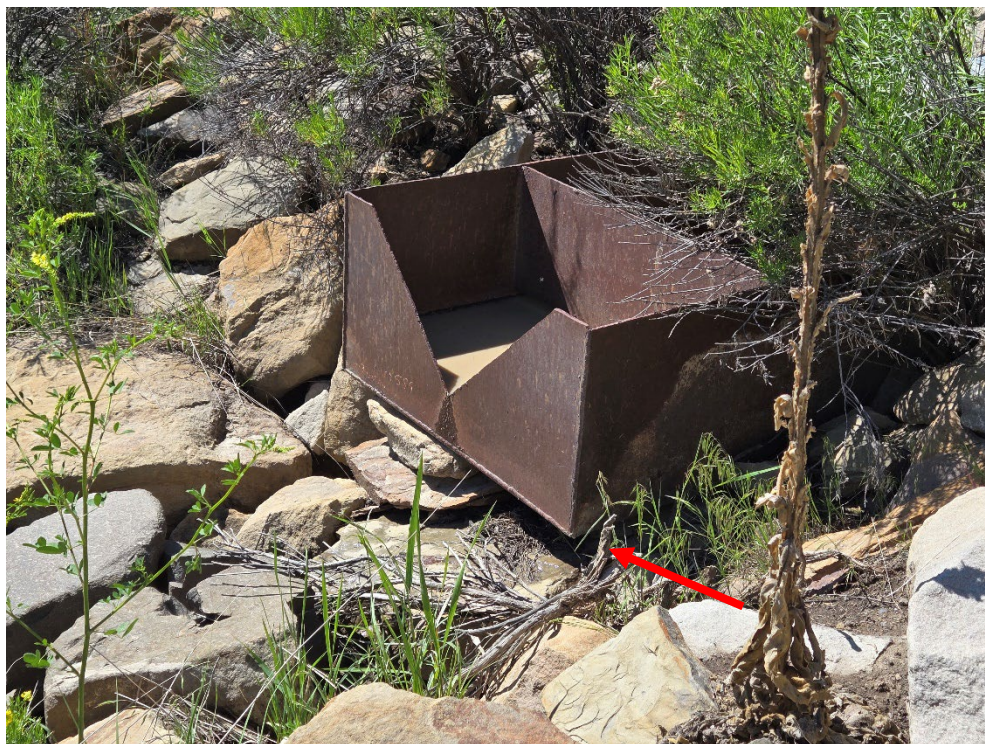
Photo 13: Flume for Pond 005. The flume was leaking from the area that the red arrow is pointing at.

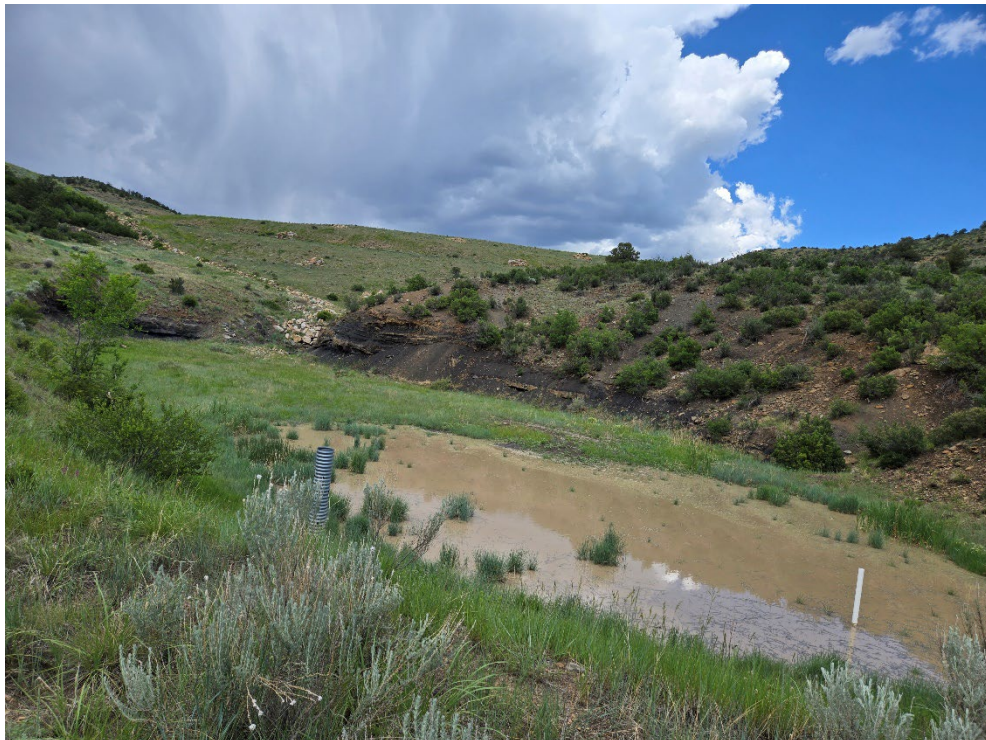
Photo 15: Pond 007a

- The flume was dry. **See outstanding maintenance item #9.**
- Pond 007a:
 - The pond held water at the time of the inspection. (Photo 15).
 - The pond embankment appeared to be stable and vegetated.

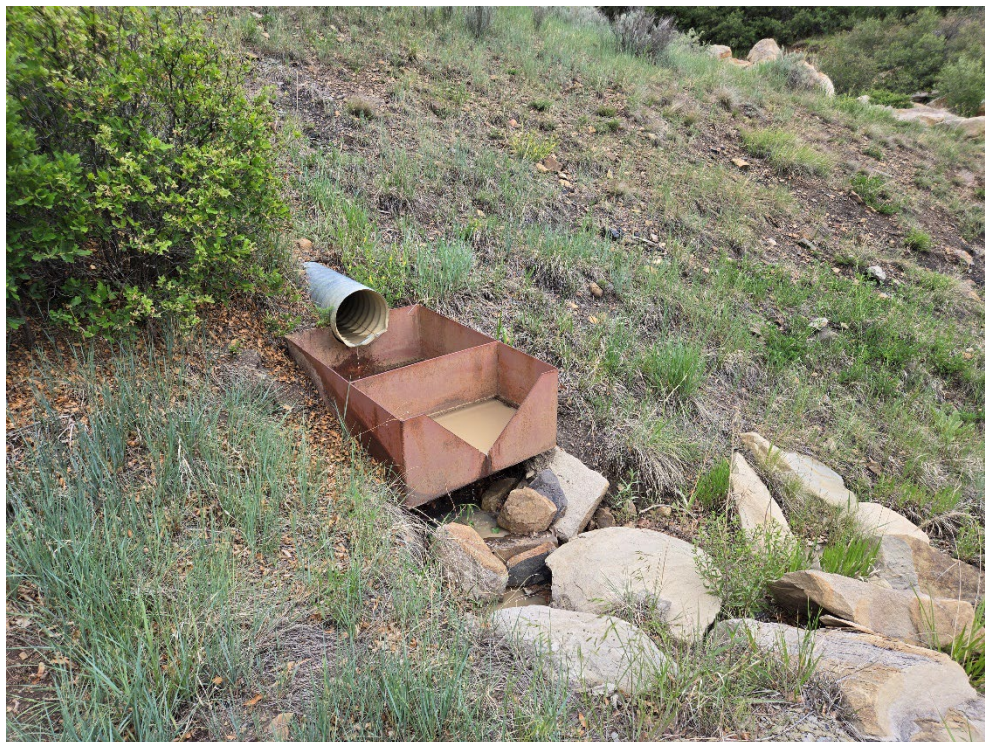
Photo 16: Flume for Pond 007a

- The primary and emergency spillways appeared clear and functional.
 - The flume held some water and was discharging (Photo 16).
- Pond 08:
 - The pond held water at the time of the inspection. (Photo 17).

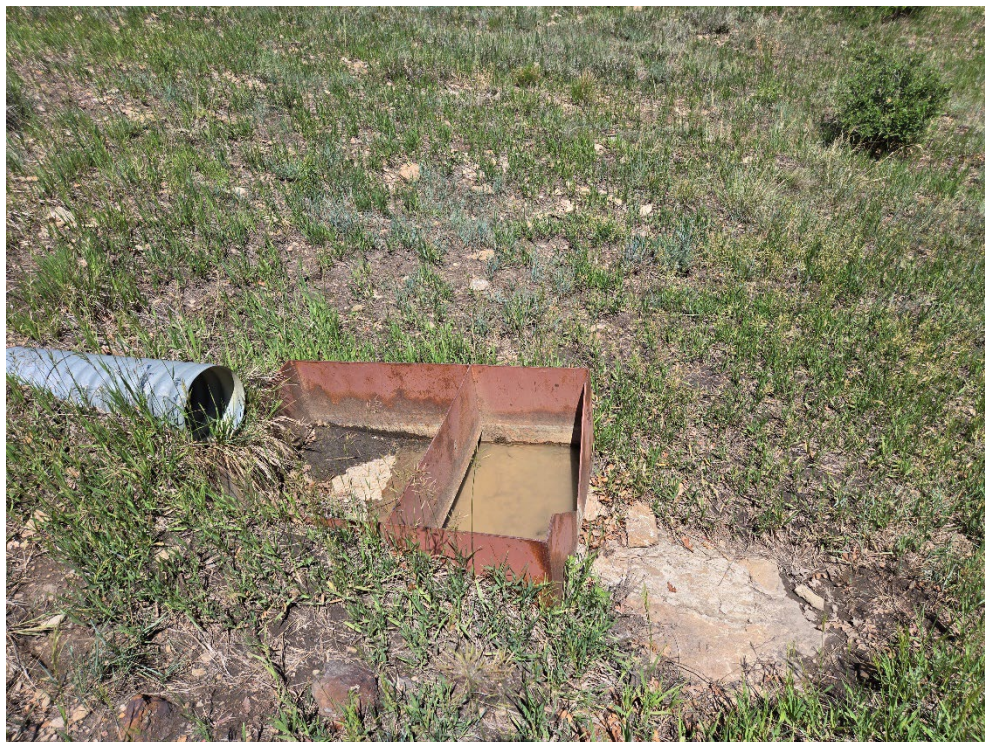
Photo 18: Flume for Pond 08

- The flume held water at the time of the inspection but was not discharging (Photo 18).
- Pond 009:
 - The pond contained some water at the time of the inspection. (Photo 19).

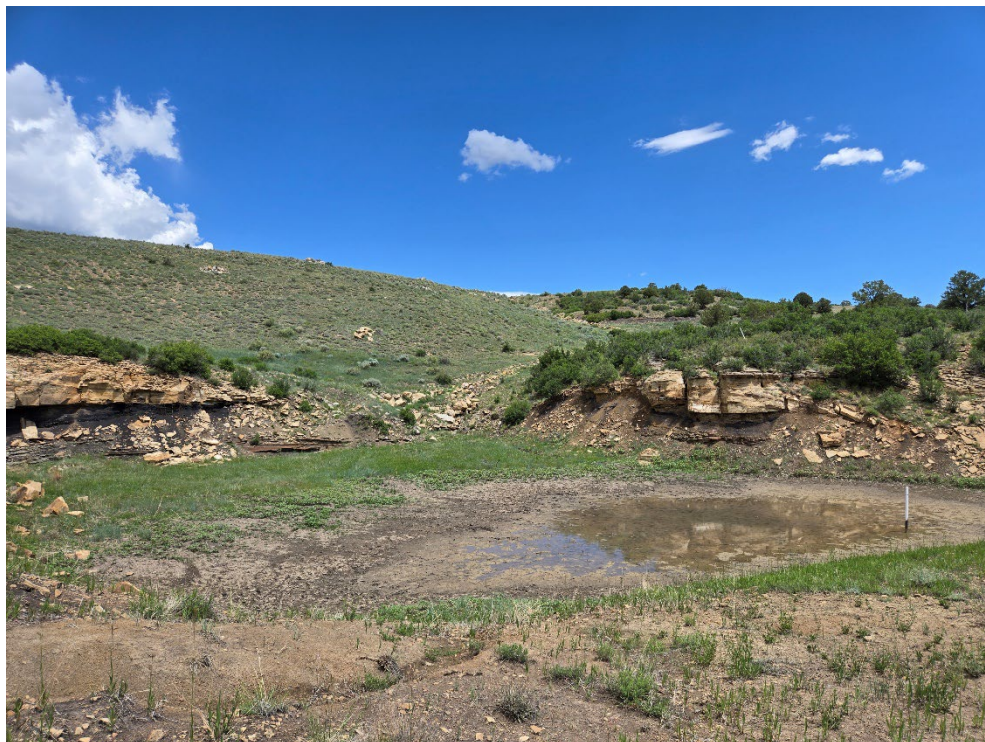
Photo 20: Pond 009a

- Pond 009a:
 - The pond contained some water at the time of the inspection. (Photo 20).
 - The pond embankment appeared to be stable and vegetated.
 - The primary and emergency spillways appeared clear and functional.

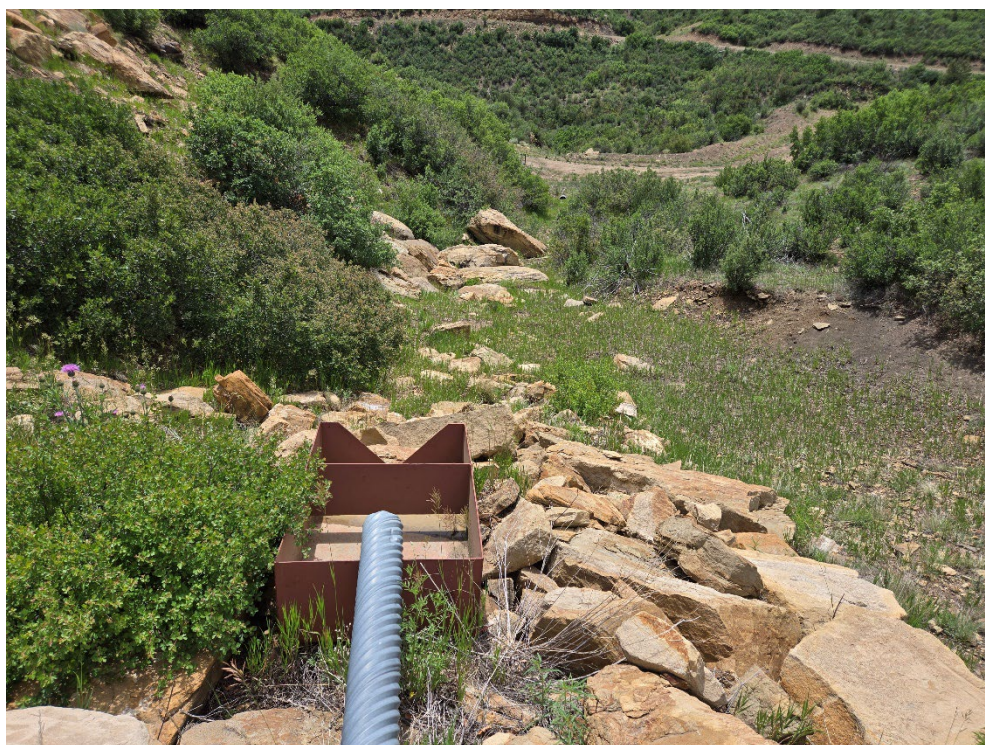
Photo 21: Flume for Pond 009a

- The flume held a small amount of water but was not discharging (Photo 21).

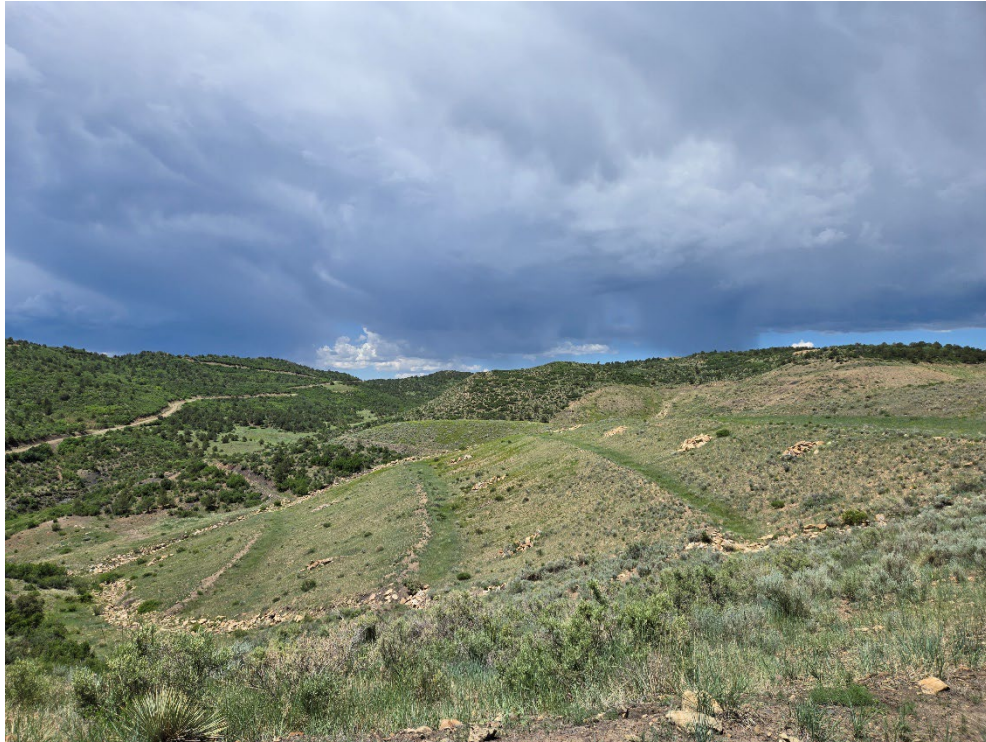
Photo 22: Looking west across Fill 7.

- Fill 7 was observed (Photo 22). Fill 7 was well vegetated and appeared stable.
- Fill 8 was observed (Photo 23). Fill 8 was well vegetated and appeared stable.
- Fill 9 was observed (Photo 24). Fill 9 was well vegetated and appeared stable.

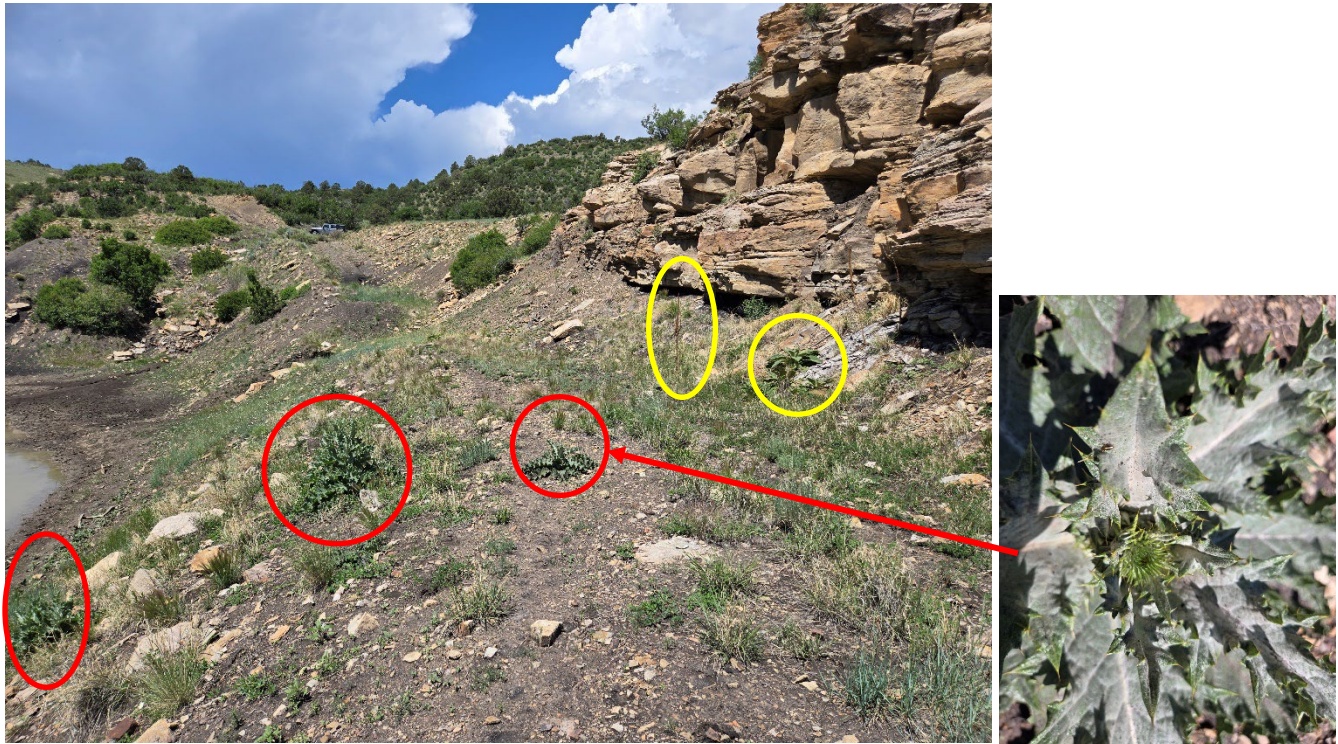
- In addition to the mullein observed around the site (see ongoing maintenance item #6), what appears to be the B-listed state noxious weed musk thistle was observed along the west side of Pond 08 (Photo 25). **The Operator shall treat/remove musk thistle from this area.**
- See outstanding maintenance Item #6

Photo 25: The red circles highlight areas where musk thistle has begun to establish along the west side of Pond 08. The yellow circles highlight some of the mullein stocks and florets mentioned in outstanding maintenance item #6c.

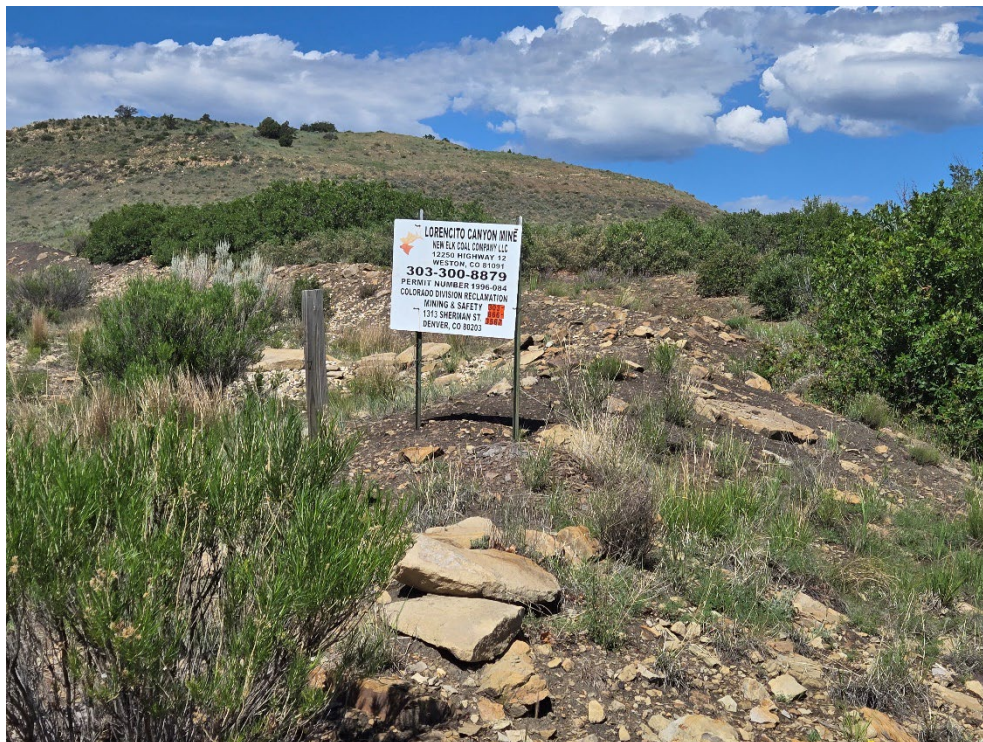
Photo 26: Mine sign

- Mine signs were posted at road entrances and at the entrance to the permit boundary in compliance with Rule 4.02 (Photo 26).
