**MINERALS PROGRAM INSPECTION REPORT**  
**PHONE: (303) 866-3567**

<b>MINE NAME:</b> Henderson Mine	<b>MINE/PROSPECTING ID#:</b> M-1977-342	<b>MINERAL:</b> Molybdenum	<b>COUNTY:</b> Clear Creek
<b>INSPECTION TYPE:</b> Monitoring	<b>WEATHER:</b> Clear	<b>INSP. DATE:</b> May 27, 2025	<b>INSP. TIME:</b> 08:30
<b>OPERATOR:</b> Climax Molybdenum Company	<b>OPERATOR REPRESENTATIVE:</b> Ron Hickman, Ben Bates	<b>TYPE OF OPERATION:</b> 112d-3 - Designated Mining Operation	
<b>REASON FOR INSPECTION:</b> Normal I&E Program	<b>BOND CALCULATION TYPE:</b> Complete Bond	<b>BOND AMOUNT:</b> \$271,566,513.00	
<b>DATE OF COMPLAINT:</b> NA	<b>POST INSP. CONTACTS:</b> None	<b>JOINT INSP. AGENCY:</b> None	
<b>INSPECTOR(S):</b> Joel Renfro	<b>INSPECTOR'S SIGNATURE:</b>

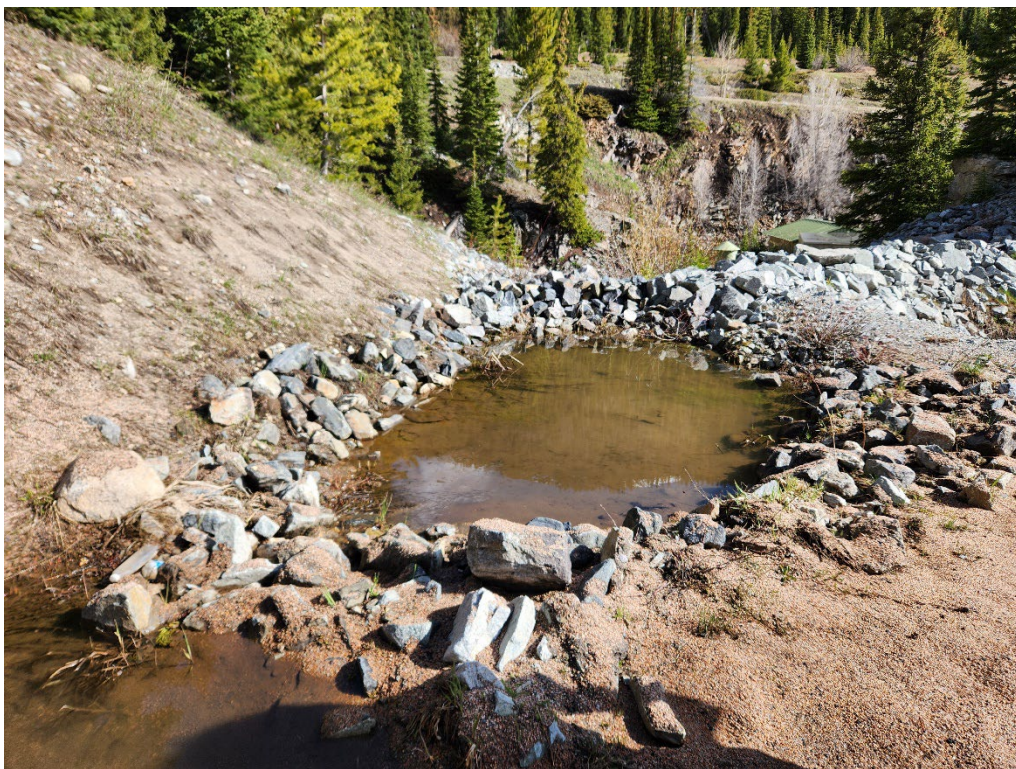
**OF-2 (Photo 1)** – These BMPs are located in the northwest corner of the office parking lot. It consists of several rock check dams along the edges of the parking lot leading to a setline basin where water then slowly moves through the rip-rap outfall. Water was observed moving through this BMP during the inspection. OF-2 appeared to be functioning as intended and was in good condition.

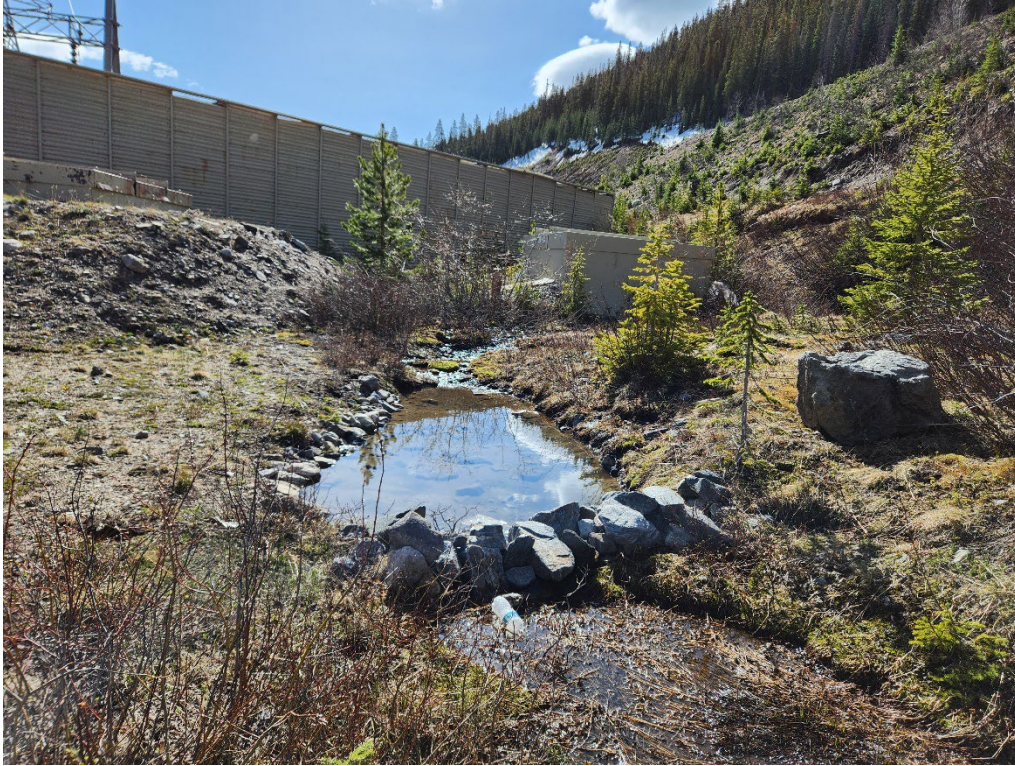
**OF-9 (Photo 2)** – A rock check dam located southeast of the road. Water was moving through this check dam during the inspection, and the structure appeared to be in good condition.

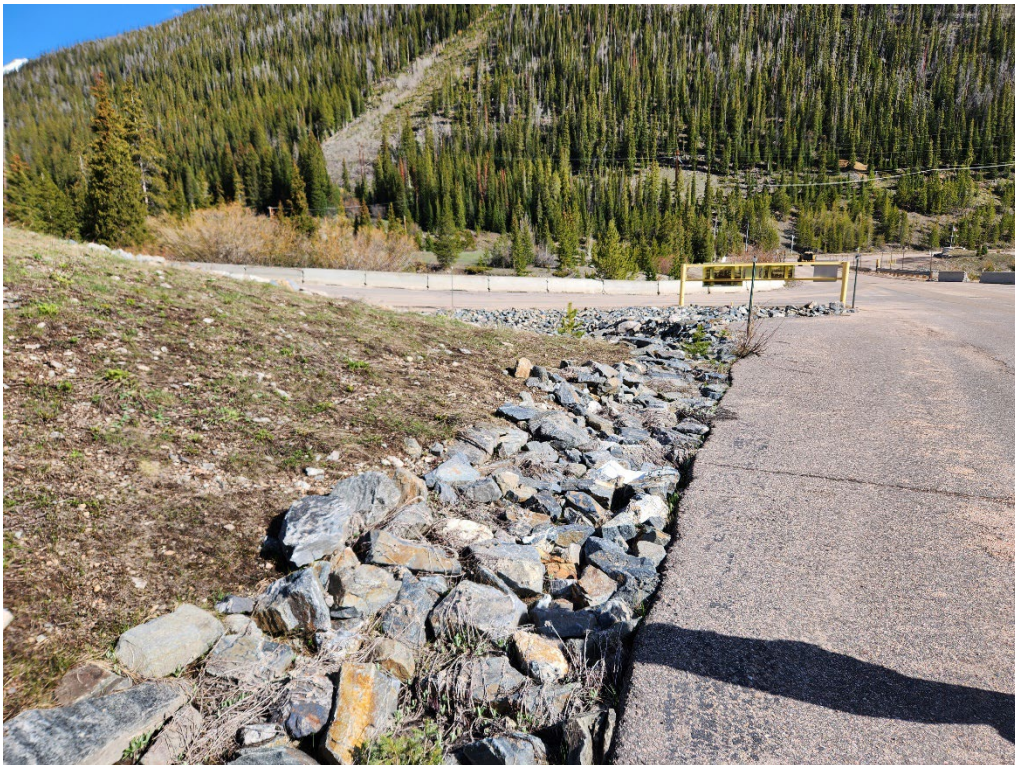
**OF-9 (Photo 3)** – Rip-rap along the western edge of the road leading to an outfall.

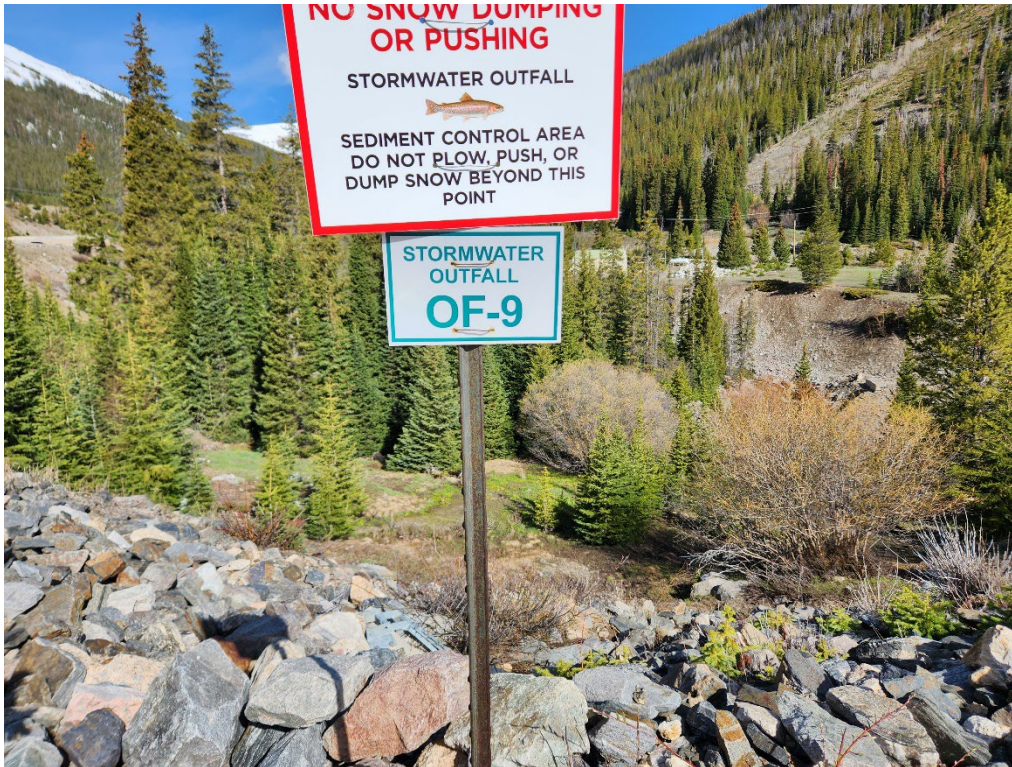
**OF-9 (Photo 4)** – Sign for OF-9. The rip-rap and check dam structures that comprise OF-9 all appeared to be in good condition, and the water moving through these structures during the inspection showed that they were working as intended.

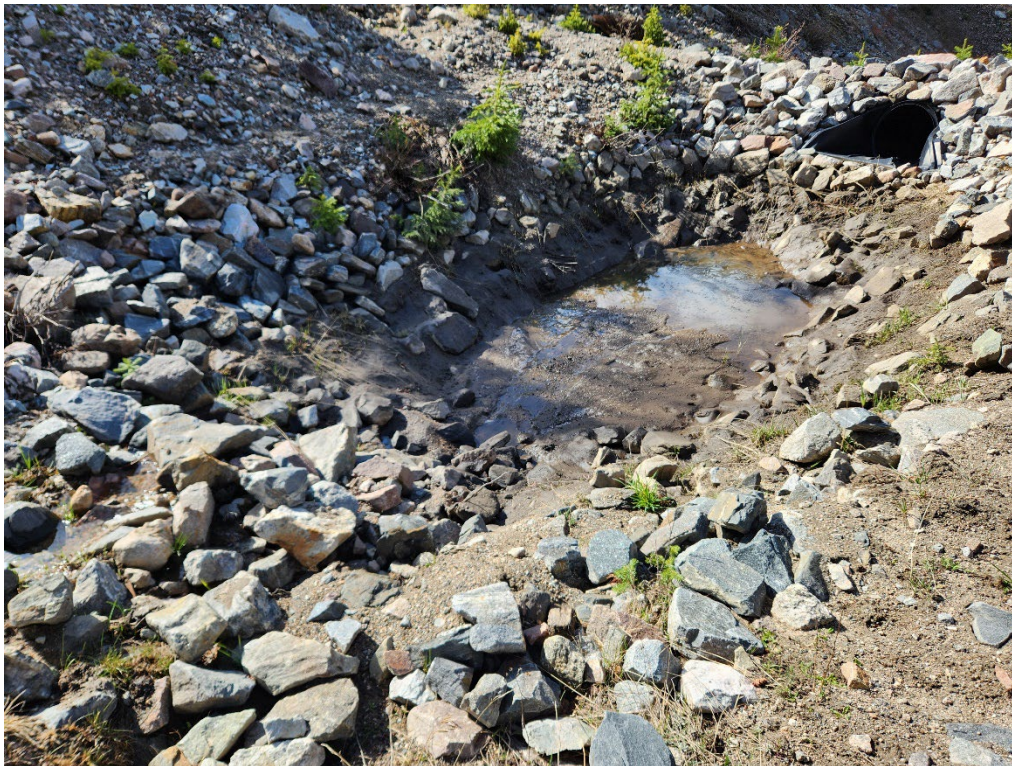
**OF-15 (Photo 5)** – The BMPs for OF-15 consist of rock rip-rap leading to and from a settling basin to slow down stormwater and collect sediment.

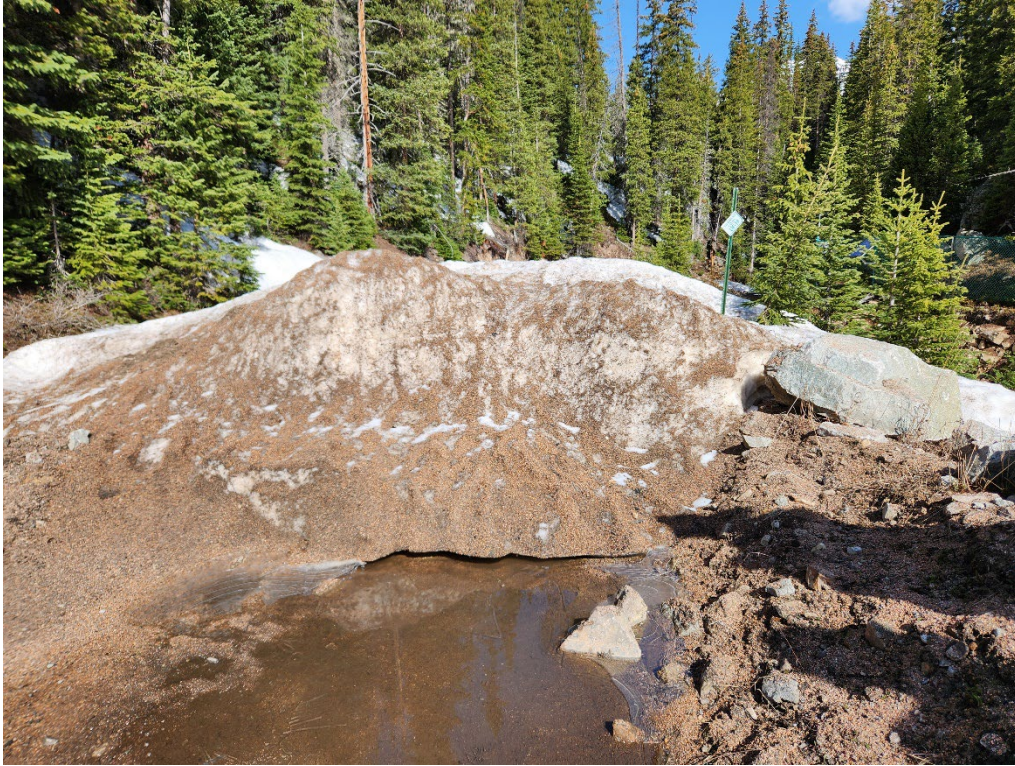
**OF-19 (Photo 6)** – The BMPs for this outfall consist of rip-rap, which was buried under the snow. This image shows water being slowed down at OF-19, showing that this structure is working despite being buried by snow.

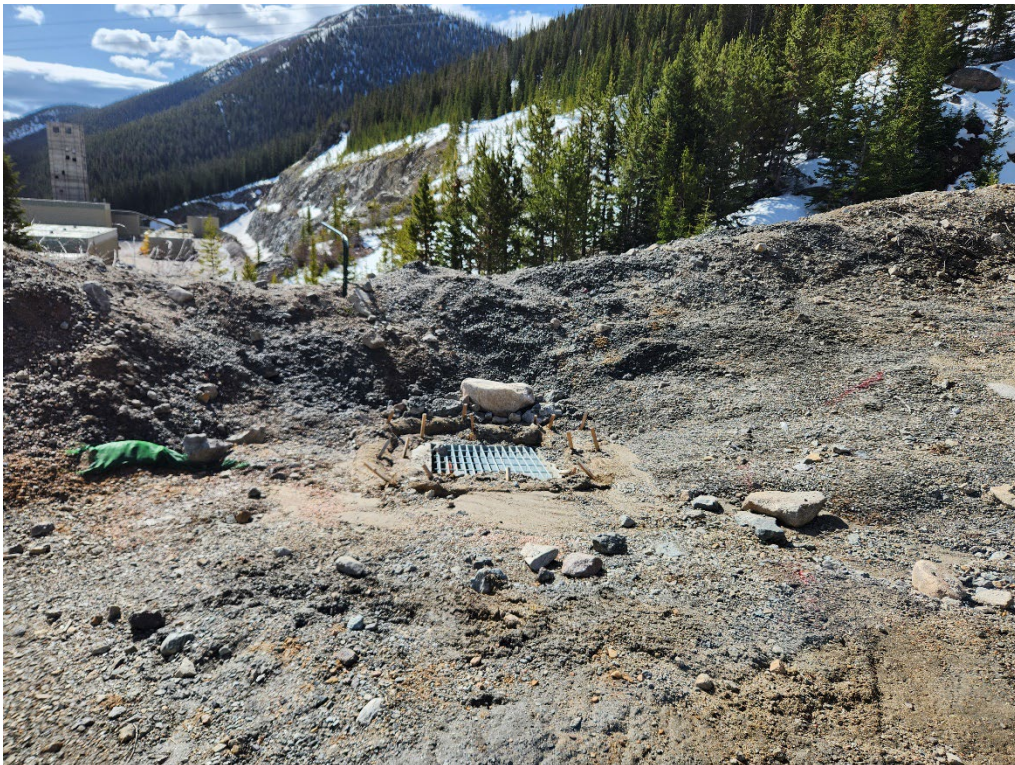
**OF-18 (Photo 7)** – A collecting basin uphill from OF-18 surrounded by straw wattles. This is intended to capture stormwater runoff from the steep slopes in the southwest corner of the mine near the Potable Water System. Sediment will be caught in this basin, and the remaining water moves through a culvert to the outfall.

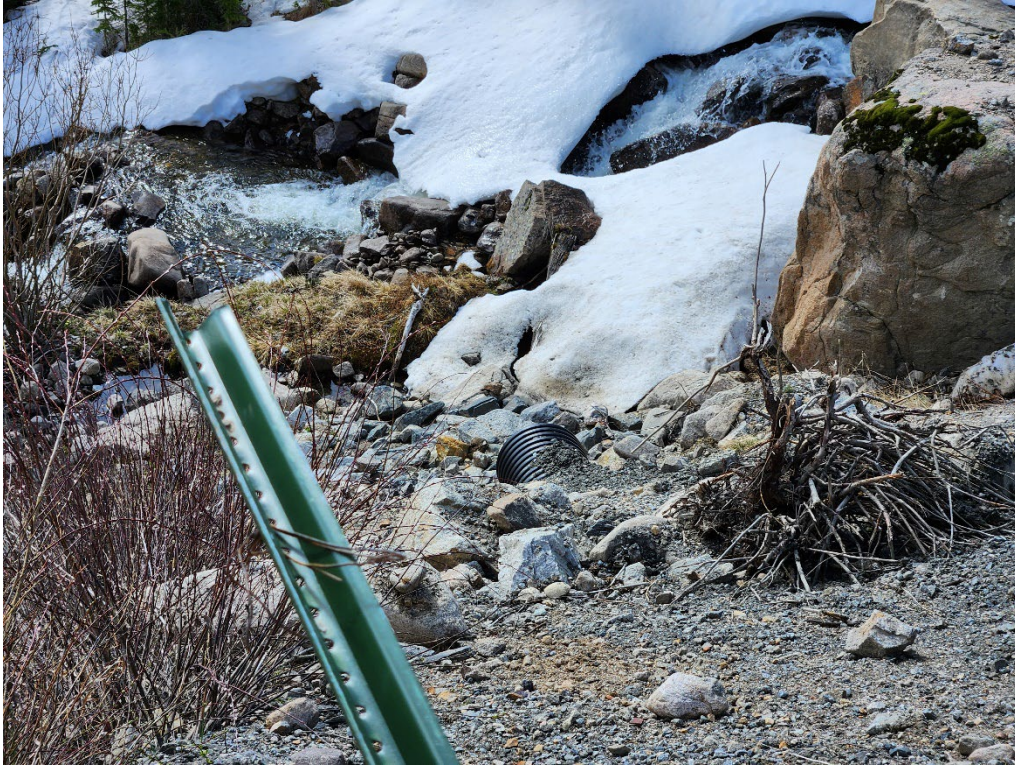
**OF-18 (Photo 8)** – The culvert leads water to some rip-rap. The worn-out straw wattles and sediment deposits in the collecting basin suggest that OF-18 sees a lot of stormwater throughout the year. No water was observed to be moving through OF-18, but it appeared to be in good condition, and there were no signs that this BMP was not working as intended.

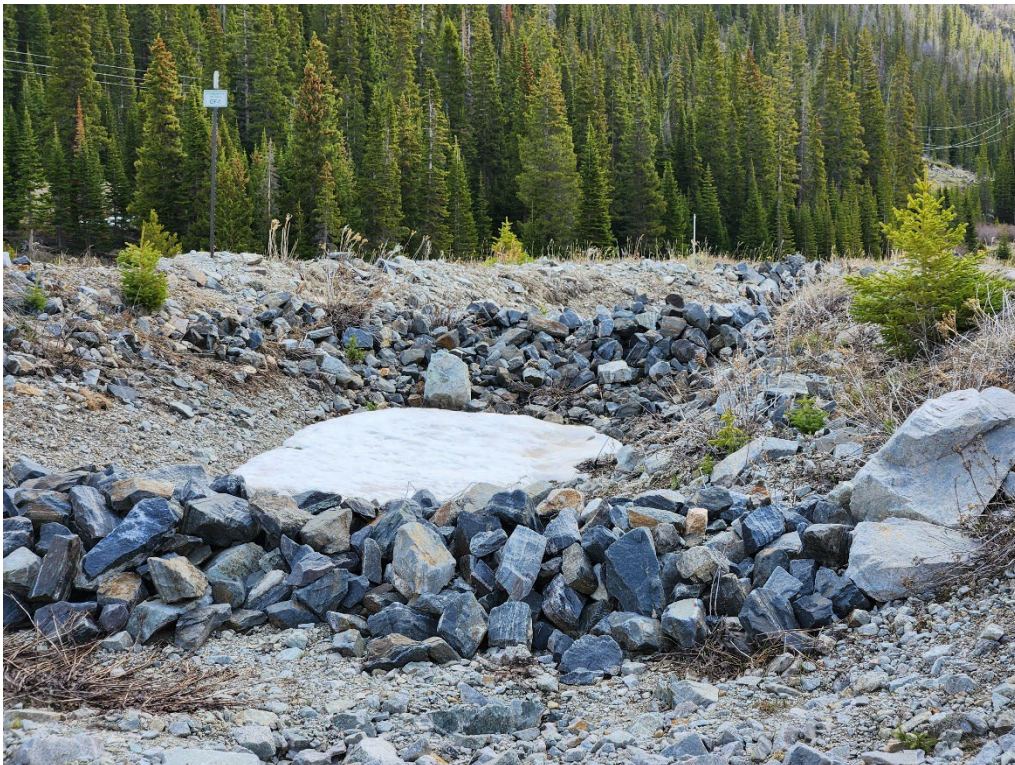
**OF-1 (Photo 9)** – These BMPs are in the northeast corner of the West Lay-down Yard. It is comprised of several rock check dams moving northeast toward the river. No water was observed moving through these

structures during the inspection. OF-1 appeared to be in good condition.

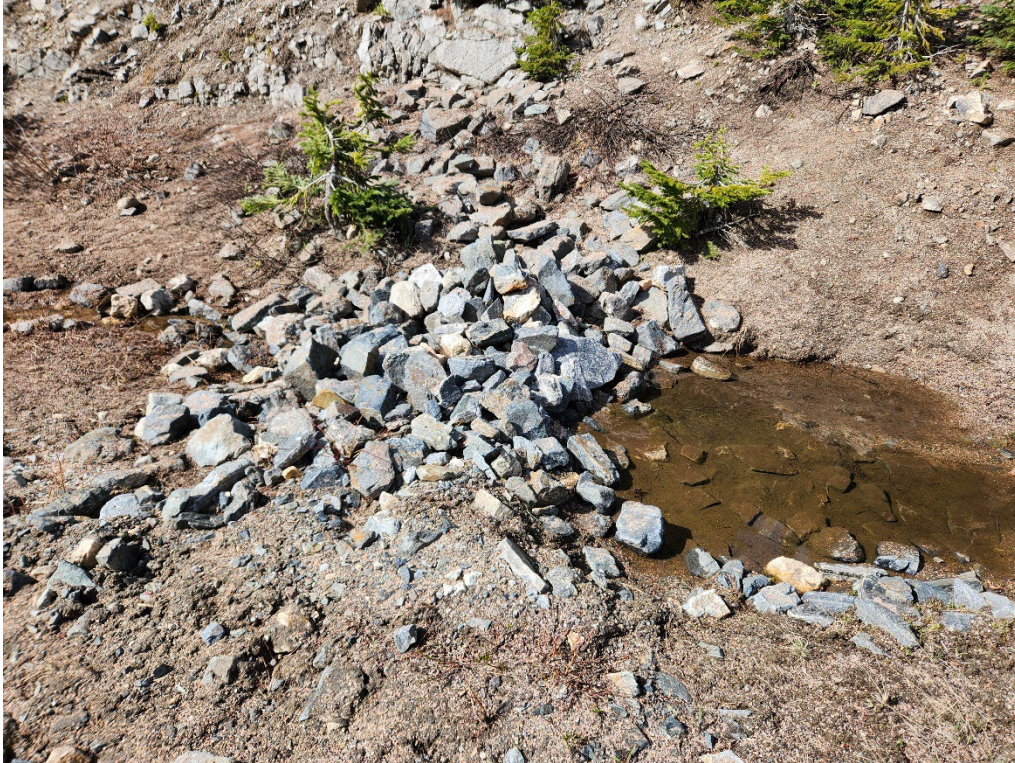
**OF-8B (Photo 10)** – The BMPs for OF-8B are located south of the road, south of the West Lay-down Yard. The image shows one of many rock check dams associated with OF-8B. Water was moving through the dams during the inspection.

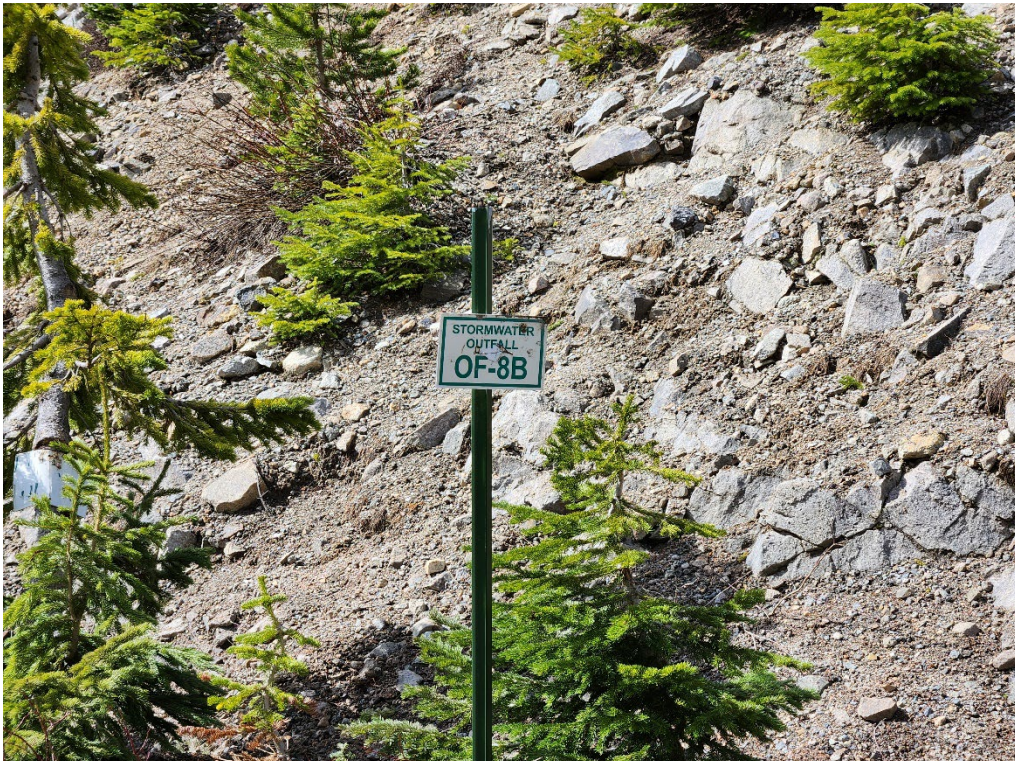
**OF-8B (Photo 11)** – The sign for OF-8B. Overall, the BMPs appeared to be in good condition and were

functioning as intended.

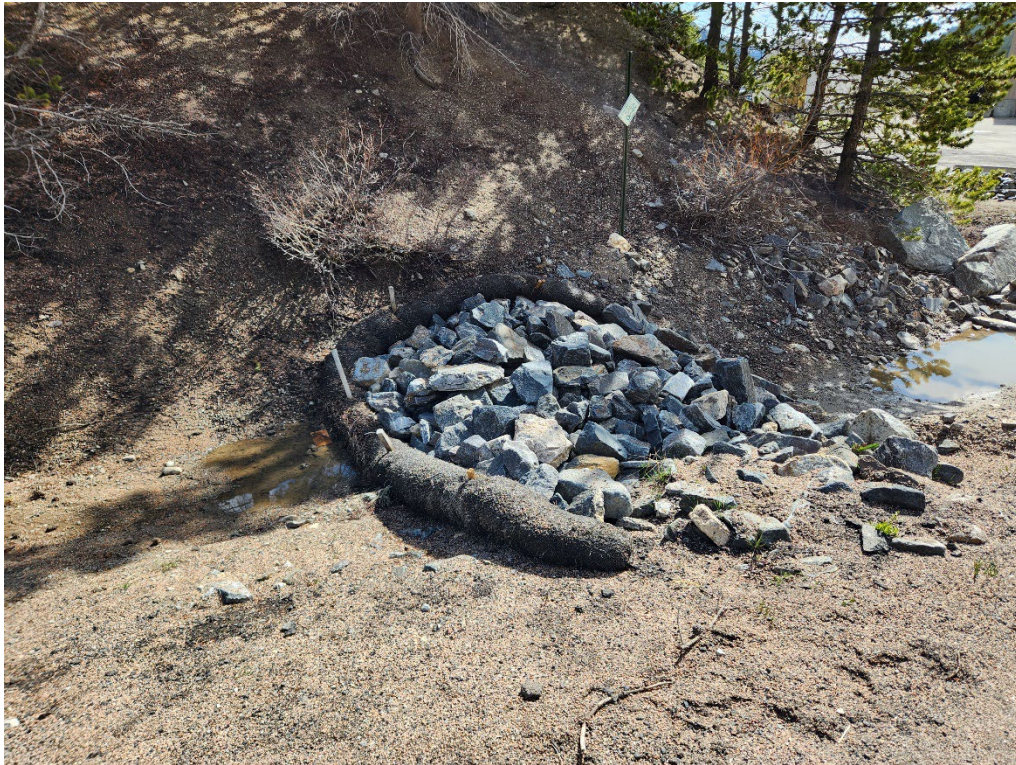
**OF-8C (Photo 12)** – BMPs for OF-8C are found north of the same road. Rock check dams and straw wattles are used in combination here to help slow the movement of water and collect sediment. Water was flowing through these BMPs during the inspection.

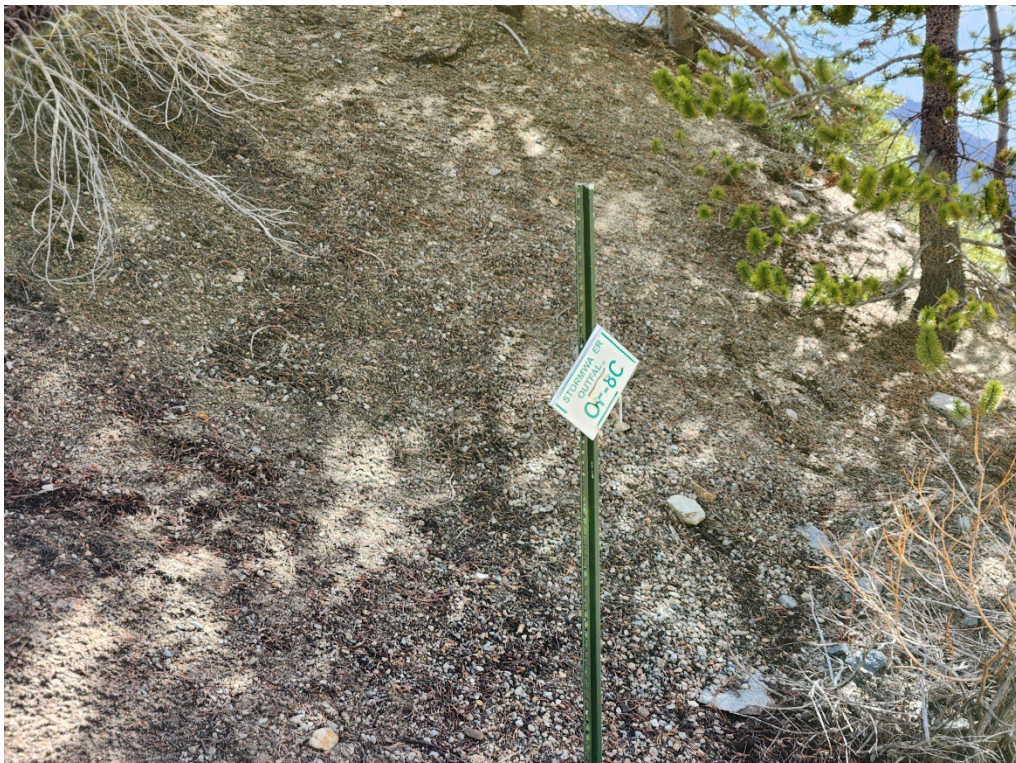
**OF-8C (Photo 13)** – The sign for OF-8C. Overall, the BMPs appeared to be in good condition and functioning

as intended.

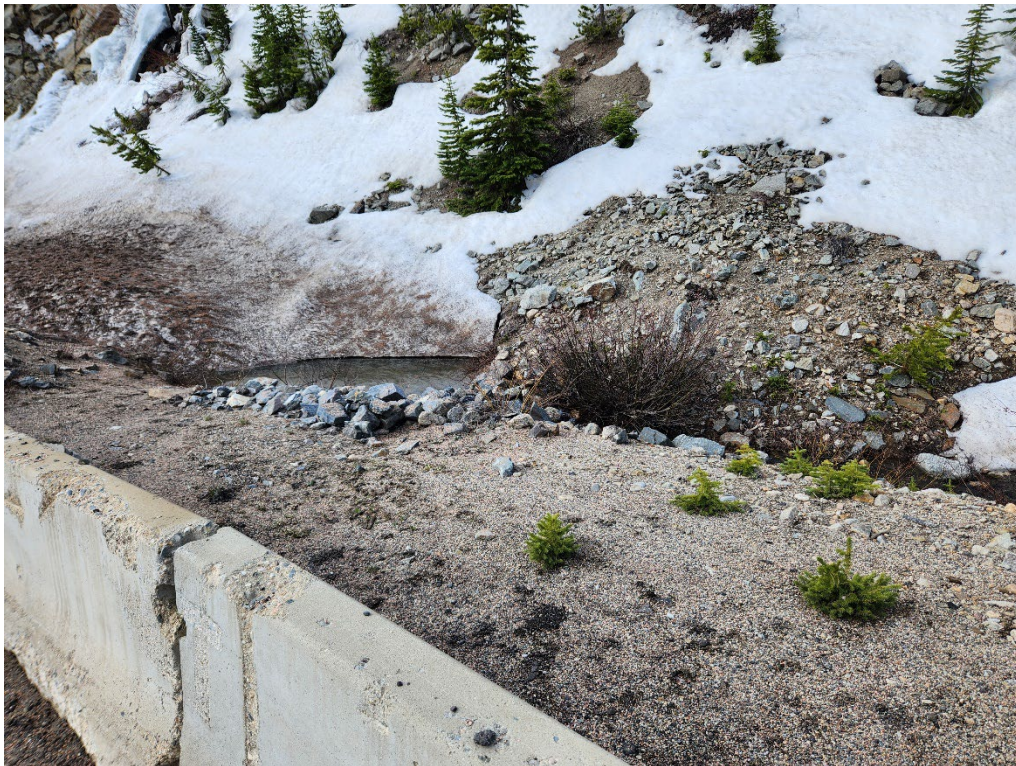
**OF-8A (Photo 15)** – OF-8A is located east of Butler Gulch in the southern end of the site. The BMPs used here are mostly rip-rap, and some of it was buried in snow. Water was moving through the structures during the inspection, and it appeared to be working as intended.

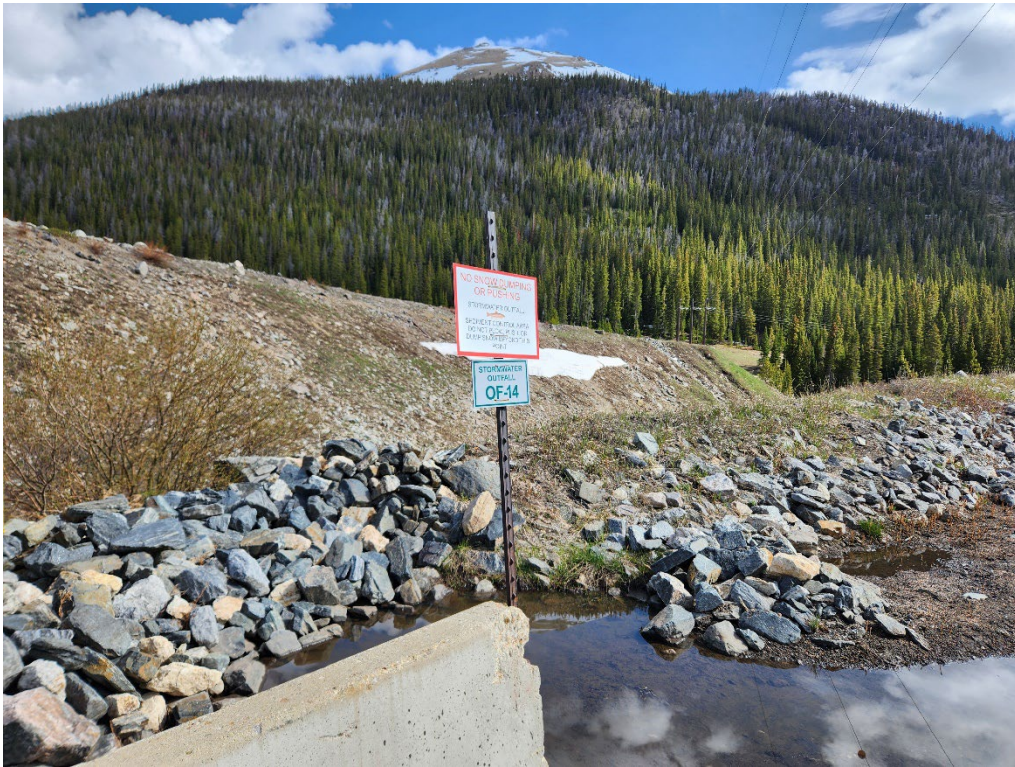
**OF-14 (Photo 16)** – The BMPs for OF-14 include rip-rap and rock check dams west of the Warehouse Docks and Equipment Yard. Water was observed moving through these BMPs, and it appeared everything was working as intended and the structures were in good condition.

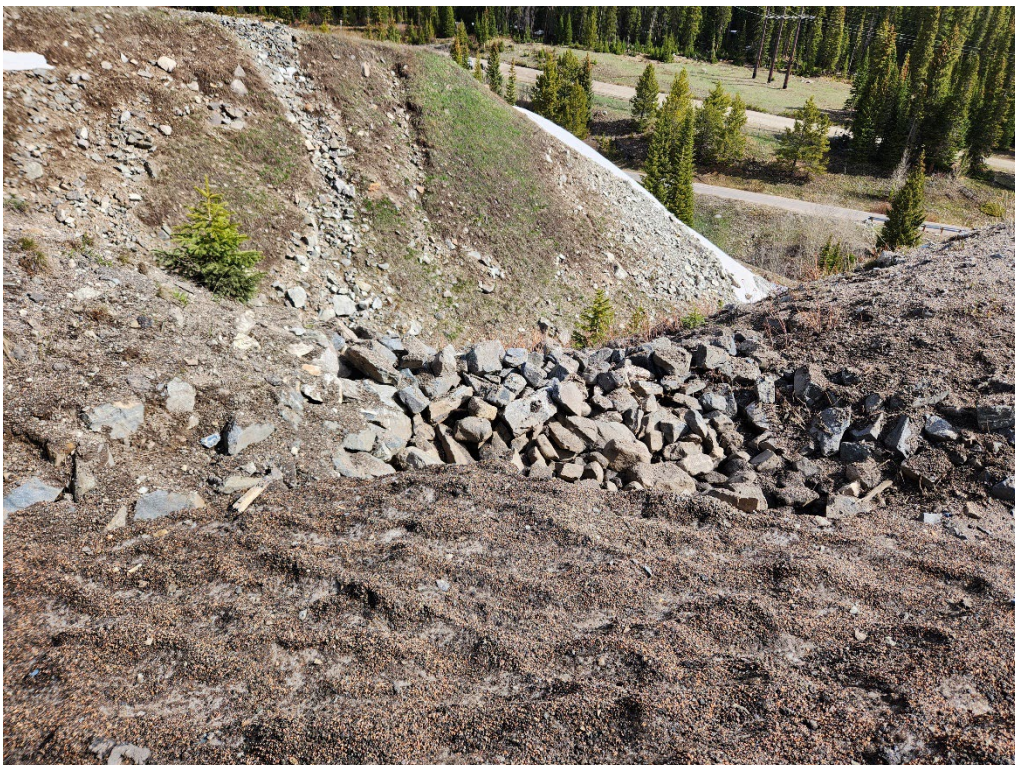
**OF-7 (Photo 17)** – The BMPs for OF-7 are mostly rip-rap that diverts water from the Warehouse Docks and Equipment Yard to Butler Gulch. No water was moving through these structures during the inspection, and it

appears that they were in good condition.

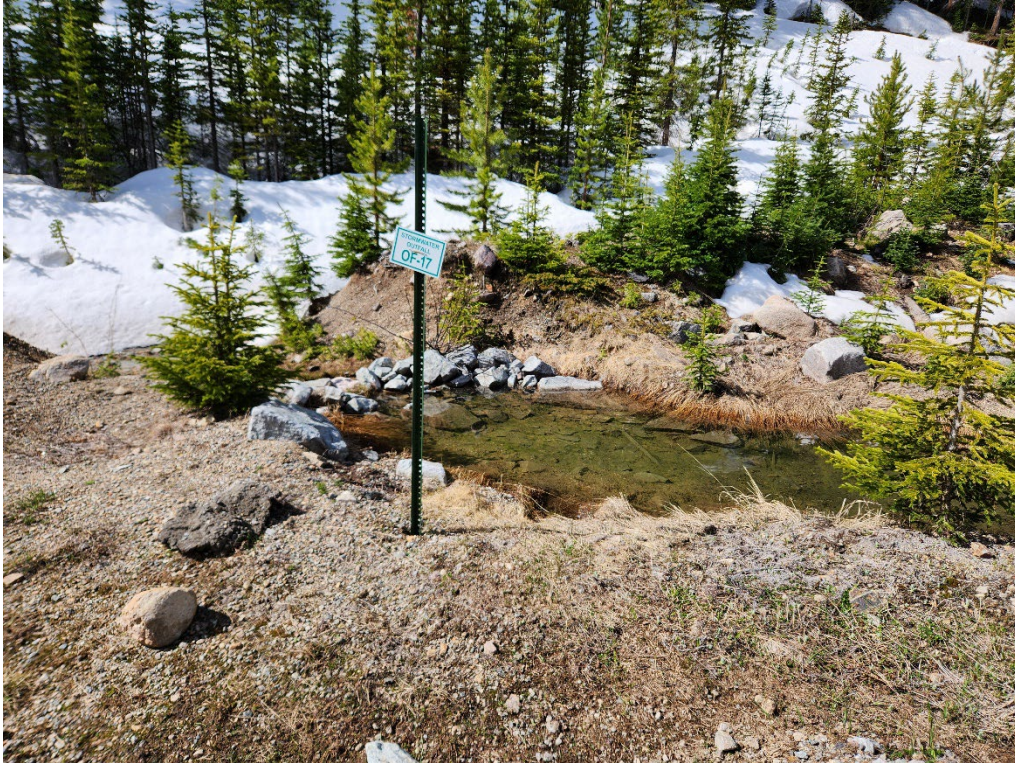
**OF-17 (Photo 18)** – OF-17 is located east of the mine and diverts water to the No-Name Gulch. The BMPs for this include a sediment pond and rock check dams. Water was in the sediment pond and moving through the dam during the inspection. OF-17 appeared to be working and was in good condition.

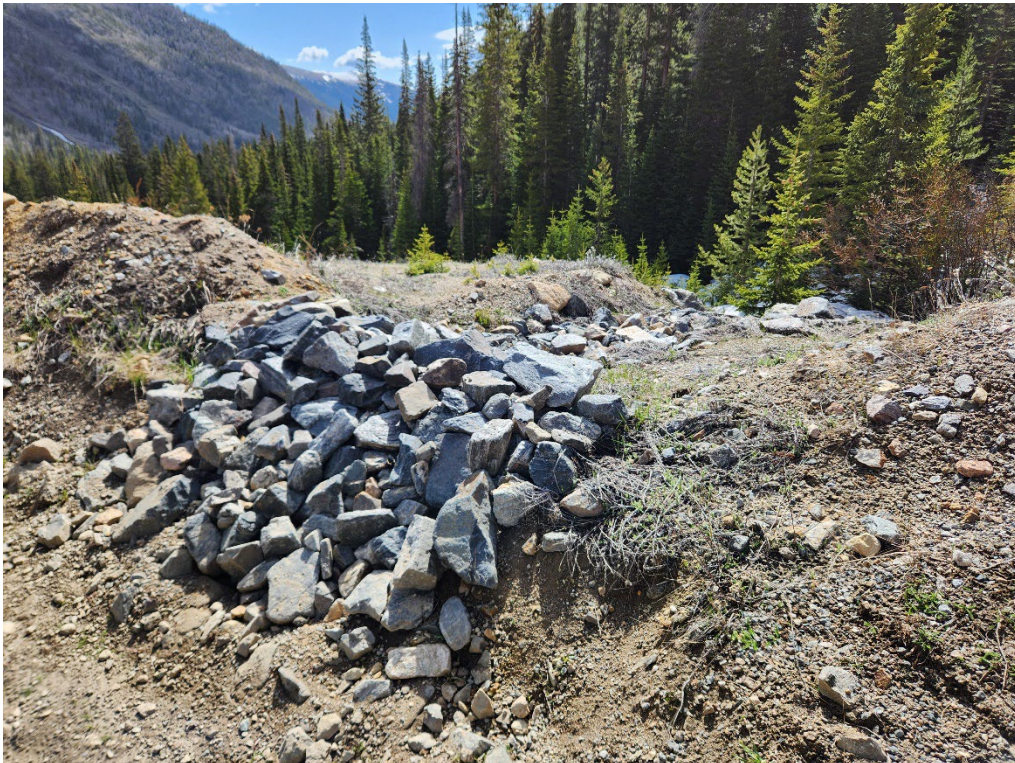
**OF-6 (Photo 19)** – OF-6 is located east of the mine, directly south of OF-17, and functions similarly. There is a

sediment pond that moves water through a check dam and rip-rap. No water was moving through these structures during the inspection, but they appeared to be in good condition.

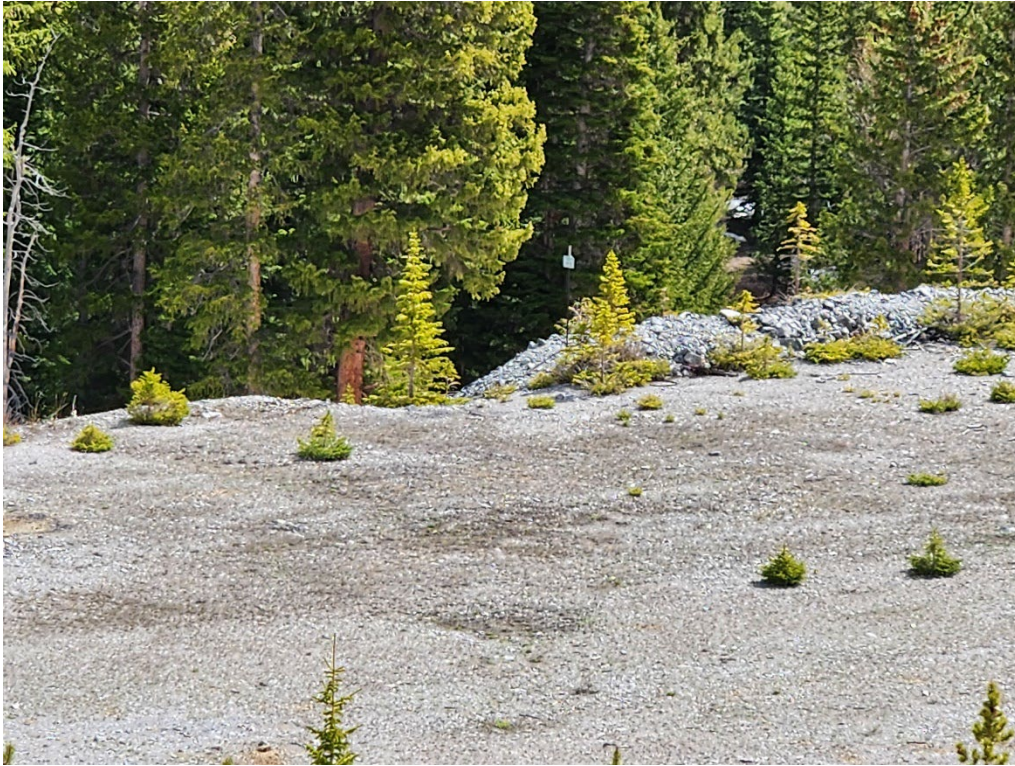
**OF-12 (Photo 20)** – OF-12 was not accessible by vehicle, but was visible from the road on site. OF-12 is mostly comprised of rip-rap along the northeastern edge of the site. No water was moving through these structures during the inspection, but they appeared to be in good condition.

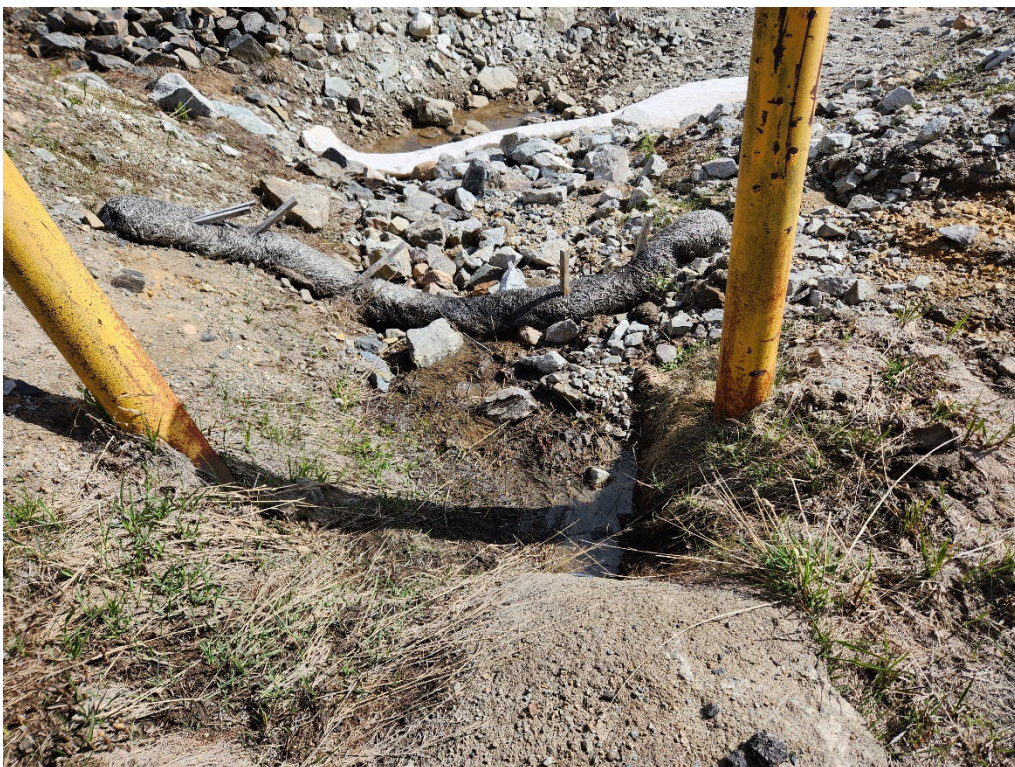
**OF-5 (Photo 21)** – OF-5 is located just northeast of the #5 Shaft Yard. The BMPs include a sediment pond, straw wattles, rock check dam, and rip-rap. There was no water moving through these structures during the inspection, but they appeared to be in good condition.

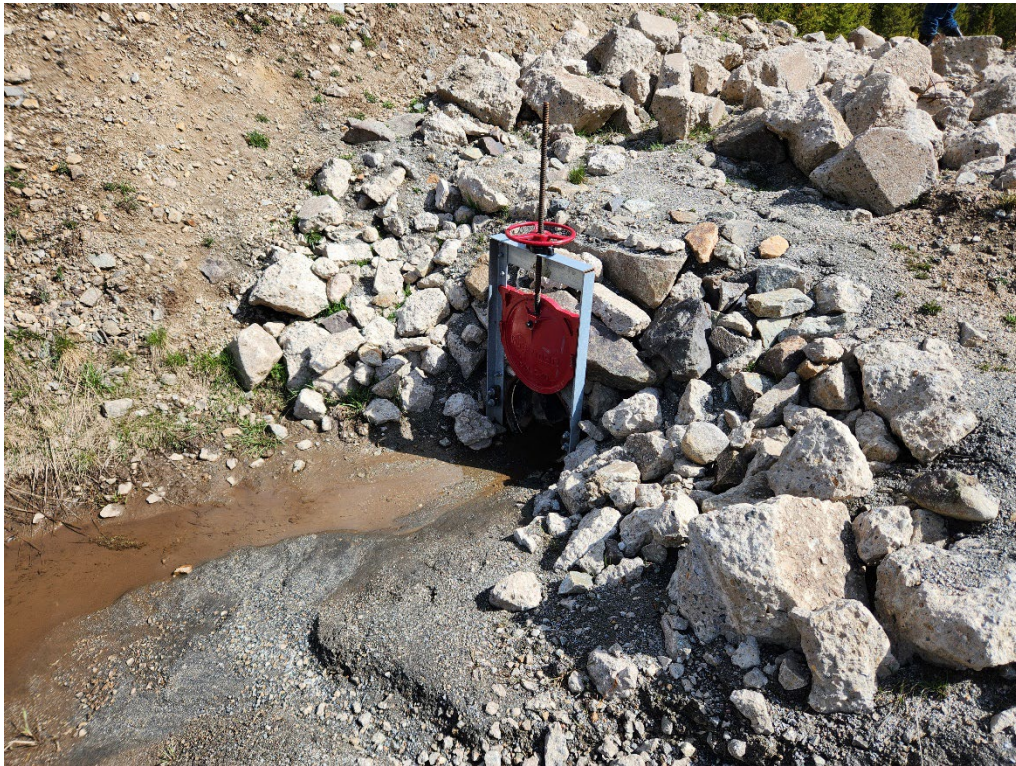
**OF-3 (Photo 22)** – The structures for OF-3 are located north of the Lower Yard Fuel Island. The BMPs used include rip-rap and a sediment pond. Water is moved toward the Clear Creek West Fork through these BMPs. Last year, a gate was added to a culvert fed from a channel near the fuel island as an additional containment feature in case of a failure with the fuel island storage. This gate can be closed to block spilled fuel from the rest of the BMPs.

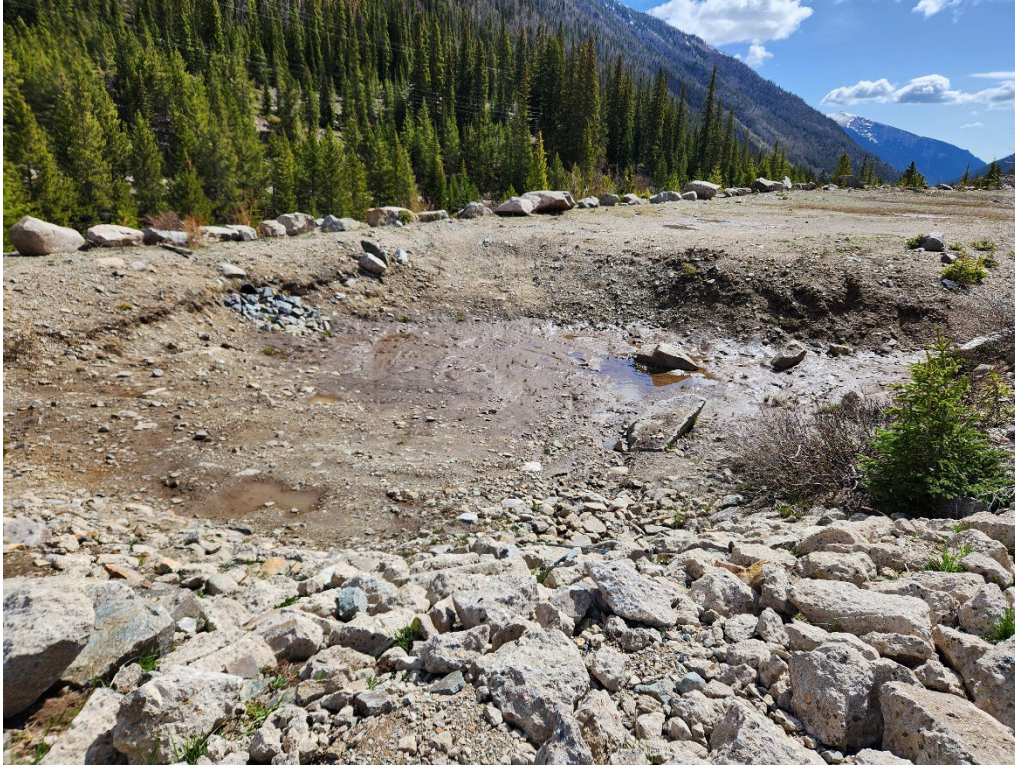
**OF-3 (Photo 23)** – The sediment pond for OF-3. Some water was in the pond. It appeared that the BMPs for OF-3 were functioning as intended and were in good condition.
