MINERALS PROGRAM INSPECTION REPORT
PHONE: (303) 866-3567

MINE NAME: Perrino Pit	MINE/PROSPECTING ID#: M-2017-007	MINERAL: Sand and gravel	COUNTY: Huerfano
INSPECTION TYPE: Monitoring	WEATHER: Cloudy	INSP. DATE: June 11, 2025	INSP. TIME: 13:35
OPERATOR: Colorado Crushing, Inc.	OPERATOR REPRESENTATIVE: Rocky Ryan	TYPE OF OPERATION: 112c - Construction Regular Operation	
REASON FOR INSPECTION: Normal I&E Program	BOND CALCULATION TYPE: Complete Bond	BOND AMOUNT: \$92,100.00	
DATE OF COMPLAINT: NA	POST INSP. CONTACTS: None	JOINT INSP. AGENCY: None	
INSPECTOR(S): Amber M. Gibson	INSPECTOR'S SIGNATURE:

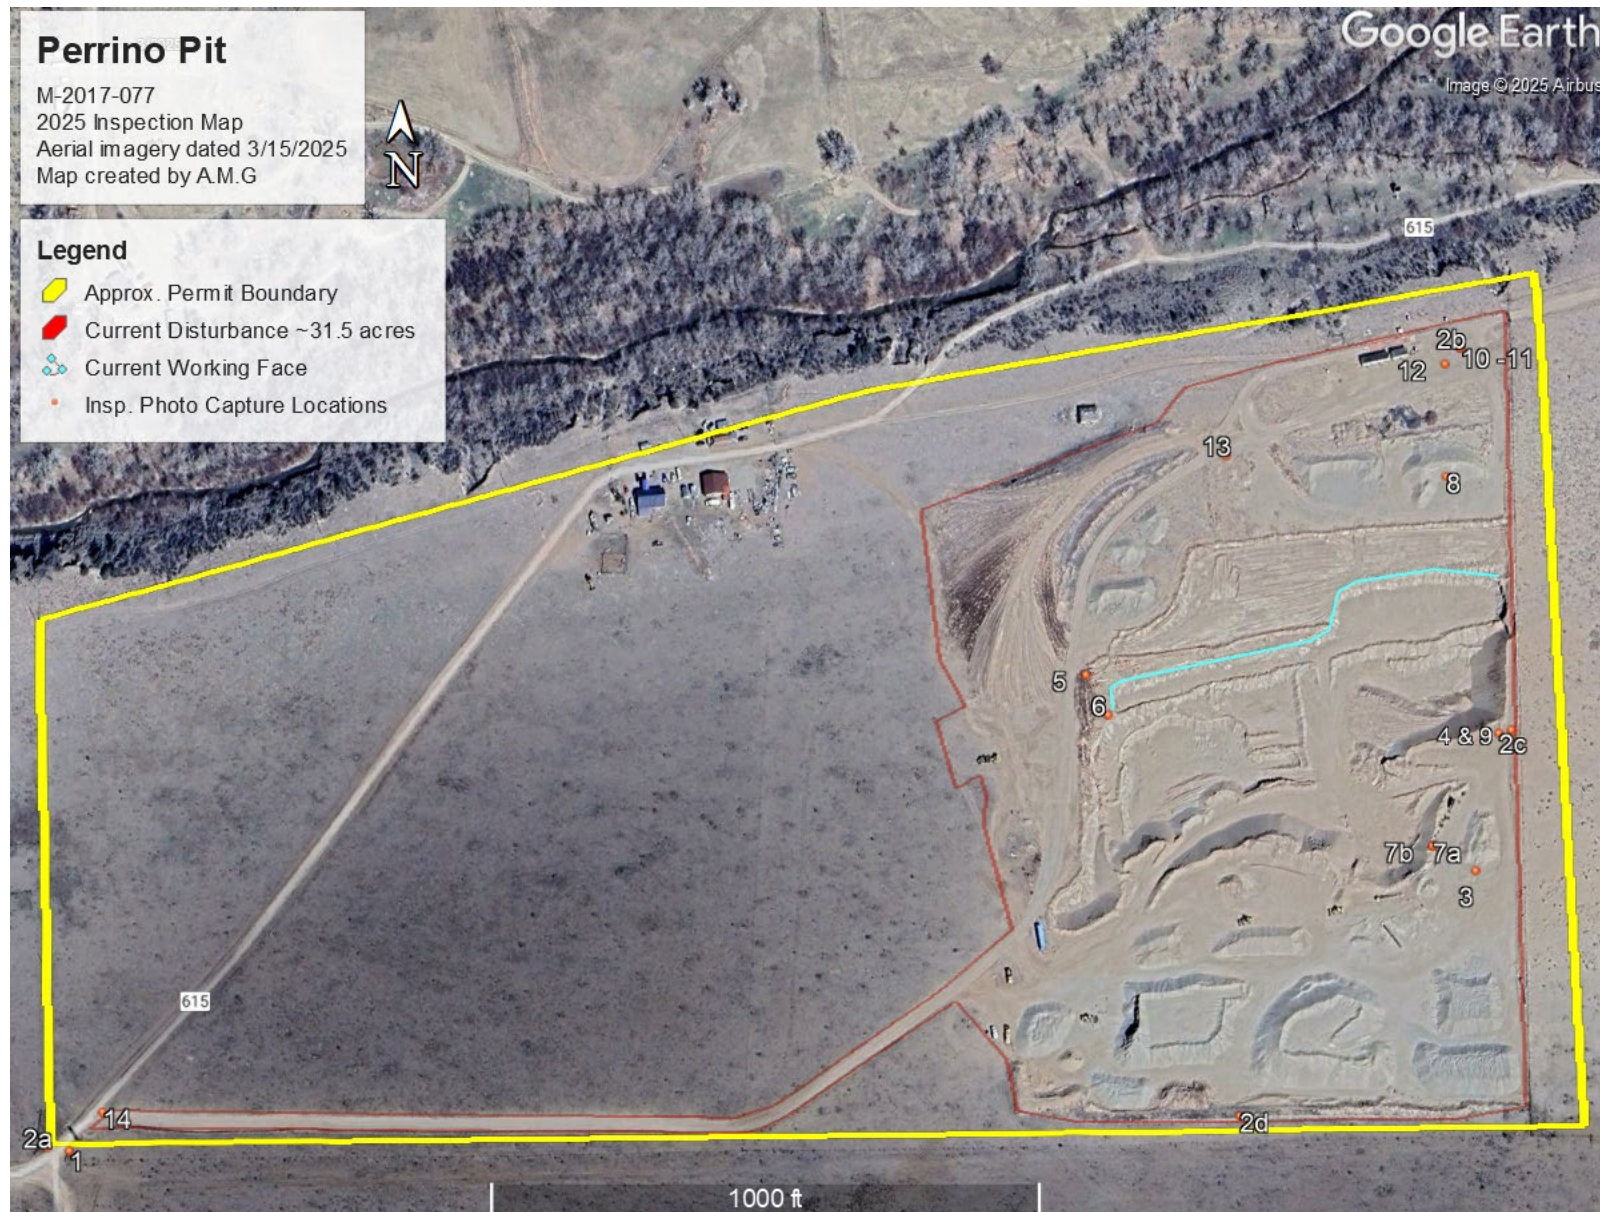
Map 1: 2025 Inspection Report map of the Perrino Pit, inspected on June 11, 2025. Map 1 was generated using Google Earth Pro. The numbers associated with the locations where the photos within this inspection report were taken correspond with the photo captions below.

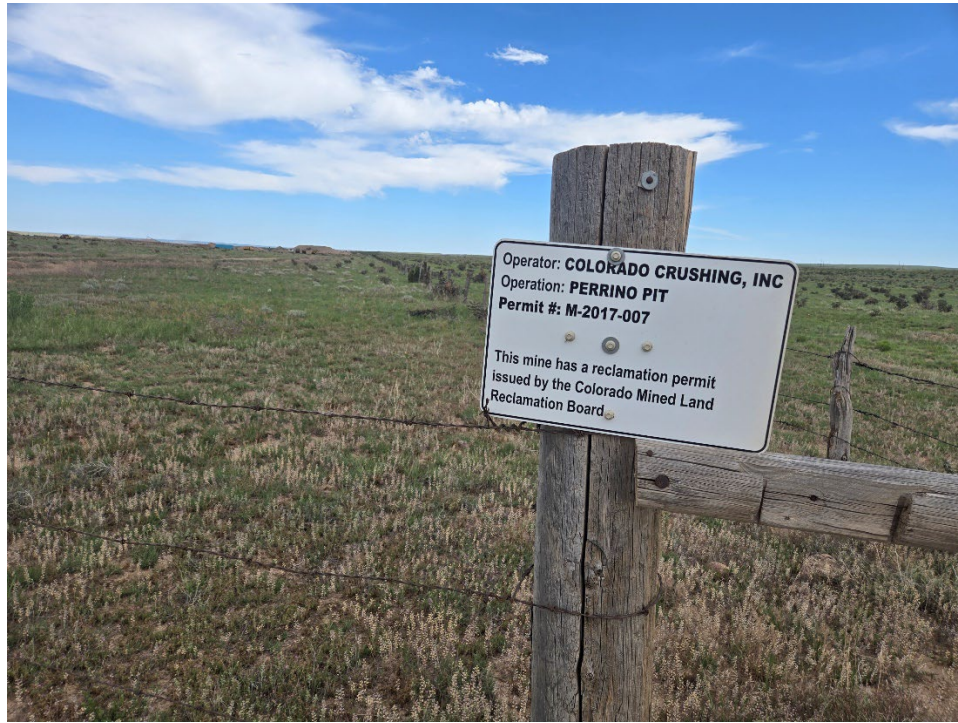
Mine signs, in compliance with Rule 3.1.12(1), were located both at the site's current southwest entrance and at the old northwest entrance. White PVC, atop t-posts, mark the permit boundary. The permit boundary appeared to be accurately marked and in compliance with Rule 3.1.12(2). The fence line on the west side of the permit is located inside the permit boundary, on the south side it is located outside of the permit boundary, and on the east side it follows the permit boundary. The white PVC-topped t-posts indicate these relationships along the boundary. The Operator stated that they do not plan to extend the disturbance any further to the east, and will remain within the eastern fenceline.

Photo 1: Looking east at the mine sign posted at the currently used southwest corner of the permit boundary.

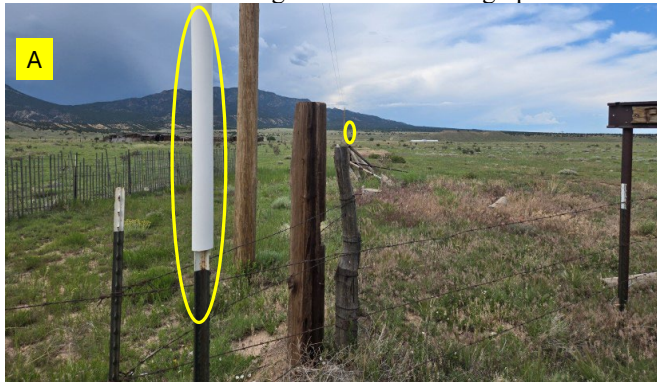
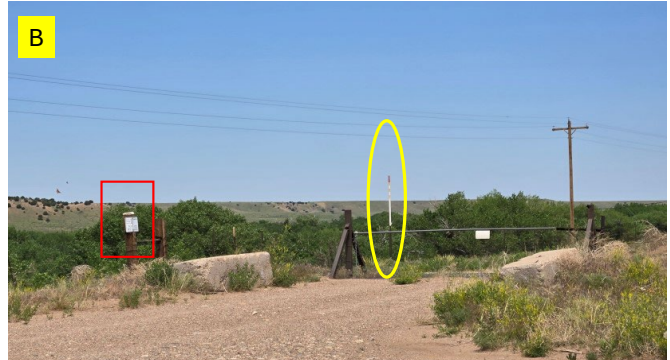
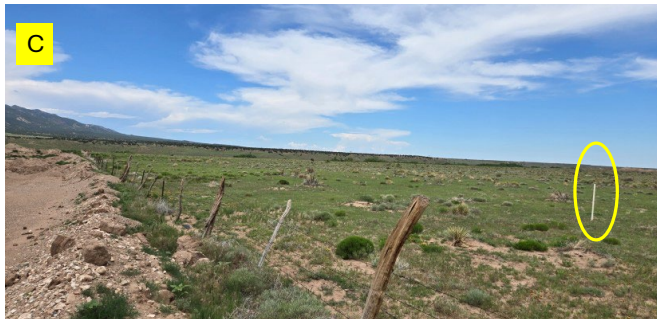
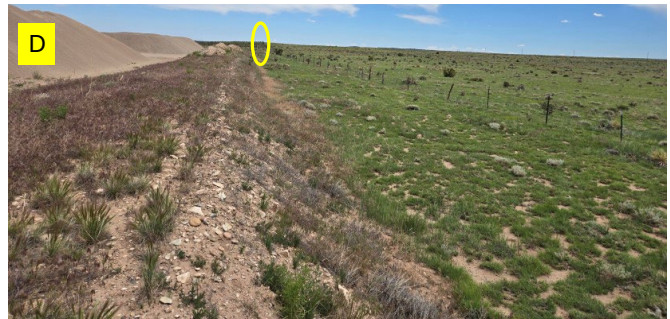
Photo 2: Examples of the white PVC pipe-topped t-posts serving as permit boundary markers around the site (circled in yellow). (A) Markers along the fence running north to south along the west permit boundary. (B) The red square highlights the mine sign located at the old northeast entrance. (C) Looking past the north-south fence line on the east side of the permit to where the permit boundary is located beyond. (D) Looking east along the stormwater berm lining the southside of the disturbance. Circled is a permit boundary marker, located inside of the fence that runs east-west below the southern permit boundary.

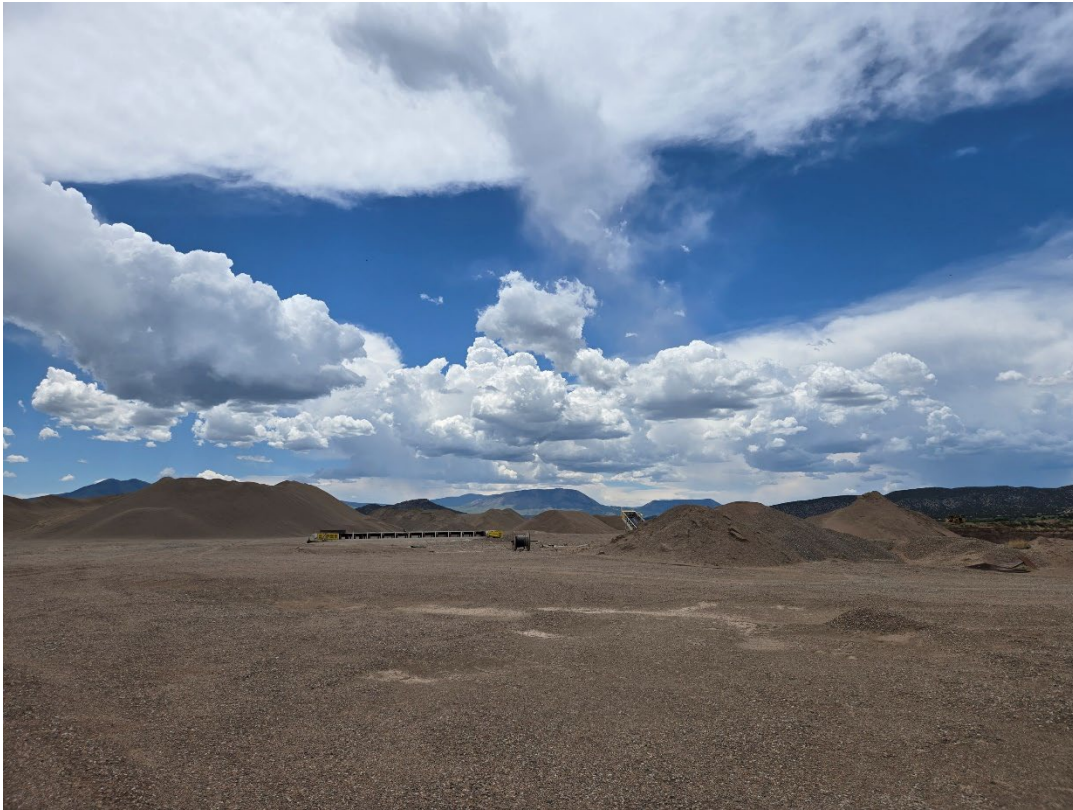
The site was active at the time of the inspection. The Operator stated that excavation and crushing at the site last took place about six months ago. There is a significant amount of product separated into designated stockpiles that will be hauled off-site throughout the year. Excavating and crushing will resume once stockpiles are depleted, which the Operator believes will be later this year. Product is primarily stockpiled along the south side of the disturbed area, located within the southeast side of the permit boundary. A small amount of product is also stockpiled on the north side of the disturbance.

Photo 3: Looking east at the various sorted product stockpiles onsite. Loaders were onsite and hauling material offsite during the inspection.

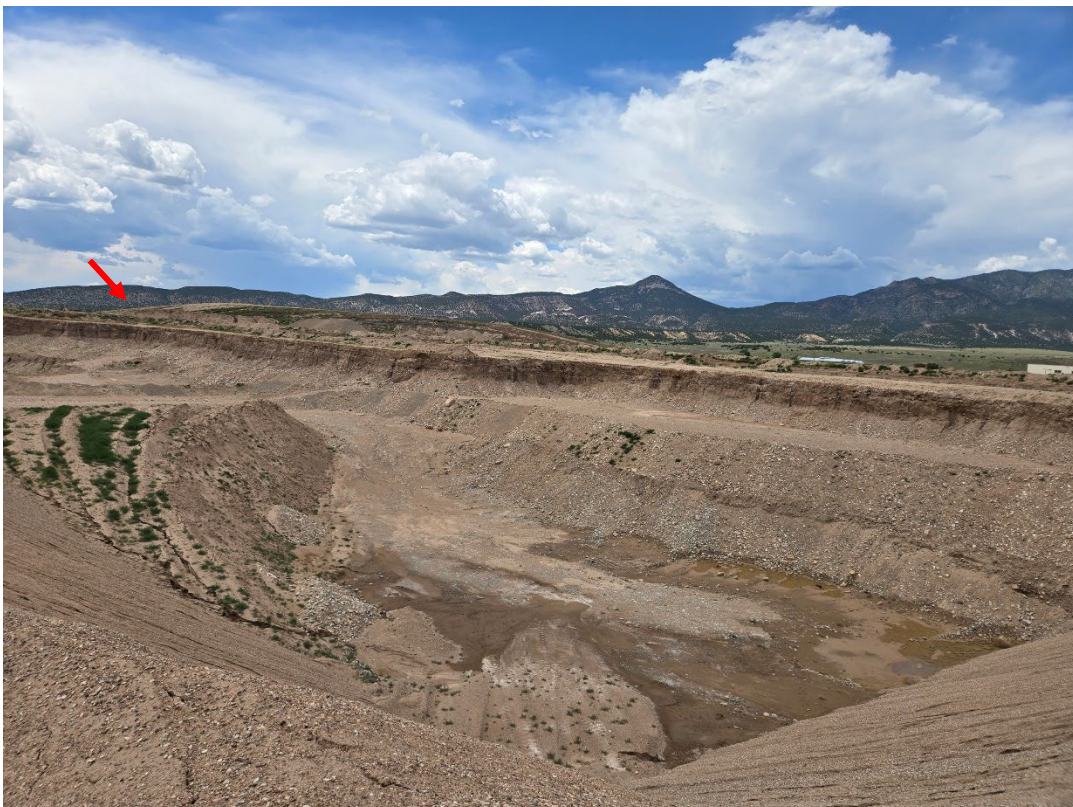
Mining began on the southeast side of the permit area and has progressed to the north and to the west. The pit is approximately 30 feet deep. As excavation progresses along the working face, processing fines are used to backslope mined out slopes to at least a 2H:1V configuration, with some slopes on portions of the south and west sides at nearly 3H:1V configurations. Highwalls within the pit are benched, so that the vertical sections above are between 12-15 feet deep and the lower portions of the benches are back-sloped to a 2H:1V slope. Along the east side of the pit, there is a mining setback for vehicle traffic and for the Operator to conduct final backfilling and grading to a 3H:1V slope using the cut/fill method.

Photo 4: Looking northwest at the main working face. Along the bottom of the photo shows areas where reject fines have been used to backslope to a 3H:1V. Within the pit, slopes that have been back-sloped to at least a 2H:1V are seen.

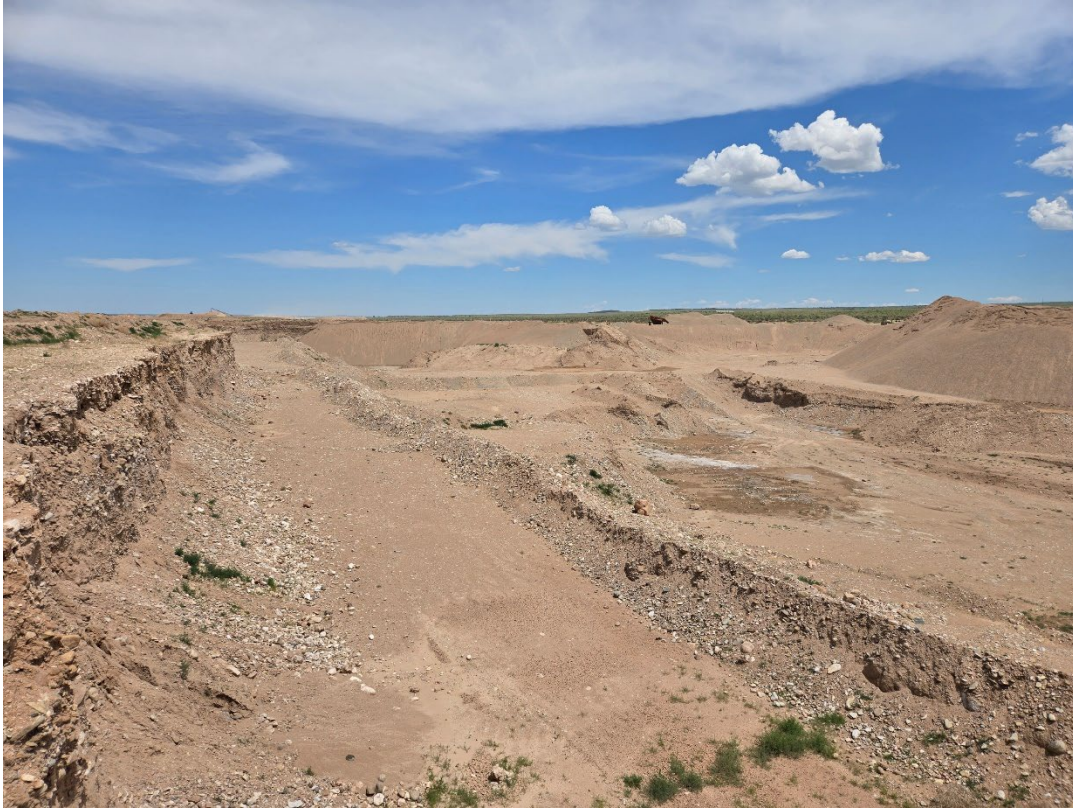
Photo 5: Looking east along the northern working face. At the base of the working face is the benched area. Below the benched area the slopes are backsloped to at least a 2H:1V.

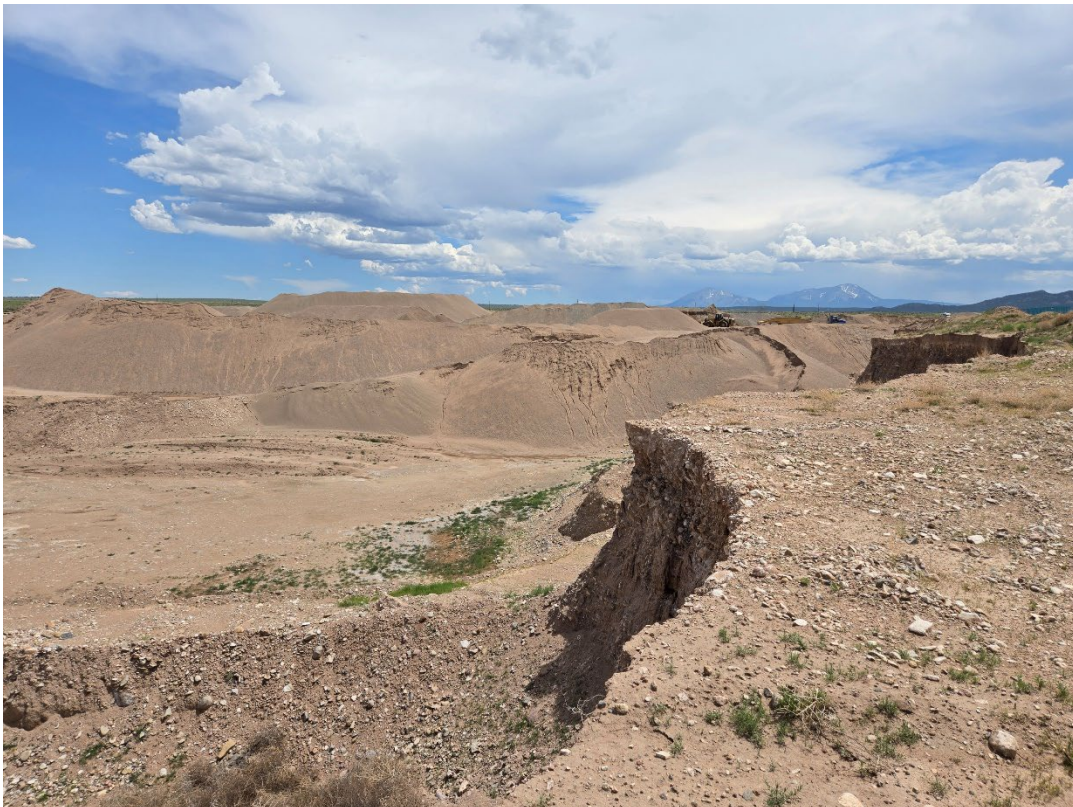
Photo 6: Looking south along the west portion of the working face. Areas where the mined-out southern face has been at least partially backsloped are located in the center of the photo, with the southern stockpile/processing area in the background.

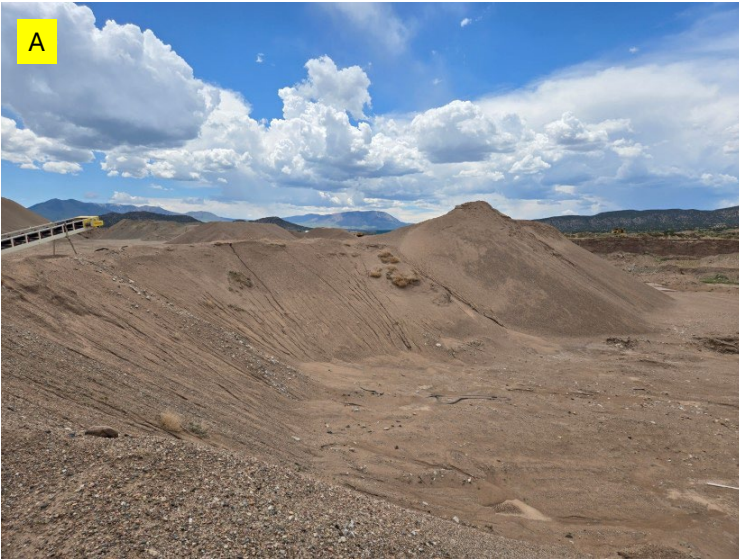
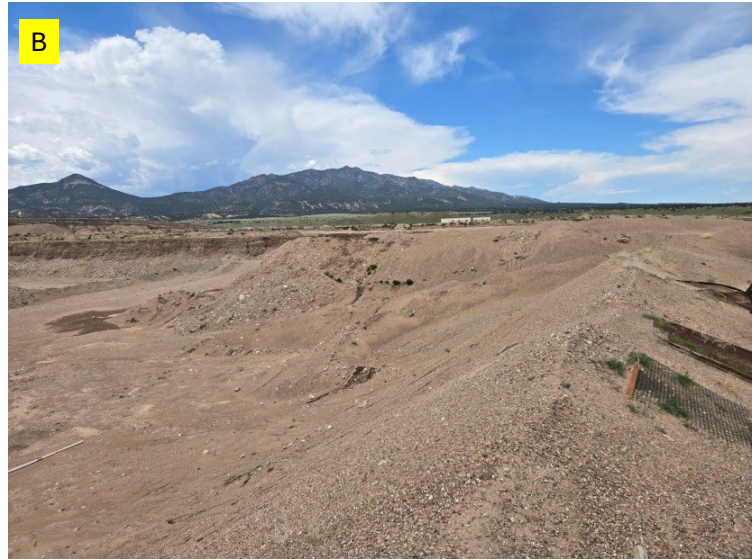
Photo 7: (A) Looking at some 2-3H:1V back-sloped slopes along the south side of the pit. (B) Looking at some 2-3H:1V back-sloped slopes along the east side of the pit.

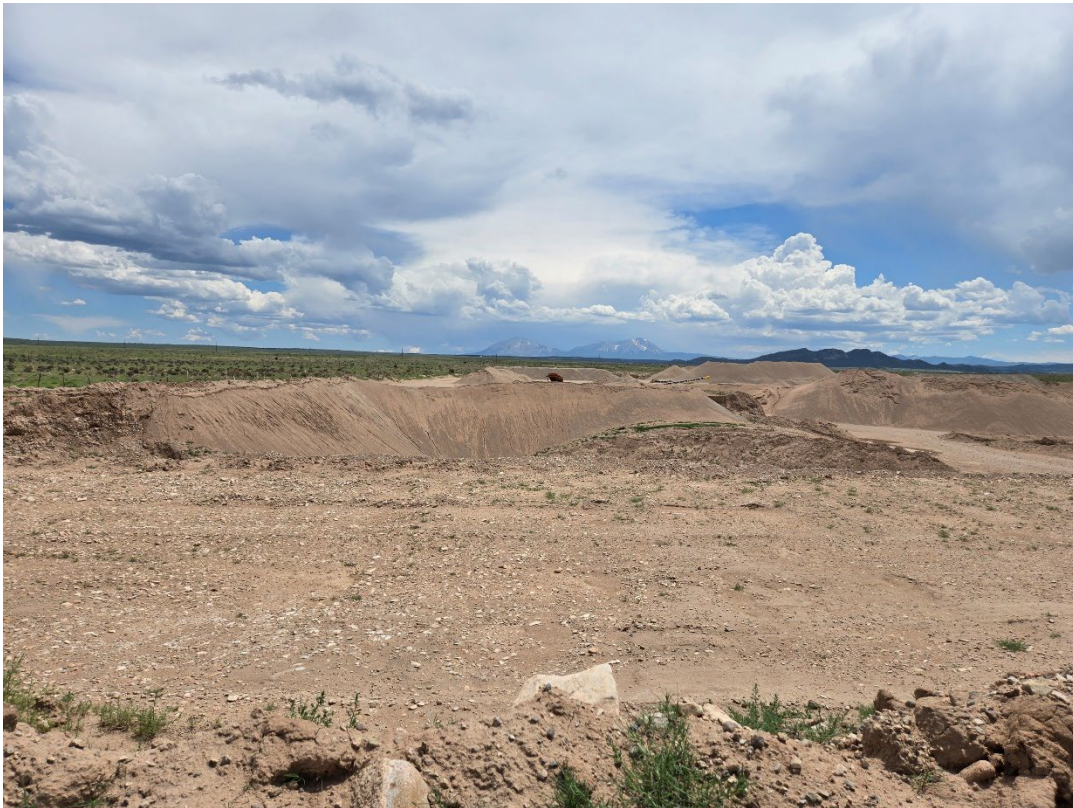
Photo 8: Looking at some 2-3H:1V back-sloped slopes along the east and south sides of the pit.

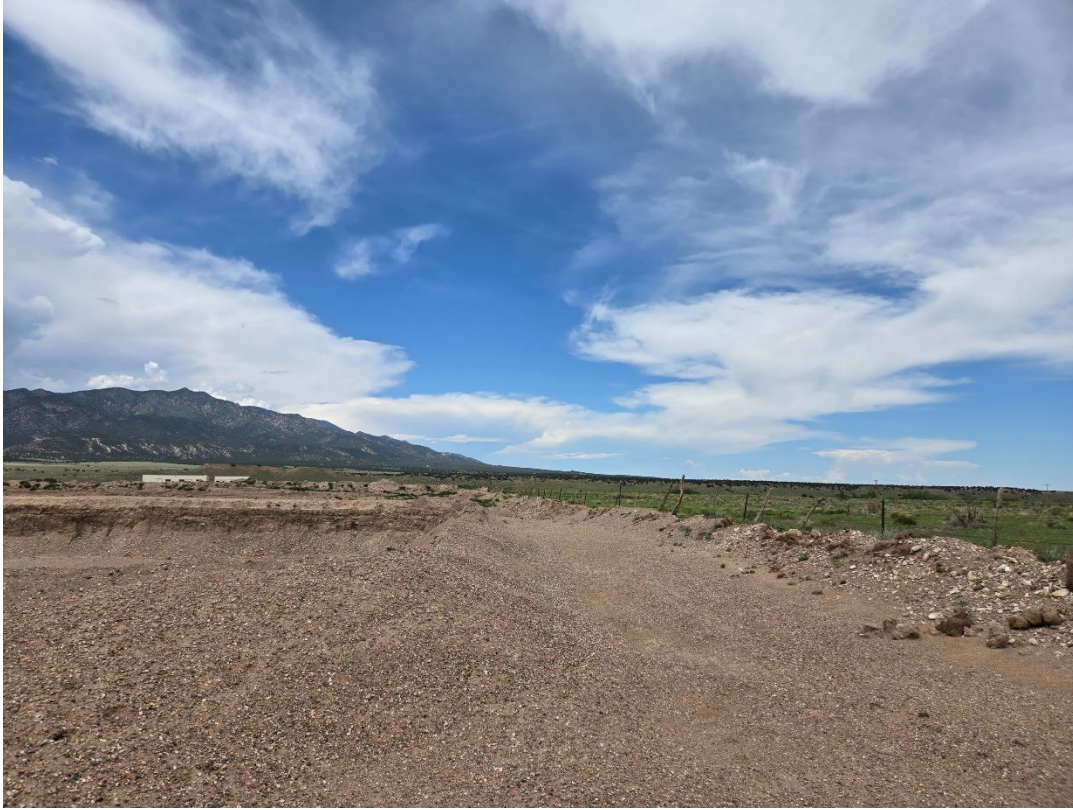
Photo 9: Looking north along the eastern fence line where room has been left for vehicle traffic and for final backfilling and grading.

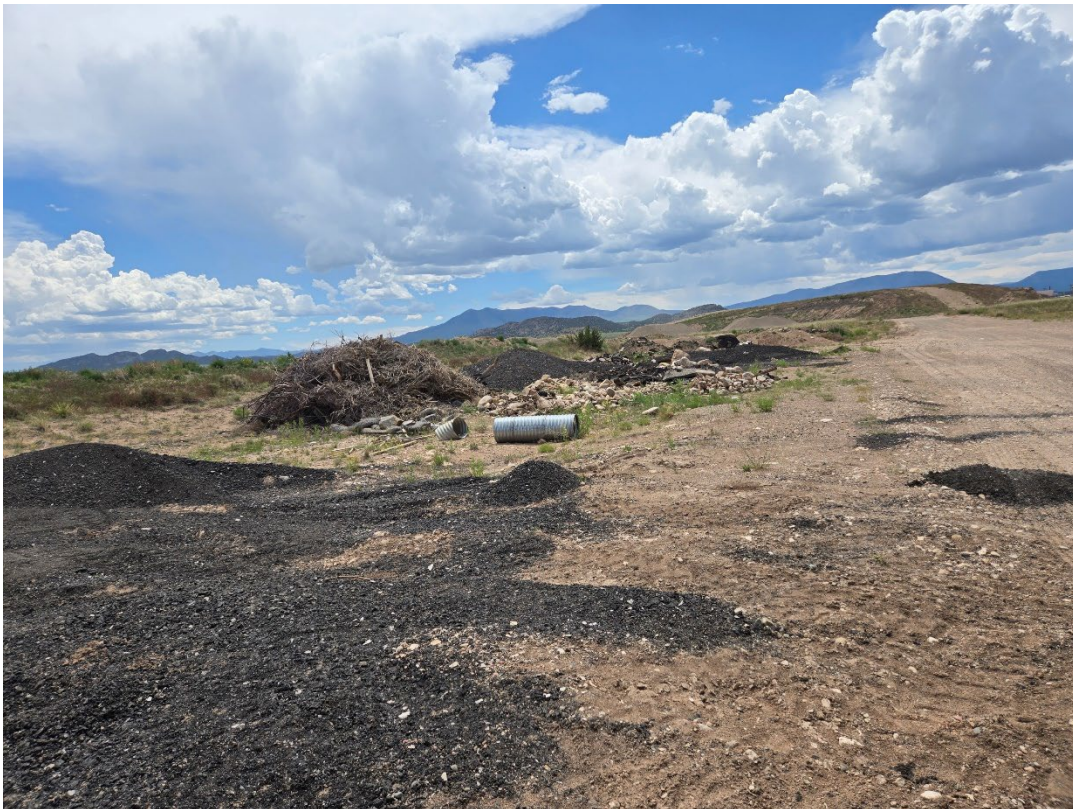
On the north side of the site, there is a temporary truck scale, an office trailer, some refuse piles, and a fuel tank. The Operator stated that the office trailer and the refuse piles belong to CDOT, who are working on a nearby project and were given permission by the Operator to temporarily operate onsite. The Operator stated that they will soon remove the refuse, and their trailer, when their project finishes. The fuel storage onsite was contained within a double-walled tank and was inside an additional containment berm. The truck scale is approved to eventually move to the southwest side of the site via the approval of technical revision no. 1 (TR1) in 2021.

Photo 10: Looking at the refuse material brought into the site from CDOT that will be removed once CDOT's project is complete.

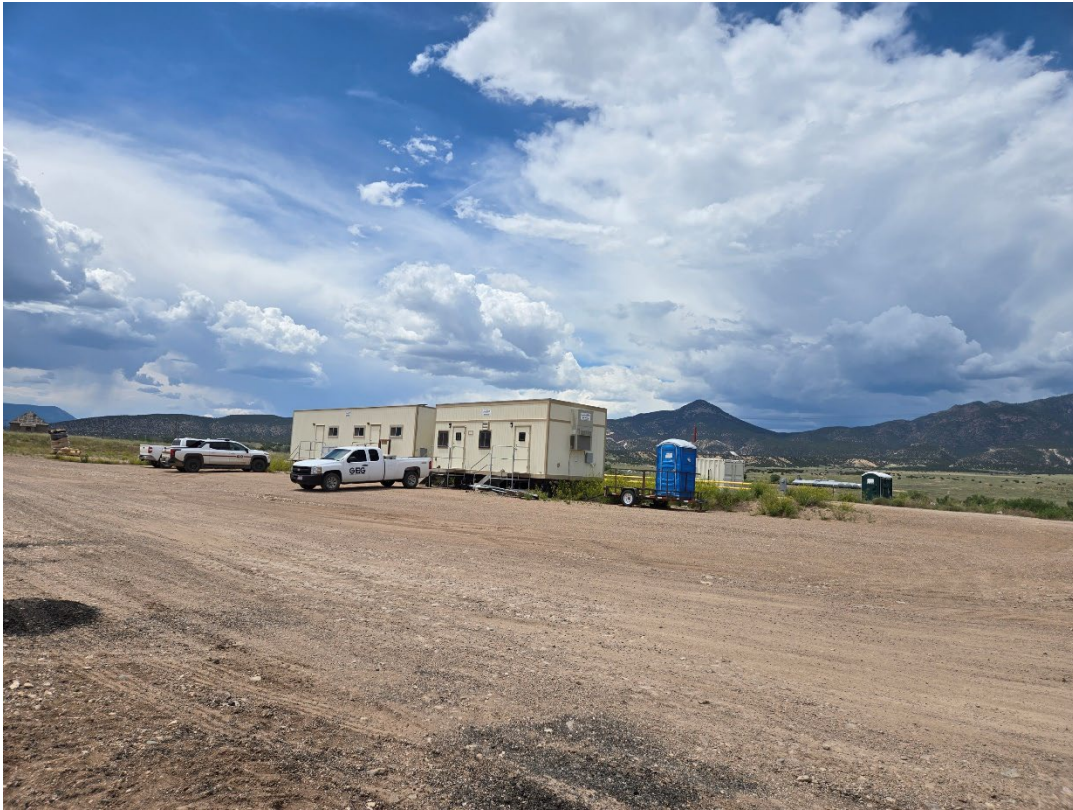
Photo 11: Trailer and vehicles onsite belonging to CDOT. The truck scale is temporarily located on the north side of the trailer.

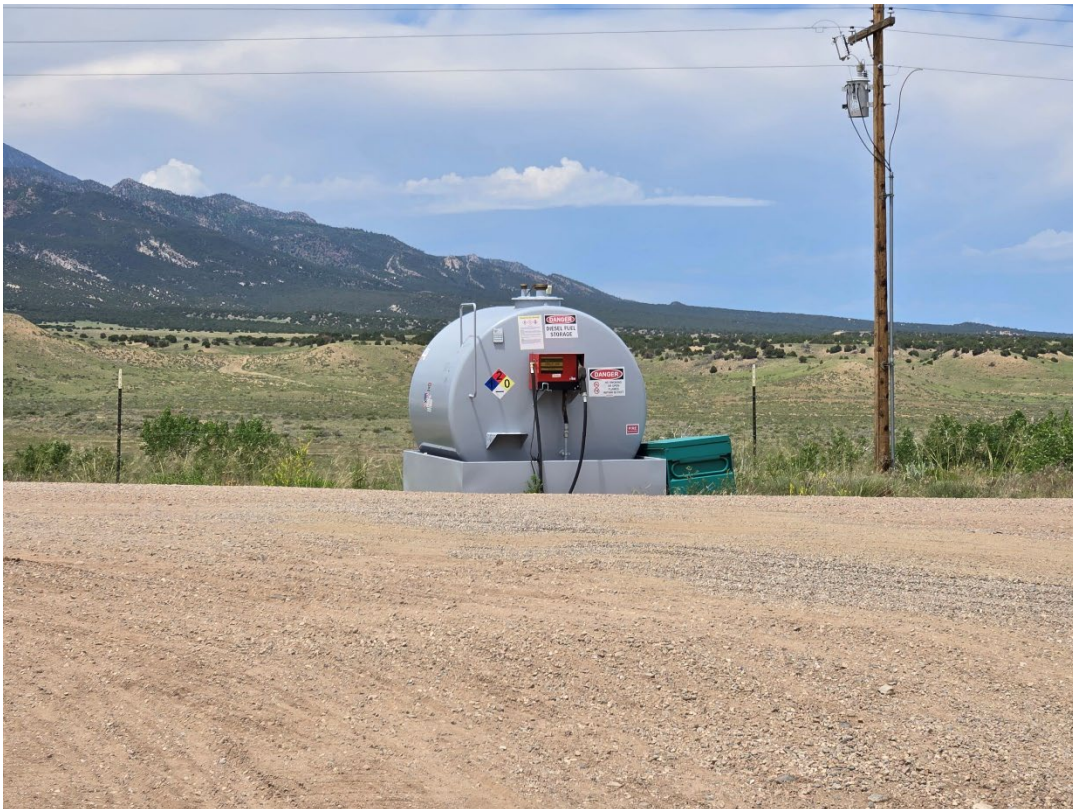
Photo 12: Fuel tank storage onsite.

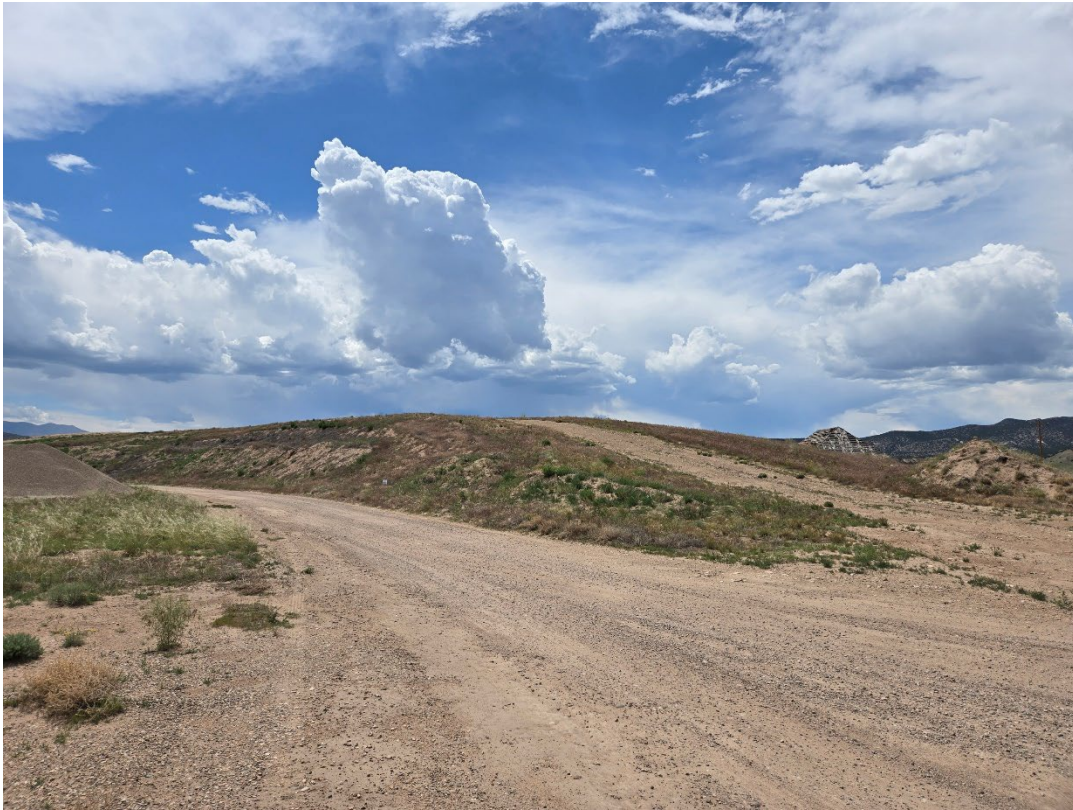
Topsoil is stockpiled in the northwest corner of the disturbed area, out of the way of ongoing mining operations, in compliance with Rule 3.1.9(3). The topsoil pile has been shaped into a stable configuration and has also been seeded.

Photo 13: Looking southwest at the large topsoil pile located in the northwest portion of the disturbed area.

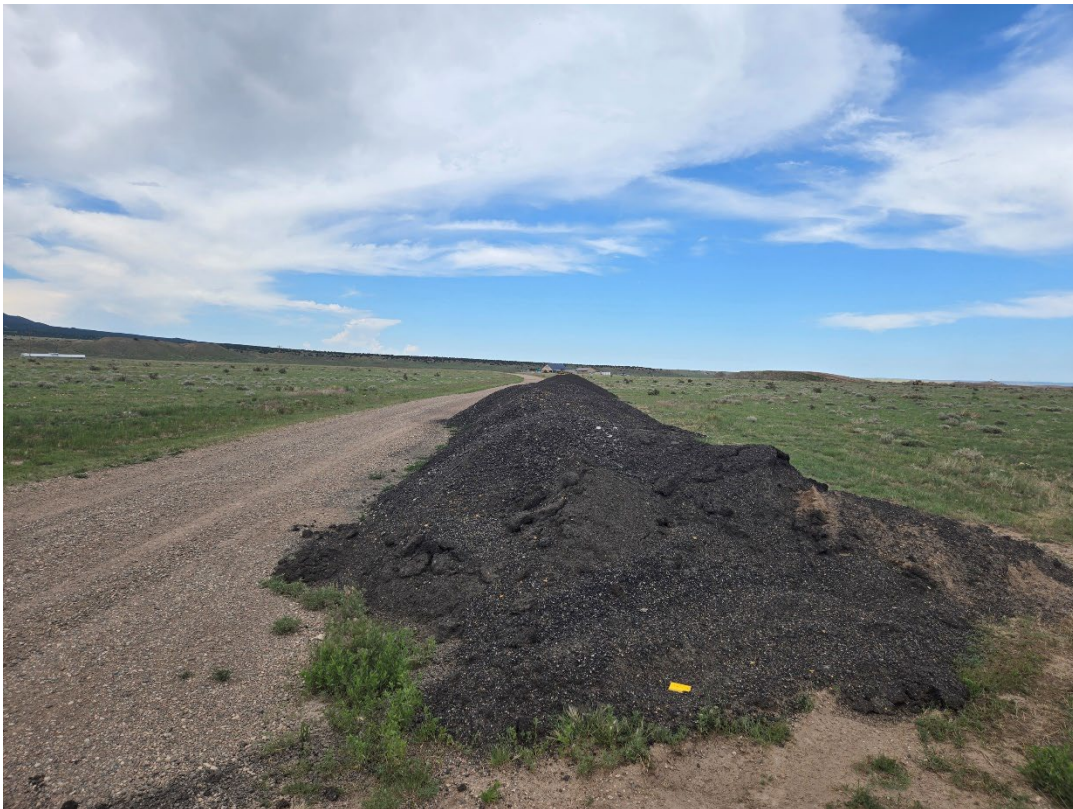
The haul road leading from the entrance gate to the main pit area is well maintained. Along the east side of the pre-existing private road, near the entrance to the permit boundary, a small pile of black stockpiled material was observed. The Operator stated that the material was placed there by the Landowner for use on their private road.

Photo 14: Material located along the Landowner's private drive, placed there from the Landowner for use on their private drive.
