MINERALS PROGRAM INSPECTION REPORT
PHONE: (303) 866-3567

MINE NAME: Hay Camp Pit	MINE/PROSPECTING ID#: M-1990-025	MINERAL: Gravel	COUNTY: Montezuma
INSPECTION TYPE: Surety Release Inspection	WEATHER: Clear	INSP. DATE: May 29, 2025	INSP. TIME: 11:00
OPERATOR: Montezuma County	OPERATOR REPRESENTATIVE: Kim Gaasch	TYPE OF OPERATION: 112c - Construction Regular Operation	
REASON FOR INSPECTION: Surety Release Requested	BOND CALCULATION TYPE:	BOND AMOUNT: \$0.00	
DATE OF COMPLAINT: NA	POST INSP. CONTACTS: None	JOINT INSP. AGENCY: None	
INSPECTOR(S): Todd Jesse	INSPECTOR'S SIGNATURE:

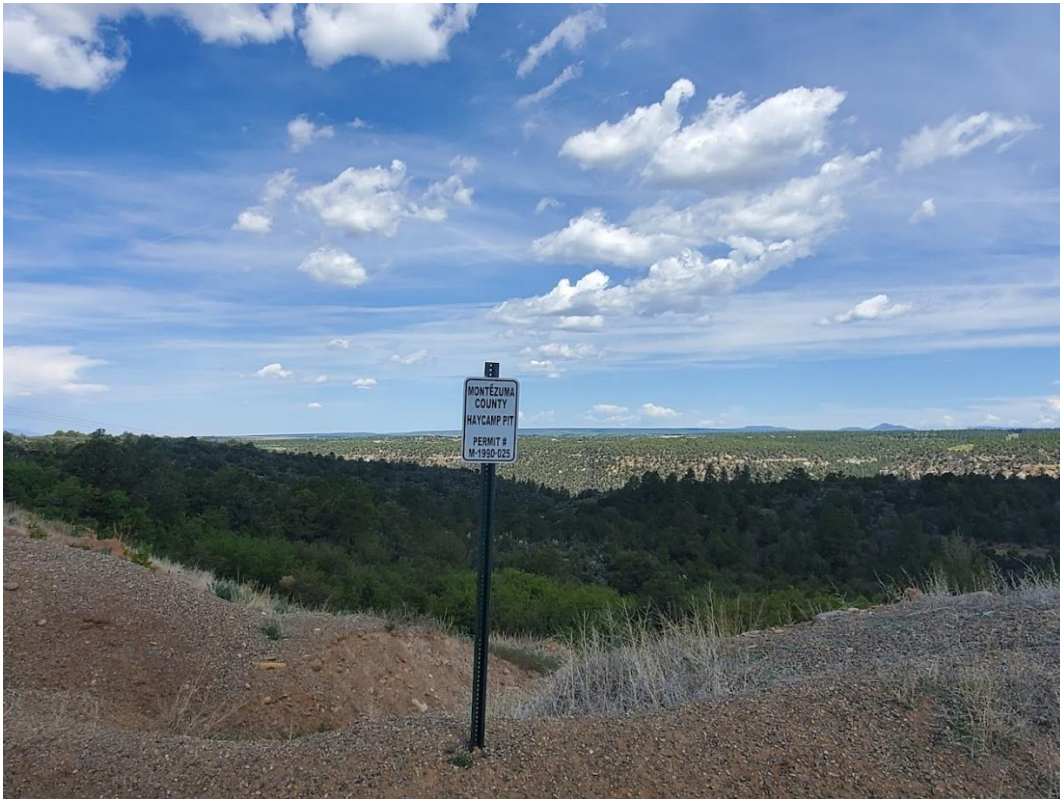
The mine identification sign and boundary markers are in place and in compliance with Rule 3.1.12. The sign is posted by the entrance to site. The permit boundary is marked with berms and posts that are easily identifiable.

Photo 1: View to the northwest of mine ID sign.

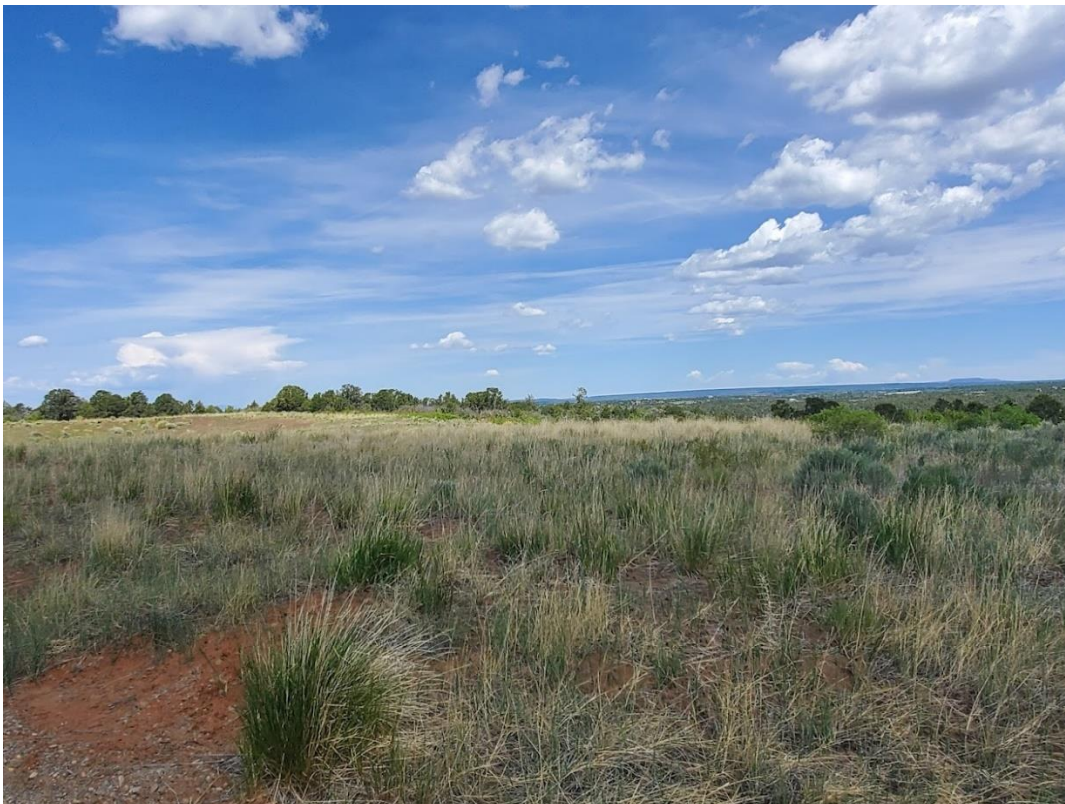
There has been two reseeding events within the requested release area. Revegetation species include a dryland Brome, a dryland wheatgrass and a ryegrass. This is an appropriate seed mix for the post mine land use of rangeland. The eastern portion of the release area was reseeded 4 years ago and again this spring. This portion of the requested release area The western portion of the requested release area was seeded this year. There are large sections of this area that are infested with Downy Brome.

Photo 2: View to the northwest of area that was reseeded 4 years ago.

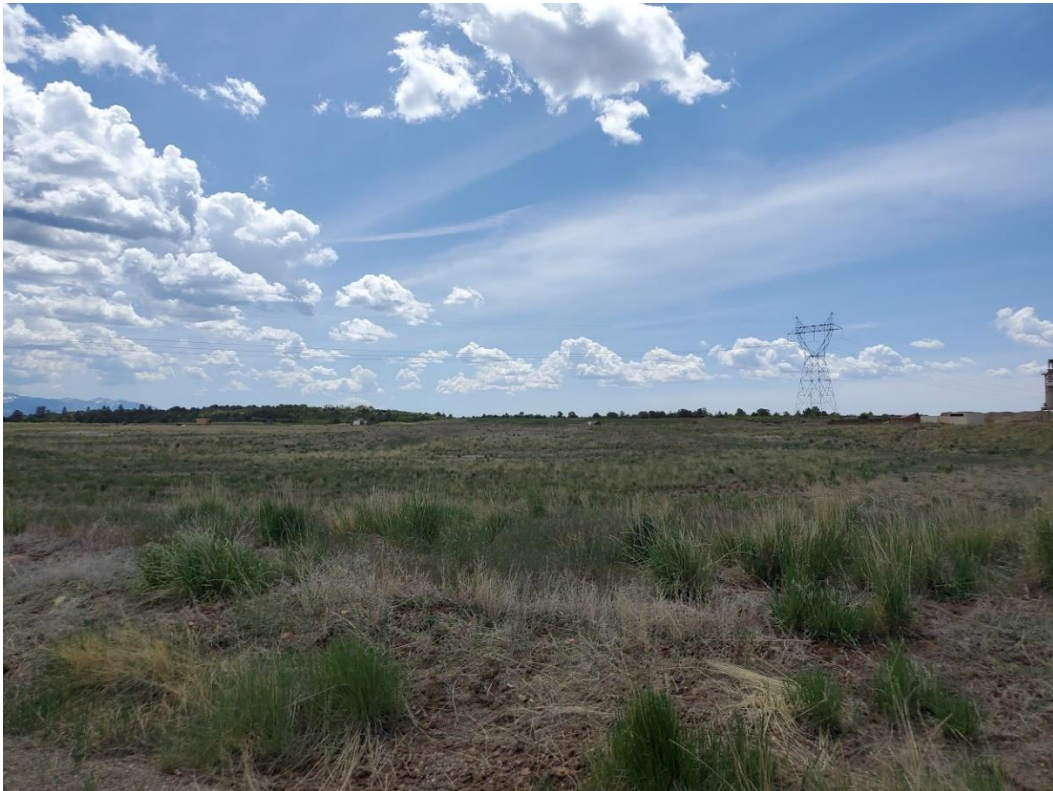
Photo 3: View to the southeast of area that was reseeded 4 years ago.

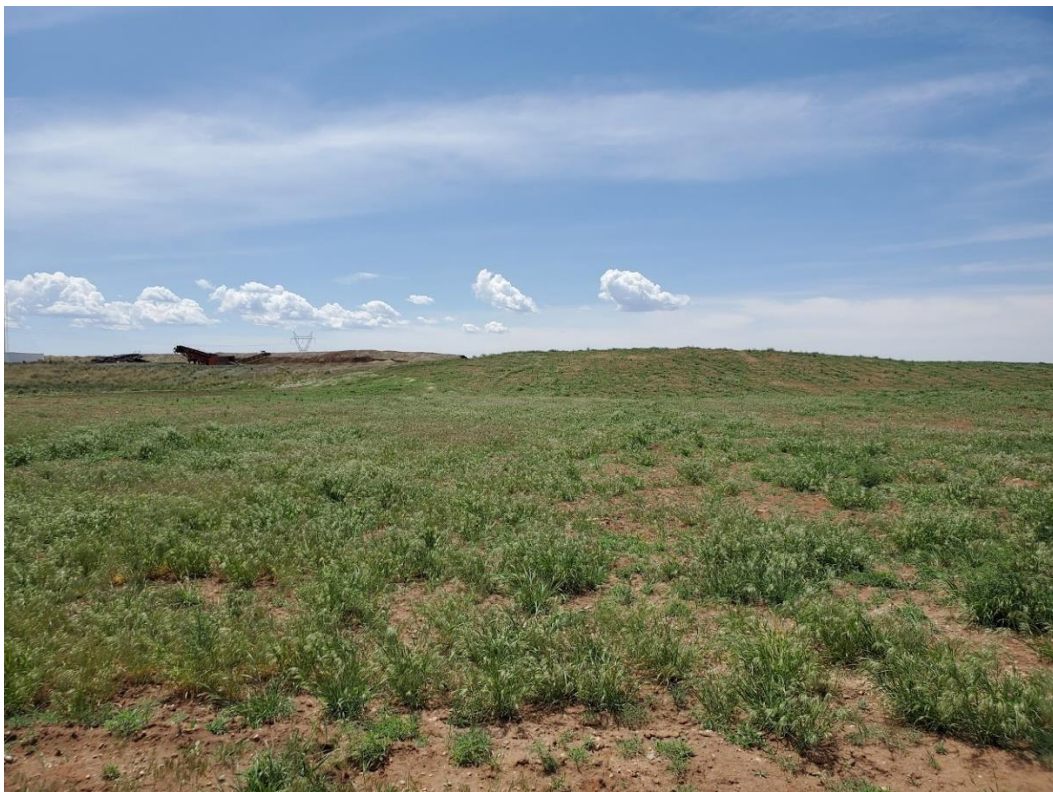
Photo 4: View to the south of
