## **Inspection Yoast Bond Release SL9**

## **PERMIT INFORMATION**

Permit Number: C-1994-082 County: Routt

Mine Name: Yoast Mine Operation Type: Surface

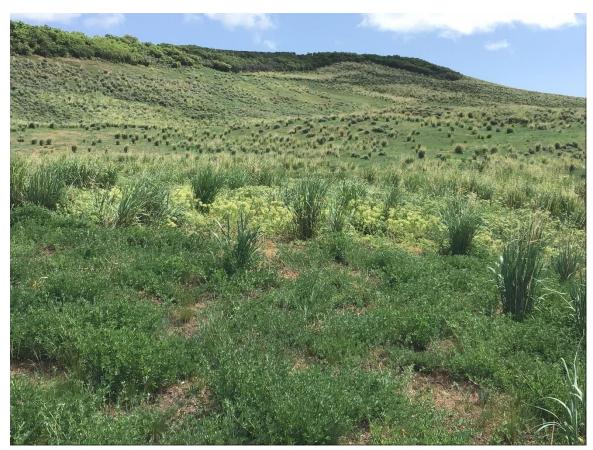
- No extensive areas devoid of vegetation or expansive areas of weeds were noted at the time of inspection.
- o Reclamation appeared stable with well established and diverse vegetation, with dense cover supportive of the post mining land use.

**Photo 4:** Overview of reclamation looking northeast from Pond 12 toward parcels 78, 80, and 84.

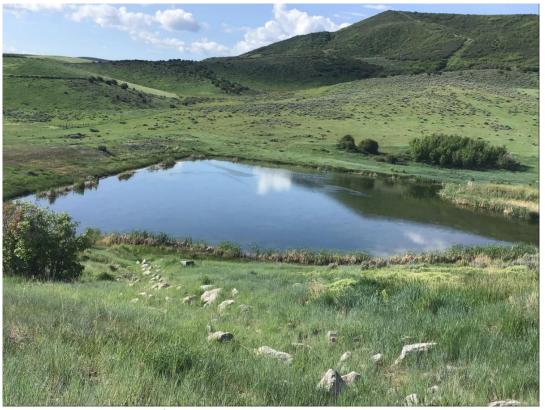
Photo 5: Pond looking east from above.

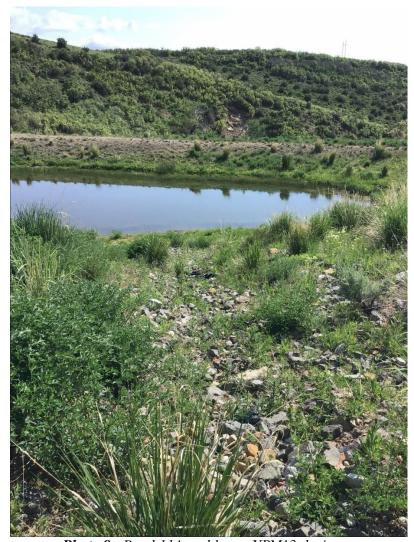
- DrainageYPM13, (parcel 88) above pond 11A was inspected and found to be in good repair, functioning adequately with well vegetated banks. Exposed landscape fabric was noted in a couple of areas.

Photo 9: Pond 11A and lower YPM13 drainage

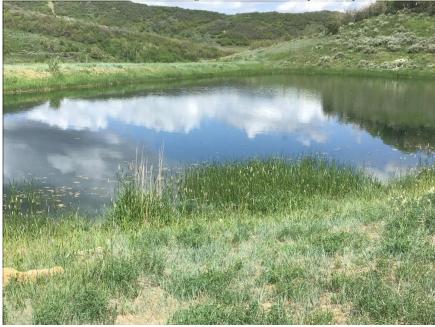
**Photo 11:** Pond 13.

- o Pond 13 in parcel 17 was not discharging. Banks and drainage way appeared stable at the time of inspection
- o Pond 14 in parcel 62 was not discharging at the time of inspection and banks were stable and well vegetated at the time of inspection.

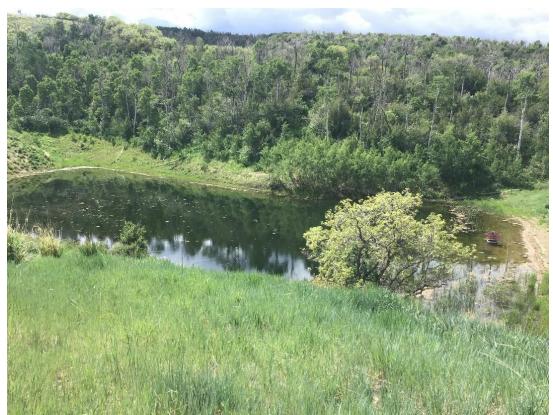
Photo 12: Pond 14 from above, exhibiting some algal growth on the surface.

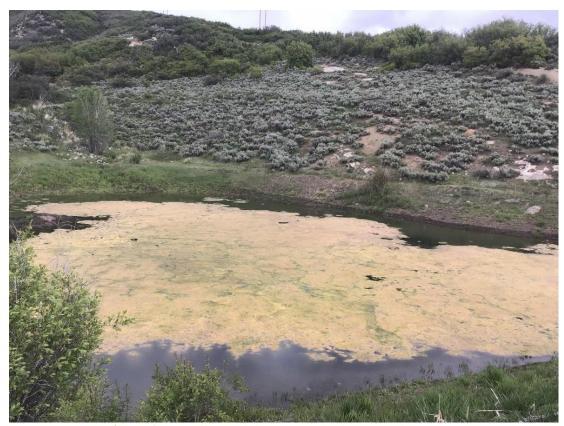
- o Pond 11 in parcel 6 held water and was stable at the time of inspection. An algal growth was evident on the surface of the pond.
- o Pond 12 in parcel 74 was discharging at the time of inspection.

Photo 13: Pond 11, exhibiting an algal mat on the surface.

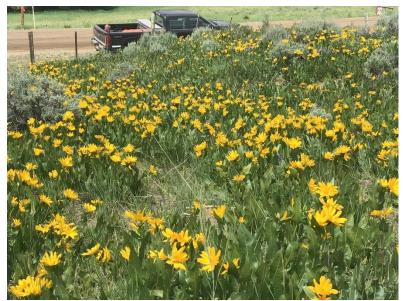
Photo 14: West facing slopes or arrowhead balsa root.

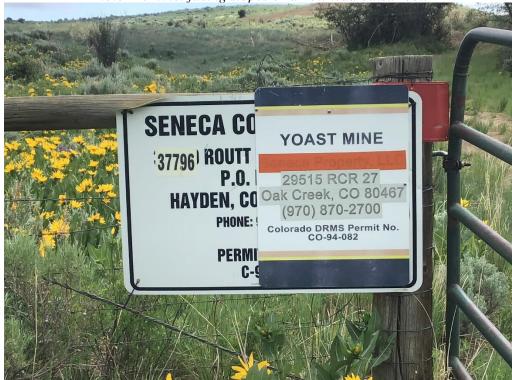
Photo 15: Mine identification sign along the County Road entrance.
