**Inspection Report, Coal Complete, Colowyo, C-1981-019**

<b>Permit Number:</b> C-1981-019 <b>Mine Name:</b> Colowyo Coal Mine <b>Operator:</b> Colowyo Coal Company L.P. <b>Operator Address:</b> Mr Tony Tennyson 5731 State Highway 13 Meeker, CO 81641	<b>County:</b> Moffat, Rio Blanco <b>Operation Type:</b> Surface <b>Permit Status:</b> Active <b>Ownership:</b> Private
	<b>Operator Representative Present:</b>  Tony Tennyson
<b>Operator Representative Signature: (Field Issuance Only)</b>

<b>Inspection Start Date:</b> June 25, 2025 <b>Inspection Start Time:</b> 11:30 <b>Inspection End Date:</b> June 26, 2025 <b>Inspection End Time:</b> 14:30		<b>Inspection Type:</b> Coal Complete Inspection <b>Inspection Reason:</b> Normal I&E Program <b>Weather:</b> Clear	
<b>Joint Inspection Agency:</b>  None		<b>Joint Inspection Contacts:</b>	
<b>Post Inspection Agency:</b>  None		<b>Post Inspection Contacts:</b>	
<b>Inspector(s):</b>  Hunter Ridley  Brock Bowles	<b>Inspector's Signature:</b>  <i>Hunter Ridley</i>		<b>Signature Date:</b>  July 1, 2025

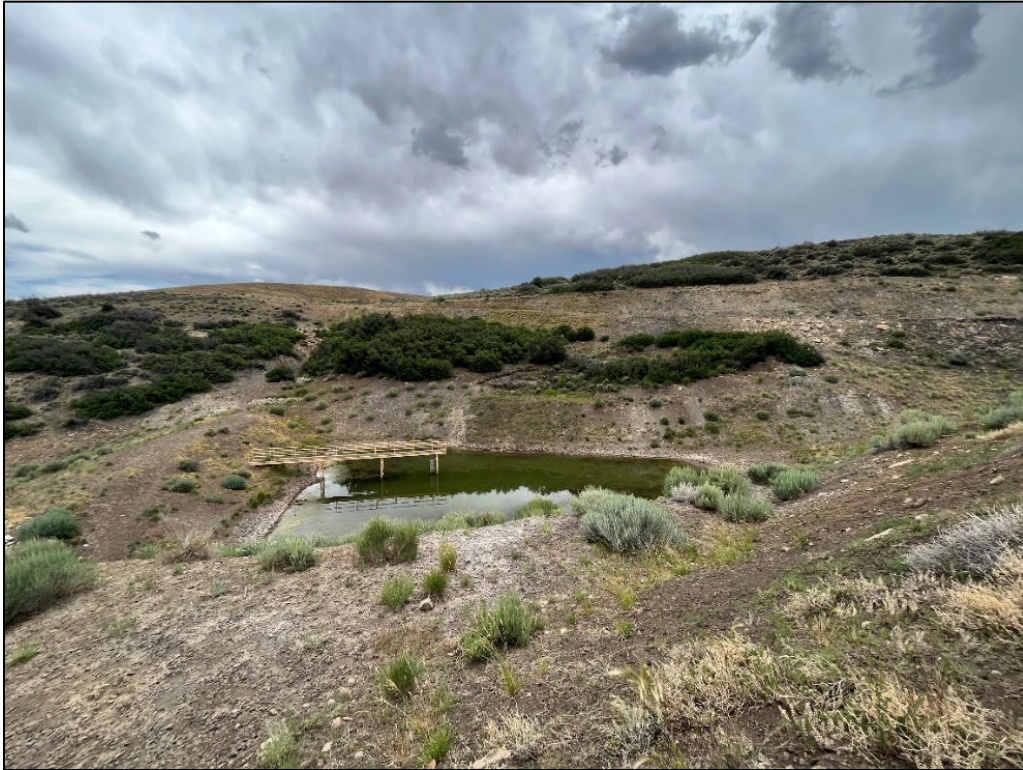
The following ponds in Collom Pit were inspected this month: Section 26, Sidehill, Section 36, Middle, Section 25. All ponds, except Sidehill Pond, were seen to be holding water. All inlet / outlet areas were free of obstructions and no issues with erosion were noted (Photos 1,2, and 6-8). Most ponds that held water also held some amount of dead Mormon crickets (*Anabrus simplex*), which have been recently migrating in mass numbers across Moffat County.

*Photo 1: View northeast of Section 26 pond.*

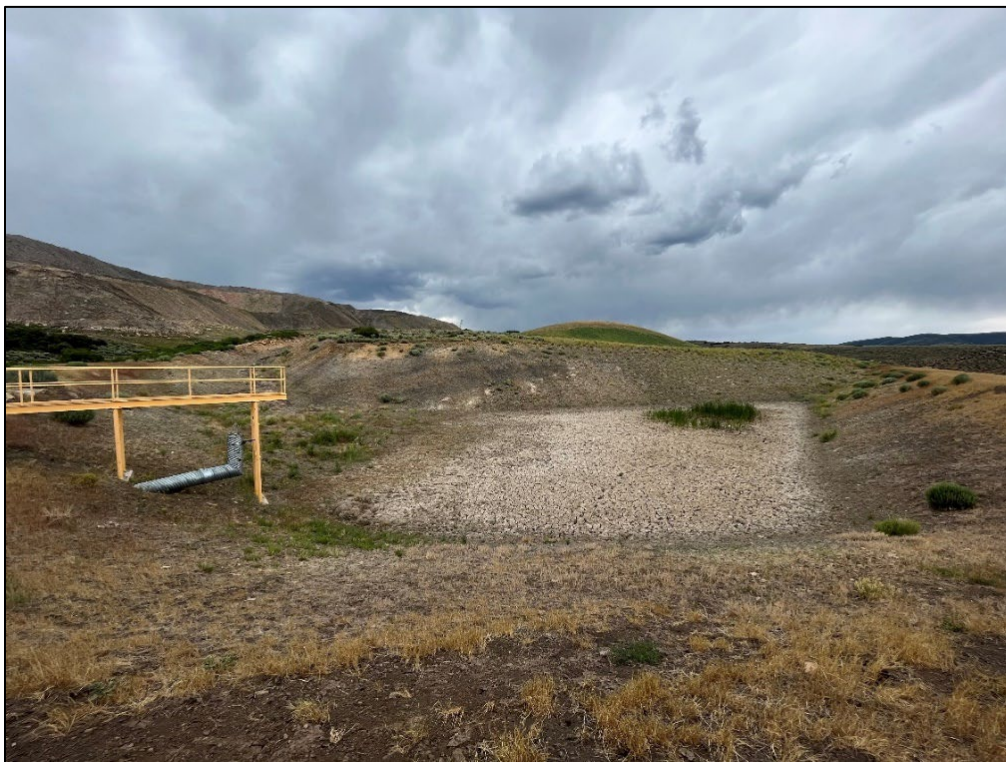
*Photo 2: View south of Sidehill Pond.*

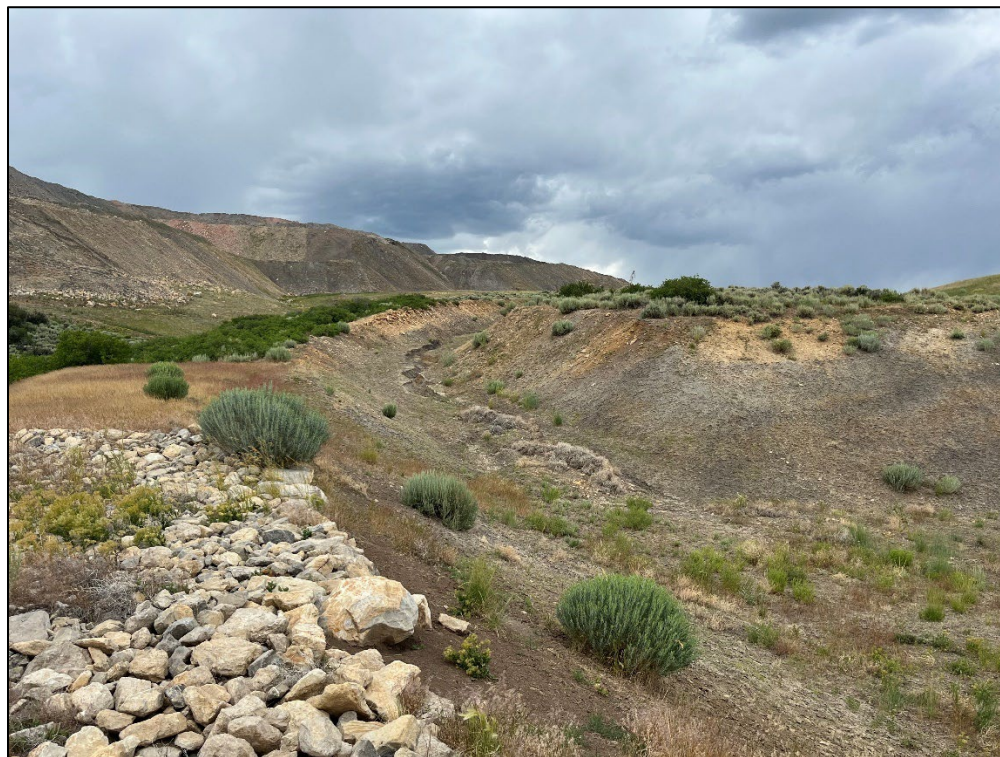
The following ditches in Collom Pit were inspected this month: Ditches D-1, D-3, and D-4 (Photos 3,4, and 9). Ditch D-2 was inaccessible due to the required wildlife buffer related to a sighting of burrowing owls (discussed in detail below). All ditches appeared to be functioning as designed, with no signs of cutting or major erosion. Small vegetation is present in nearly all un-riprapped areas of the ditches.

*Photo 3: View south of Ditch D-4 from Sidehill Pond.*

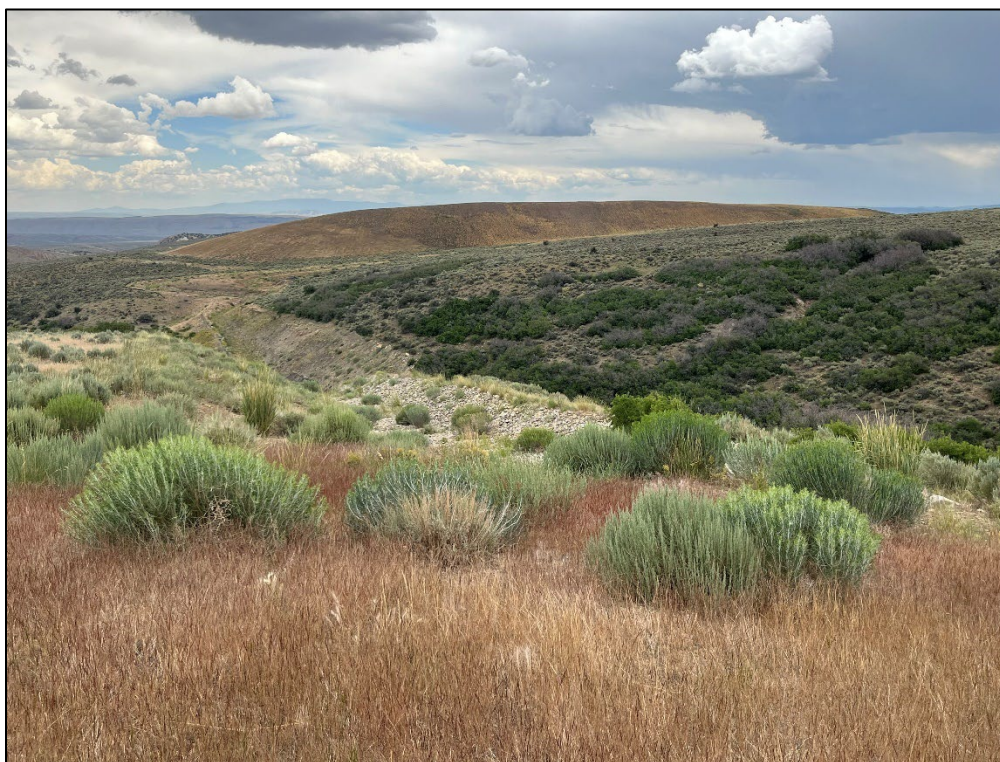
*Photo 4: View north of Ditch D-1 from the outlet area of Sidehill Pond.*

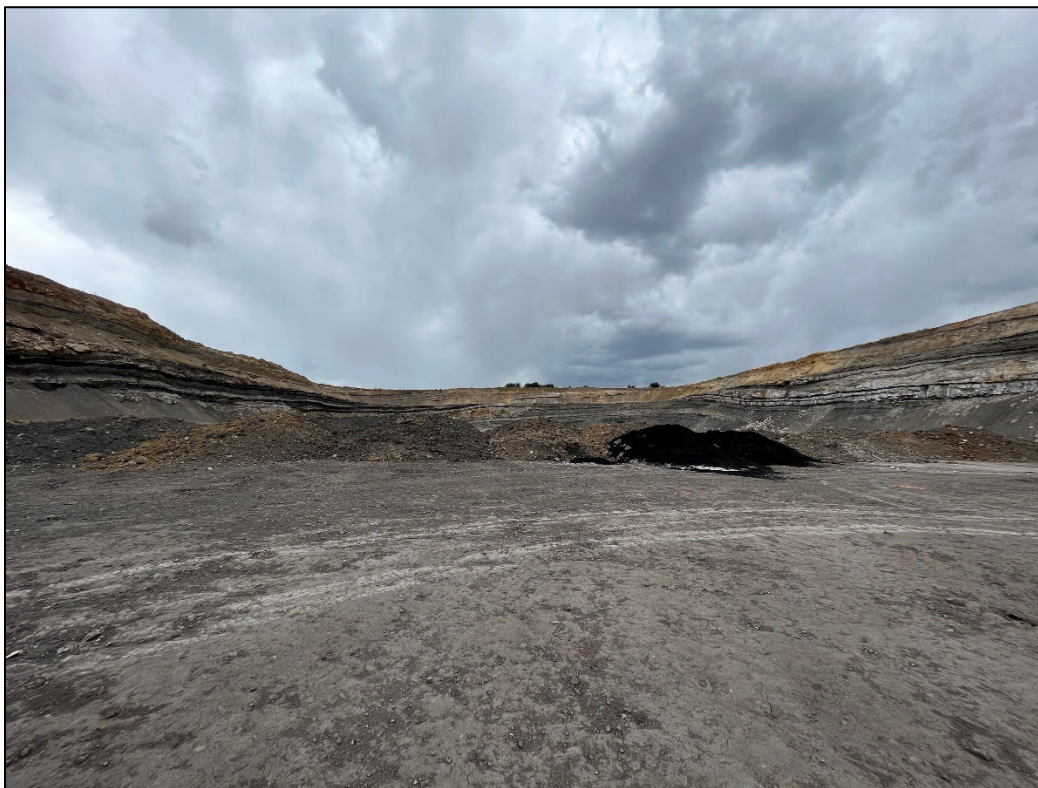
While not active at the time of inspection, the Division noted that backfill work had been done in Collom Pit, especially in the eastern box cut area (Photo 5).

*Photo 5: View of previous backfill operations in the eastern box cut of Collom Pit.*

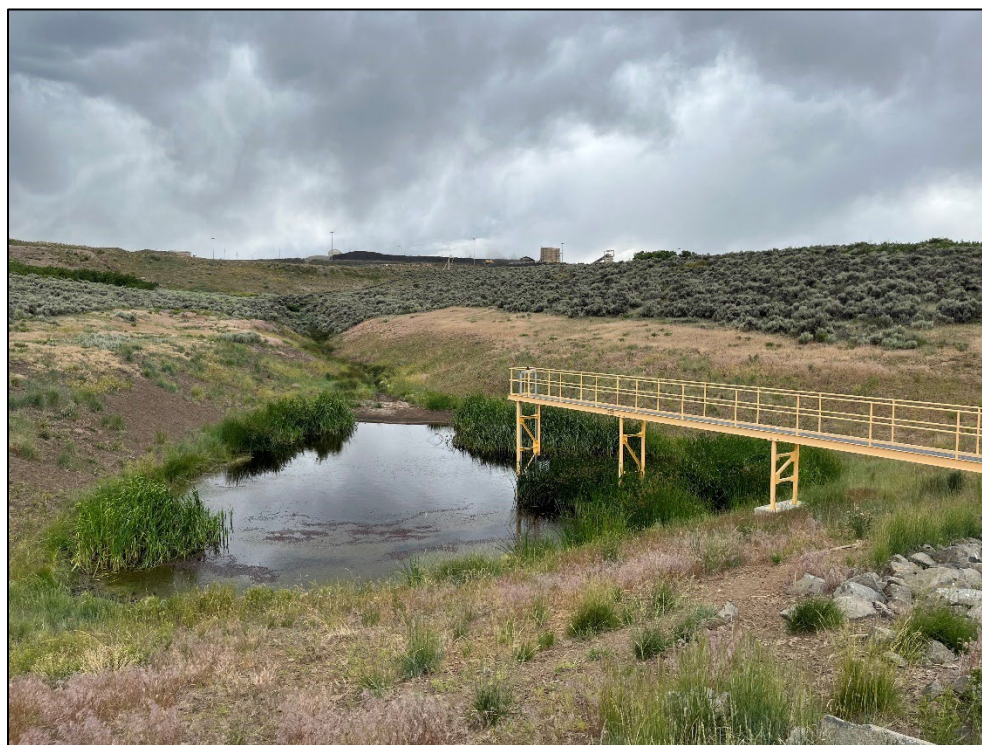
*Photo 6: Section 36 Pond.*

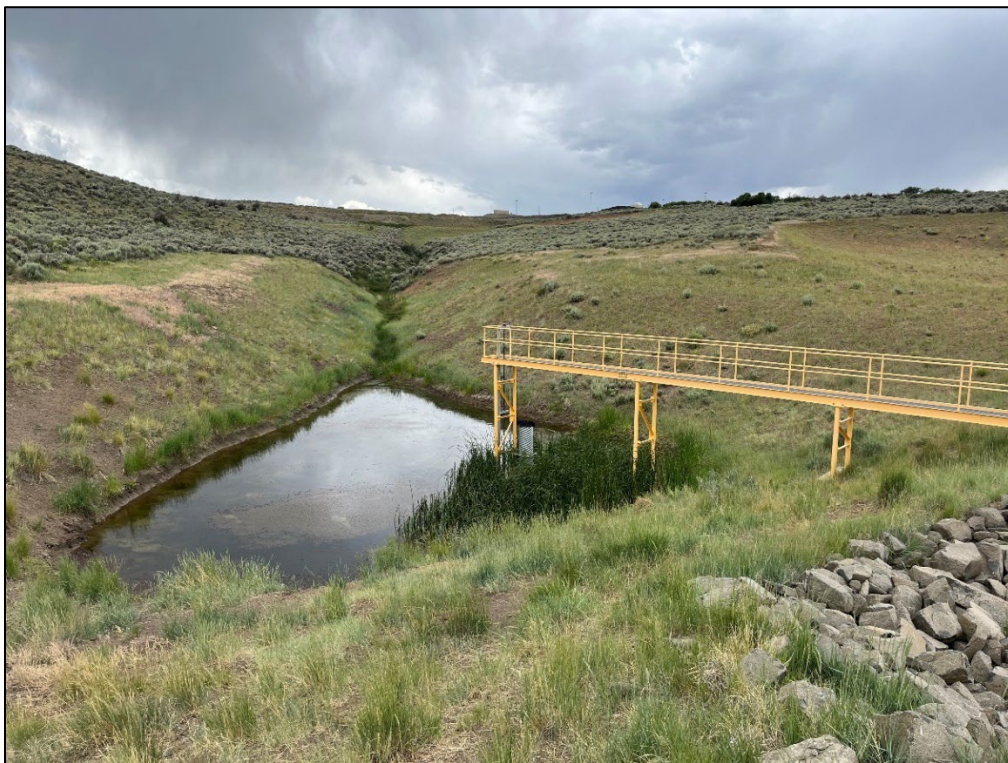
*Photo 7: Middle Pond.*

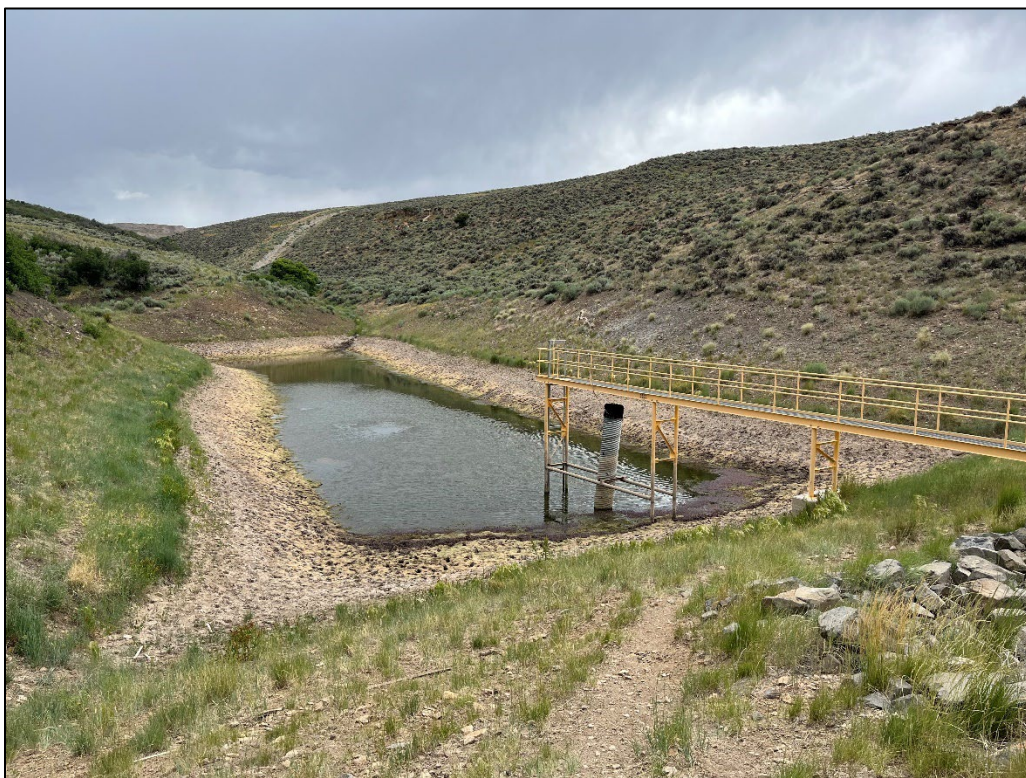
*Photo 8: Section 25 Pond.*

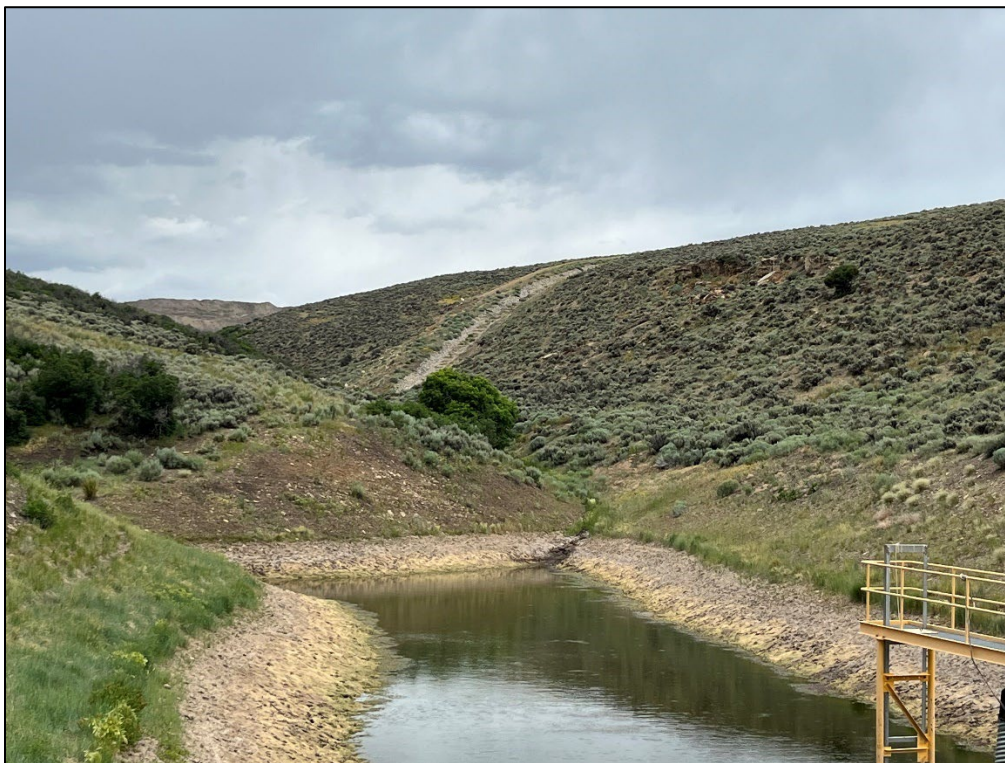
*Photo 9: Ditch D-3 in the background of Section 25 Pond.*

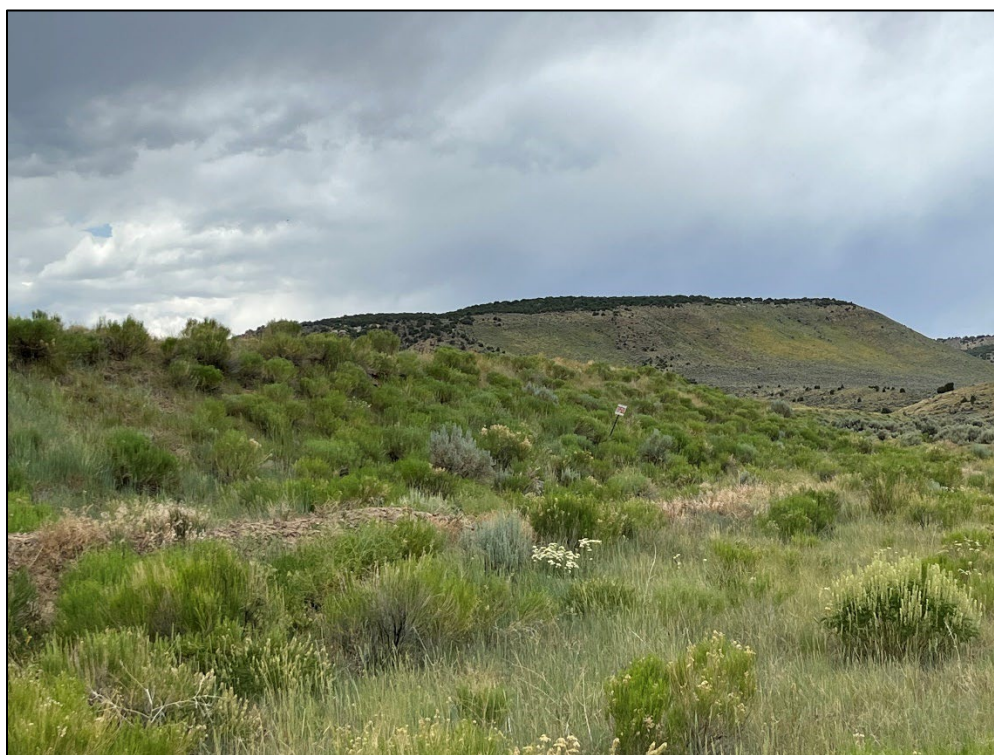
Topsoil piles across the site contained appropriate markers (e.g. Photo 10).

*Photo 10: Example of a topsoil pile labeled in the Collom temporary facilities area.*

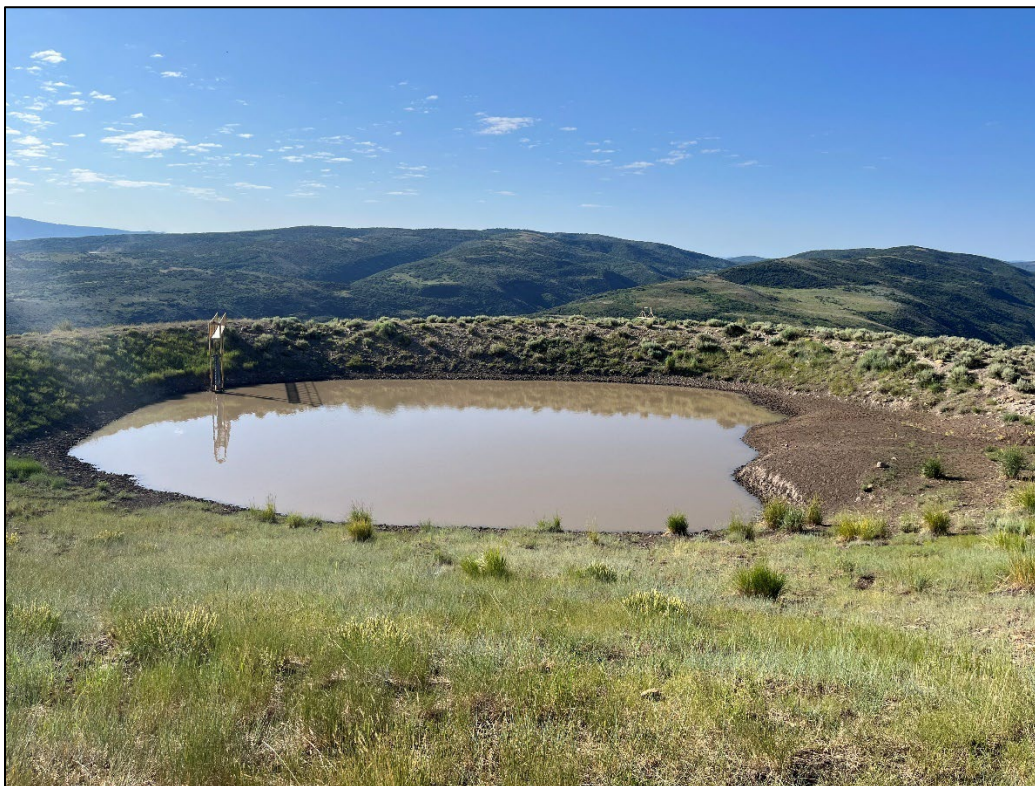
Section 15 Pond and Ditch (Photo 16) were observed in East Pit. Section 15 Pond was nearly completely dry. Section 16 Pond was found to be holding water and free of any stability or erosional issues (Photo 11). Nearly the entirety of East Section 16 and West section 16 Ditches were walked during the inspection. No issues were noted (Photos 13 and 14).

*Photo 11: Section 16 Pond.*

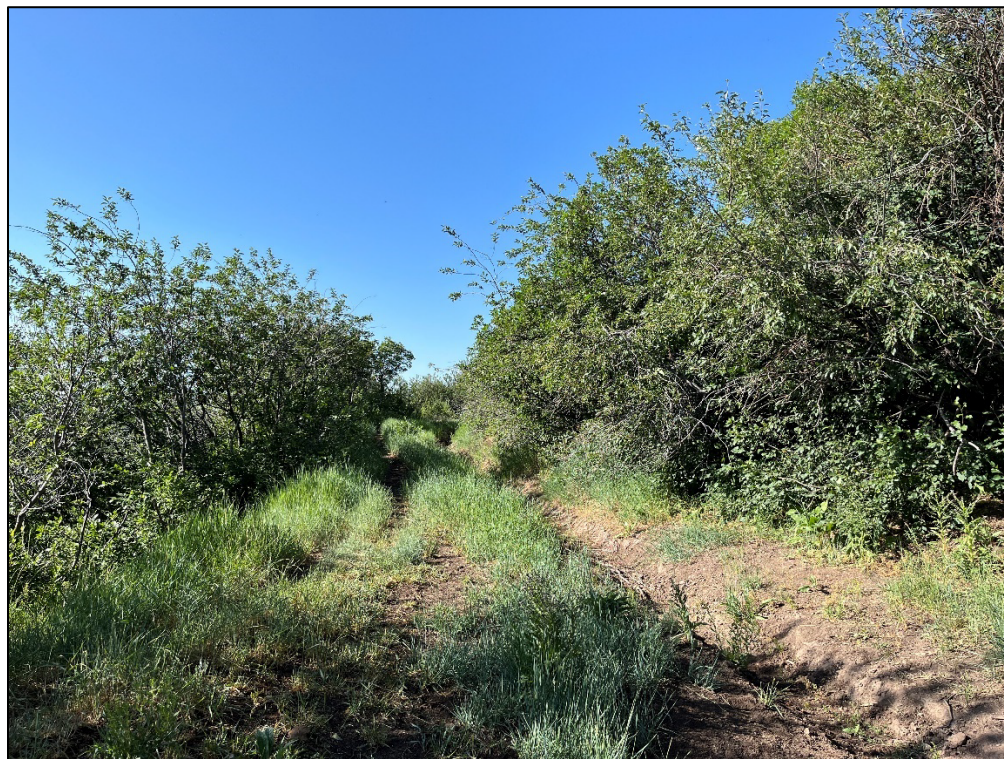
*Photo 13: View of the southwestern end of the West Section 16 Ditch.*

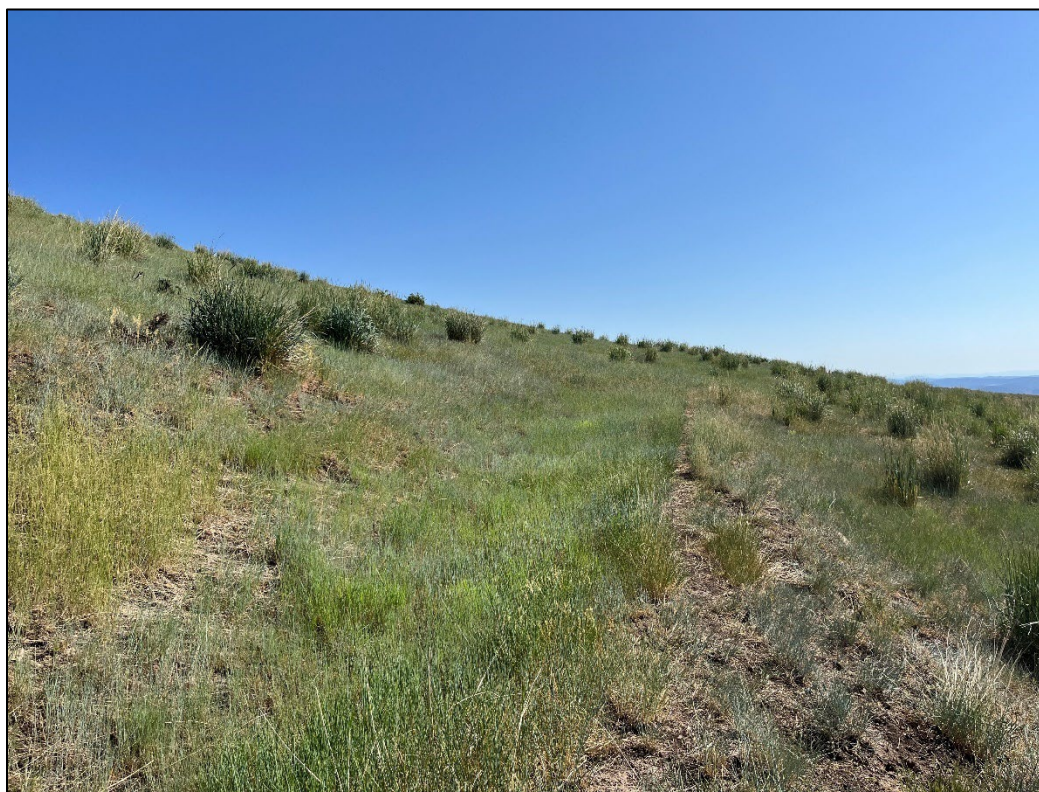
*Photo 14: View of the northeastern end of the East Section 16 Ditch.*

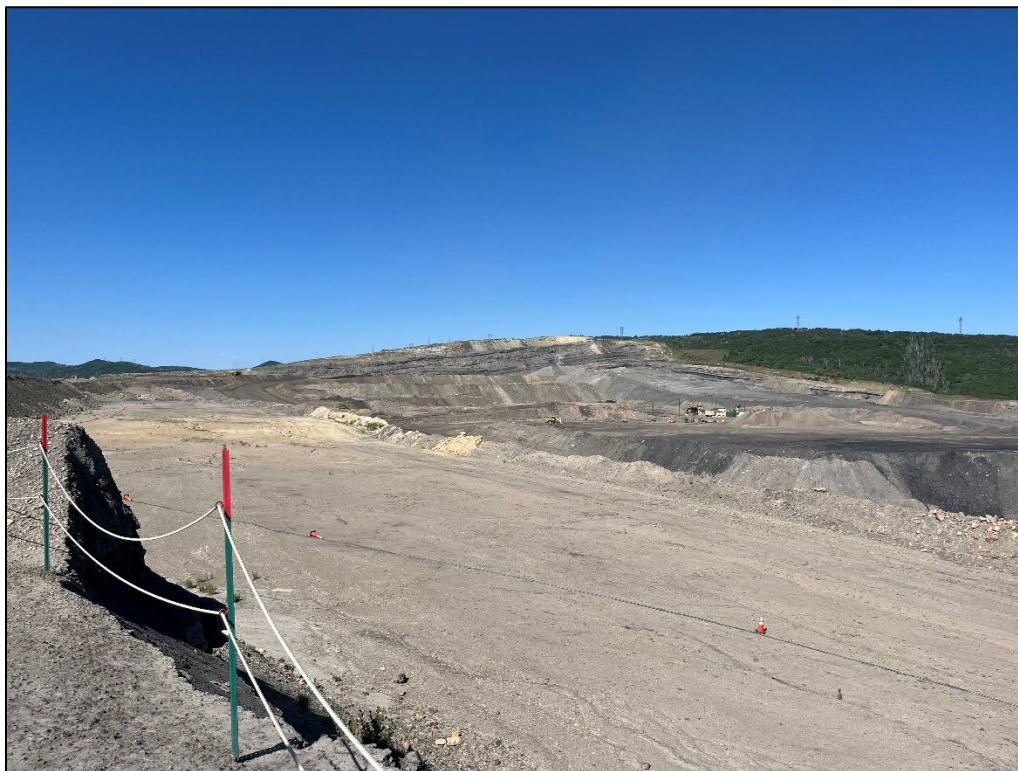
Active backfill operations were observed during this inspection of the South Taylor Pit. Haul trucks were noted at the time of inspection to be distributing spoil material into the southwestern corner of the pit (Photo 15).

*Photo 15: View west into South Taylor Pit and active backfill operations.*

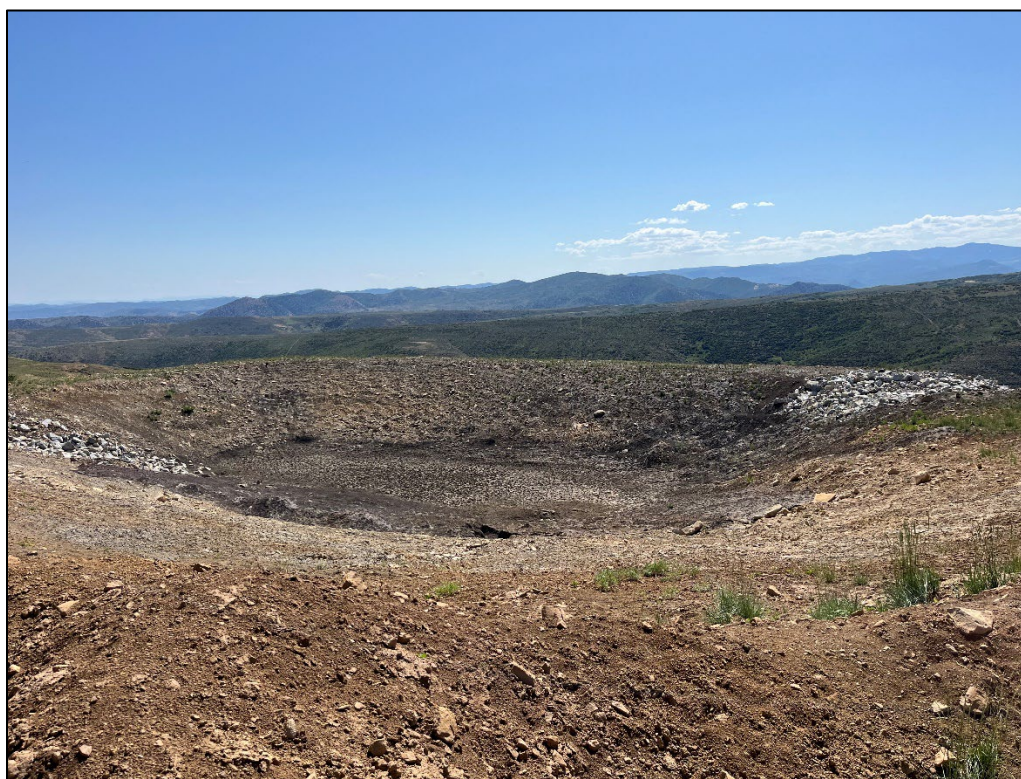
*Photo 16: Section 15 Ditch, dry.*

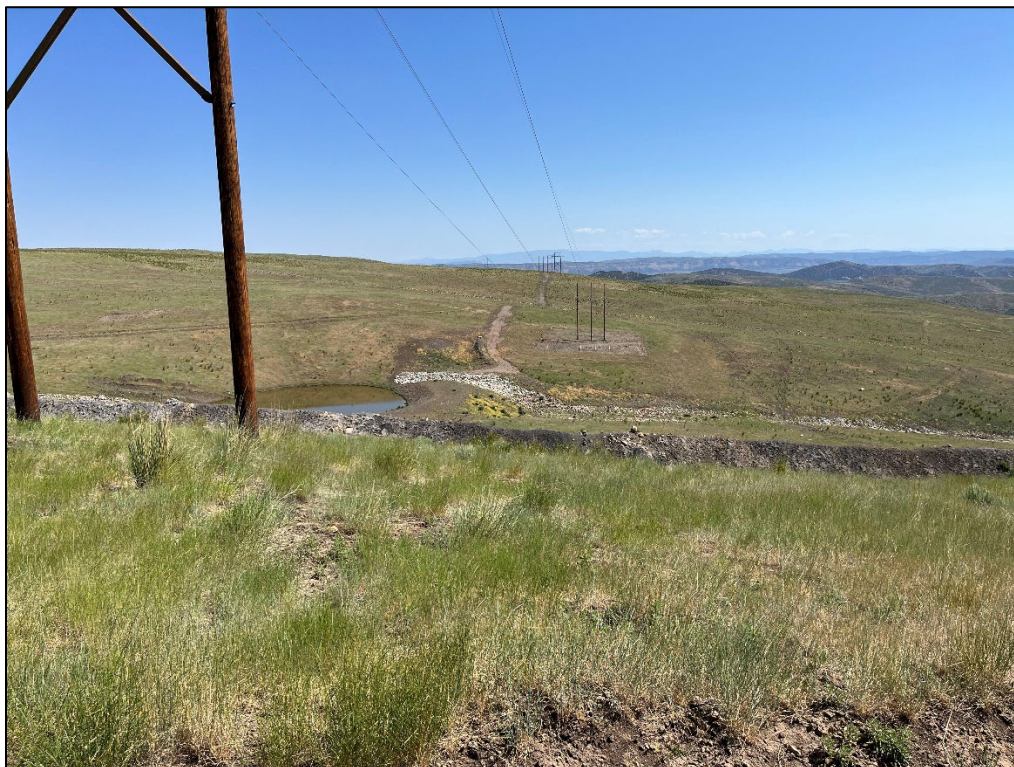
The following stock ponds in the East pit were observed during this inspection: EP1, EP2, and EP3 (Photos 17 and 18), and were observed from above at the Section 15 Ditch. Only EP2 appeared to be holding any water and was flowing into Reach 2 of the Final East Pit Ditch as designed.

*Photo 17: View north of EP2 and Final East Pit Ditch.*

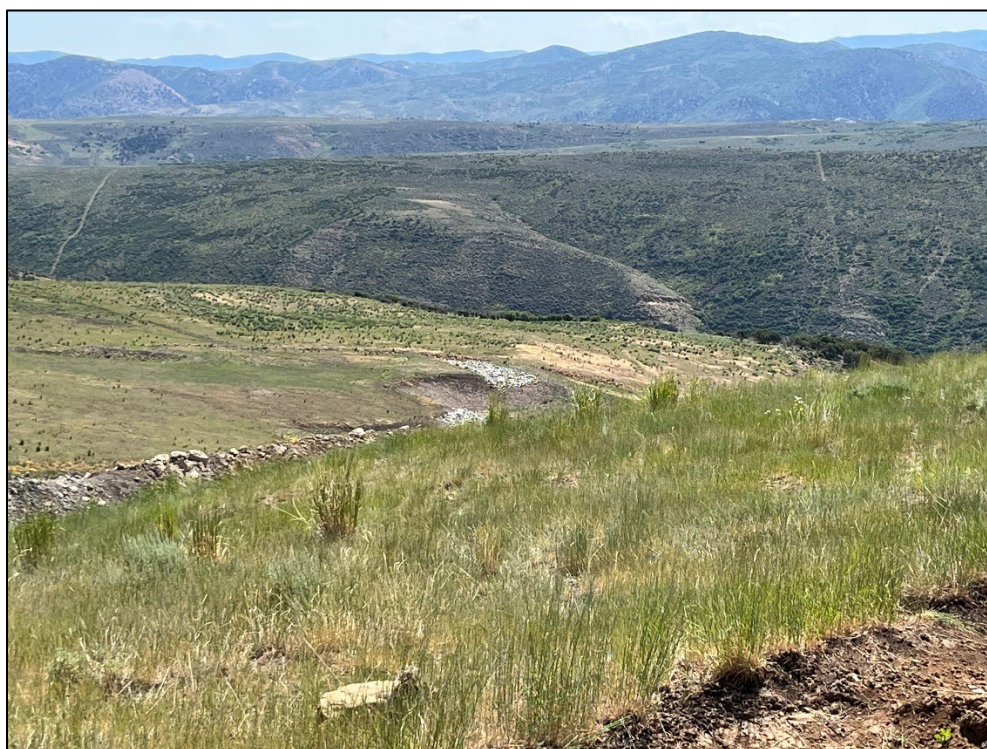
*Photo 18: View west of Final East Pit Ditch, EP1 and EP3 viewed from above at Section 15 ditch.*

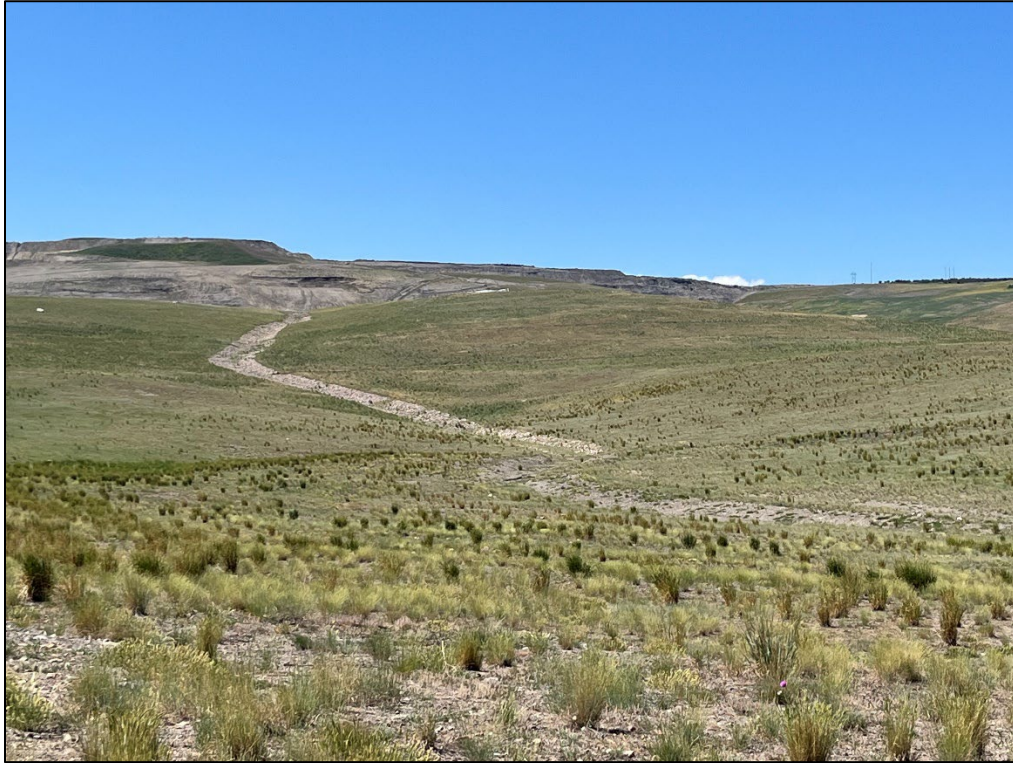
West Pit has been almost entirely backfilled and is largely in its revegetation phase. West Pit was inspected from vantage points along the haul road as well as from below in the reclamation areas (Photos 19-22). A large portion of the West Pit area has been proposed for Phase I Bond Release under SL-24.

The following ditches in the West Pit area were inspected this month: East Taylor Ditch and Taylor Ditch (Photos 19-22). Both ditches were inspected from within the West Pit reclaimed area. No signs of erosion or cutting were visible along any of the observed West Pit ditches and inlet / outlet design for stock ponds appeared to be functioning properly.

*Photo 19: View south of East Taylor Ditch in West Pit.*

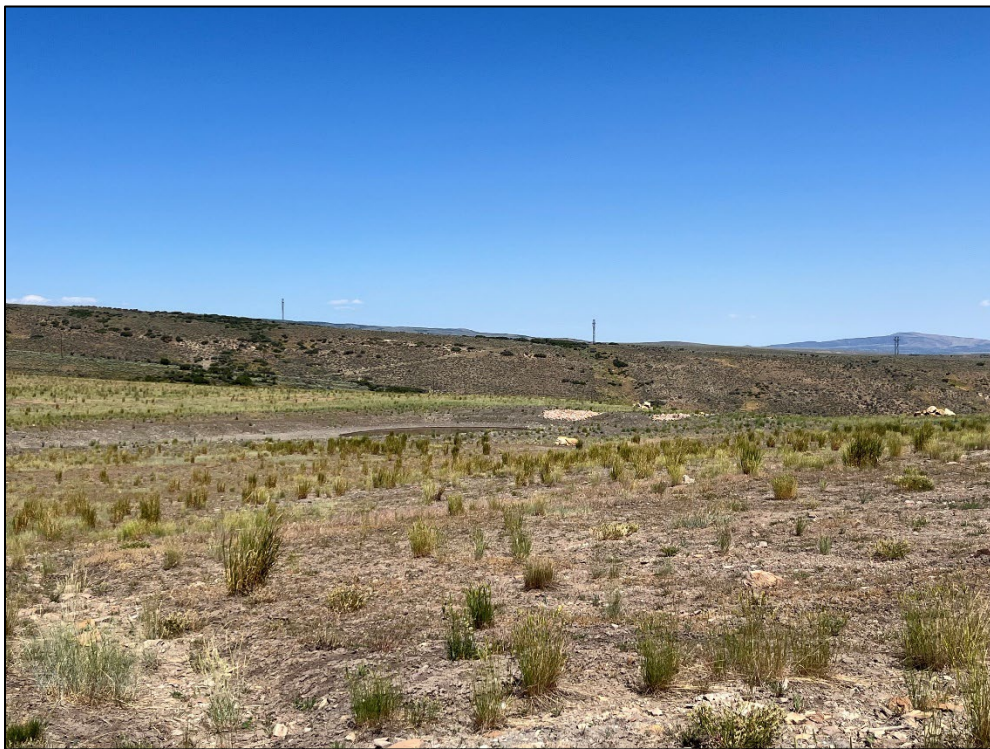
The following stock ponds in the West Pit area were inspected this month: TD1, TD2 and ETD1 (Photos 20-22). All stock ponds besides TD2 were seen to be holding a small amount of water, with no erosional issues or concerns noted.

*Photo 20: View west of East Taylor Ditch and ETD1 in West Pit.*

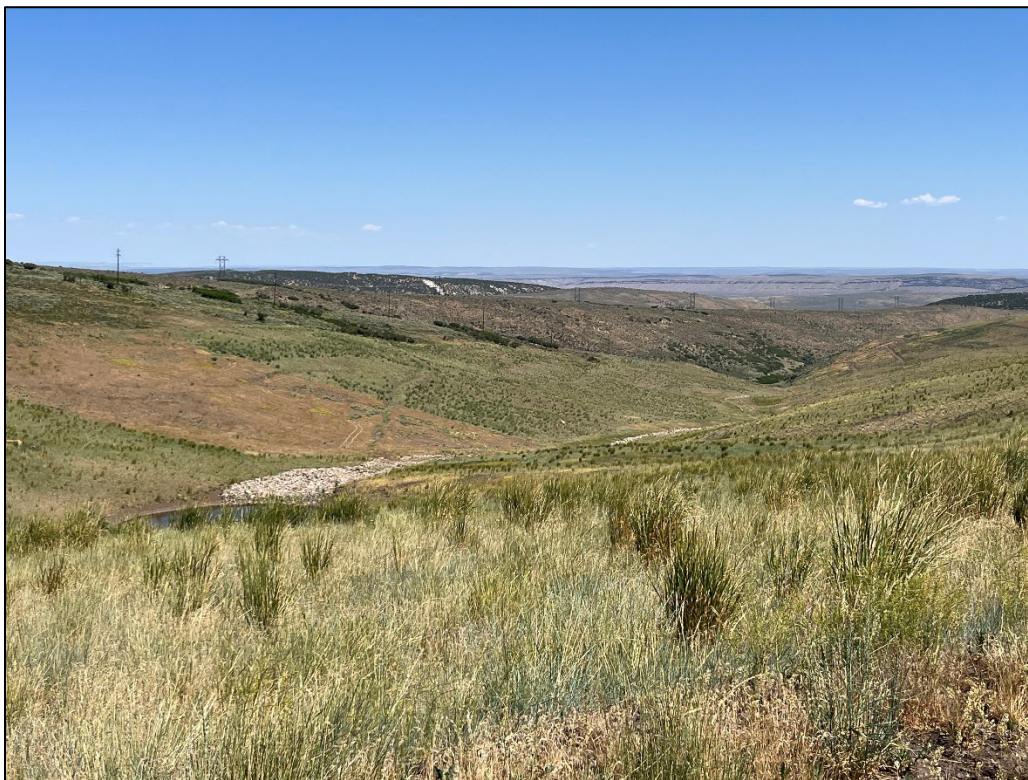
*Photo 21: View north of Taylor Ditch and TD1.*

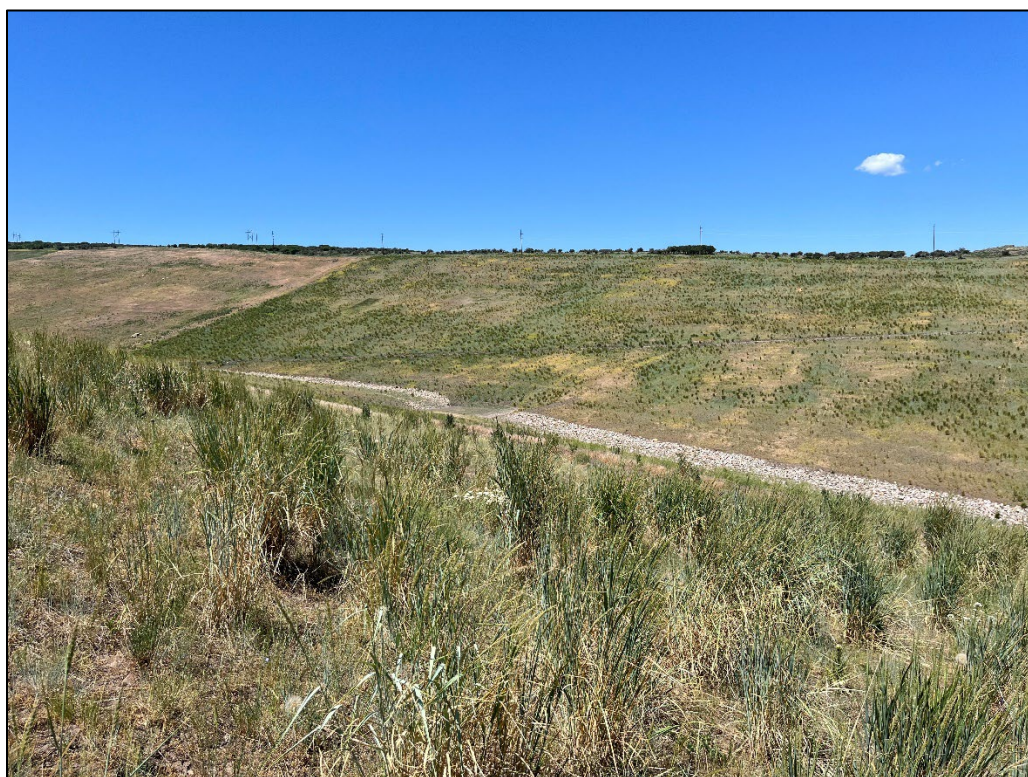
*Photo 22: View southwest of Taylor Ditch and TD2 in West Pit.*

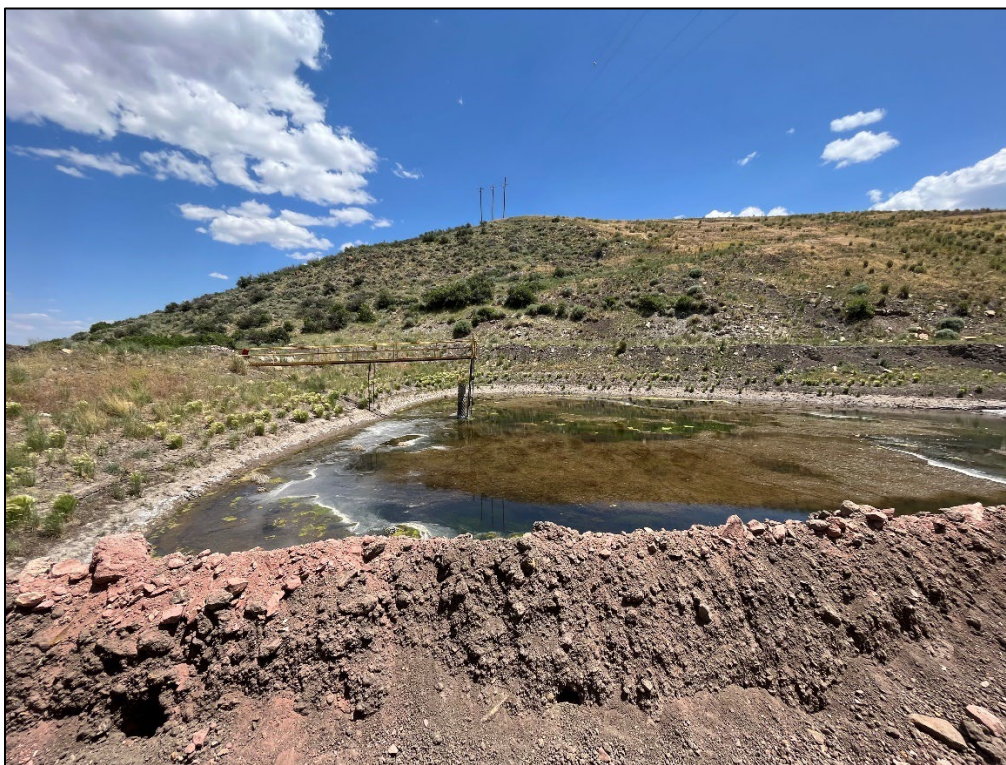
East Taylor and West Taylor Pond were inspected this month along Taylor Creek (Photos 24 and 29). Both ponds were holding water and had stable embankments. Inlet and outlet structures were free of obstructions. No issues were noted.

*Photo 24: View east of East Taylor Pond.*

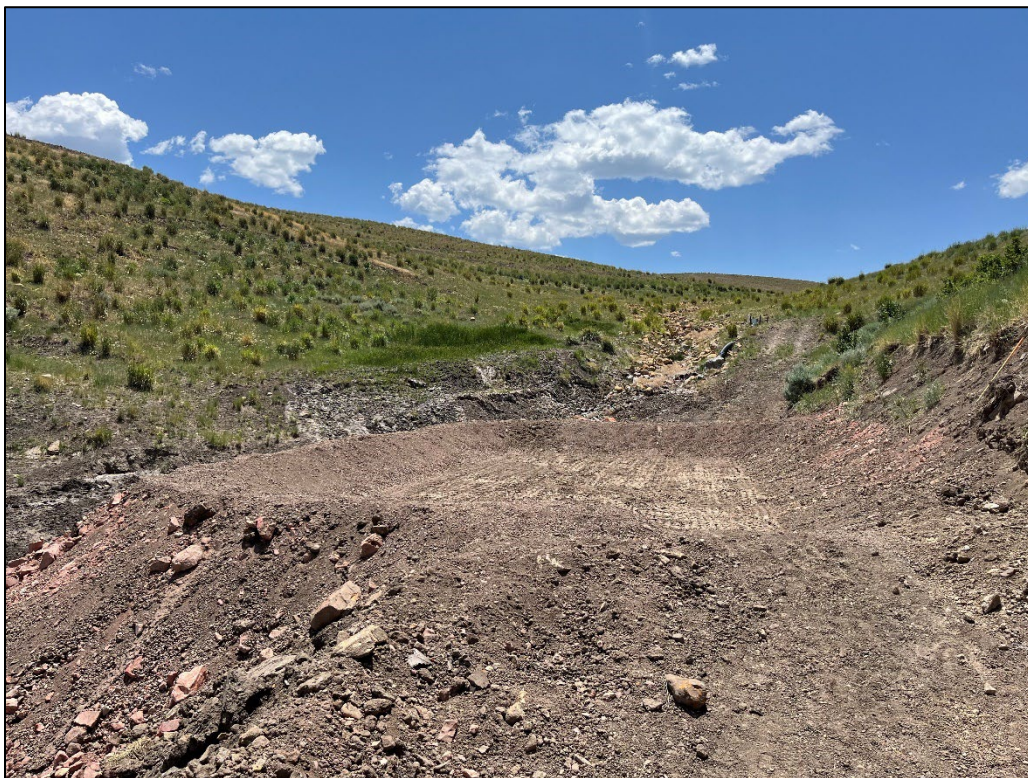
A partially built pad for the recently approved test pilot plant at East Taylor Pond was observed (Photo 25). This pad will still need to be lined before the test evaporation system is built. Once in place, the system will pump water from the spoil spring outfall at the pond into the test evaporation system. Colowyo will be assessing the

*Photo 25: View southeast of the area approved under MR263 to be used for a pilot test plant at East Taylor Pond.*

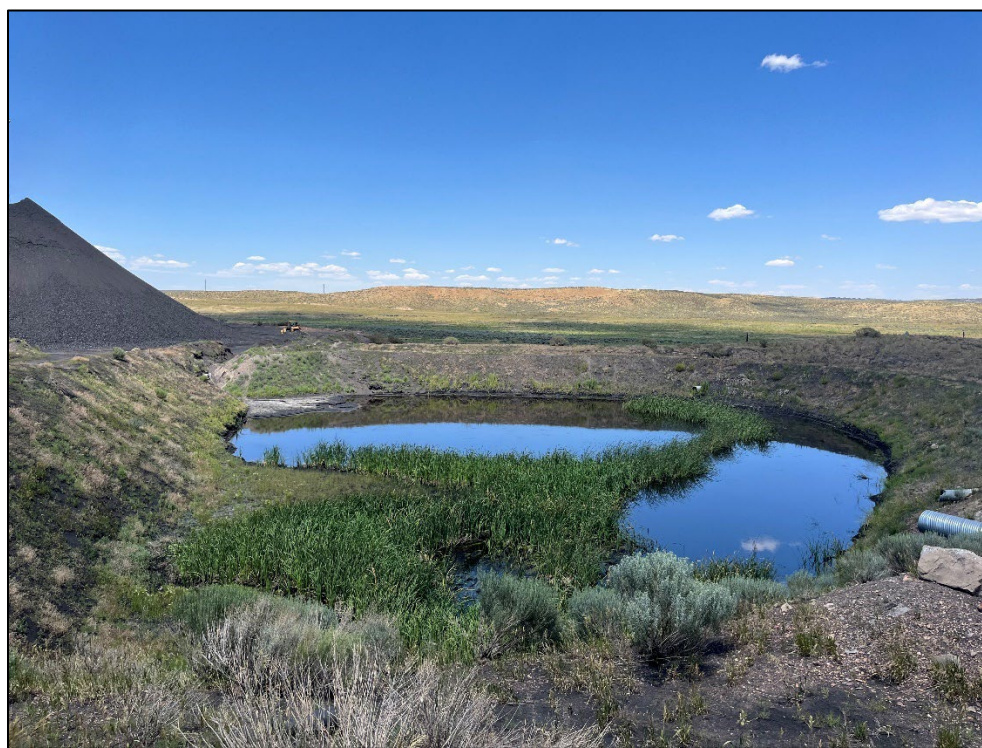
The Stoker Siding and Gossard Ponds were observed in the loadout area. A train was being loaded with coal at the time of inspection and blocked access to Rail Loop Pond. Both ponds were holding water and were free of any issues (Photos 26 and 27).

*Photo 26: View west of Gossard Pond.*

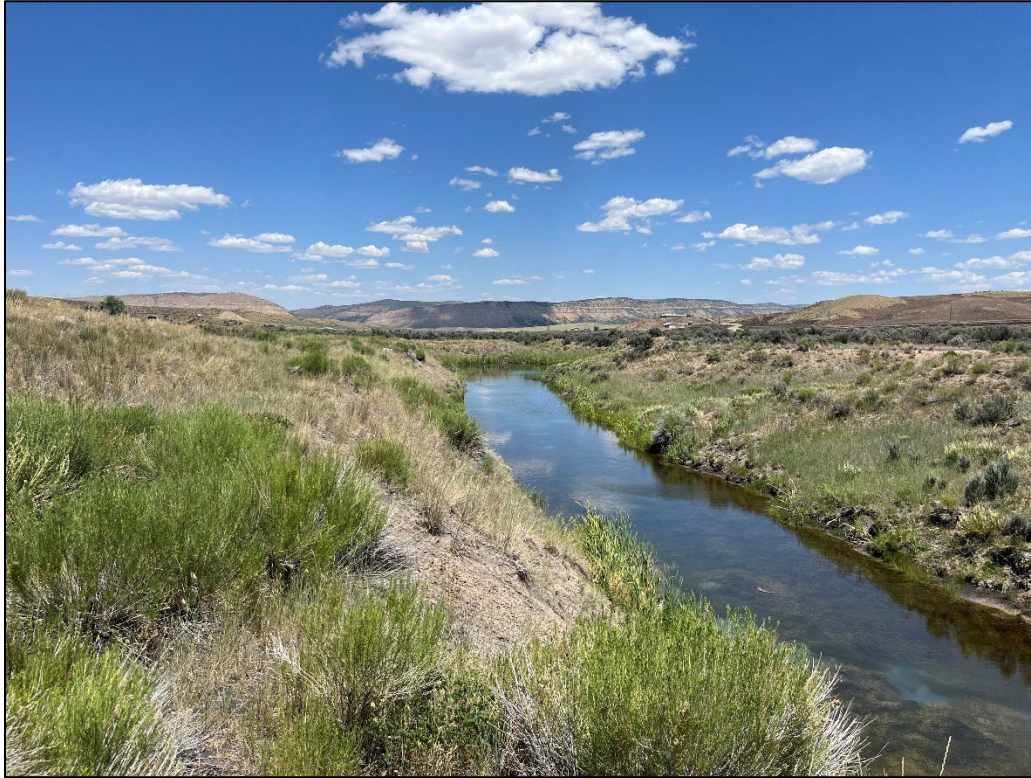
*Photo 27: View northeast of the Stoker Siding Pond.*

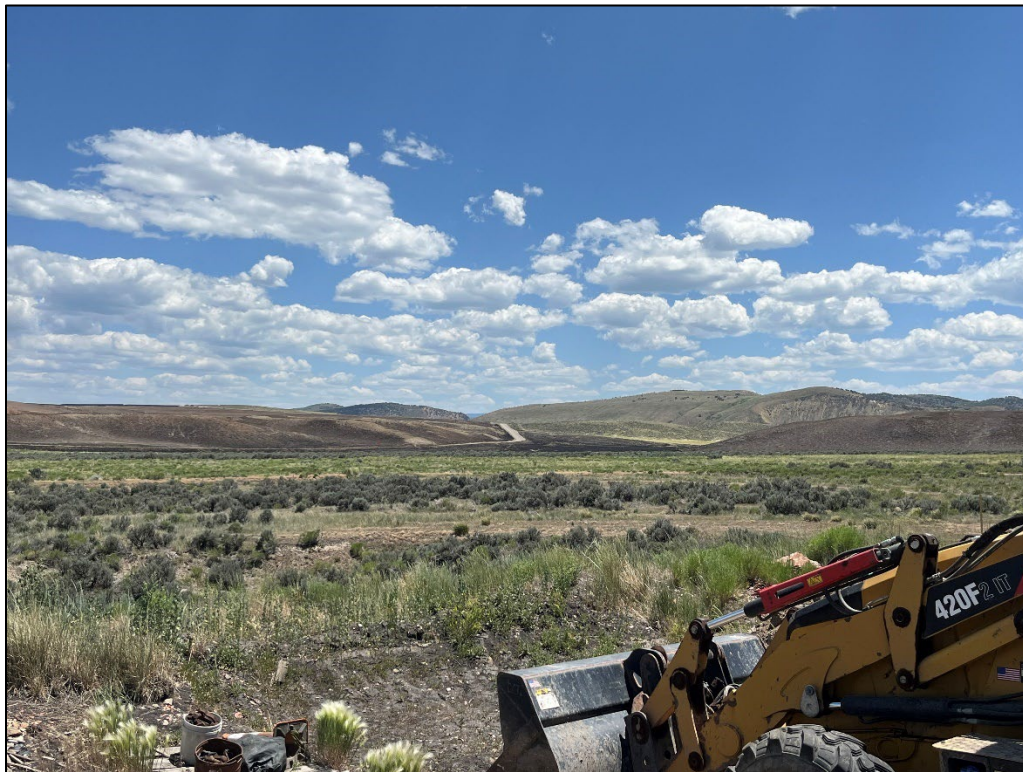
A few days before the inspection, a fire broke out adjacent to this rail loop area (Photo 28). The Division was notified of the event on June 24, 2025. Mr. Tennyson stated that a drone survey was being conducted to assess the extent of damage. At this time, it is understood that the fire was not caused by Colowyo or related to mine disturbance. Only a small area of the total burn acreage was within the Colowyo permit boundary. Colowyo will submit an MR to document the incident and disturbance.

*Photo 28: View east of the recent burn area across CR17.*

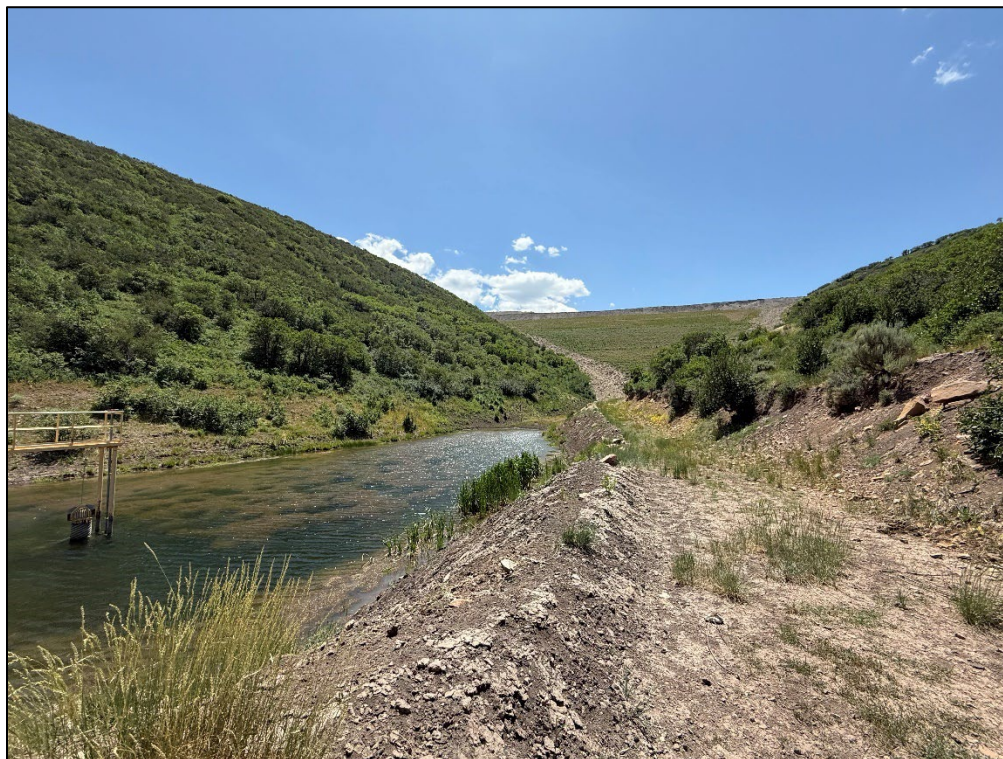
The West Taylor Valley Fill area was inspected from below at the West Taylor Pond (Photo 29). The face of the valley fill is well covered with vegetation, made up of sagebrush and native grasses and no erosional issues were visible. A few elk were noted to be walking across the face of the fill. Water was noted to be flowing through the valley fill underdrain and into West Taylor Pond as designed. Side ditches, which divert water from the face of the fill, were observed to be stable.

*Photo 29: View south of the West Taylor valley fill and West Taylor pond.*
