PERMIT INFORMATION

Permit Number: C-1981-038 Mine Name: Bowie No. 1 Mine Operator: Bowie Resources, LLC Operator Address: Mr. Art Etter P.O. Box 1488 Paonia, CO 81428	County: Delta Operation Type: Underground Permit Status: Active Ownership: Private
	Operator Representative Present: None
Operator Representative Signature: (Field Issuance Only)

Inspection Start Date: June 24, 2025 Inspection Start Time: 14:15 Inspection End Date: June 24, 2025 Inspection End Time: 17:10		Inspection Type: Coal Partial Inspection Inspection Reason: Normal I&E Program Weather: Cloudy	
Joint Inspection Agency: None		Joint Inspection Contacts:	
Post Inspection Agency: None		Post Inspection Contacts:	
Inspector(s): Robert Zuber, P.E.	Inspector's Signature:

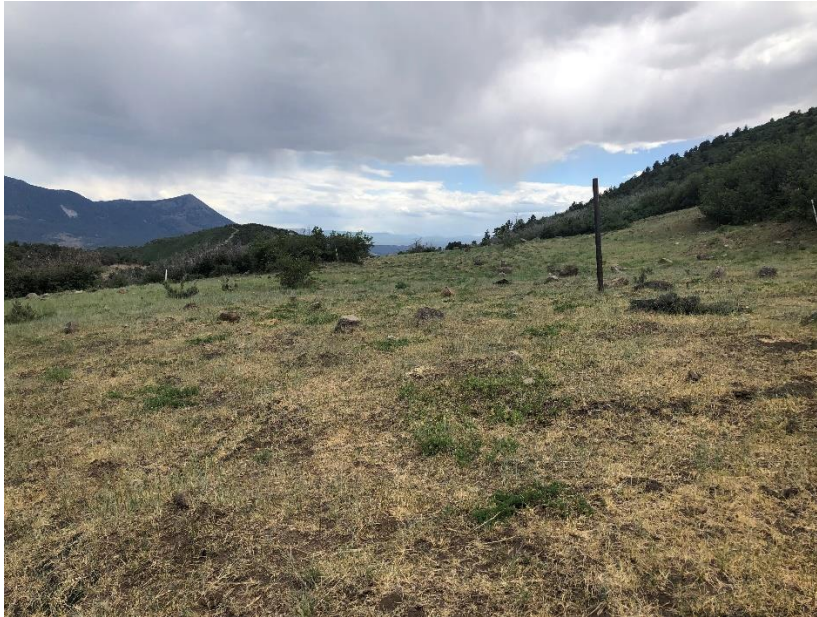
West Mine Fan (reclaimed pad)

No erosion was seen in the reclaimed areas of the West Mine, including the reclaimed road and the reclaimed fan area.

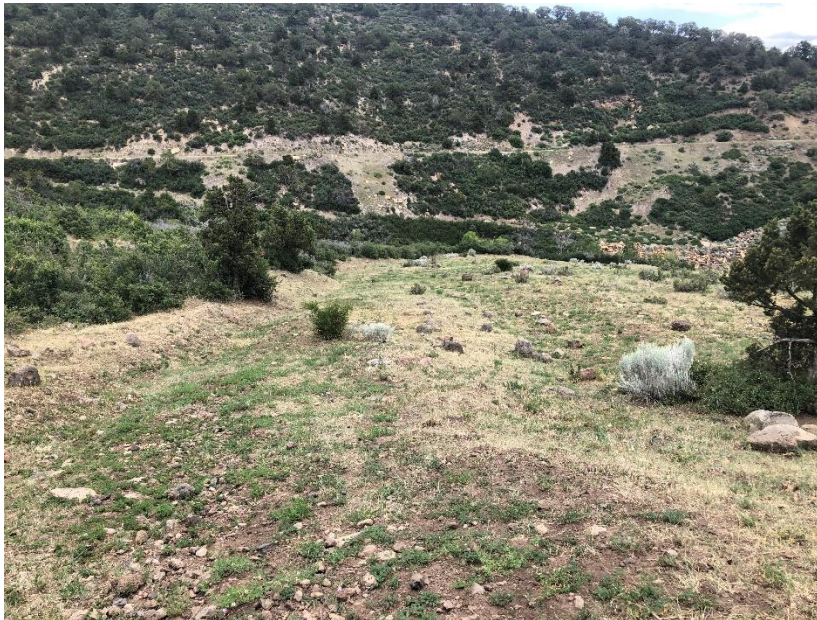
West Mine road

Few weed problems were observed at any of the locations that were inspected. These areas include the West Mine (the area that has not been released), the lower reclaimed ponds at the East Mine (Formerly Ponds 3 and 4), and the loadout. Some thistle was seen at the West Mine, near the reclaimed road. The area where yellow starthistle was observed in the past at the West Mine was closely observed, and this species was not seen.

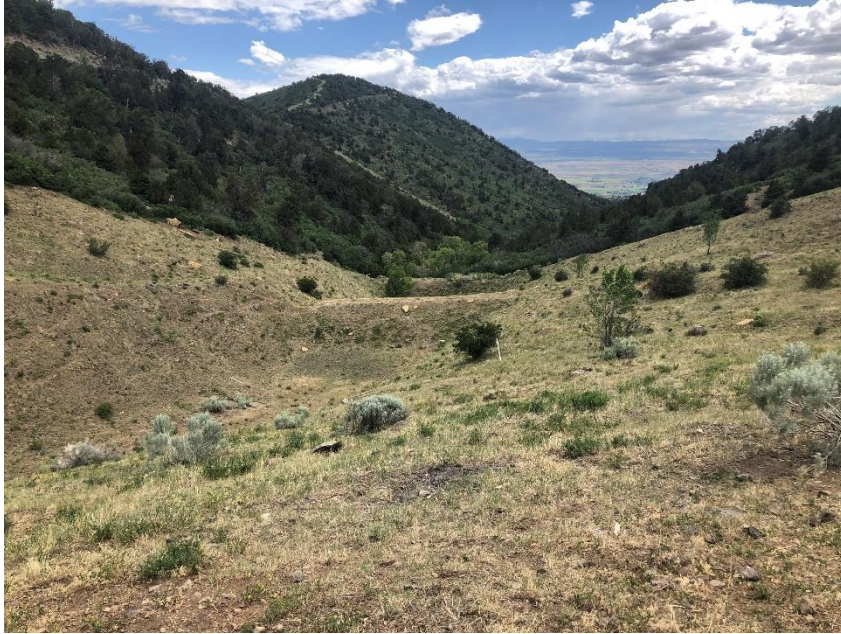
West Mine ponds

The ponds at the loadout and the West Mine contained no water. No discharges or signs of discharges were observed. No problems were identified with embankments, spillways, or other aspects of these ponds.

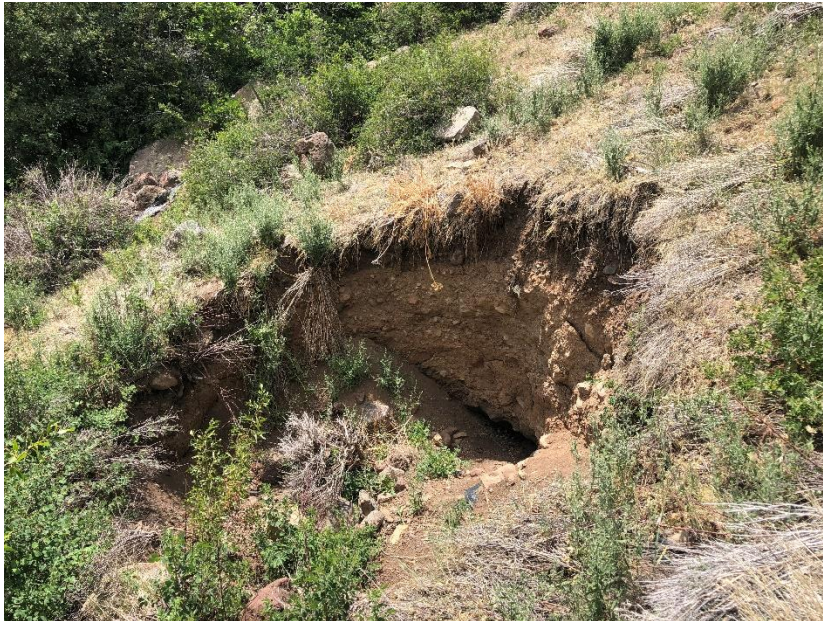
Above the large culvert under the West Mine, the sinkhole (discussed in the May 2025 inspection report by DRMS) was inspected and found to have not gotten bigger. In the office, BRL indicated that they plan to perform reclamation at the West Mine, including removal of the large culvert, in 2025.

West Mine – sinkhole below lower pond

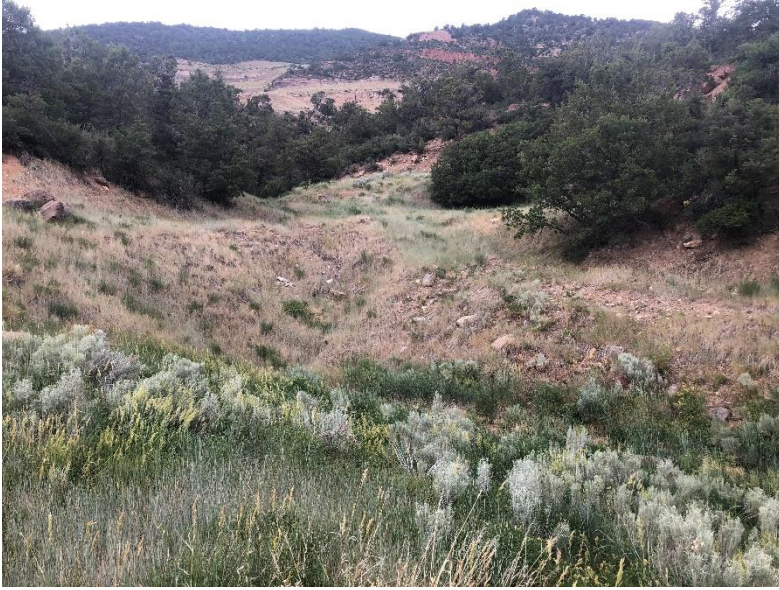
No problems were identified with the reclamation at Ponds 3 and 4 at the East Mine. The vegetation cover is good in this area.

East Mine – reclaimed Pond 4, looking upstream

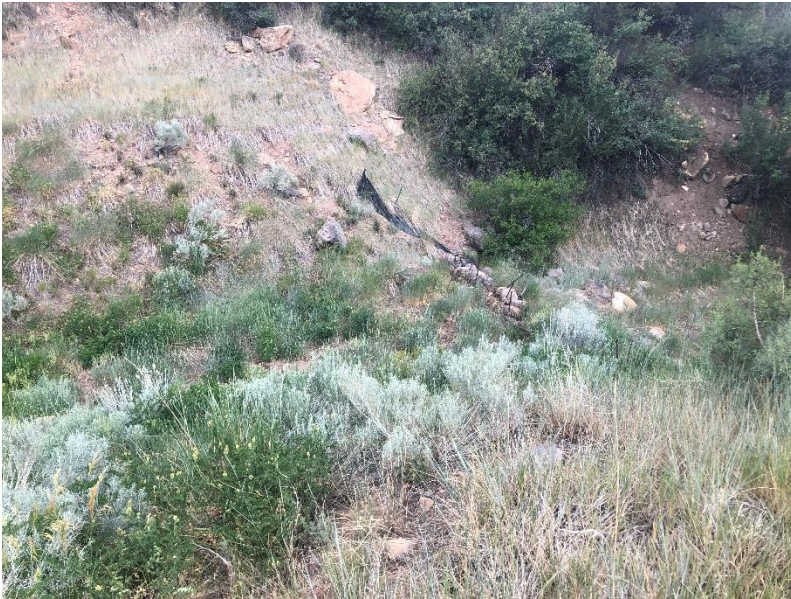
East Mine – reclaimed Pond 4, looking at lower end with old BMPs

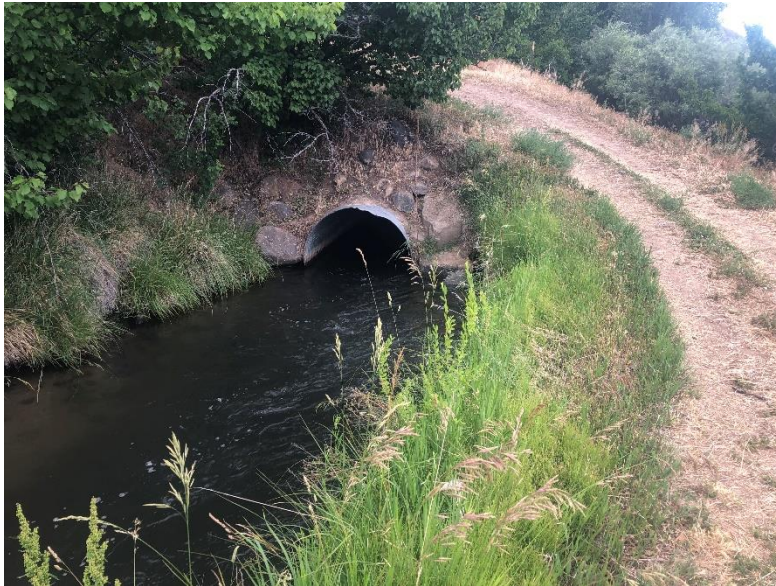
No problems were identified with the large culvert (that carries the Farmers Ditch) or the other ditches and culverts at the loadout. The Farmers Ditch was flowing about half full in the culvert.

Culvert for Farmers Ditch at Loadout (lower end)
