**MINERALS PROGRAM INSPECTION REPORT**  
**PHONE: (303) 866-3567**

<b>MINE NAME:</b> Dahlia North Resources Pit	<b>MINE/PROSPECTING ID#:</b> M-1994-093	<b>MINERAL:</b> Sand and gravel	<b>COUNTY:</b> Adams
<b>INSPECTION TYPE:</b> Surety Release Inspection	<b>WEATHER:</b> Clear	<b>INSP. DATE:</b> June 25, 2025	<b>INSP. TIME:</b> 10:00
<b>OPERATOR:</b> Holcim - WCR, Inc.	<b>OPERATOR REPRESENTATIVE:</b> Wyatt Webster	<b>TYPE OF OPERATION:</b> 112c - Construction Regular Operation	
<b>REASON FOR INSPECTION:</b> Surety Release Requested SL2	<b>BOND CALCULATION TYPE:</b> None	<b>BOND AMOUNT:</b> \$100,000.00	
<b>DATE OF COMPLAINT:</b> NA	<b>POST INSP. CONTACTS:</b> None	<b>JOINT INSP. AGENCY:</b> None	
<b>INSPECTOR(S):</b> Nikie Gagnon	<b>INSPECTOR'S SIGNATURE:</b>

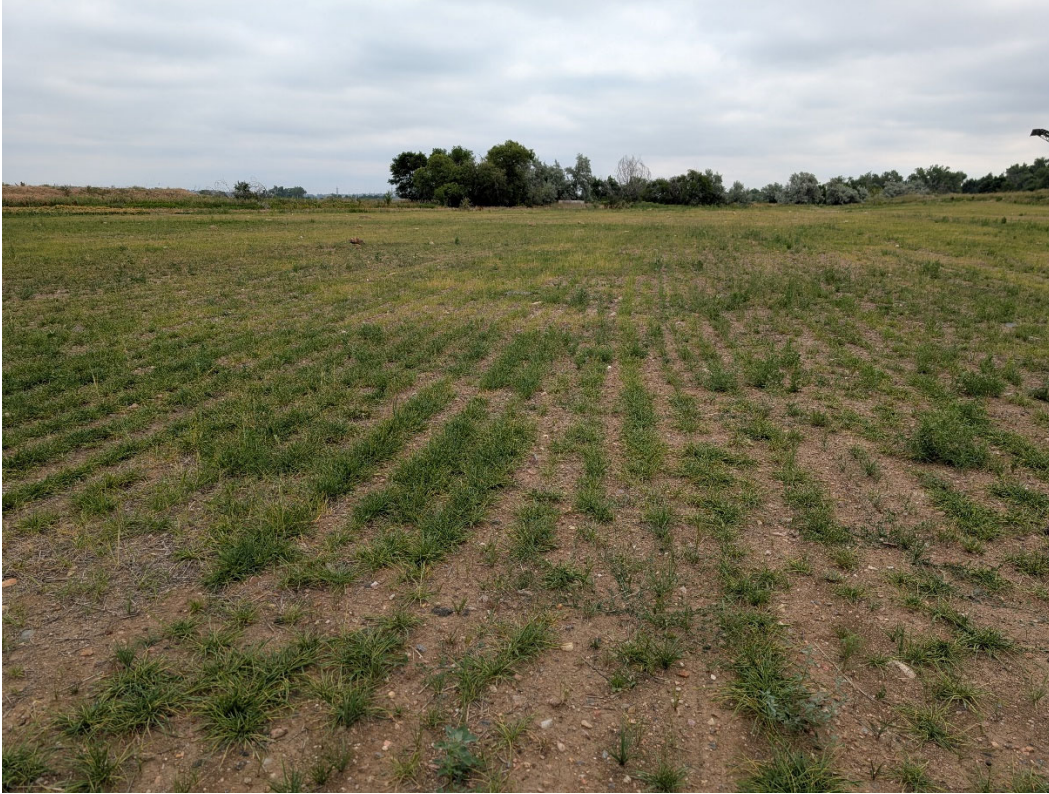
Photo 1: Looking north from the entrance to the backfilled area.

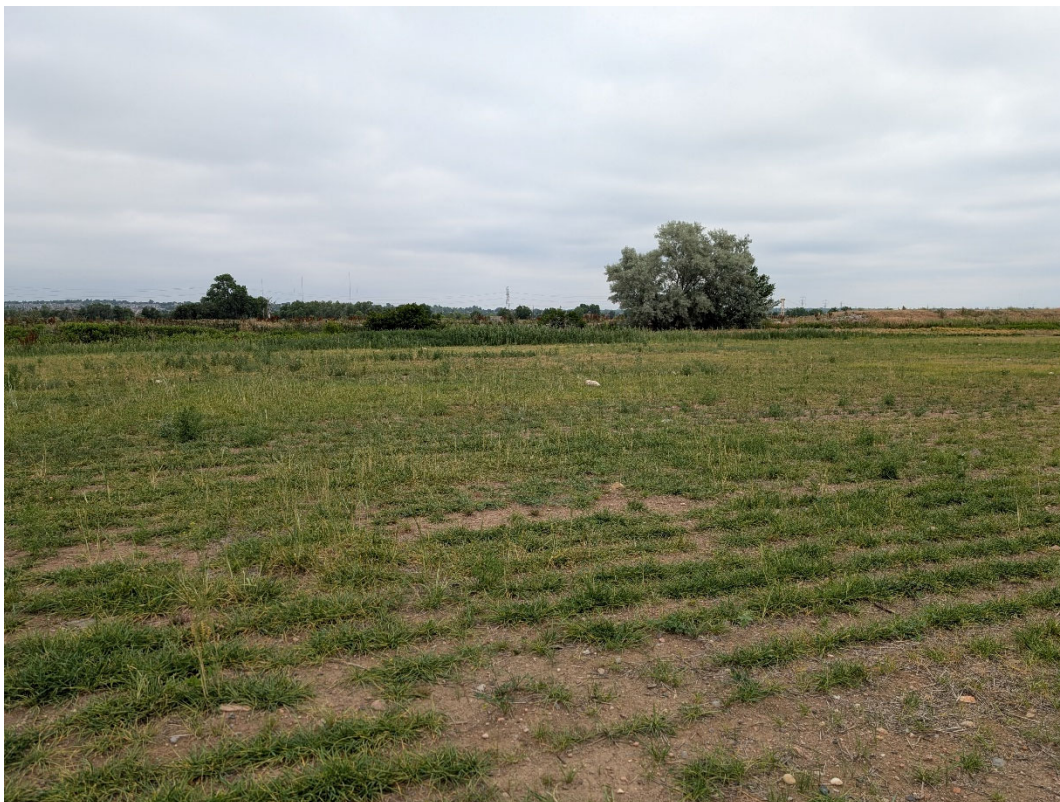
Photo 2: Looking west across the backfilled area.

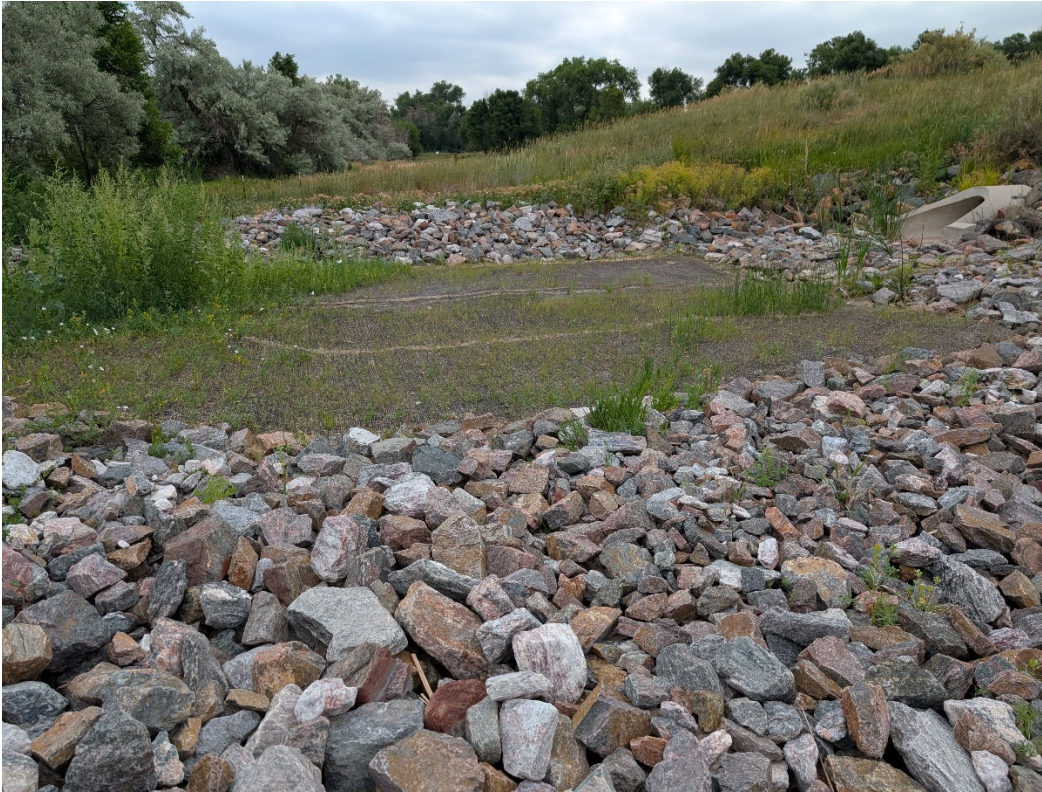
Photo 3: Looking at outlet and swale feature was installed on the north end of the permit area to handle stormwater runoff to the adjacent Bull Seep.

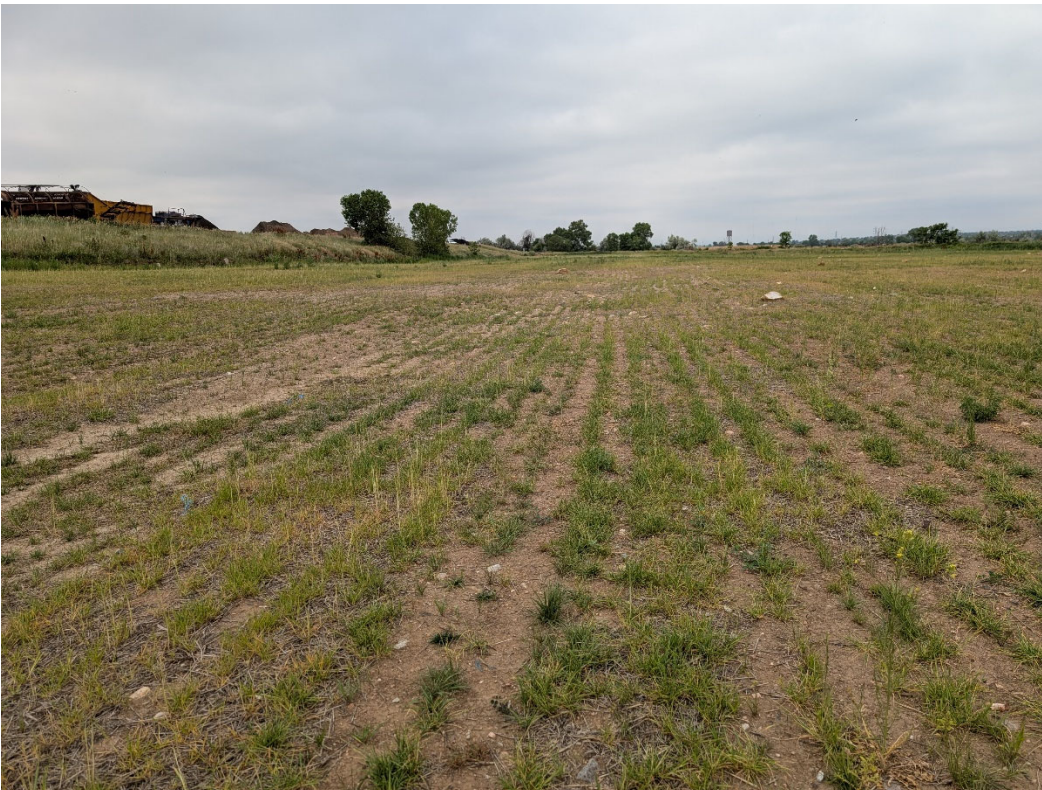
Photo 4: Looking south from the north end of the release area.
