MINERALS PROGRAM INSPECTION REPORT
PHONE: (303) 866-3567

MINE NAME: North Star Pit	MINE/PROSPECTING ID#: M-2012-004	MINERAL: Gravel	COUNTY: Weld
INSPECTION TYPE: Monitoring	WEATHER: Clear	INSP. DATE: June 3, 2025	INSP. TIME: 09:00
OPERATOR: Superior Oilfield Services Co., LTD	OPERATOR REPRESENTATIVE: Jim McFarland	TYPE OF OPERATION: 112c - Construction Regular Operation	
REASON FOR INSPECTION: Normal I&E Program	BOND CALCULATION TYPE: Complete Bond	BOND AMOUNT: \$130,355.00	
DATE OF COMPLAINT: NA	POST INSP. CONTACTS: None	JOINT INSP. AGENCY: None	
INSPECTOR(S): Nikie Gagnon	INSPECTOR'S SIGNATURE:

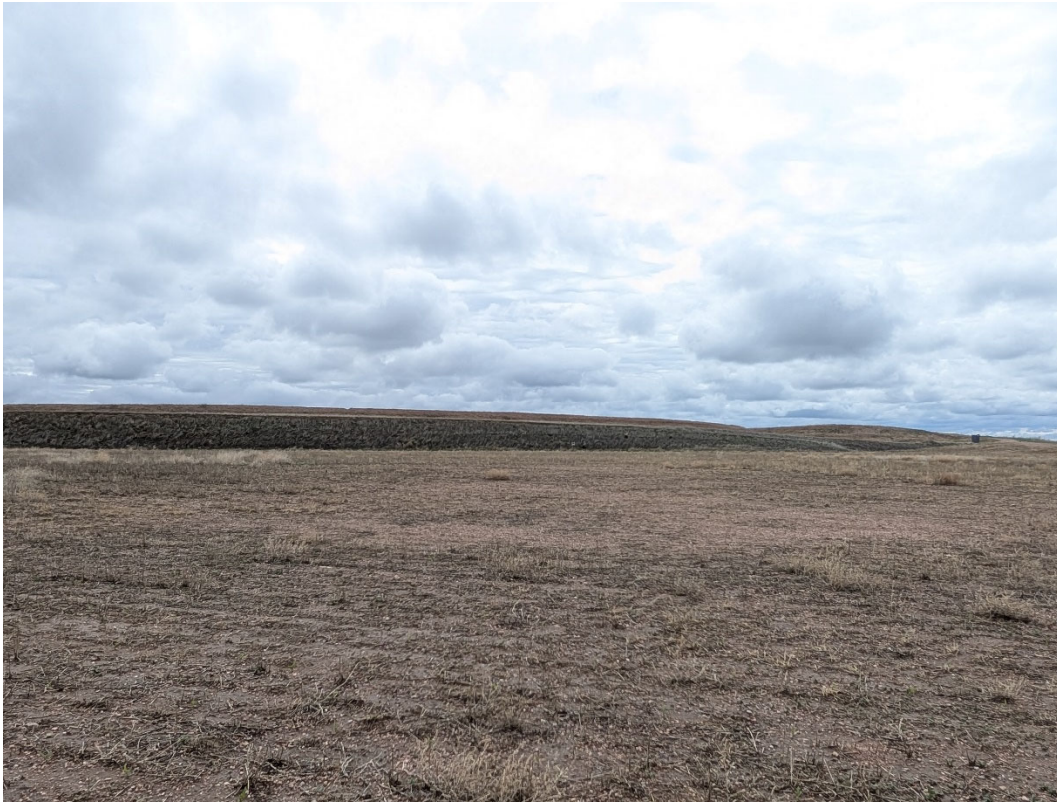
Photo 1: Looking southeast across the agricultural field in the release area.

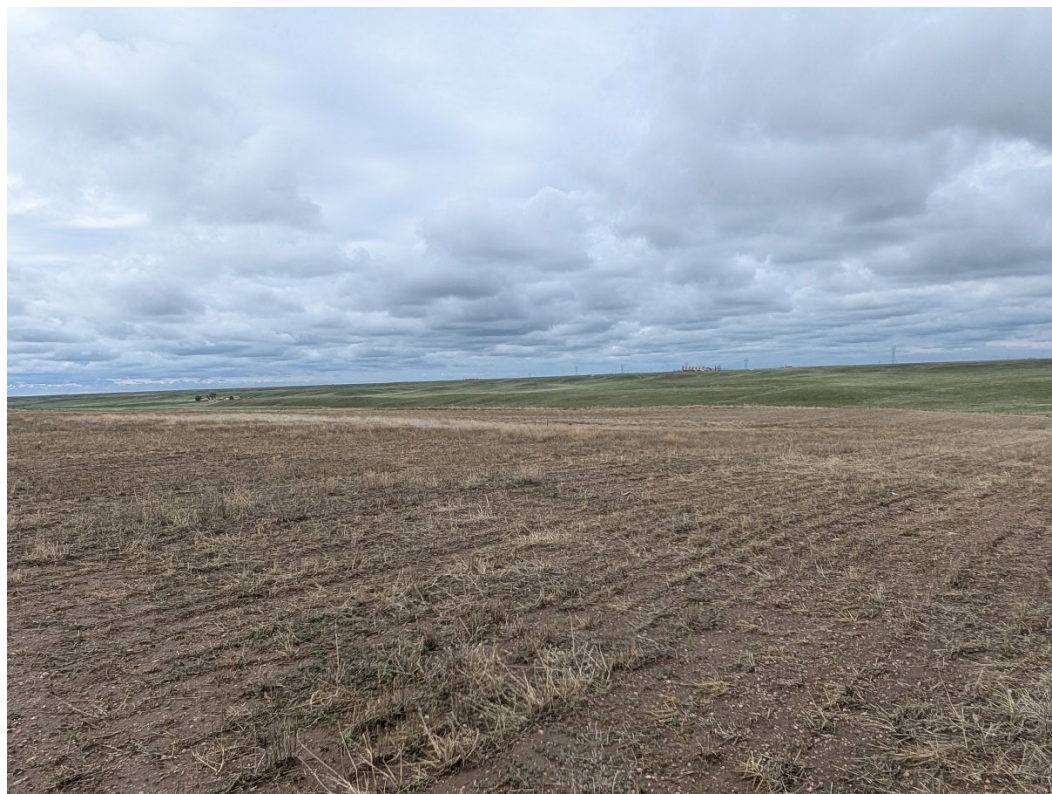
Photo 2: Looking west at the slope across the agricultural field in the release area.

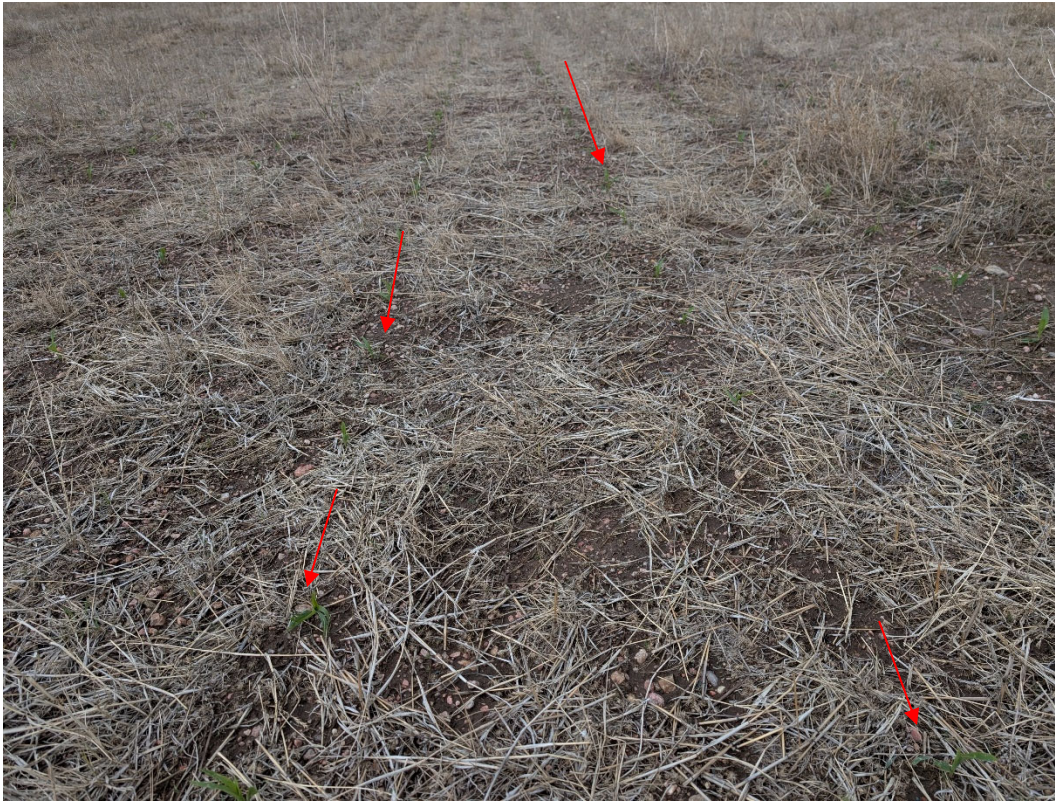
Photo 3: Close up of the crop planting. Wheat stalks from the previous year and rows of corn planted this season are noted by red arrows.

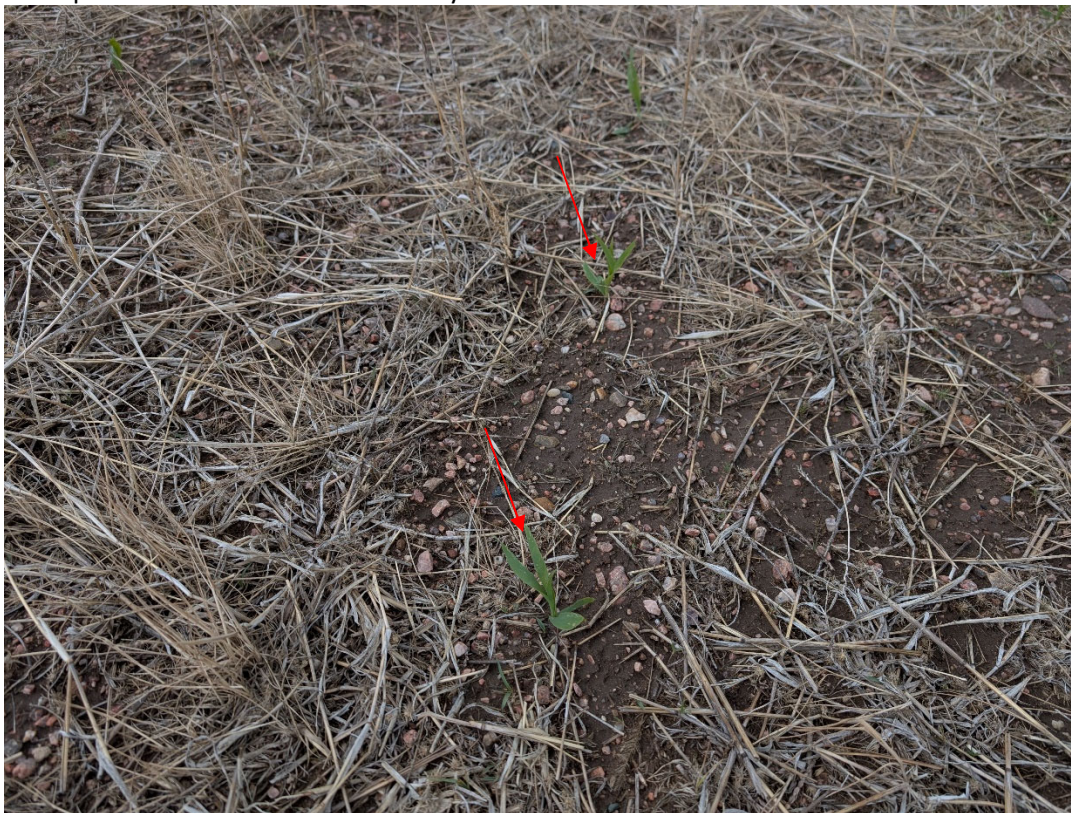
Photo 4: Corn seedlings planted in the release area this year.

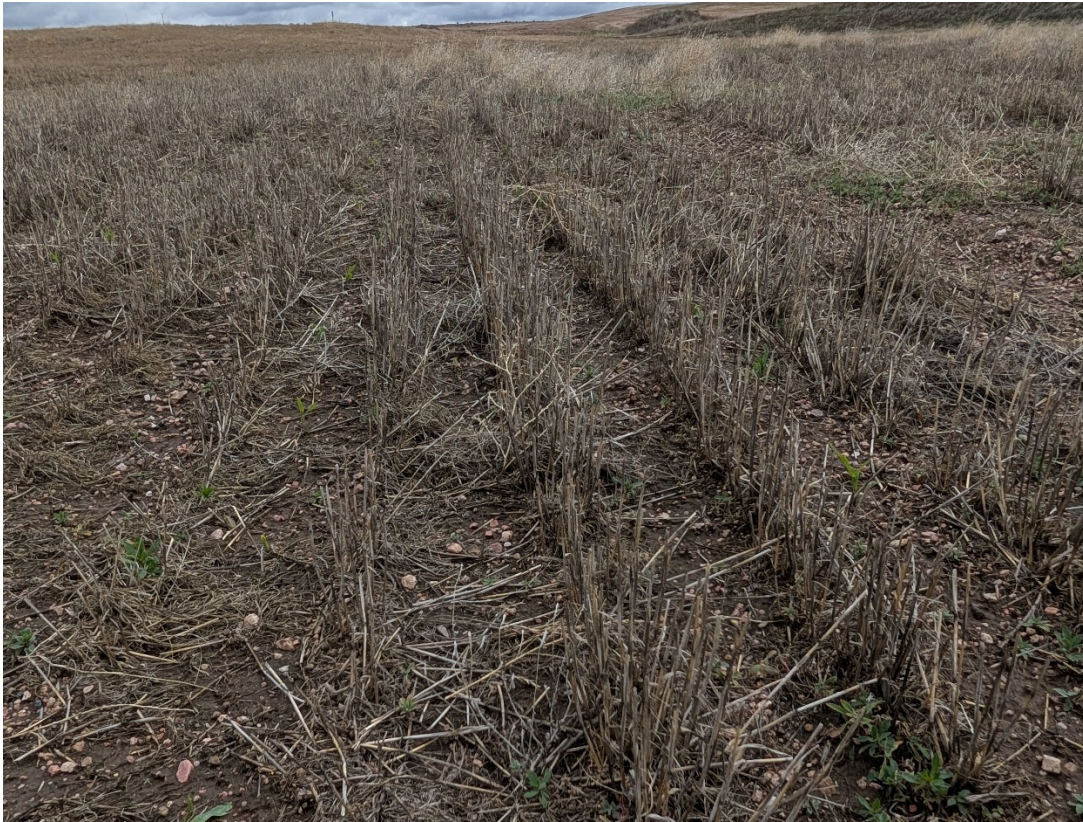
Photo 5: Rows of wheat stalks from the previous year.

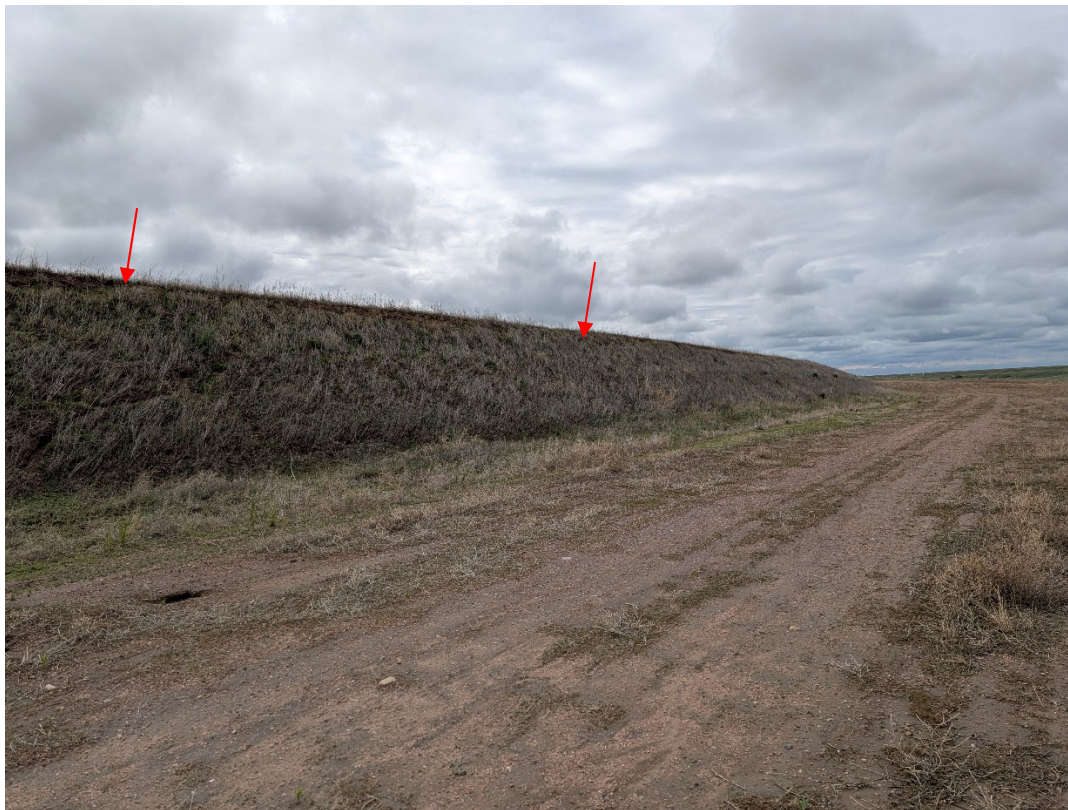
Photo 6: Access road around the west side of the active mining area will remain in the permit area. Topsoil berm placed along the west side of the active mining area. (red arrows)

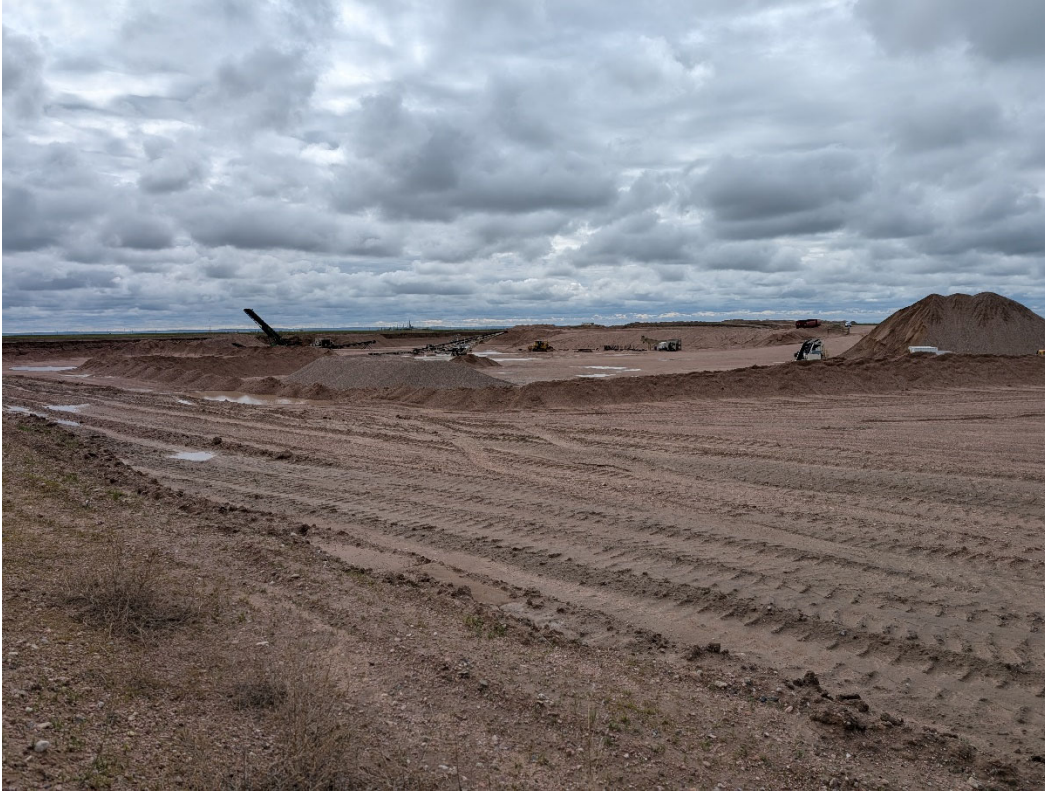
Photo 7: Looking east across the active mining area.

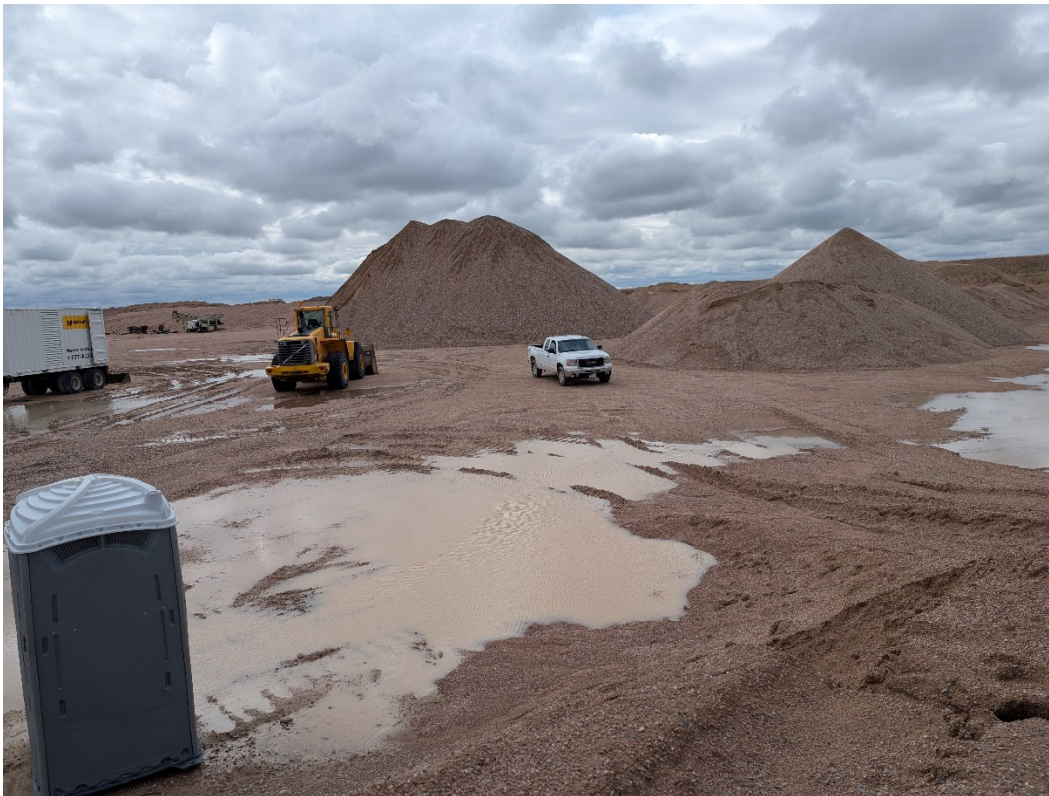
Photo 8: Stockpiles in the active mining area. Small amount of stormwater observed due to recent rains.

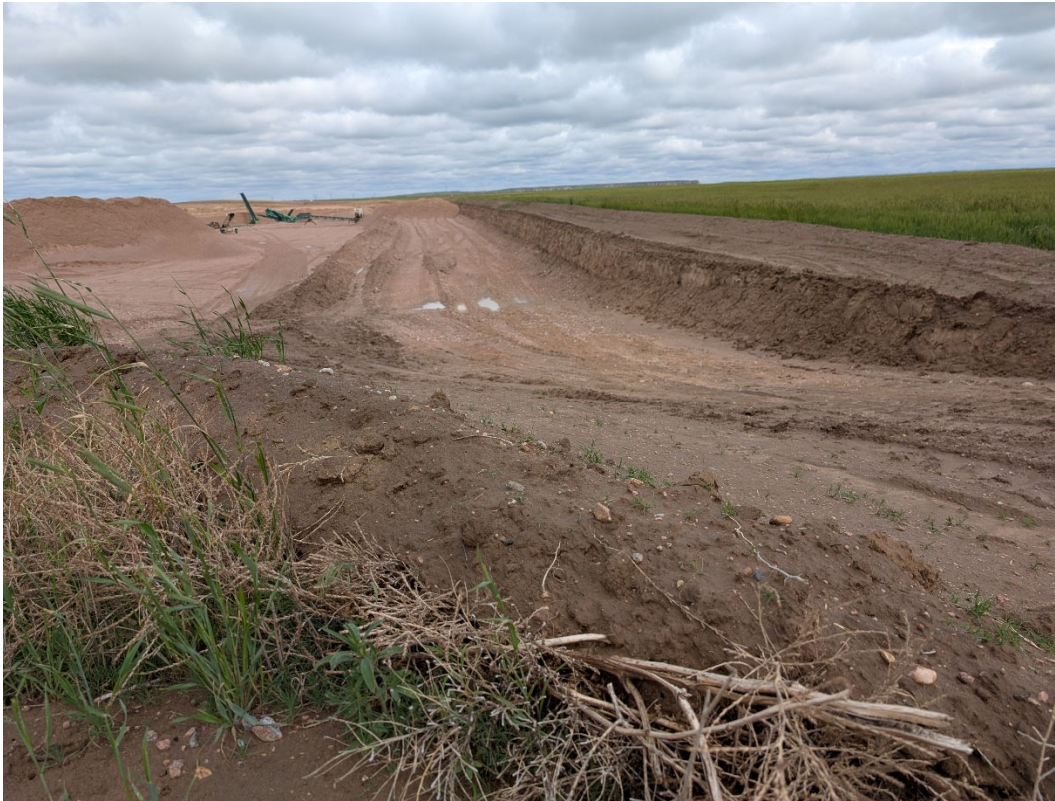
Photo 9: Looking north down the highwall which is located along the eastern permit boundary. Proposed amendment area is the field on the left.

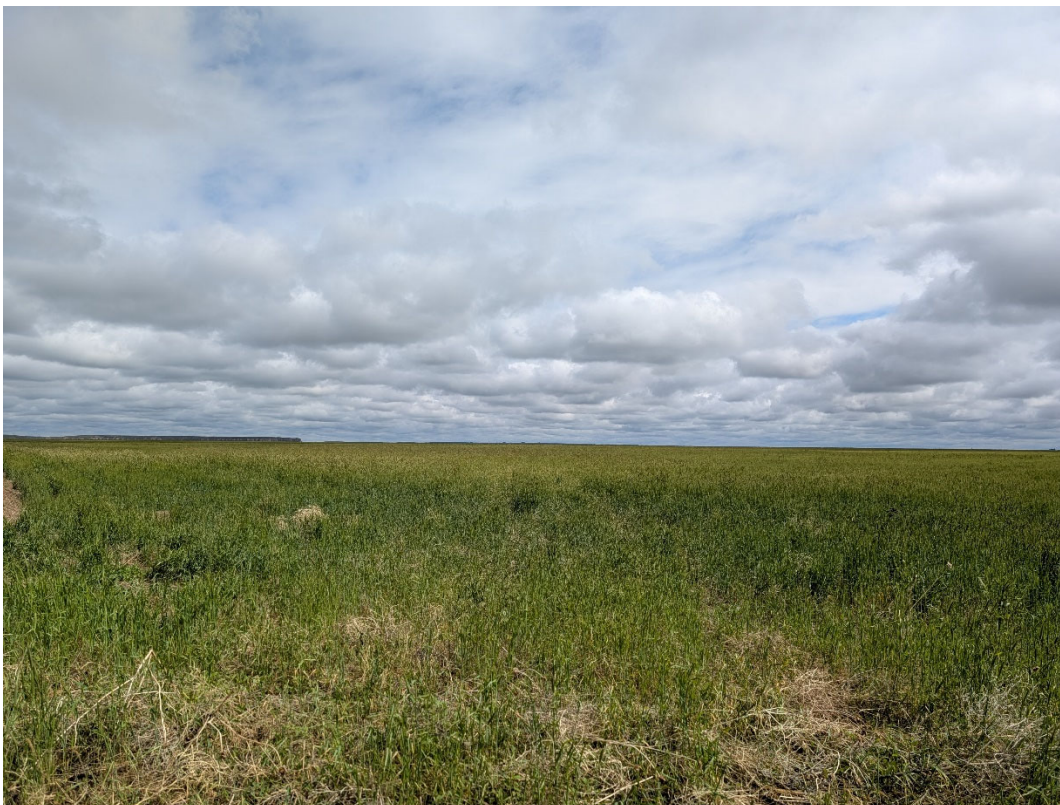
Photo 10: Dryland crop planted in the proposed amendment area, east of the existing permit area.

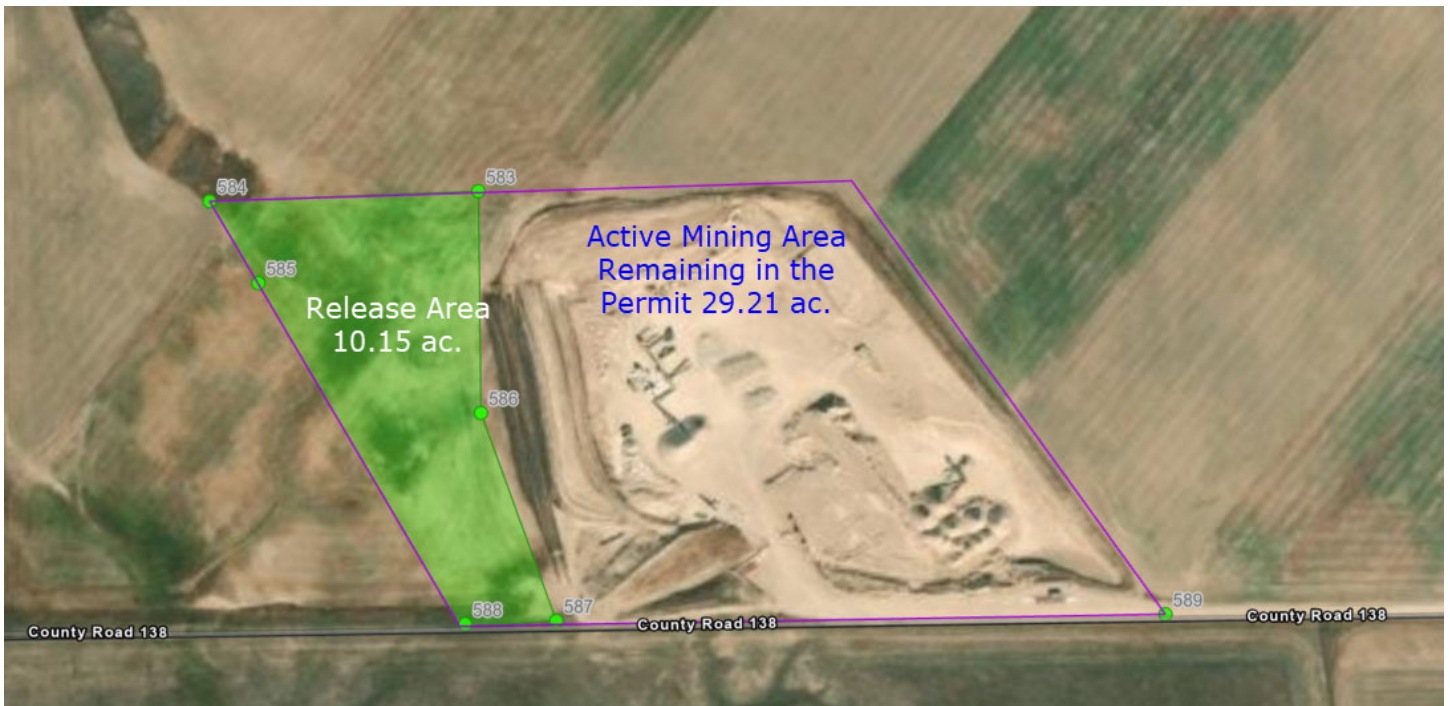
Figure 1: Google Image of release area shown in green. Remaining permit boundary outlined in purple.
