**MINERALS PROGRAM INSPECTION REPORT**  
**PHONE: (303) 866-3567**

<b>MINE NAME:</b> Orlando Pit	<b>MINE/PROSPECTING ID#:</b> M-2001-106	<b>MINERAL:</b> Sand and gravel	<b>COUNTY:</b> Huerfano
<b>INSPECTION TYPE:</b> Monitoring	<b>WEATHER:</b> Cloudy	<b>INSP. DATE:</b> June 11, 2025	<b>INSP. TIME:</b> 12:03
<b>OPERATOR:</b> Huerfano County	<b>OPERATOR REPRESENTATIVE:</b> Dustin Hribar	<b>TYPE OF OPERATION:</b> 112c - Construction Regular Operation	
<b>REASON FOR INSPECTION:</b> Normal I&E Program	<b>BOND CALCULATION TYPE:</b> None	<b>BOND AMOUNT:</b> \$0.00	
<b>DATE OF COMPLAINT:</b> NA	<b>POST INSP. CONTACTS:</b> None	<b>JOINT INSP. AGENCY:</b> None	
<b>INSPECTOR(S):</b> Amber M. Gibson	<b>INSPECTOR'S SIGNATURE:</b>

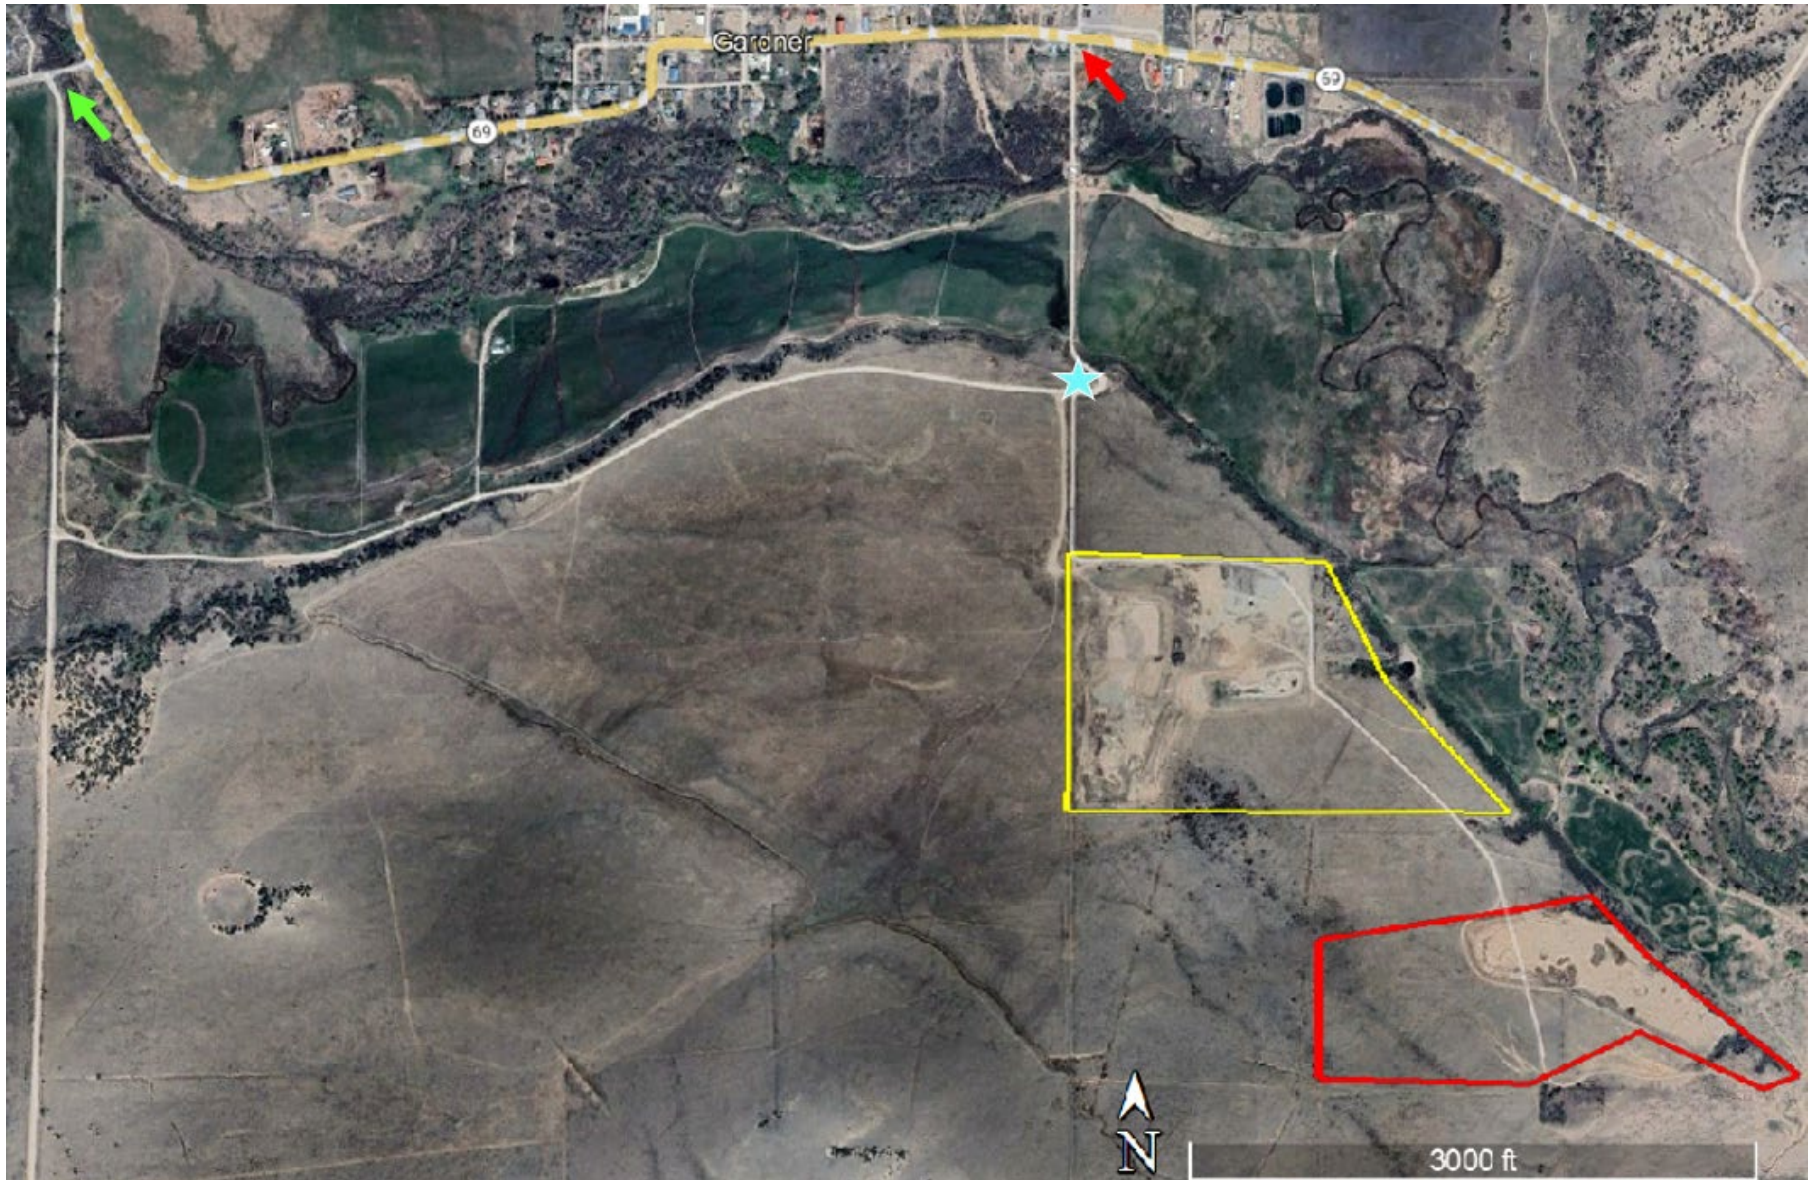
The entrance to the site is usually accessed by taking County Road 543, off of Highway 69 (see Map 2). During the inspection, the access to County Road 543 was detoured, and was accessed via County Road 560 instead. The site shares an access road with another permitted operation (M-1985-008). During the Inspection, the Operator stated that they move the access road (a.k.a haul road or ranch road) around new disturbance, so that the Landowner on the south side of the permit boundary maintains access to their house. Upon post inspection review, it appears that the diverted road has been diverted outside of the permit boundary on the north side (see Figure 1). It is unclear whether the diversion to the road occurred when the CN1 boundary still encompassed that area (from 2012 to 2021), or after the permit boundary was adjusted following a correction survey through TR1 (2021-current). The aerial imagery available jumps from 2020 to 2025 and is unable to be used to determine exactly when the now offsite disturbance occurred. Additionally, the currently approved reclamation plan states that the access road will remain after reclamation, per request of the Landowner. The current reclamation plan map depicts that the road will remain in/or be put back to its original orientation.

**Map 2:** Location map. The blue star indicates the mine sign's location (see the **left** side of Photo 1). The yellow boundary belongs to an adjacent permitted operation. The red boundary indicates the approximate permit boundary for the Orlando Pit. The red arrow points to where the site is normally accessed. The green arrow points to where the access road access has been temporarily detoured.

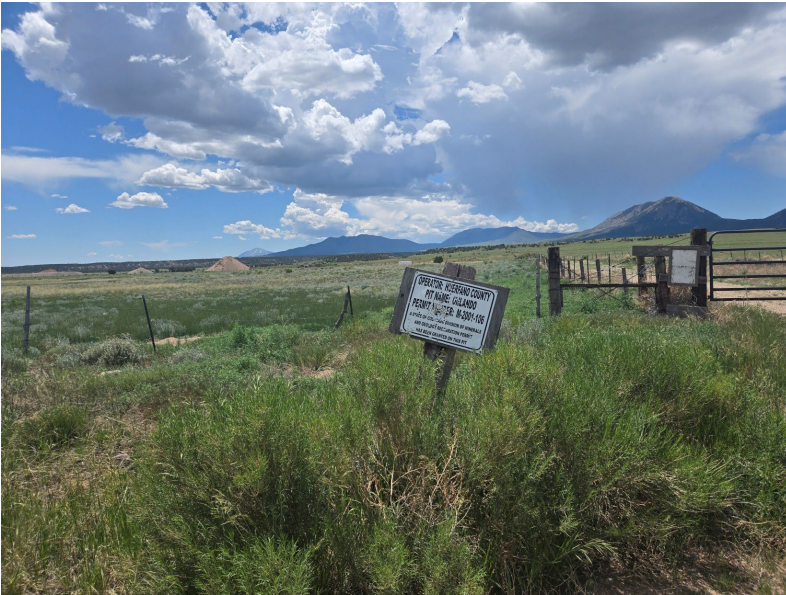
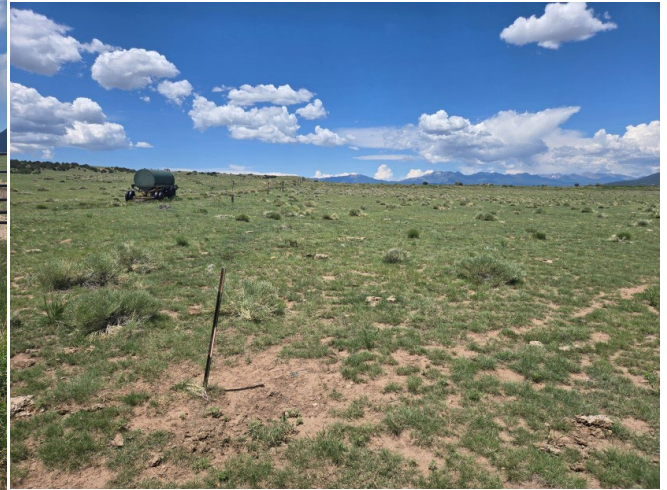
The mine sign was posted at the beginning of the entrance road mentioned in the 'Roads' section above (see Map 2). The sign is posted in compliance with Rule 3.1.12(1). T-posts marking the permit boundary were observed around the site. The markers appeared to be posted in compliance with Rule 3.1.12(2).

**Photo 1: (Left)** Looking south at the permit sign located near the old entrance. The entrance to the access road is located to the west of the gated entrance (see Map 2). **(Right)** Example of t-post marking the permit boundary. Coordinates for this point were collected in the field (see Map 1).

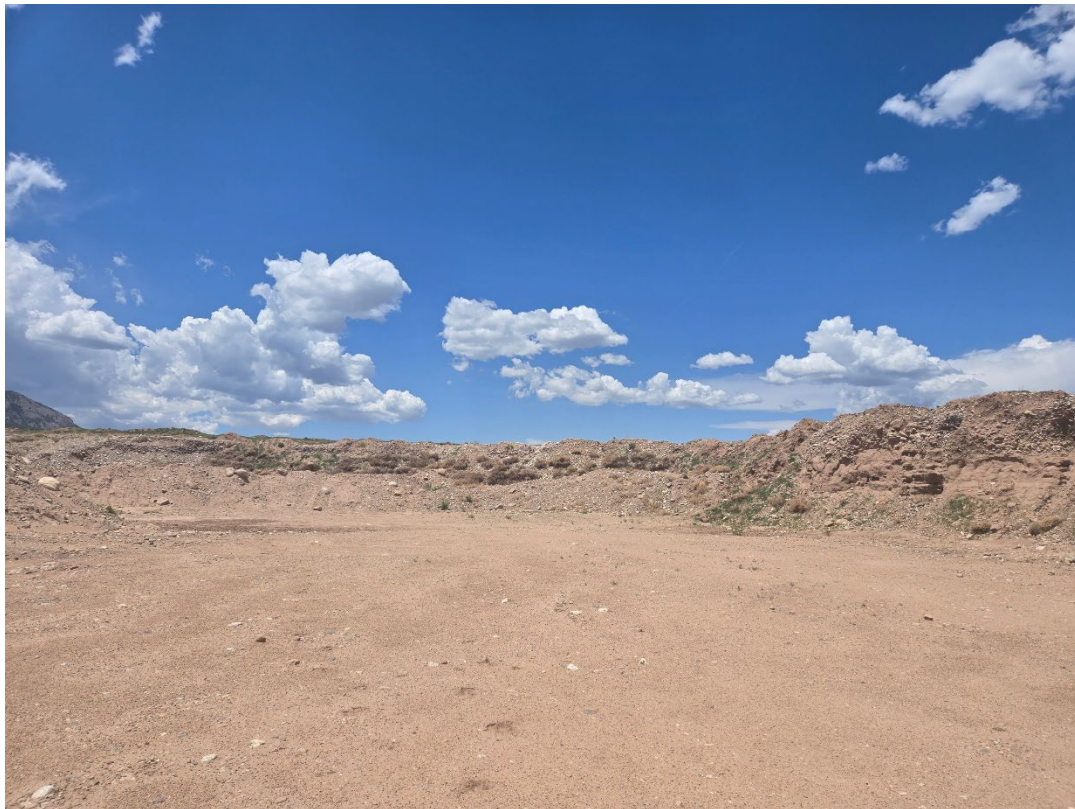
This site is approved to affect a maximum of 15 acres at any one time. The Division estimates that the current disturbance at this site consists of approximately 12.1 acres. The most recently excavated area contains approximately 750 feet of highwalls along the western side of the pit. The highwalls are approximately at a 1-0.5H:1V slope, and reach depths up to about 15 feet. Mining at this site is approved to reach depths between 20 and 25 feet. The approved mining and reclamation plans explicitly state that mining will be conducted by pushing slopes to a 3H:1V and that highwalls were not planned for this site. **This has been cited as a problem above.** By the corrective action date, the Operator shall either provide proof that the highwalls have been reclaimed to a 3H:1V slope and commit to not creating highwalls at this site for the remainder of the permitted operation, or submit a technical revision (TR) to update the mining and reclamation plans to reflect the current and future operating plans for the site to allow for the use of highwalls.

**Photo 2:** Looking west at the most recent extent of the pit disturbance.

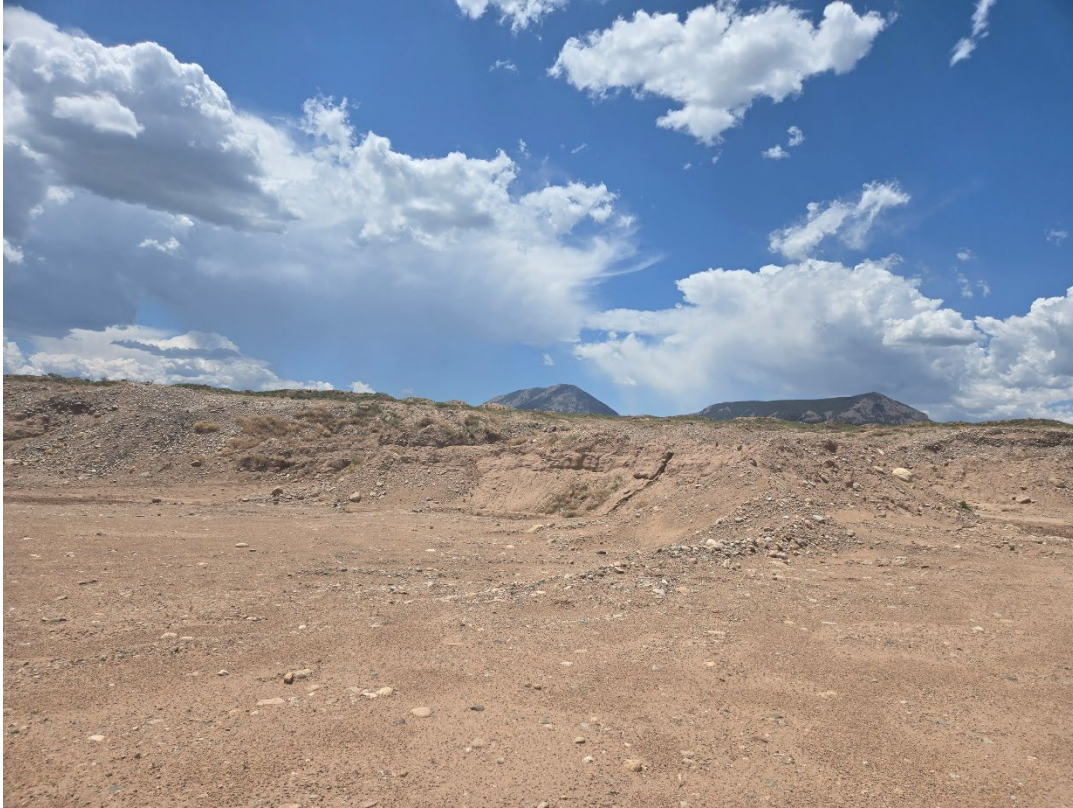
**Photo 3:** Looking southwest at the most recent extent of the pit disturbance.

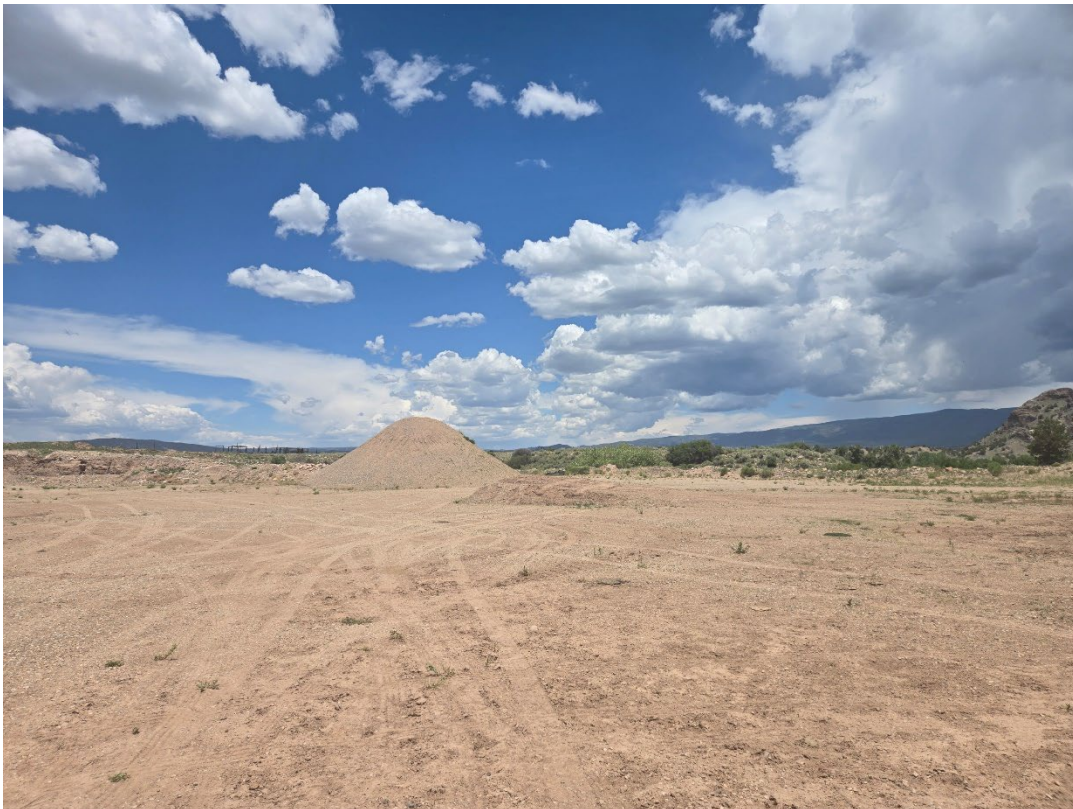
**Photo 4:** Looking northwest at the Landowner's gravel material.

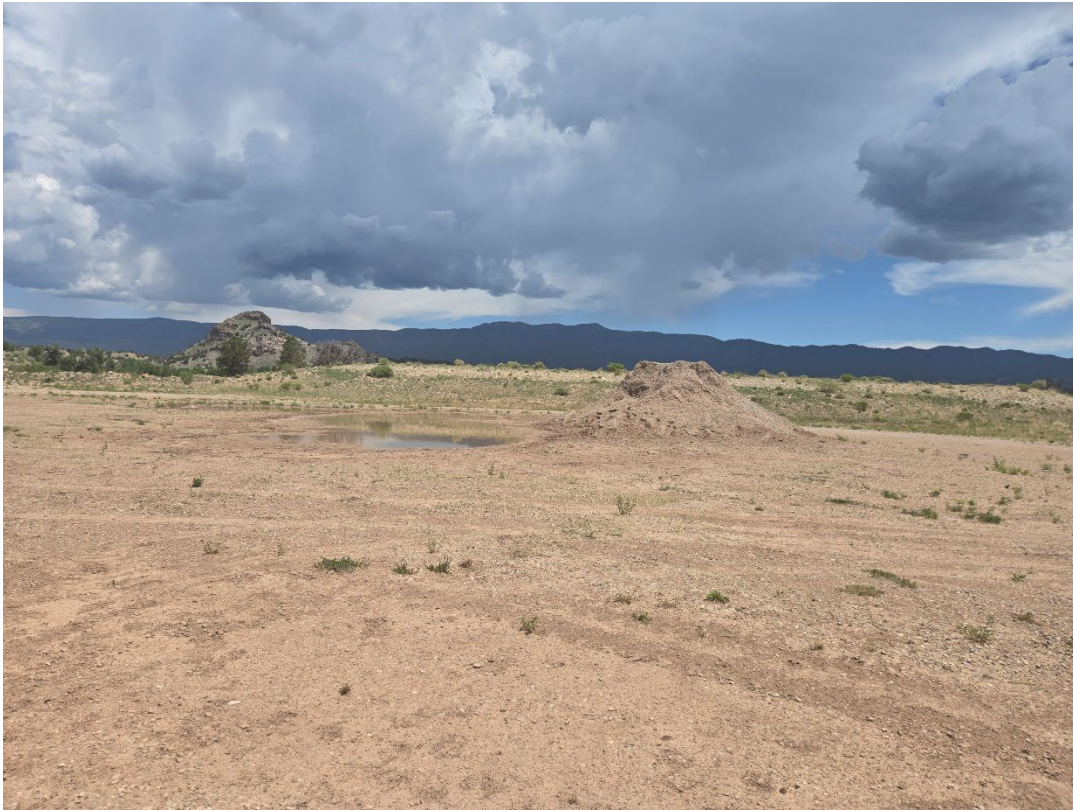
**Photo 5:** Looking north at the Permittee's remaining product stockpile material. Reclaimed slopes are seen in the background.

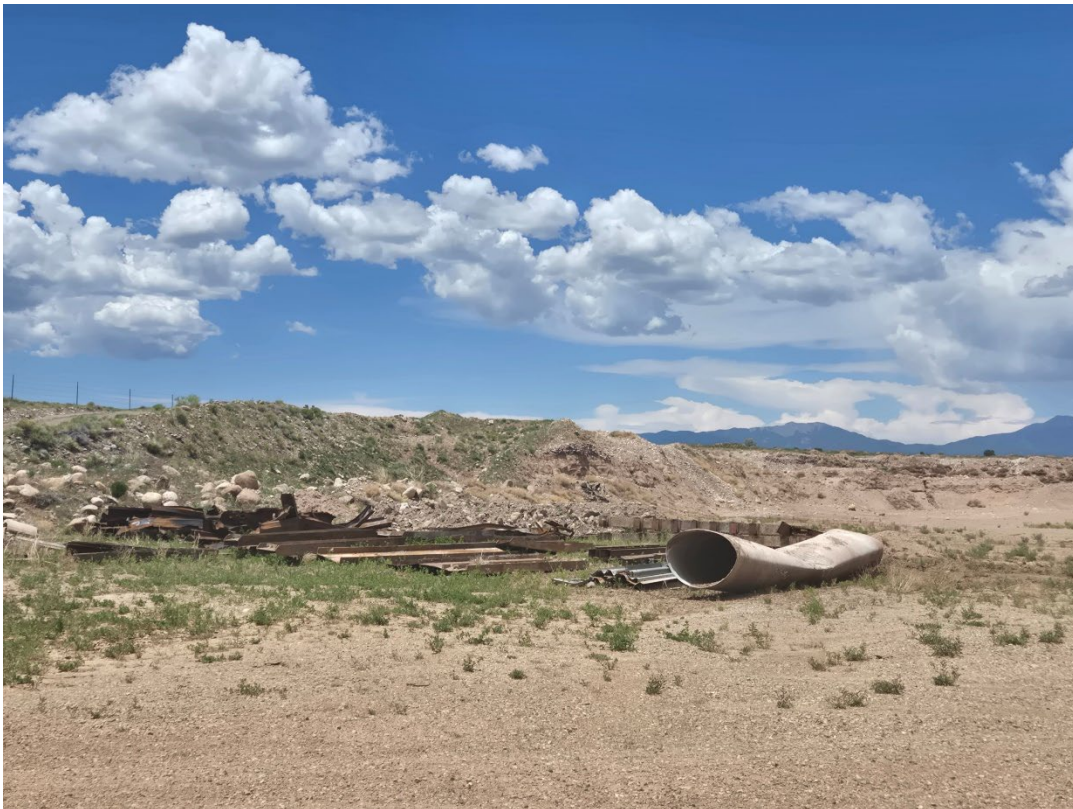
**Photo 6:** Looking west at the steel material salvaged from the nearby bridge demolition that is currently stored within the southside of the pit area.

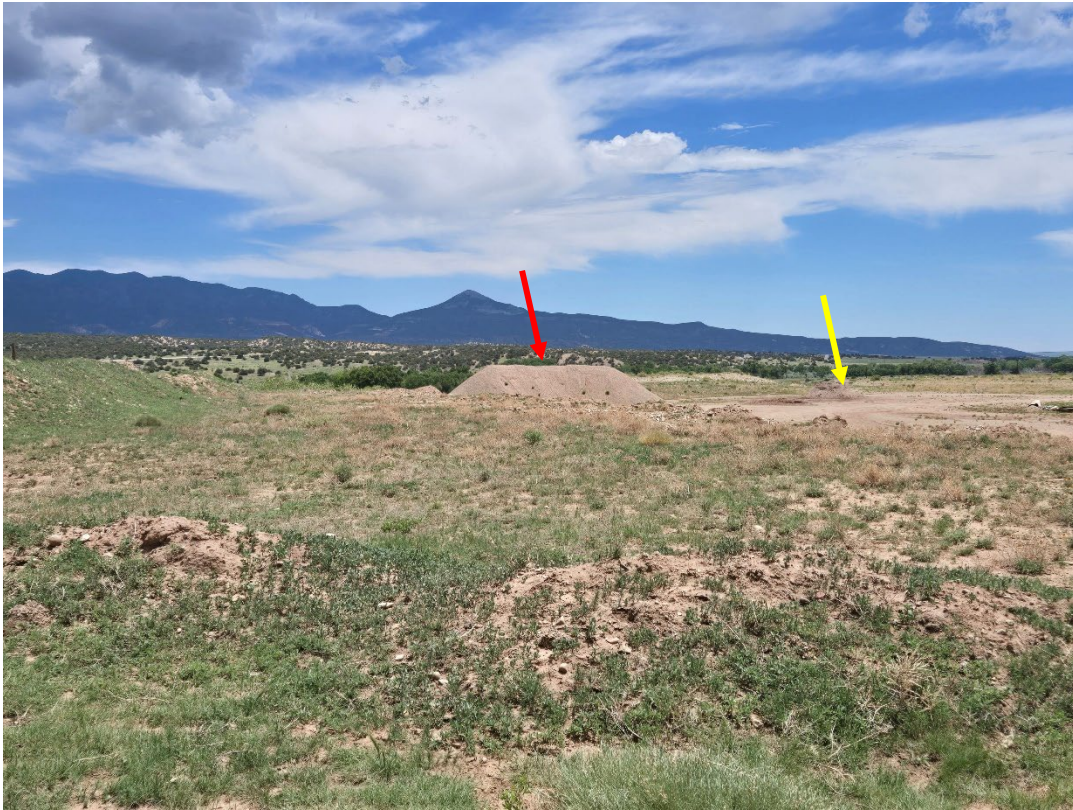
**Photo 7:** Looking northeast at the current extent of the pit boundary. The red arrow points to the Landowner's product stockpile (see Photo 4). The yellow arrow points to the Permittee's/Operator's product stockpile (see Photo 5).

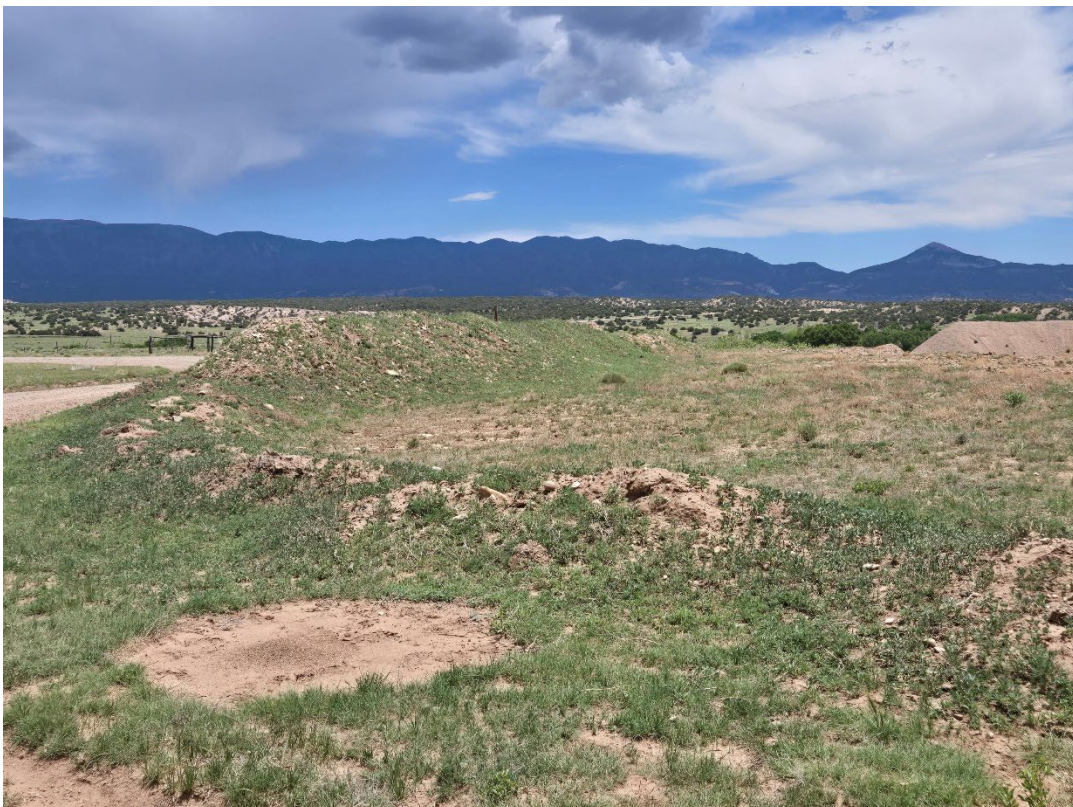
Topsoil berms line the perimeter of the disturbance and are placed up and out of the way of ongoing mining operations. The topsoil piles appeared to be stable and were vegetated at the time of the inspection.

**Photo 8:** Looking north at some of the stockpiled topsoil. On the left side of the photo is the diverted access road (mentioned in the Roads section in this report).

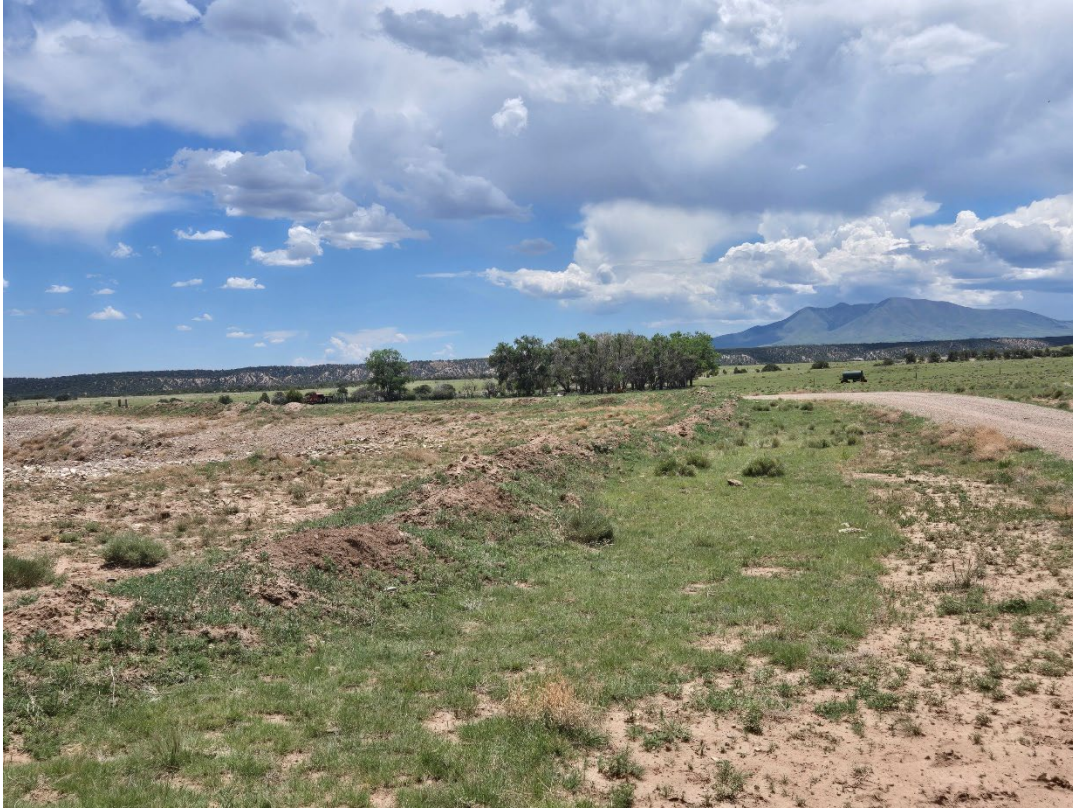
**Photo 9:** Looking south at some of the stockpiled topsoil lining the disturbance. On the right side of the photo is the diverted access road (mentioned in the Roads section in this report). The Landowner's house is near the cluster of trees seen in the middle of the photo.

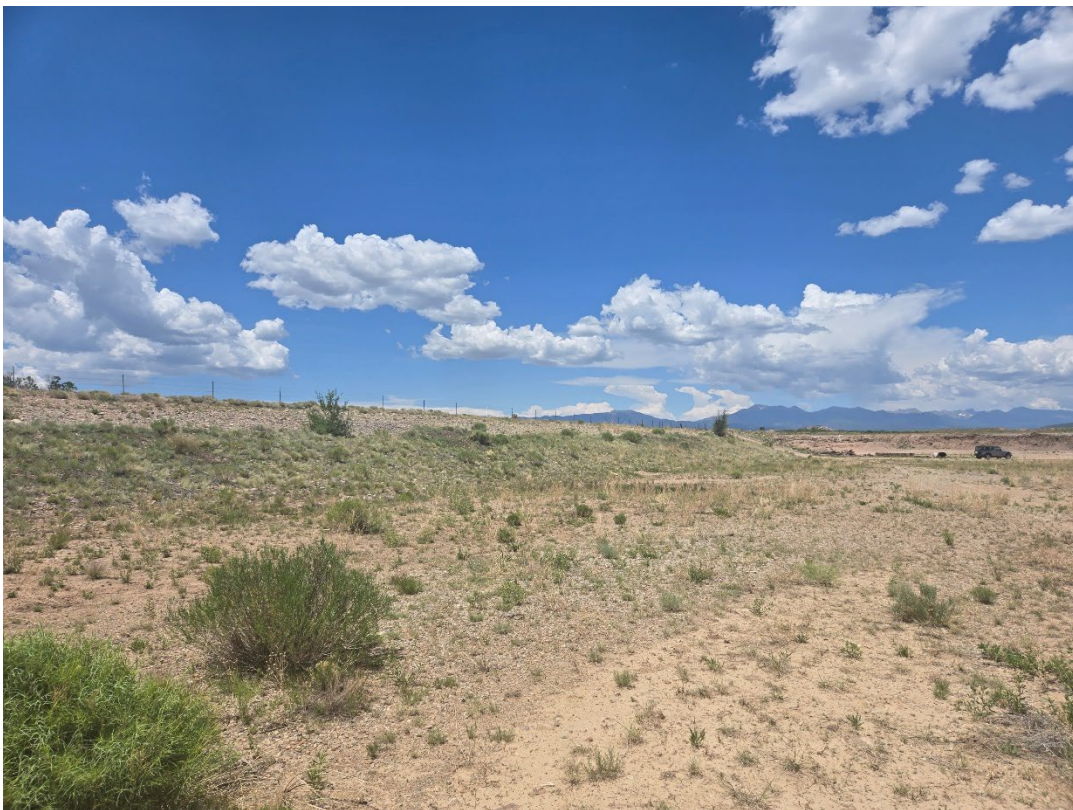
The southeasternmost area of the disturbance occurred during the originally permitted 110c operation. According to the annual reports, approximately 10 acres have been backfilled, graded, topsoiled, and about 3.5 acres have been seeded. The side slopes along the north and south sides have been graded to a 3H:1V or flatter. The side slopes appear to be well vegetated, but the pit floor will require seeding and/or re-seeding before it will be eligible for release. Wrapping around the disturbance, and joining with the slopes, is a low earthen berm, that the approved reclamation plan states is to be used to prevent stormwater runoff from leaving the site.

**Photo 10:** Looking west from within the previously reclaimed area at reclaimed slopes and reclaimed pit floor.

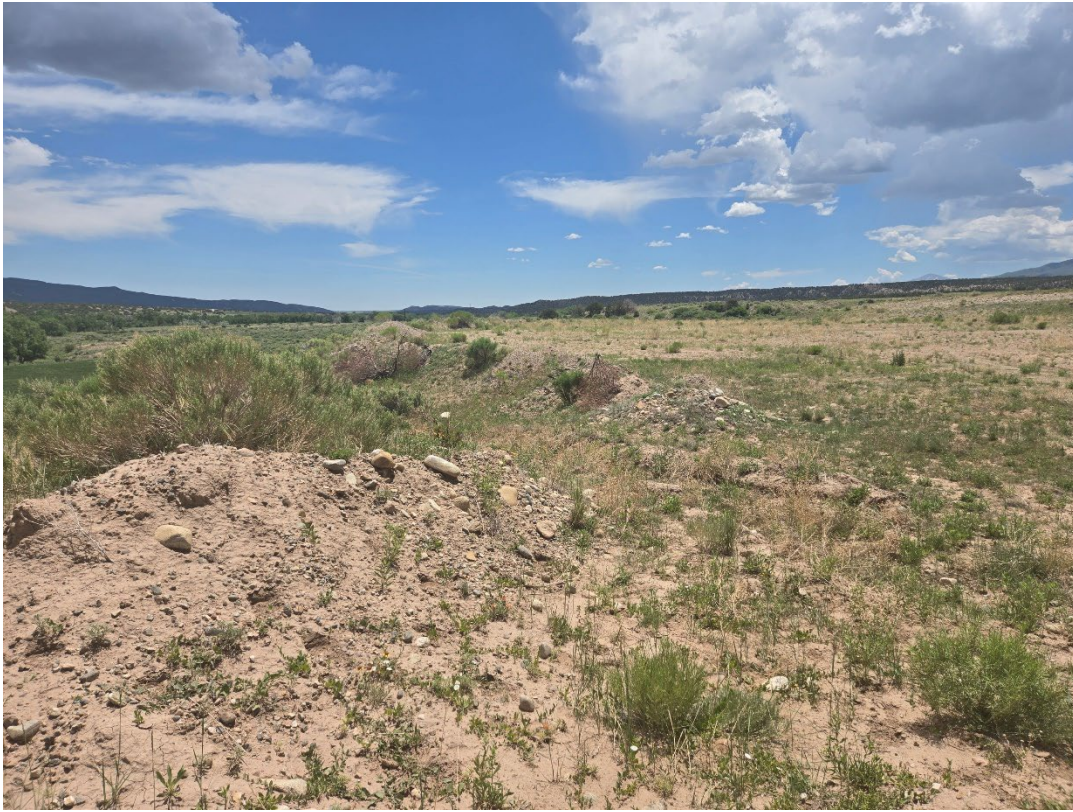
**Photo 11:** Looking east from within the previously reclaimed area at reclaimed slopes and reclaimed pit floor.

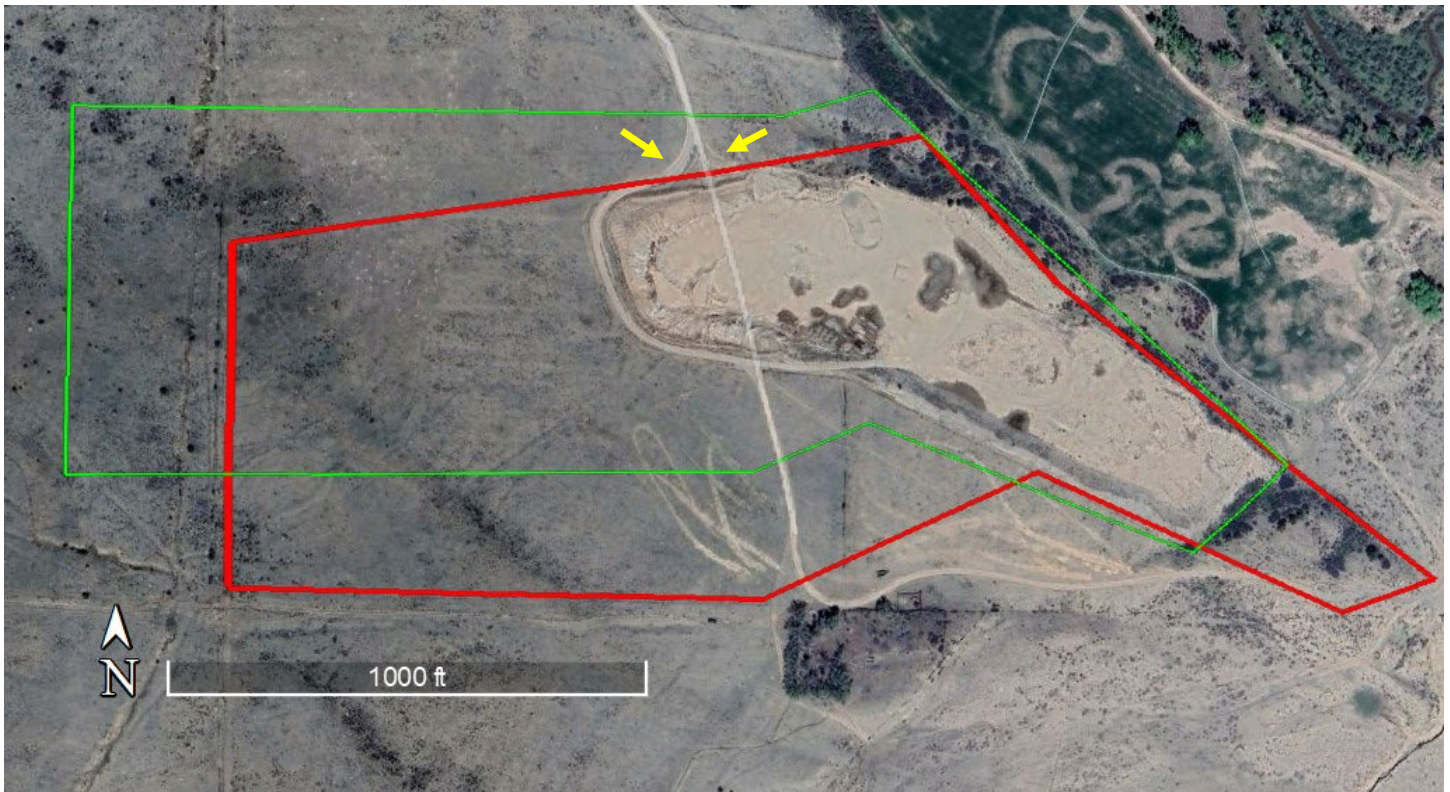
**Figure 1:** The green boundary indicates the permit boundary as described in the 2012 CN1 revision. The red boundary indicates the permit boundary as described in the TR1 revision, and represents the currently approved boundary. The yellow arrows point to disturbance located out of the currently approved boundary, resulting from diverting the access road. The access road running north-south has been diverted, and the path seen in the image is from Google Earth's 'roads' layer. The orientation of the access road prior

to the diversion corresponds to what is seen in the Google Earth 'roads' layer. The orientation of the access road depicted on the approved Reclamation Plan Map also corresponds with this orientation (see the currently approved Reclamation Plan Map below).

**This has been cited as a problem above.** With the TR application required by the previous problem citation, the Operator shall also update the mining plan to describe how the Landowner's access will be maintained throughout the life of the operation. The Operator shall also update the reclamation plan and reclamation plan map to describe the anticipated final configuration of the Landowner's access. The Operator shall provide a signed and notarized agreement with the Landowner that indicates that they were provided notice on how the Operator plans to maintain their access, and that they agree with the proposed final configuration of the road, by the corrective action date.

Note\*- No additional disturbance to the access road outside of the permit boundary will be accepted. If additional disturbance is found to be located outside of the permit boundary at the next inspection, the Division may cite a possible violation, resulting in enforcement actions. If the Operator intends to divert the road above and outside of the permitted boundary, an amendment to the application would be required prior to additional disturbance.
