Bowie #2 inspection report

PERMIT INFORMATION

Permit Number: C-1996-083 Mine Name: Bowie No. 2 Mine Operator: Bowie Resources, LLC Operator Address: Mr. Art Etter P.O. Box 1488 Paonia, CO 81428	County: Delta Operation Type: Underground Permit Status: Active Ownership: Private Operator Representative Present: Ryan Wilson, Art Etter				
Operator Representative Signature: (Field Issuance Only)

This inspection by the Division of Reclamation, Mining and Safety (the Division) was conducted as part of the review of a bond release application (SL-04) submitted by Bowie Resources, LLC (BRL) on April 10, 2025. This inspection is required by Rule 3.03.2(2).

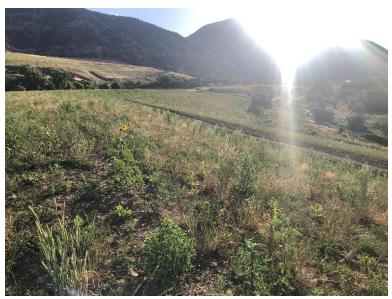
South side of Gob Pile #3 - no erosion

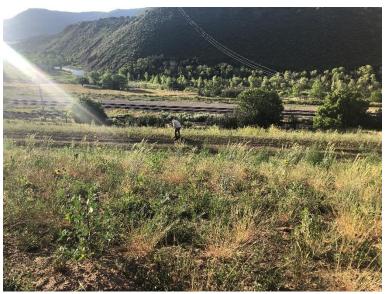
The first part of the inspection entailed using an AeroPoint drone to collect elevation data and imagery of the portions of the gob piles that are the subject of SL-04. On Gob Pile #3, four base points were placed around the pile, and the mission was flown by Leigh Simmons from the haul road above the pile (east of the Prep Plant). On Gob Piles 1, 2, and 4, five base points were placed around these piles (which are close together and can be

Leigh Simmons setting base point on Gob Pile #3

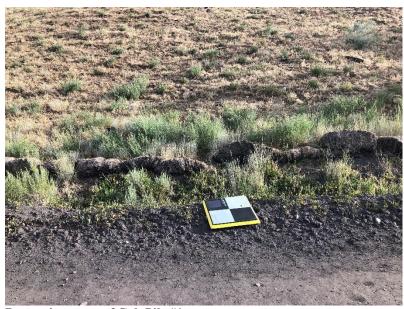
Base point at toe of Gob Pile #1

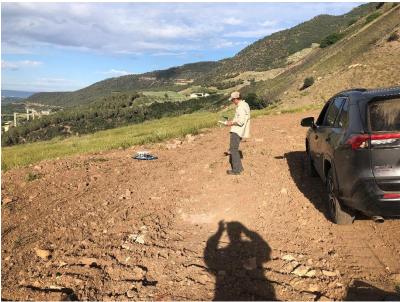
considered one complex of piles), and the mission was flown from a high point above them, at the northeast corner of Gob Pile #4. At the time of this inspection report, the data from this survey has not been processed. It will be closely reviewed during the adequacy process for SL-04.

Use of drone above Gob Pile #4

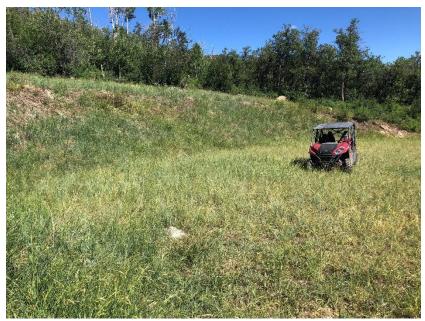
For all three of the GVB pads on private land, there is no erosion, and markers for former hole locations are in place. These pads have not been reclaimed to match the approximate original contours, however, Section 2.05 of the permit states that drill pads will be graded to approximate original contours. Therefore, these areas appear to not comply with Rule 4.14.1(2a). BRL will need to submit a Minor Revision to change the plan for these pads before the Division can release them.

Pad for GVB-B17F – stable slope

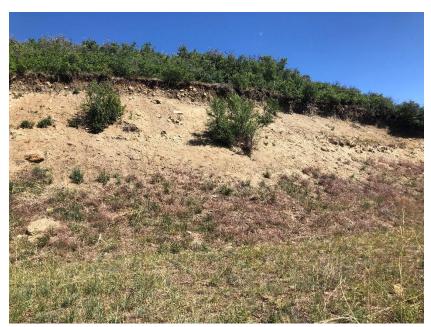
Pad for GVB-B17D – high, steep slope

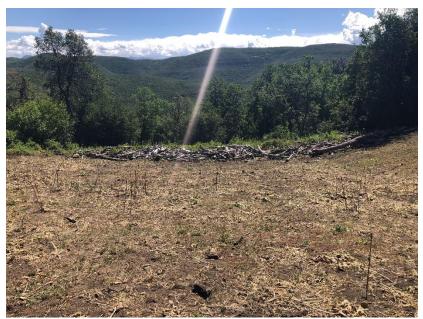
The fourth GVB pad, GVB-B17C, is on BLM land. It has been graded well; it fits in with the surrounding topography, and there was no erosion identified. Logs have been placed at the bottom of this pad to assist with erosion control. The marker for this site was not seen. BRL must place this marker and provide proof to the Division for this pad to be Phase I released (per Rule 4.07.3(2a)). There is also an issue with overgrazing at this pad, which will have to be addressed for the vegetation to grow in the future, and for the site to be eligible for Phase II and Phase III release.

Pad for GVB-B17C – well graded, branches for erosion control, poor vegetation

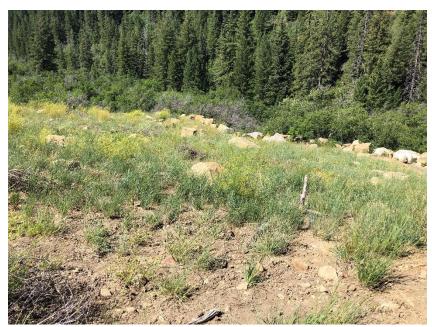
The pad for the Terror Creek Vent Shaft has been reclaimed well. The contours fit well into the surrounding topography. There is no erosion, and the vegetation cover is very good. From visual observation, it was clear that the Terror Creek Vent Shaft has been sealed.

Pad for Terror Creek Vent Shaft – well graded, good vegetation cover

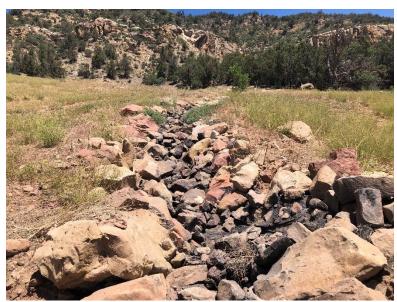
Ditch F-4, east side of Gob Pile #2

Another issue is with Ditch F-4. Part of it will need to be repaired where there is a crossing for trucks hauling soil to Gob Pile #2. BRL should make this repair and provide the Division with proof of the work, such as photographs.

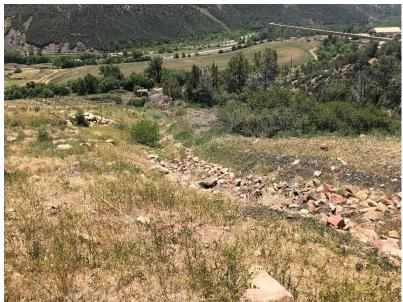
Ditch D-10, west side of Gob Pile #4

The third part of the inspection entailed checking the ditches near the gob piles for stability and compliance with specifications in the Permit. All ditches were found to be stable with no signs of erosion. This is necessary for Phase I release of gob piles. Rule 3.03.1(2a) states that an area cannot be released without drainage control in accordance with the approved reclamation plan.

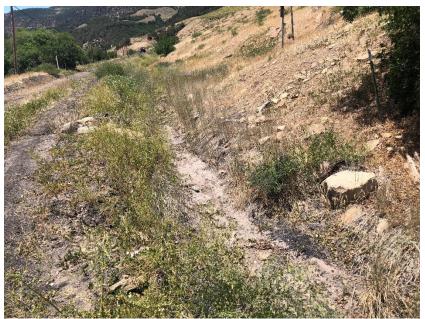
All the specifications were met with the following exception. In the specifications, Ditch F-7 (below Gob Pile #2) is listed as a riprap-lined channel. However, field observation revealed that it is not riprap lined. BRL has submitted a Minor Revision to change the analysis and specifications for this ditch; this revision (MR-211, submitted June 30, 2025) must be approved before the Division can release any tasks related to Gob Pile #2.

Ditch F-7, along toe of Gob Pile #2 – erodible channel does not meet the current spec, but is stable
