## Roadside Mine, C-1981-041, June Complete Inspection Report

<b>Permit Number:</b> C-1981-041 <b>Mine Name:</b> Roadside Portals <b>Operator:</b> Snowcap Coal Company, Inc <b>Operator Address:</b> Ms Tonya Hammond P. O. Box 443 Grand Junction, CO 81502	<b>County:</b> Mesa <b>Operation Type:</b> Underground <b>Permit Status:</b> Active <b>Ownership:</b> Private
	<b>Operator Representative Present:</b>  Tonya Hammond
<b>Operator Representative Signature:</b> (Field Issuance Only)

<b>Inspection Start Date:</b> June 25, 2025 <b>Inspection Start Time:</b> 13:30 <b>Inspection End Date:</b> June 25, 2025 <b>Inspection End Time:</b> 14:25		<b>Inspection Type:</b> Coal Complete Inspection <b>Inspection Reason:</b> Normal I&E Program <b>Weather:</b> Clear	
<b>Joint Inspection Agency:</b>  None		<b>Joint Inspection Contacts:</b>  None	
<b>Post Inspection Agency:</b>  None		<b>Post Inspection Contacts:</b>  None	
<b>Inspector(s):</b>  Clayton Wein	<b>Inspector's Signature:</b>  <i>Clayton Wein</i>  <b>Signature Date:</b> 7/2/2025

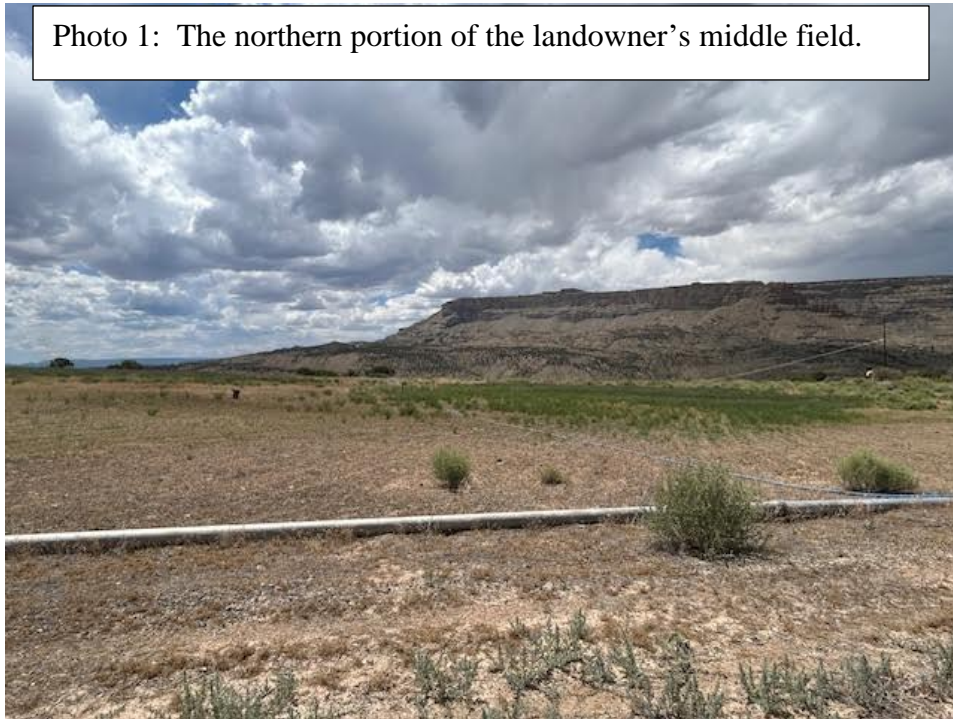
During the inspection the landowner's middle field was being irrigated at the northern most section (Photo 1). The remaining reclamation at the mine site is located to the west of the landowner's middle field on the other side of a drainage. There was no impact to the reclamation from the irrigation runoff.

Photo 1: The northern portion of the landowner's middle field.

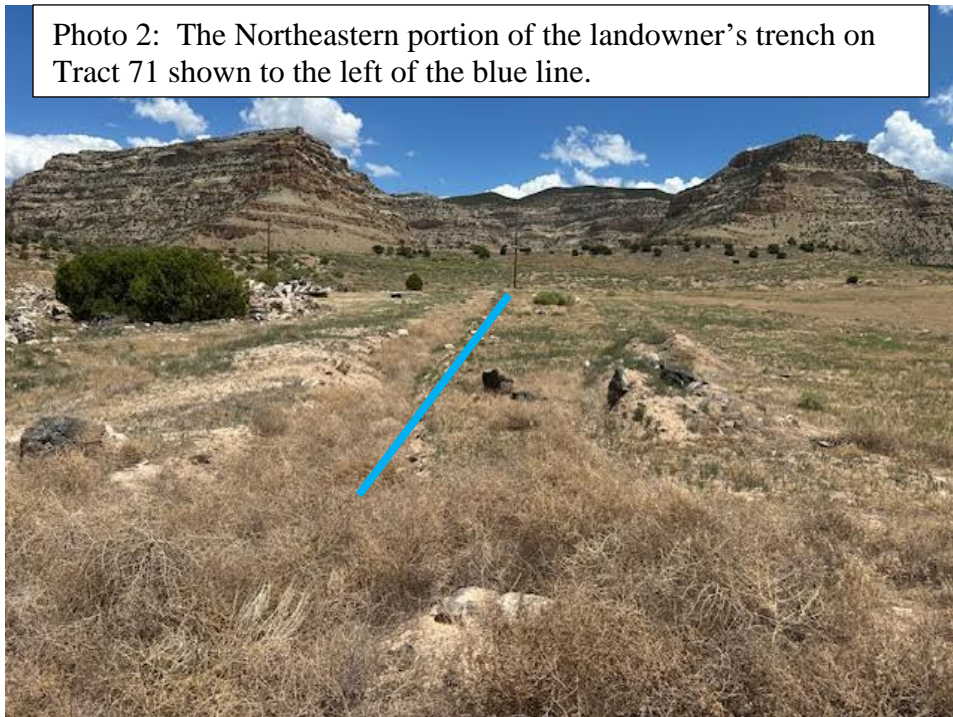
The landowner has a trench located adjacent to the north and northeast (Photo 2) of the TR-69 Repair Area. During the inspection there was no water flowing in the trench. There was no indication of impacts to the TR-69 Repair Area.

Photo 2: The Northeastern portion of the landowner's trench on Tract 71 shown to the left of the blue line.

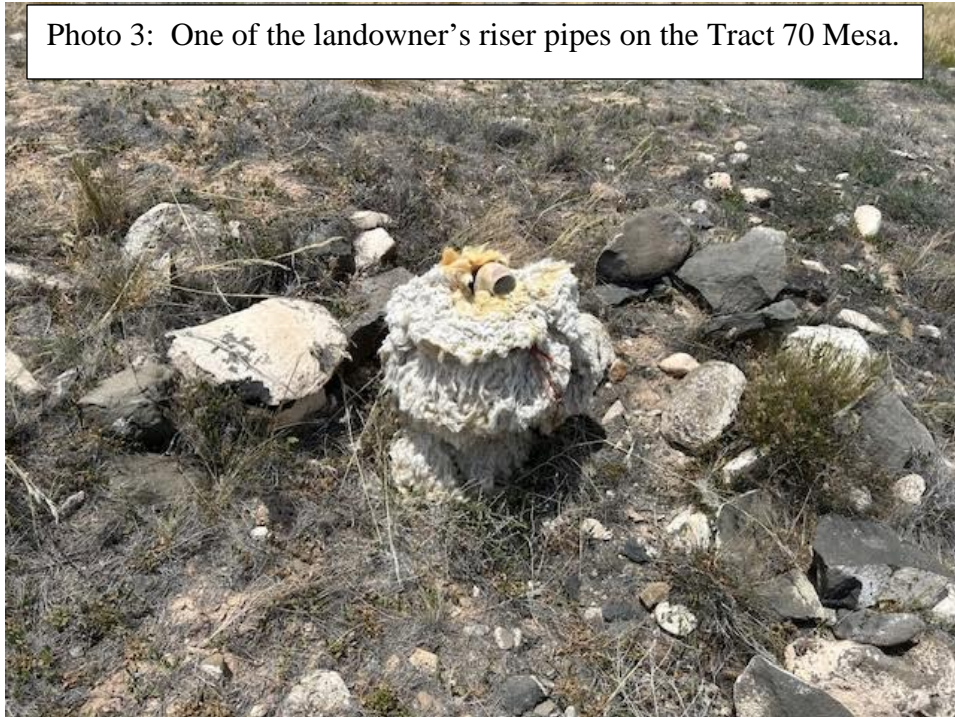
The landowner has several trenches located on top of what is commonly referred to as the Tract 70 Mesa. The Tract 70 mesa is located to the north of the Landowner's middle field and lies within the northern portion of the permit area. During the inspection there was no flow out of the riser pipes into the trenches (Photo 3).

Photo 3: One of the landowner's riser pipes on the Tract 70 Mesa.

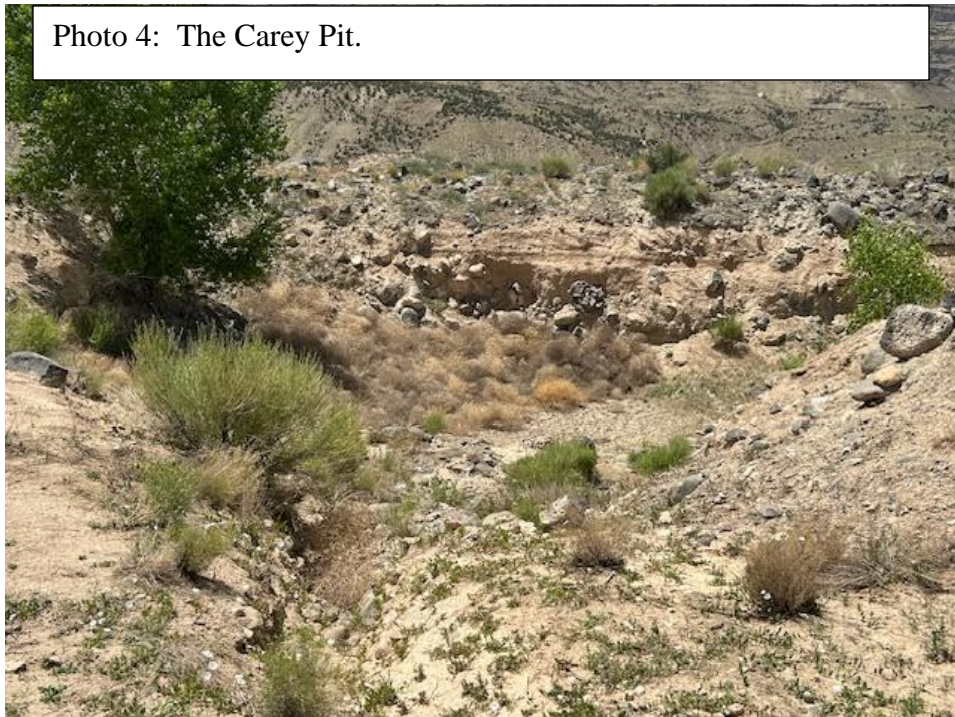
The Carey Pit is located to the southwest of the TR-69 Repair Area and Adjacent west of the southwest corner of the permit area. The pit was observed to be dry from the permit boundary (Photo 4). The trench leading into the pit from the landowner's buried pipeline had appeared to have been recently cleaned (Photo 5).

Photo 4: The Carey Pit.

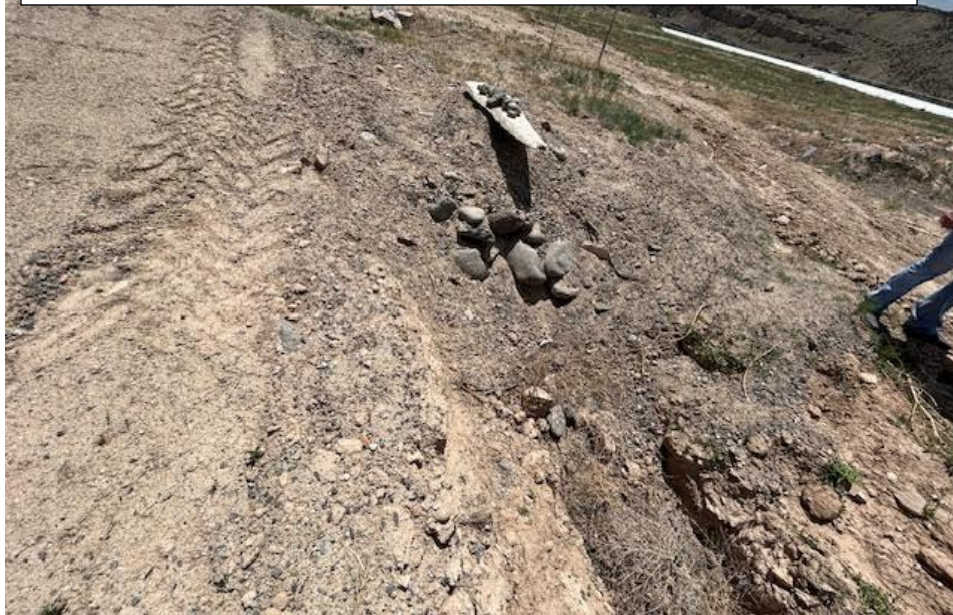
Photo 5: The inlet to the open trench from the landowner's buried pipeline that connects to the Carey Pit.

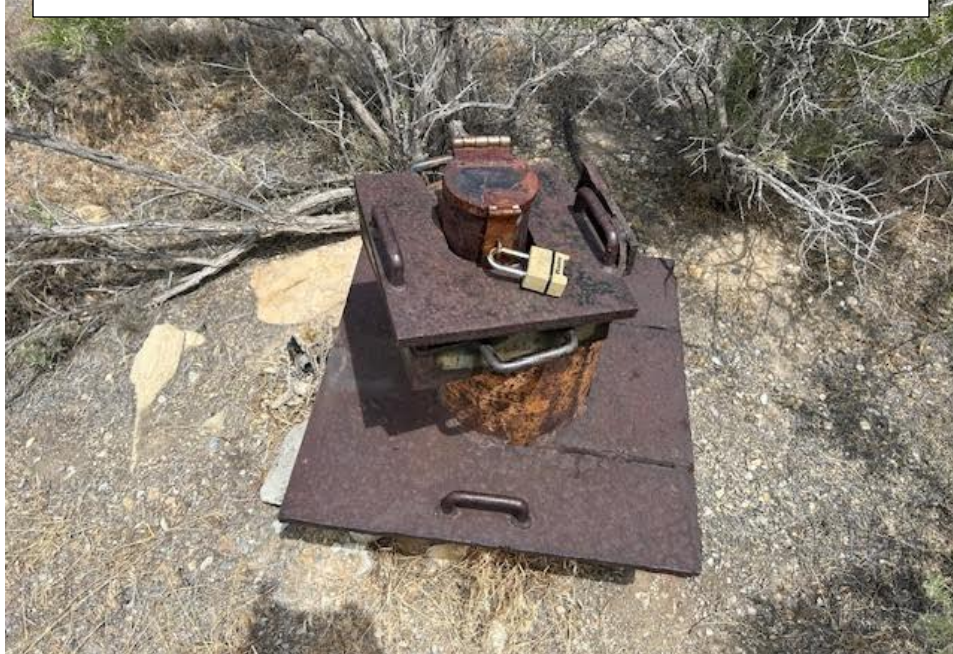
The N-1 Well casing was visited during the inspection. The casing appeared to be in good condition. The lock placed on the cover to the casing was also in good condition (Photo 6). The operator's representative measured the depth to the water in the N-1 Well on June 10, 2025. The measurement was 75.39 feet.

Photo 6: The N-1 Well casing.

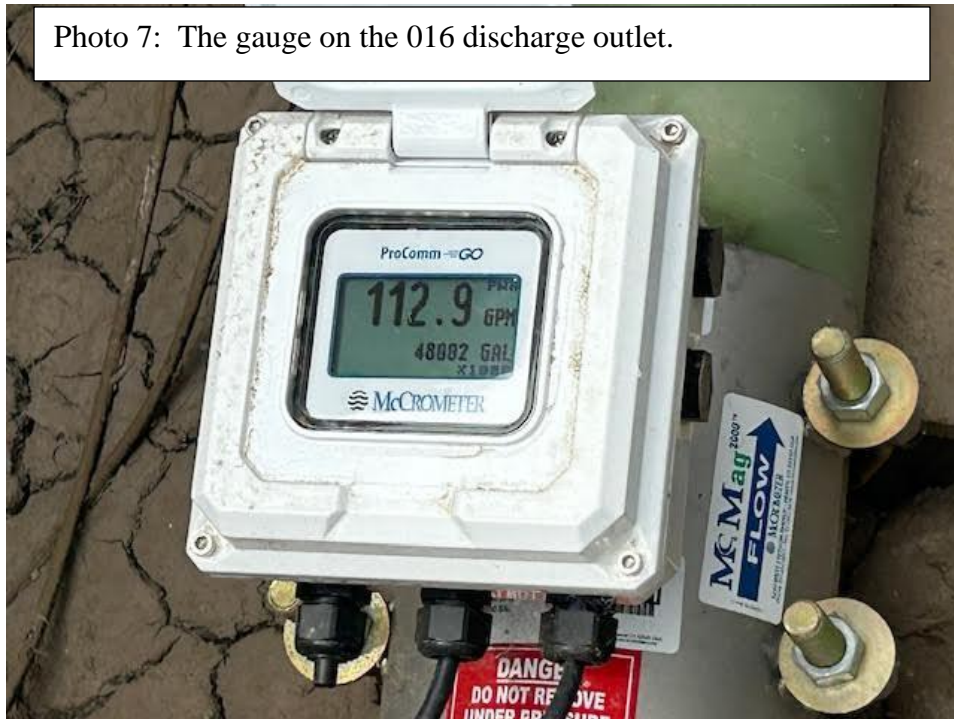
Discharge Point 016 is located within the northeastern part of the permit area. Discharge was occurring at a rate of 112.9 gallons per minute according to the gauge on the outlet (Photo 7). This value is within the historical seasonal values for this location. The outlet was observed to be stable and unobstructed.

Photo 7: The gauge on the 016 discharge outlet.

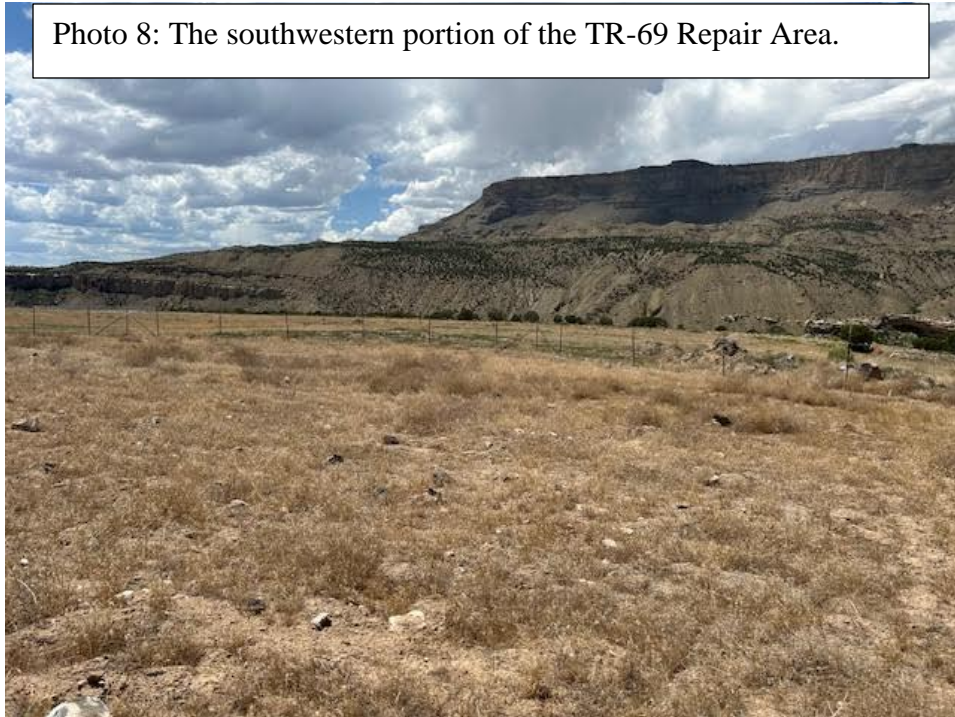
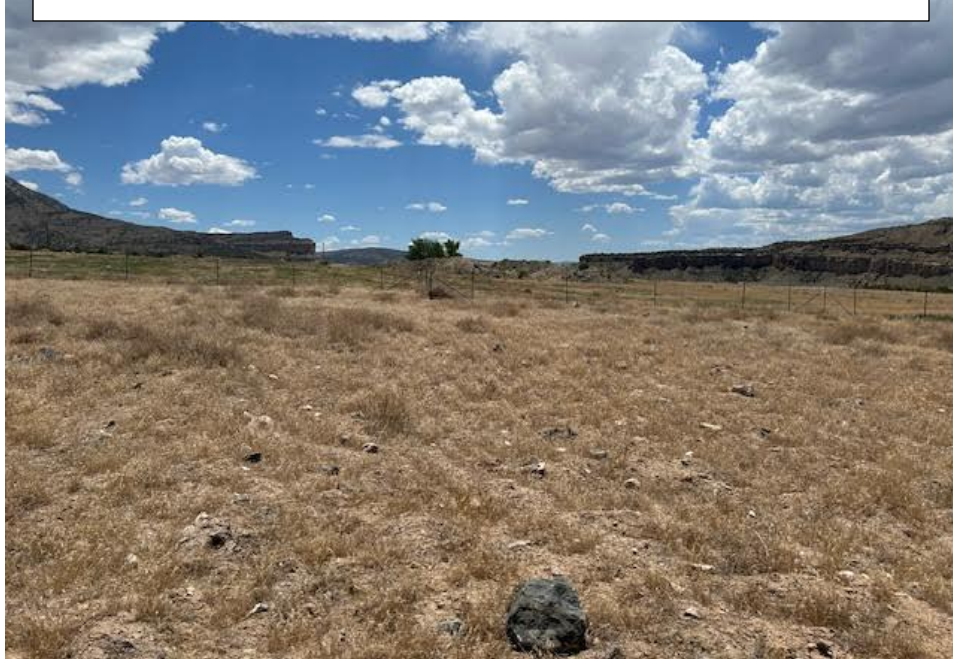
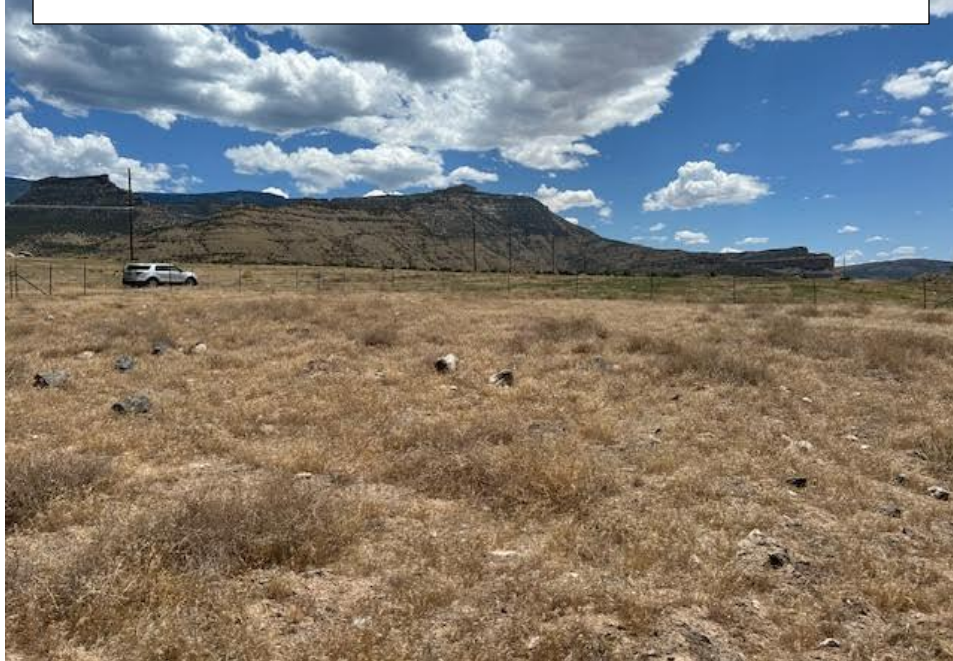
The remaining permitted disturbance at the mine site is located within the western portion of the permit area, referred to as the TR-69 Repair Area. The reclamation parcel is approximately 0.4 acres in size. The parcel was stable with no erosional features (Photos 8, 9 and 10). The site was covered with vegetation, most of which was beginning to dry out for the summer season. There were no indications of differential settling observed. The sediment logs place on the western and southern boundaries of the TR-69 Repair Area were in good condition. There were no off-site impacts observed. The Disturbance boundary was marked by a fence. The fence was stable and in good repair.

Photo 8: The southwestern portion of the TR-69 Repair Area.

Photo 9: The central portion of the TR-69 Repair Area.

Photo 10: The southeastern portion of the TR-69 Repair Area.

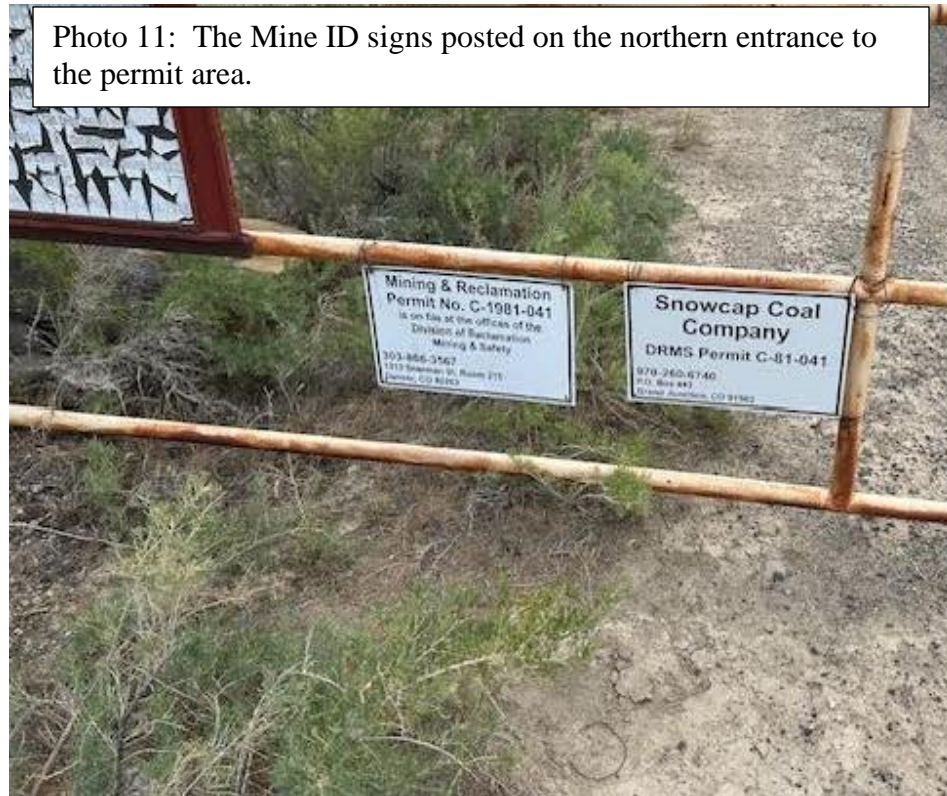
Mine Identification signs were observed to be posted at the entrance to the permit boundary. The signs were located in easy to identify locations. The signs were legible and posted information about the permittee, the permit number and contact information (Photo 11).

Photo 11: The Mine ID signs posted on the northern entrance to the permit area.
