MINERALS PROGRAM INSPECTION REPORT
PHONE: (303) 866-3567

MINE NAME: Ashbaugh Gravel Pit	MINE/PROSPECTING ID#: M-2005-060	MINERAL: Gravel, clay (general)	COUNTY: Weld
INSPECTION TYPE: Surety Release Inspection	WEATHER: Clear	INSP. DATE: May 29, 2025	INSP. TIME: 12:30
OPERATOR: Weld County Public Works	OPERATOR REPRESENTATIVE: Nate Gibson	TYPE OF OPERATION: 112c - Construction Regular Operation	
REASON FOR INSPECTION: Surety Release Requested	BOND CALCULATION TYPE: None	BOND AMOUNT: \$0.00	
DATE OF COMPLAINT: NA	POST INSP. CONTACTS: None	JOINT INSP. AGENCY: None	
INSPECTOR(S): Nikie Gagnon	INSPECTOR'S SIGNATURE:

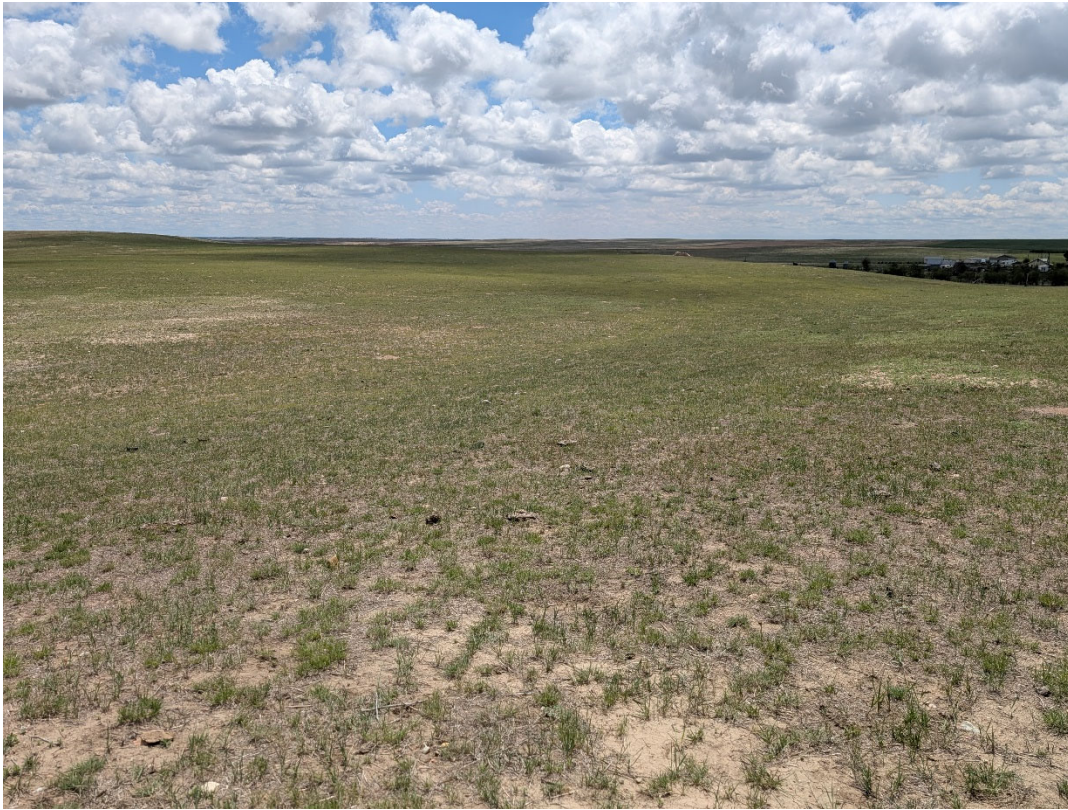
Photo 1: Looking east across the mined pit area.

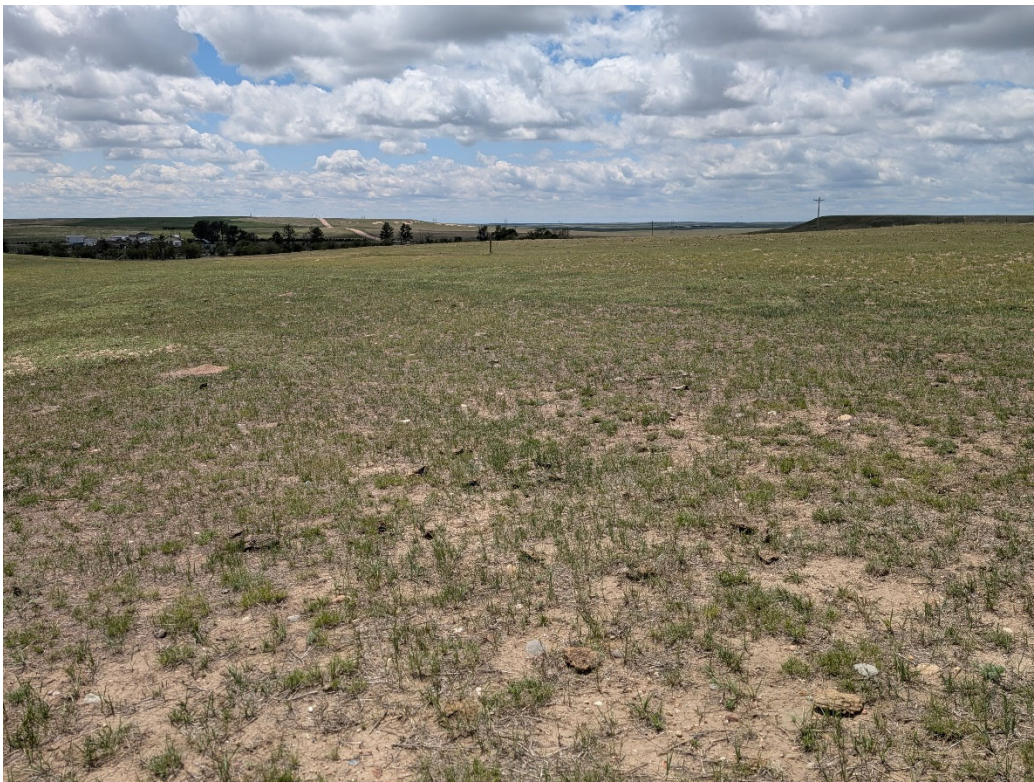
Photo 2: Looking north across the mined pit area.

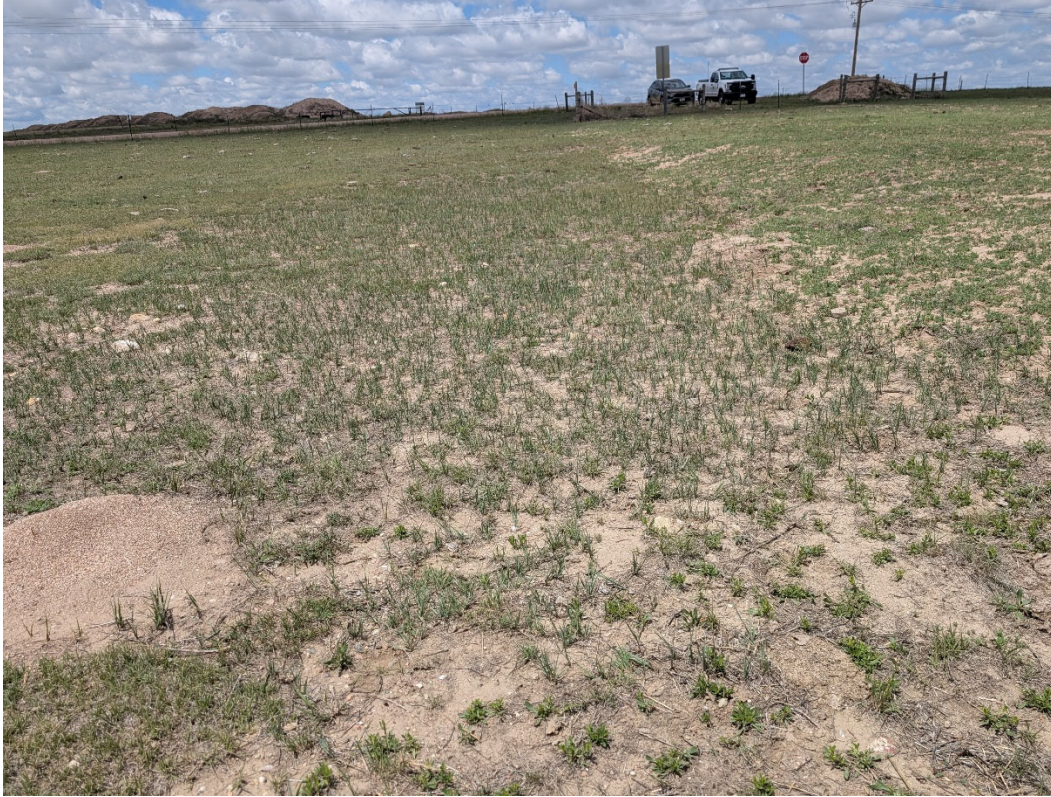
Photo 3: Looking west towards the entrance to the pit. This area has been re-topsoiled and re-seeded. Some kochia here, but overall erosion is well controlled and the native grasses are establishing.

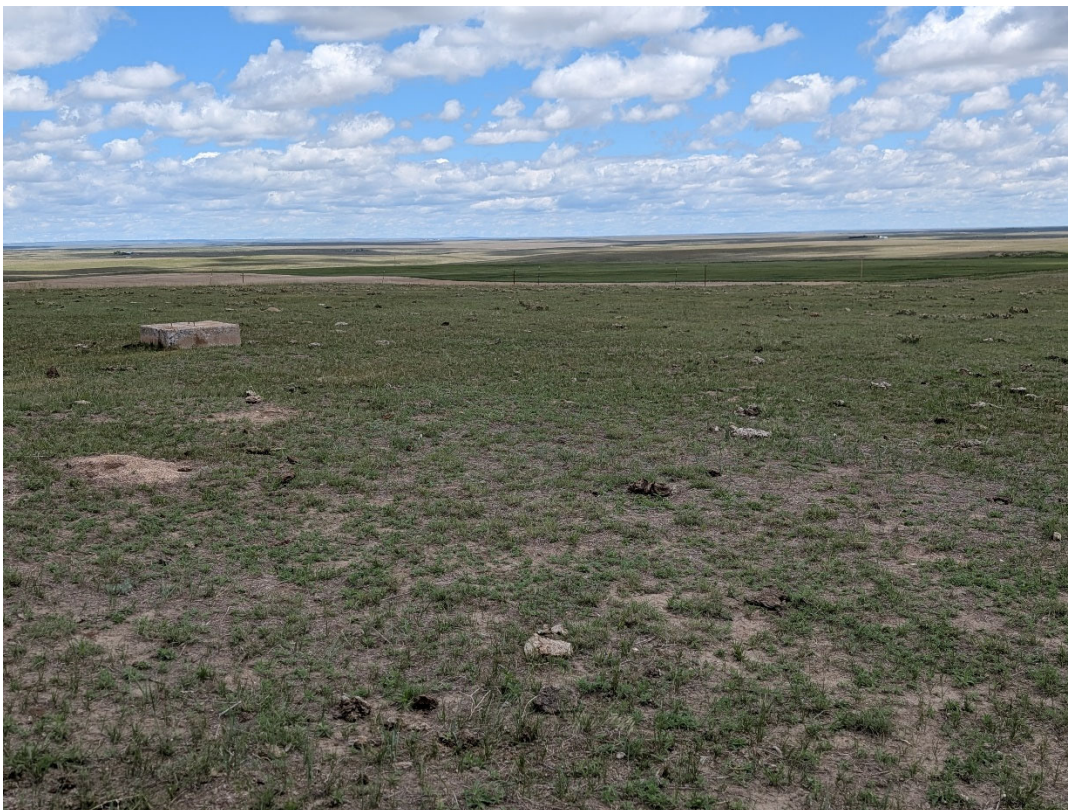
Photo 4: Looking north from the entrance. Evidence of grazing observed here.

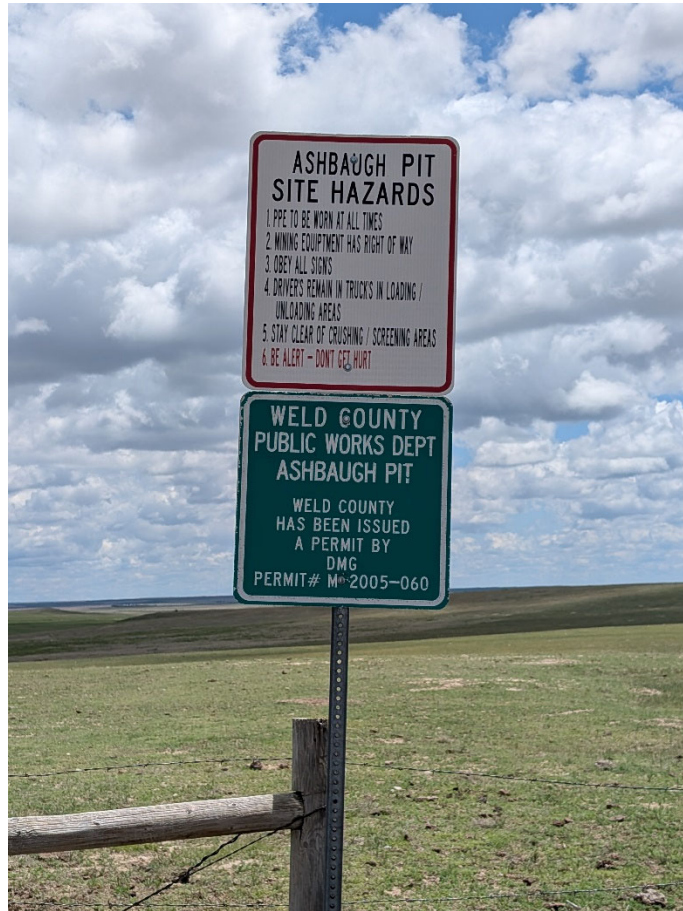
Photo 5: mine sign observed at the entrance to the pit.
