MINERALS PROGRAM INSPECTION REPORT
PHONE: (303) 866-3567

MINE NAME: Hobo 2	MINE/PROSPECTING ID#: M-2017-044	MINERAL: Gemstones	COUNTY: San Juan
INSPECTION TYPE: Monitoring	WEATHER: Clear	INSP. DATE: June 30, 2025	INSP. TIME: 09:38
OPERATOR: McFarland Enterprises, Inc.	OPERATOR REPRESENTATIVE: None	TYPE OF OPERATION: 110(1) - Hard Rock Limited Impact	
REASON FOR INSPECTION: Normal I&E Program	BOND CALCULATION TYPE: Complete Bond	BOND AMOUNT: \$12,960.00	
DATE OF COMPLAINT: NA	POST INSP. CONTACTS: None	JOINT INSP. AGENCY: None	
INSPECTOR(S): Lucas West	INSPECTOR'S SIGNATURE:

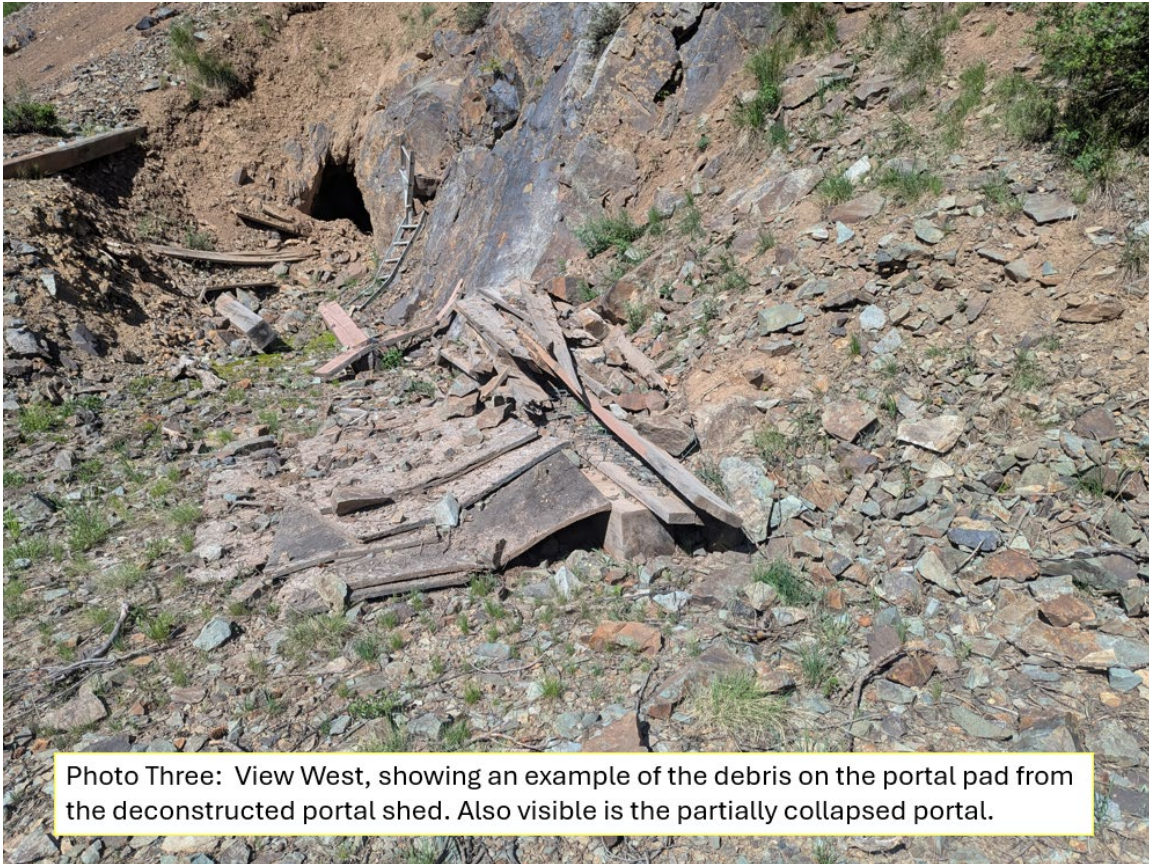
The portal shed structure was damaged in 2017-2018 and most of it was removed at that time. Various materials were observed scattered around the pad from the deconstructed portal structure. Items include the metal gates, various lumber and a damaged ladder. The portal itself was observed with a significant amount of material from above having sloughed off and closing approximately half the entrance. No water was seen emanating from the portal, however, immediately behind the sloughed material the floor of the tunnel was damp. The portal can be seen in Photo Five.

Photo Three: View West, showing an example of the debris on the portal pad from the deconstructed portal shed. Also visible is the partially collapsed portal.

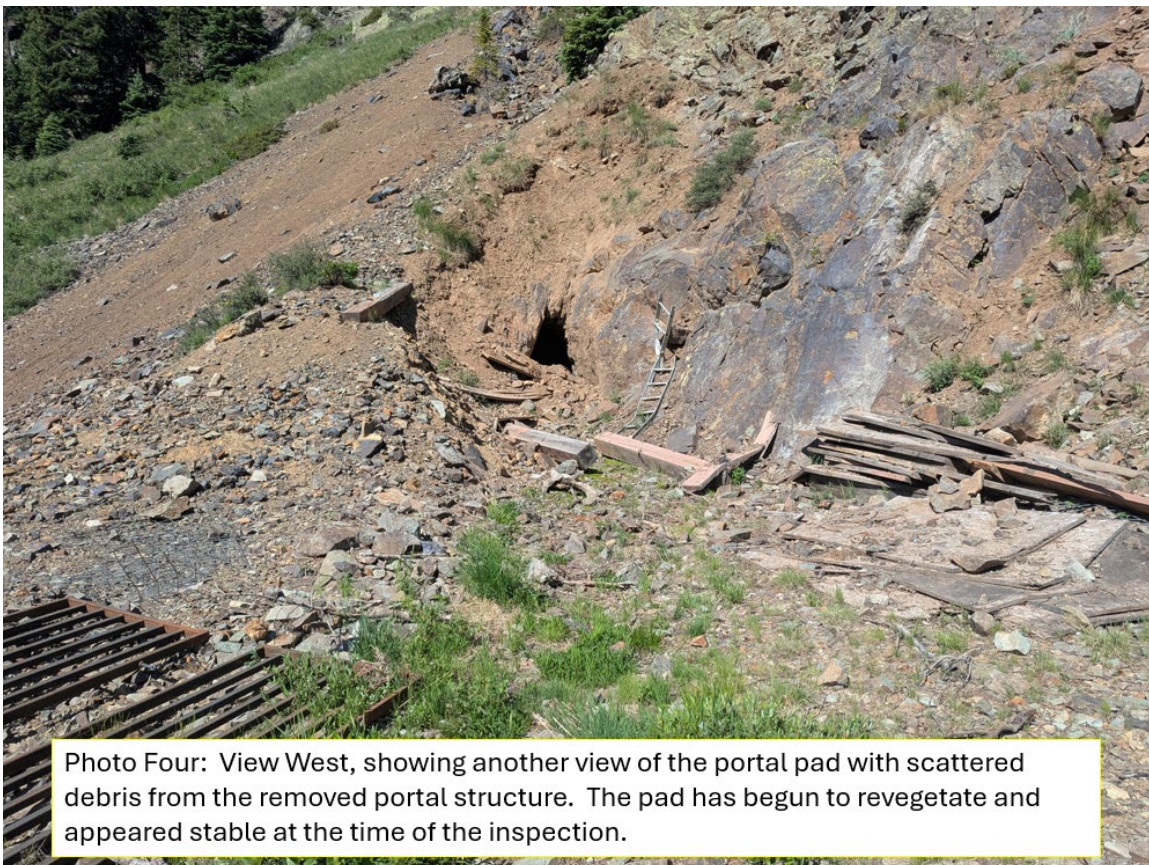
The .71 acres of the site is made up of the access road, portal pad and portal areas. The access road was observed to be in good condition and appeared stable at the time of the inspection. No evidence of erosion or slumping of the cut banks was noted. The entire length of the access road has revegetated itself with volunteer species and shows no evidence of recent travel. The access road can be seen in Photos One and Two. At the top of the access road lies the portal and portal pad. The portal pad, made up of waste rock and other local materials, was found to be in good condition and appeared stable. No evidence of settling or slumping was noted. The outsoles of the pad appeared to be stable at the time, and no significant erosion or rilling was noted down the slope. Photos Three and Four show the portal pad and an example of the out slope.

Photo Four: View West, showing another view of the portal pad with scattered debris from the removed portal structure. The pad has begun to revegetate and appeared stable at the time of the inspection.
