Inspection reports

PERMIT INFORMATION

Permit Number: C-1992-081 Mine Name: Hayden Gulch Loadout Operator: Hayden Gulch Terminal, LLC Operator Address: Ms. Miranda Kawcak 29515 Routt County Road 27 Oak Creek, CO 80467	County: Routt Operation Type: Loadout Permit Status: Active Ownership: Private
	Operator Representative Present: N/a
Operator Representative Signature: (Field Issuance Only)

Inspection Start Date: June 24, 2025 Inspection Start Time: 13:30 Inspection End Date: June 24, 2025 Inspection End Time: 14:30	Inspection Type: Coal Partial Inspection Inspection Reason: Normal I&E Program Weather: Clear
Joint Inspection Agency: None	Joint Inspection Contacts:
Post Inspection Agency: None	Post Inspection Contacts:
Inspector(s): Brock Bowles	Inspector's Signature:

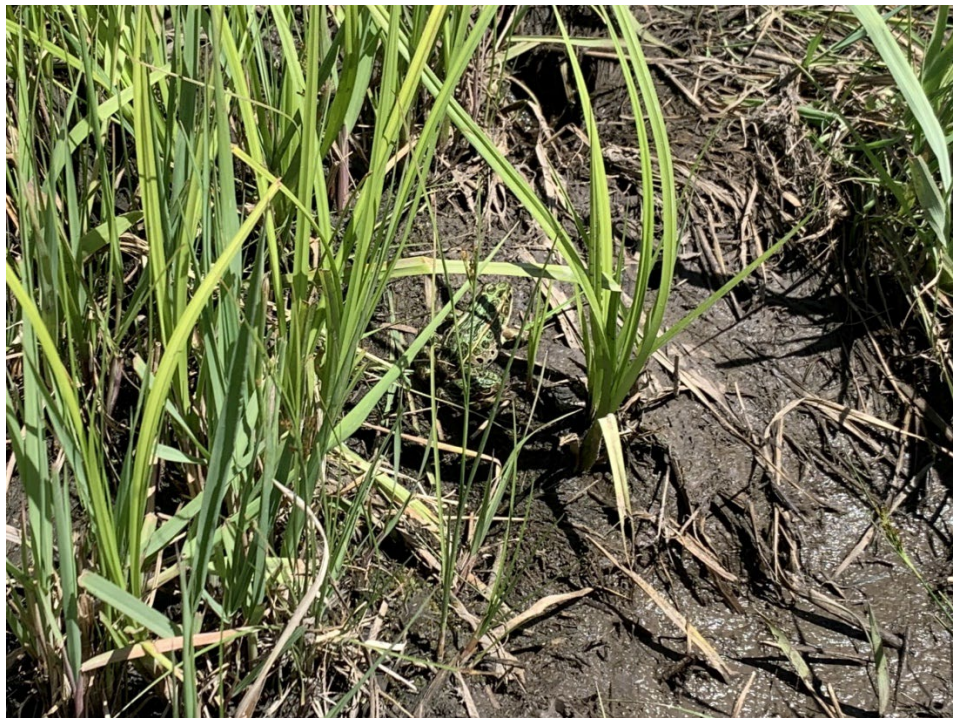
A northern leopard frog was spotted in the area of saturated soils north of Hwy 40 (photo 1). The northern leopard frog is listed in the Colorado State Wildlife Action Plan of 2015 as a Tier 1 Species of Greatest Conservation Need. Colorado Parks and Wildlife and the operator have been notified. A meeting will be set up with CPW and the operator in the coming weeks to determine a management plan.

Photo 1- Northern leopard frog in tall grasses and saturated soils.

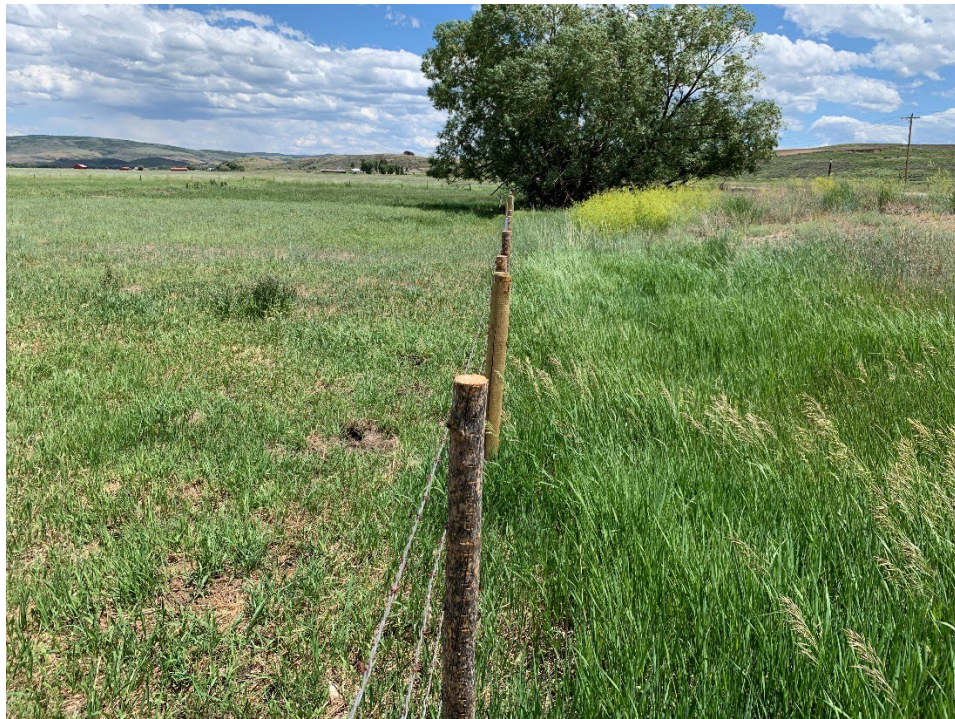
The gates to the adjacent east and west pastures were open. No cattle were in the reclaimed area during this inspection, however cattle were noted being in the reclaimed area during the May 2025 inspection. The grass in the reclaimed area was noticeably shorter than the surrounding pastures, suggesting it has been heavily grazed (photo 2).

Photo 2- Reclaimed area grazed left of the fence line.

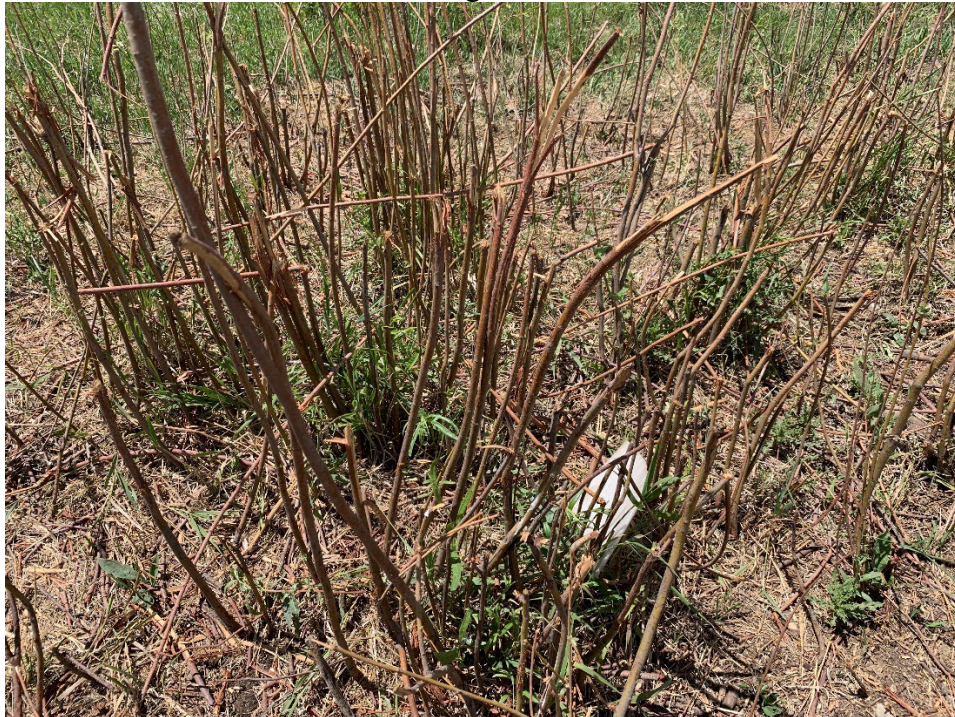
Some of the plant species noted growing on the site were orchardgrass, meadow brome, timothy, reed canary grass, yarrow, crested wheatgrass, western wheatgrass, alfalfa, slender cinquefoil, sedges and rushes. Canada thistle and houndstongue were noted by the trailhead parking lot and in the dry areas north of Hwy 40. These need to be treated as they are Colorado listed noxious species. The stand of willows north of Hwy 40 were heavily damaged (photo 3). Most of the stems had been snapped or broken. The leaves had been stripped from the branches. Some branches were trying to sprout new leaves.

Photo 3- Willow stand was damaged. Stems were broken and snapped.
