STATE OF  
COLORADO

**PERMIT INFORMATION**

<b>Permit Number:</b> C-1982-056 <b>Mine Name:</b> Foidel Creek Mine <b>Operator:</b> Twentymile Coal, LLC <b>Operator Address:</b> Ms. Miranda Kawcak 29515 Routt County Road No. 27 Oak Creek, CO 80467	<b>County:</b> Routt <b>Operation Type:</b> Underground <b>Permit Status:</b> Active <b>Ownership:</b> Private
	<b>Operator Representative Present:</b>  Miranda Kawcak
<b>Operator Representative Signature: (Field Issuance Only)</b>

<b>Inspection Start Date:</b> June 24, 2025 <b>Inspection Start Time:</b> 07:30 <b>Inspection End Date:</b> June 24, 2025 <b>Inspection End Time:</b> 13:30		<b>Inspection Type:</b> Coal Complete Inspection <b>Inspection Reason:</b> Normal I&E Program <b>Weather:</b> Clear	
<b>Joint Inspection Agency:</b>  None		<b>Joint Inspection Contacts:</b>  	
<b>Post Inspection Agency:</b>  None		<b>Post Inspection Contacts:</b>  	
<b>Inspector(s):</b>  Brock Bowles	<b>Inspector's Signature:</b>

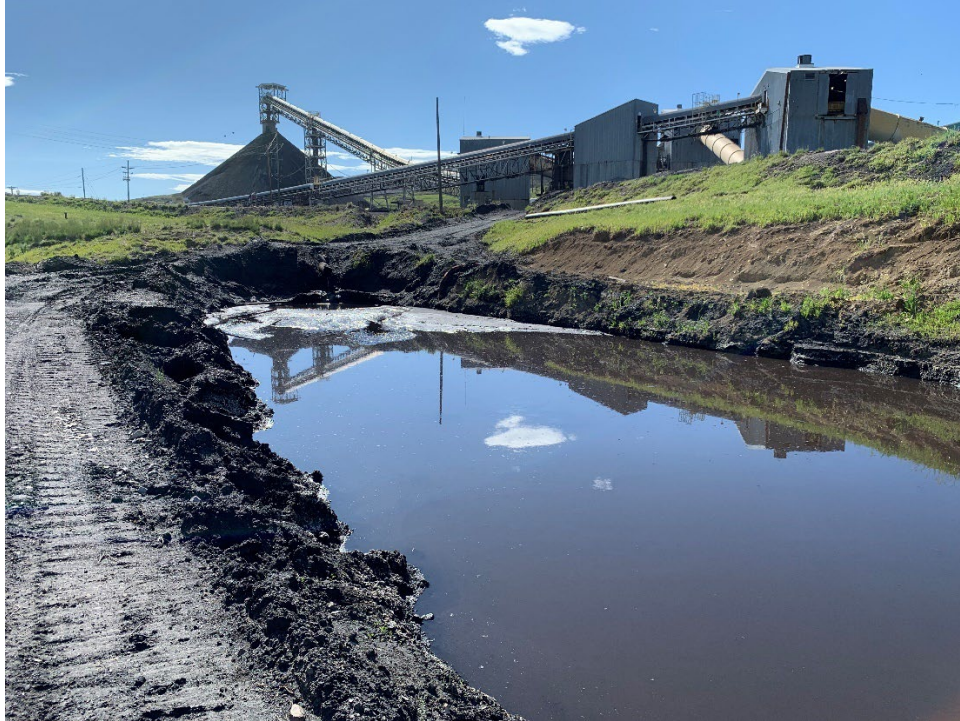
Pond B contained water and was discharging. The sump above Pond B was relatively low with a lot of capacity (photo 1).

Photo 1- Sump above Ponds B

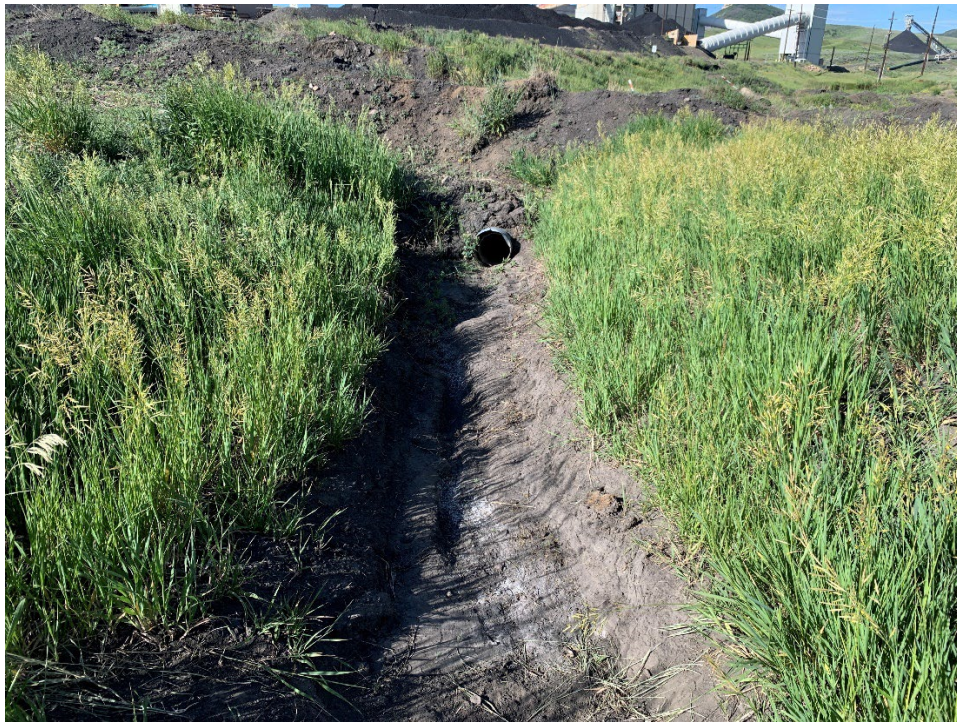
Pond E contained water. The section of Ditch E-1 east of Pond E was well maintained and clear of obstructions (photo 2). The culvert under the pond access road was clear of obstructions also. Ditch E-1 north of the warehouse area was inspected. The ditch is well vegetated with a small channel in the middle indicating water conveyance through the ditch. The ditch is functioning as designed.

Photo 2- Ditch E-1 leading into Pond E on the east side.

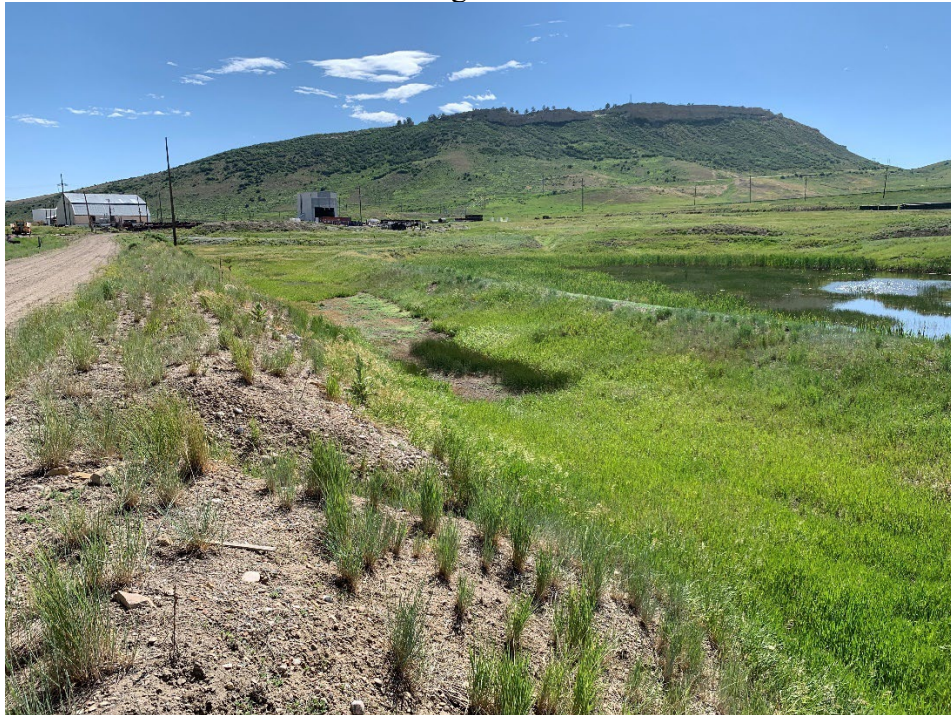
Pond F contained water but was not discharging. The embankment was well vegetated and appeared stable. The S13 SAE adjacent to Pond F is well vegetated and is in working order (photo 3).

Photo 3- SAE S13 adjacent to Pond F is well vegetated.

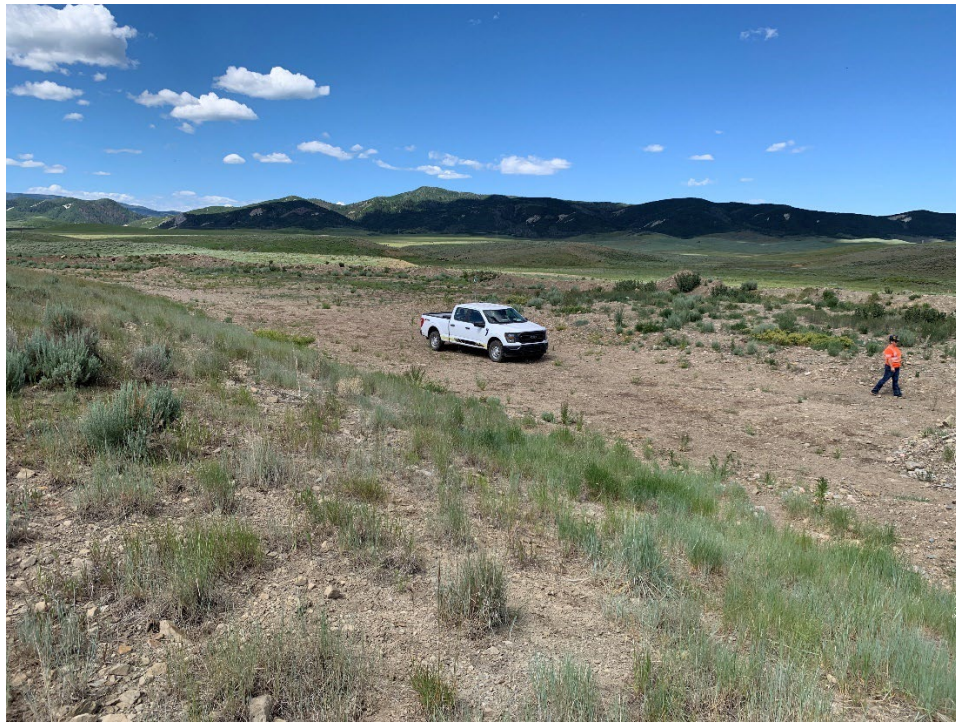
The SAE S22 site is also known as the 15LT ventilation shaft pad. The vent shaft was not constructed but the pad area was constructed (photo 4). The topsoil stockpile is on the east side of the pad and is well vegetated. Several thistles, whitetop and houndstongue plants were noted and these need to be treated as they are classified noxious species. A berm is constructed around the pad directing discharge water to the northeast corner.

Photo 4- SAE S22, 15LT ventilation shaft pad.

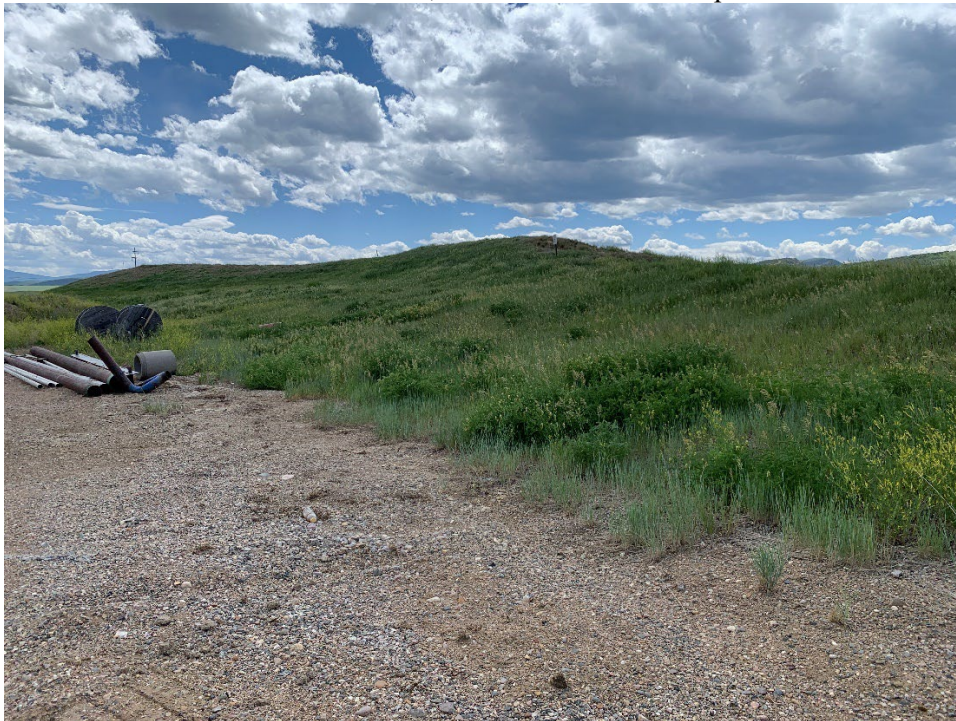
The 6MN treatment ponds were functioning. Each pond contained water with the middle sections of each pond having a dense stand of cattails. The cattails are part of the water treatment process. All the treated water is directed to the 6MN reservoir for use in the mine. The topsoil stockpiles at the 6MN pad area were well vegetated and appeared to be stable (photo 5).

Photo 5- Topsoil stockpile on south side of 6MN pad area.

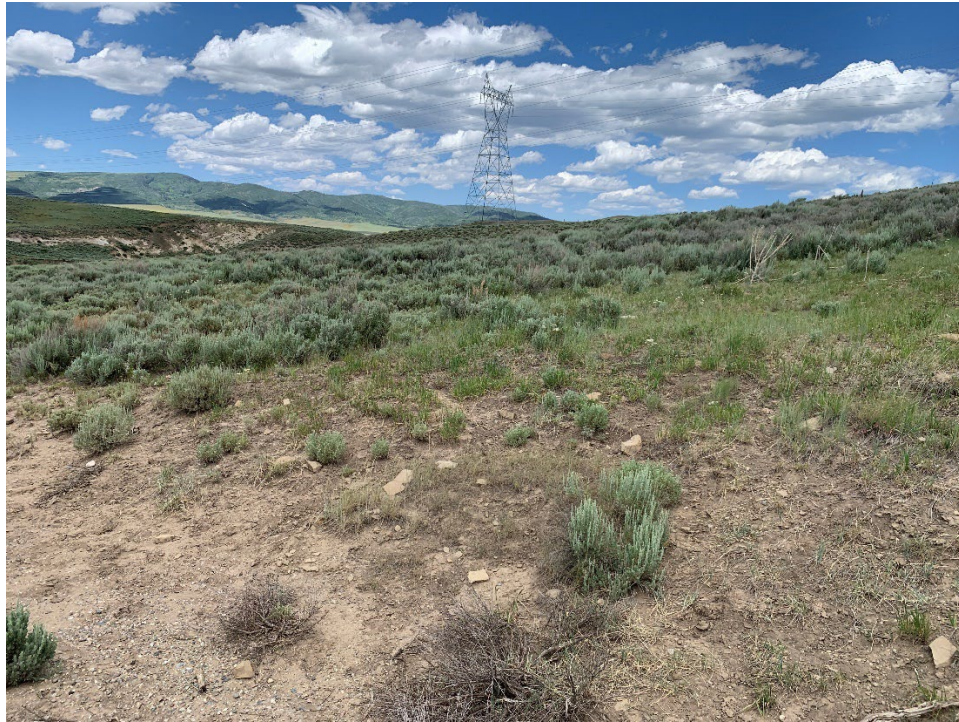
The 18 Right Borehole pad has been reclaimed (photo 6). The area has a fence around it although the gate was open. The vegetation is well established on most of the site with the exception of immediately in front of the gate where it is still a little bit gravelly.

Photo 6- 18 Right Borehole pad has been reclaimed.
