PERMIT INFORMATION

Permit Number: C-1981-019 Mine Name: Colowyo Coal Mine Operator: Colowyo Coal Company L.P. Operator Address: Mr Tony Tennyson 5731 State Highway 13 Meeker, CO 81641	County: Moffat, Rio Blanco Operation Type: Surface Permit Status: Active Ownership: Private
	Operator Representative Present: Tony Tennyson
Operator Representative Signature: (Field Issuance Only)

Inspection Start Date: June 25, 2025 Inspection Start Time: 11:30 Inspection End Date: June 26, 2025 Inspection End Time: 14:30		Inspection Type: Coal Complete Inspection Inspection Reason: Normal I&E Program Weather: Clear	
Joint Inspection Agency: None		Joint Inspection Contacts:	
Post Inspection Agency: None		Post Inspection Contacts:	
Inspector(s): Hunter Ridley Brock Bowles	Inspector's Signature: <i>Hunter Ridley</i>		Signature Date: July 1, 2025

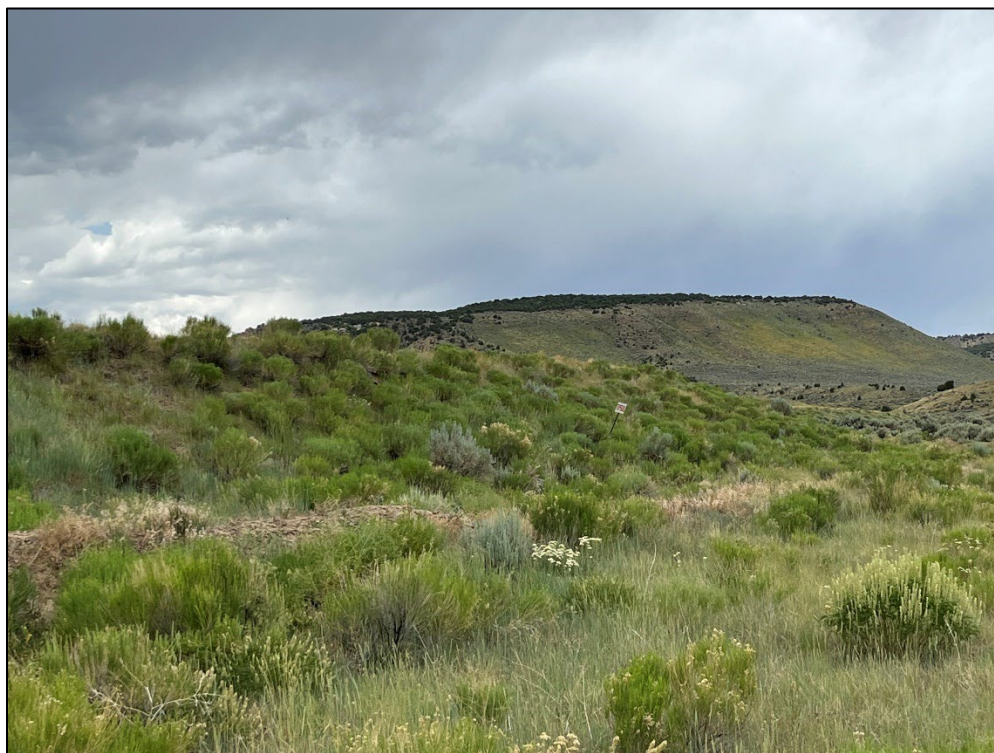
Topsoil piles across the site contained appropriate markers (e.g. Photo 10).

Photo 10: Example of a topsoil pile labeled in the Collom temporary facilities area.

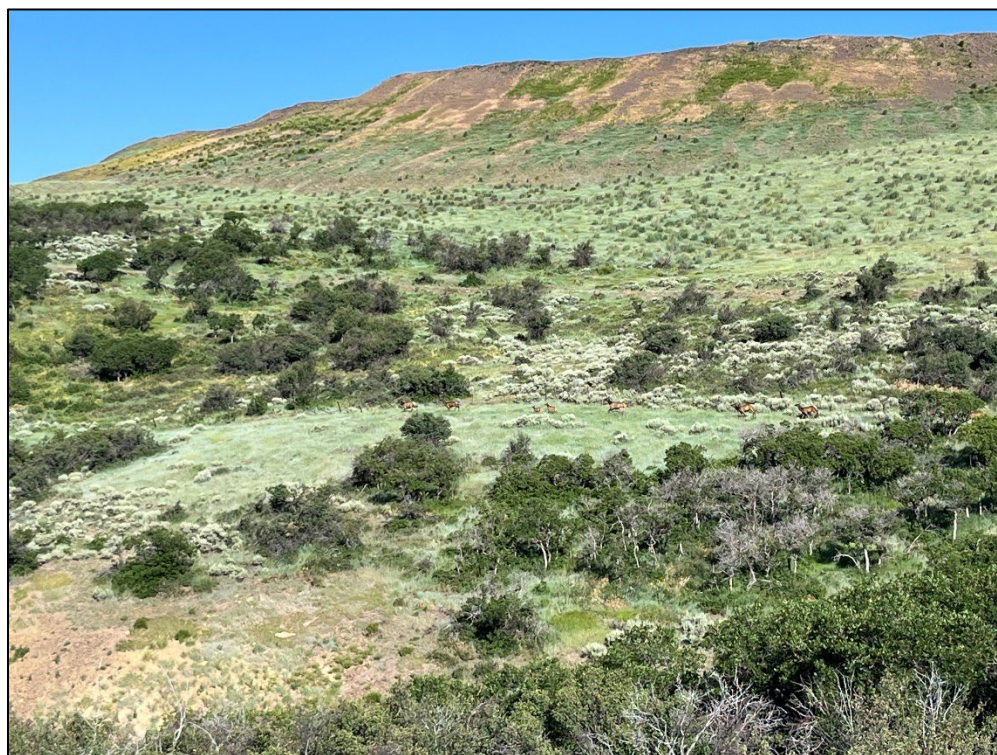
No negative impact to wildlife was observed. A herd of adult and adolescent elk were observed across several areas of the site (Photo 12), along with observation of pronghorns, a coyote, and various waterfowl.

Photo 12: Herd of elk seen near Section 16 Pond.

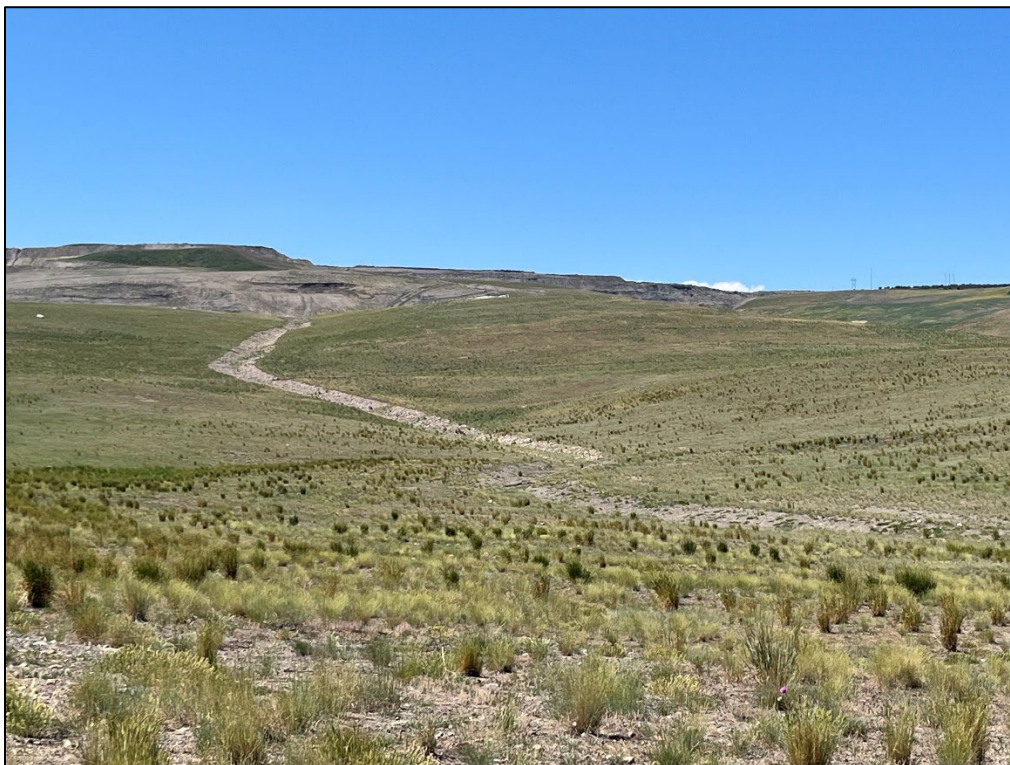
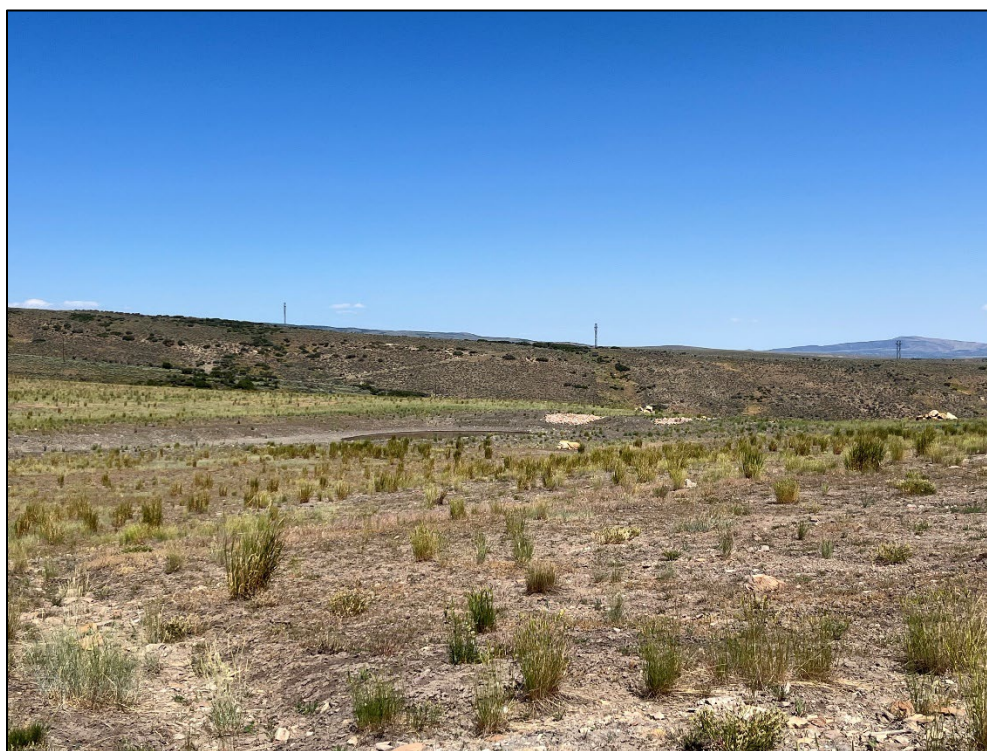
West Pit has been almost entirely backfilled and is largely in its revegetation phase. West Pit was inspected from vantage points along the haul road as well as from below in the reclamation areas (Photos 19-22). A large portion of the West Pit area has been proposed for Phase I Bond Release under SL-24.

The following stock ponds in the West Pit area were inspected this month: TD1, TD2 and ETD1 (Photos 20-22). All stock ponds besides TD2 were seen to be holding a small amount of water, with no erosional issues or concerns noted.

The following ditches in the West Pit area were inspected this month: East Taylor Ditch and Taylor Ditch (Photos 19-22). Both ditches were inspected from within the West Pit reclaimed area. No signs of erosion or cutting were visible along any of the observed West Pit ditches and inlet / outlet design for stock ponds appeared to be functioning properly.

Photo 19: View south of East Taylor Ditch in West Pit.

Photo 20: View west of East Taylor Ditch and ETD1 in West Pit.

Photo 21: View north of Taylor Ditch and TD1.

Photo 22: View southwest of Taylor Ditch and TD2 in West Pit.

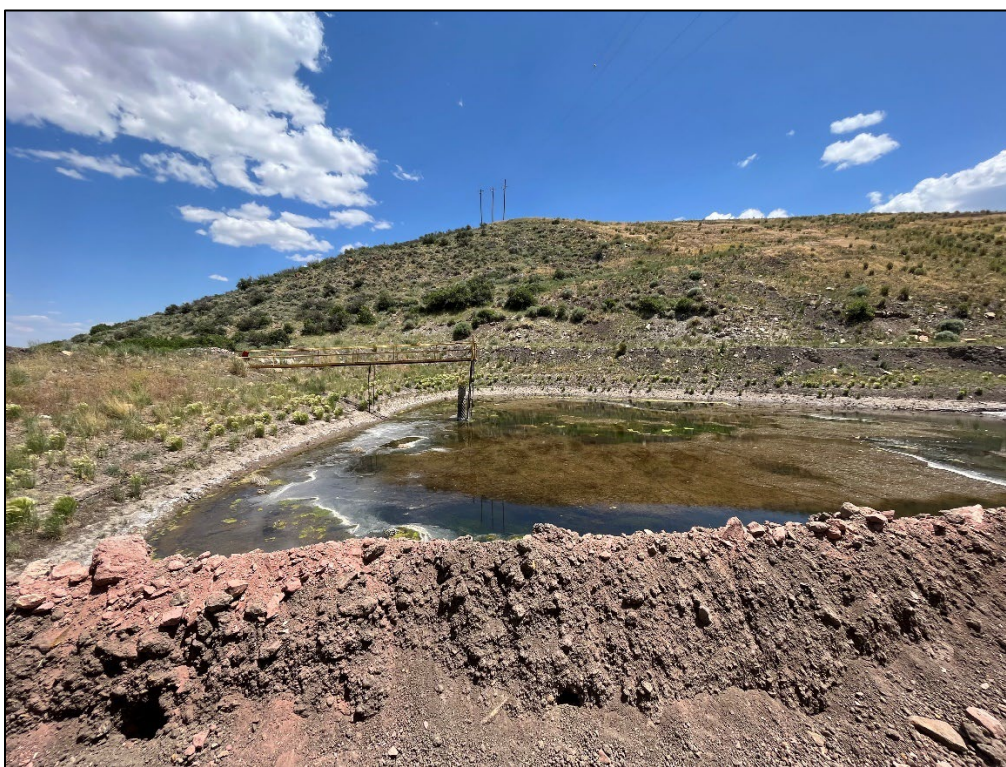
East Taylor and West Taylor Pond were inspected this month along Taylor Creek (Photos 24 and 29). Both ponds were holding water and had stable embankments. Inlet and outlet structures were free of obstructions. No issues were noted.

Photo 24: View east of East Taylor Pond.

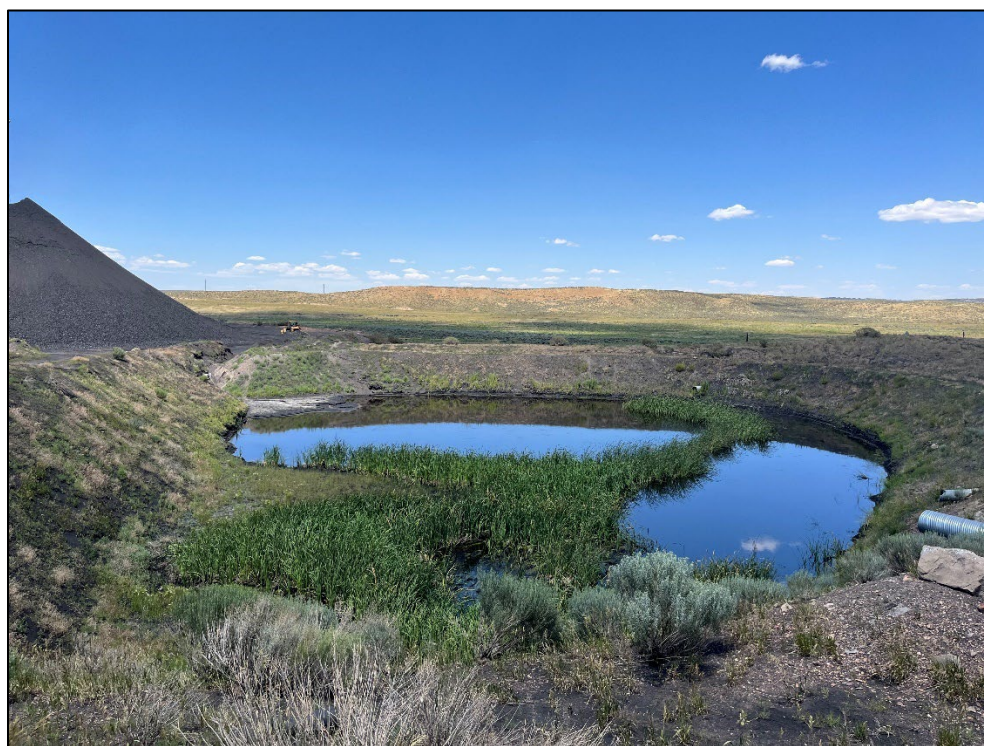
The Stoker Siding and Gossard Ponds were observed in the loadout area. A train was being loaded with coal at the time of inspection and blocked access to Rail Loop Pond. Both ponds were holding water and were free of any issues (Photos 26 and 27).

Photo 26: View west of Gossard Pond.

Photo 27: View northeast of the Stoker Siding Pond.
