COLORADO OPERATIONS

July 7, 2025

Re: Follow-up on Henderson Mill Tailings Delivery Line Inspections, Climax Molybdenum Company, Henderson Operations, Reclamation Permit No. M-1977-342

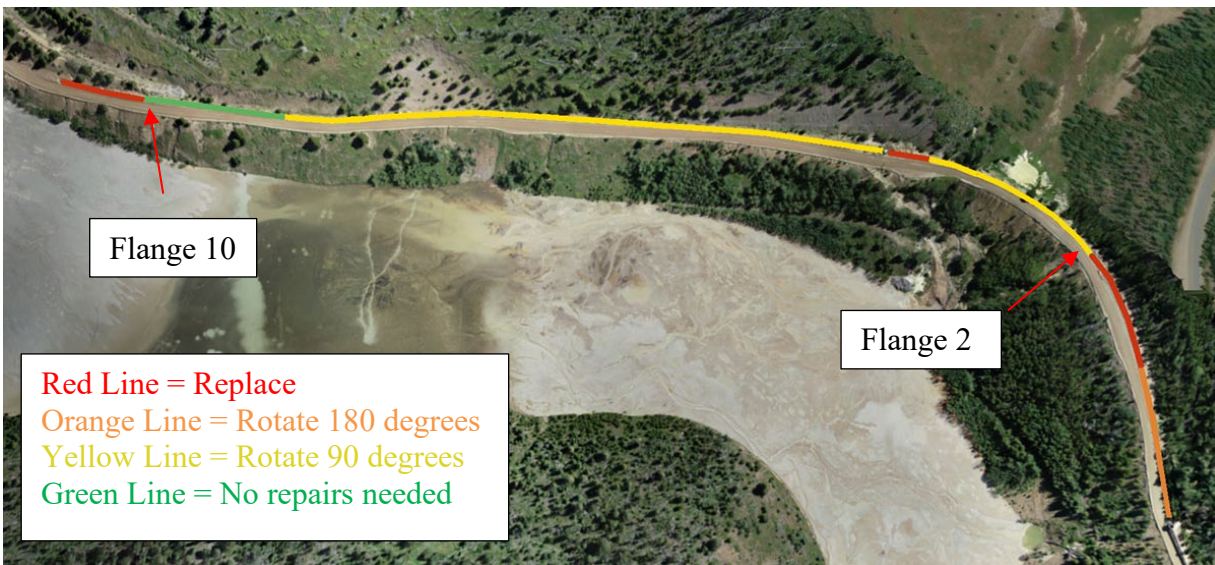
Figure 1. TDL Analysis

Based on the inspection, one more band was installed on a fuse in Section 1 (Flange 1 to Flange 2). Two holes were found in the pipe in this location, that were sealed with dirt on the bottom side. These holes had likely been there pre-2021 and had not leaked due to the dirt sealing them off. No other immediate concerns were identified that warranted banding. Accelerated wear was observed in Section 1 at Fuse 1-2, and Section 10 at Fuses 10-3 and 10-4 with thickness below or equal to 2.0-in, but wear rates indicate these sections should not leak until repairs can be made later in the summer.

Henderson also plans to rotate several sections of pipe between Drop Tower No.12 and Flange 11 based on wear rates as shown in orange and yellow on Figure 1. Henderson has also ordered approximately 1,500 feet of 42-in SDR 15.5 pipe to make the repairs in the summer and have extra on-hand for future repairs.

- Replace 200-ft of pipe in Section 10 (Flange 10 to Flange 11)
- Replace 200-ft of Section 1 (Flange 1 to Flange 2)
- Replace 100-ft of Section 3 (Flange 3 to Flange 4)

Based on these inspections, Henderson is implementing a data-driven, preventative approach to inspecting and replacing sections of the pipeline that show wear. This model will be continued to plan future rotations and replacements with onsite pipe.
