**PERMIT INFORMATION**

<b>Permit Number:</b> C1981033 <b>Mine Name:</b> Bear Mine <b>Operator:</b> N/A <b>Operator Address:</b> N/A	<b>County:</b> Gunnison <b>Operation Type:</b> Underground <b>Permit Status:</b> Revoked <b>Ownership:</b> Private
	<b>Operator Representative Present:</b>  N/A
<b>Operator Representative Signature: (Field Issuance Only)</b>

<b>Inspection Start Date:</b> June 25, 2025 <b>Inspection Start Time:</b> 11:00 <b>Inspection End Date:</b> <b>Inspection End Time:</b>	<b>Inspection Type:</b> Coal Complete Inspection <b>Inspection Reason:</b> Normal I&E Program <b>Weather:</b> Clear
<b>Joint Inspection Agency:</b>  None	<b>Joint Inspection Contacts:</b>  
<b>Post Inspection Agency:</b>  None	<b>Post Inspection Contacts:</b>  
<b>Inspector(s):</b>  Leigh Simmons	<b>Inspector's Signature:</b>

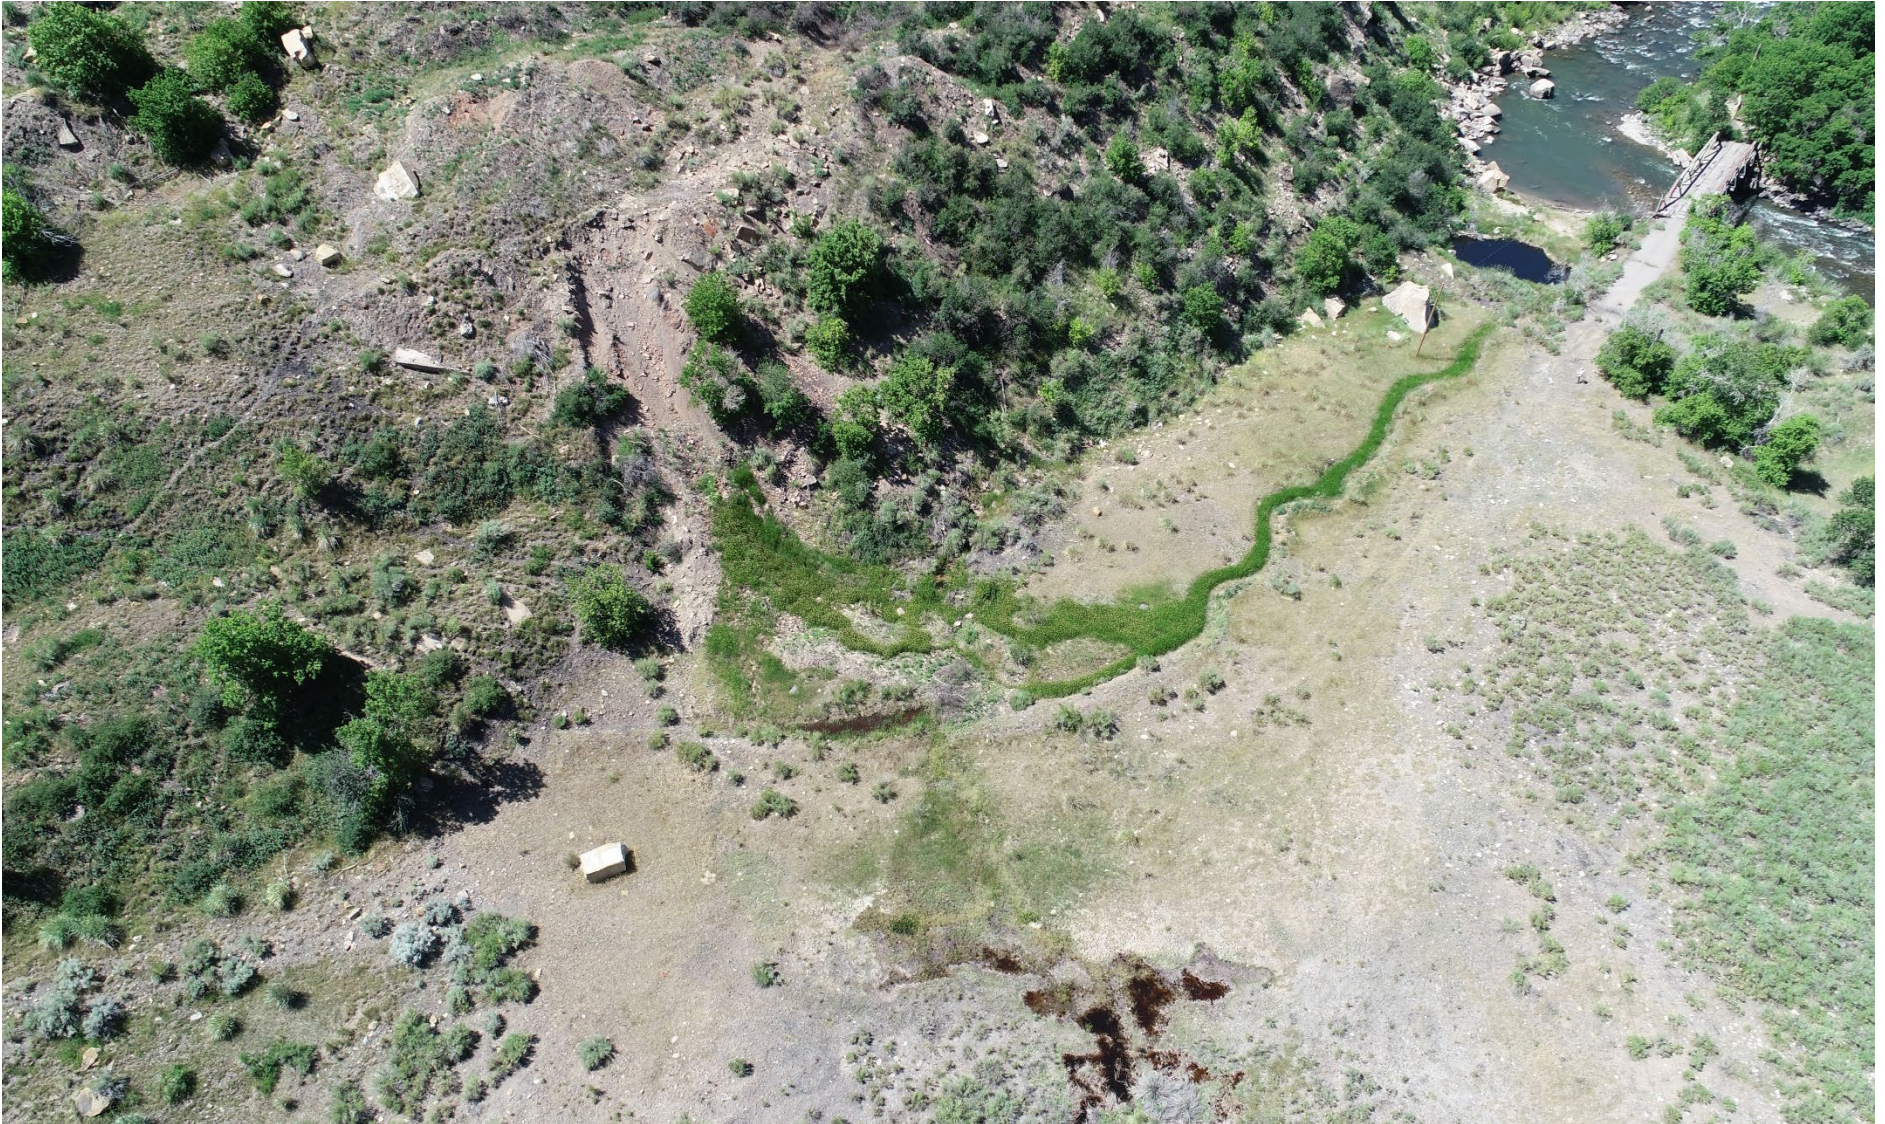
Water continued to seep from the toe of the slide area. Most of the seep water was directed into the sinuous channel, but some had been blocked by a small slump and spilled out into the flat area - there was no apparent recent change in this area.

*Figure 3: Seep and sinuous channel*

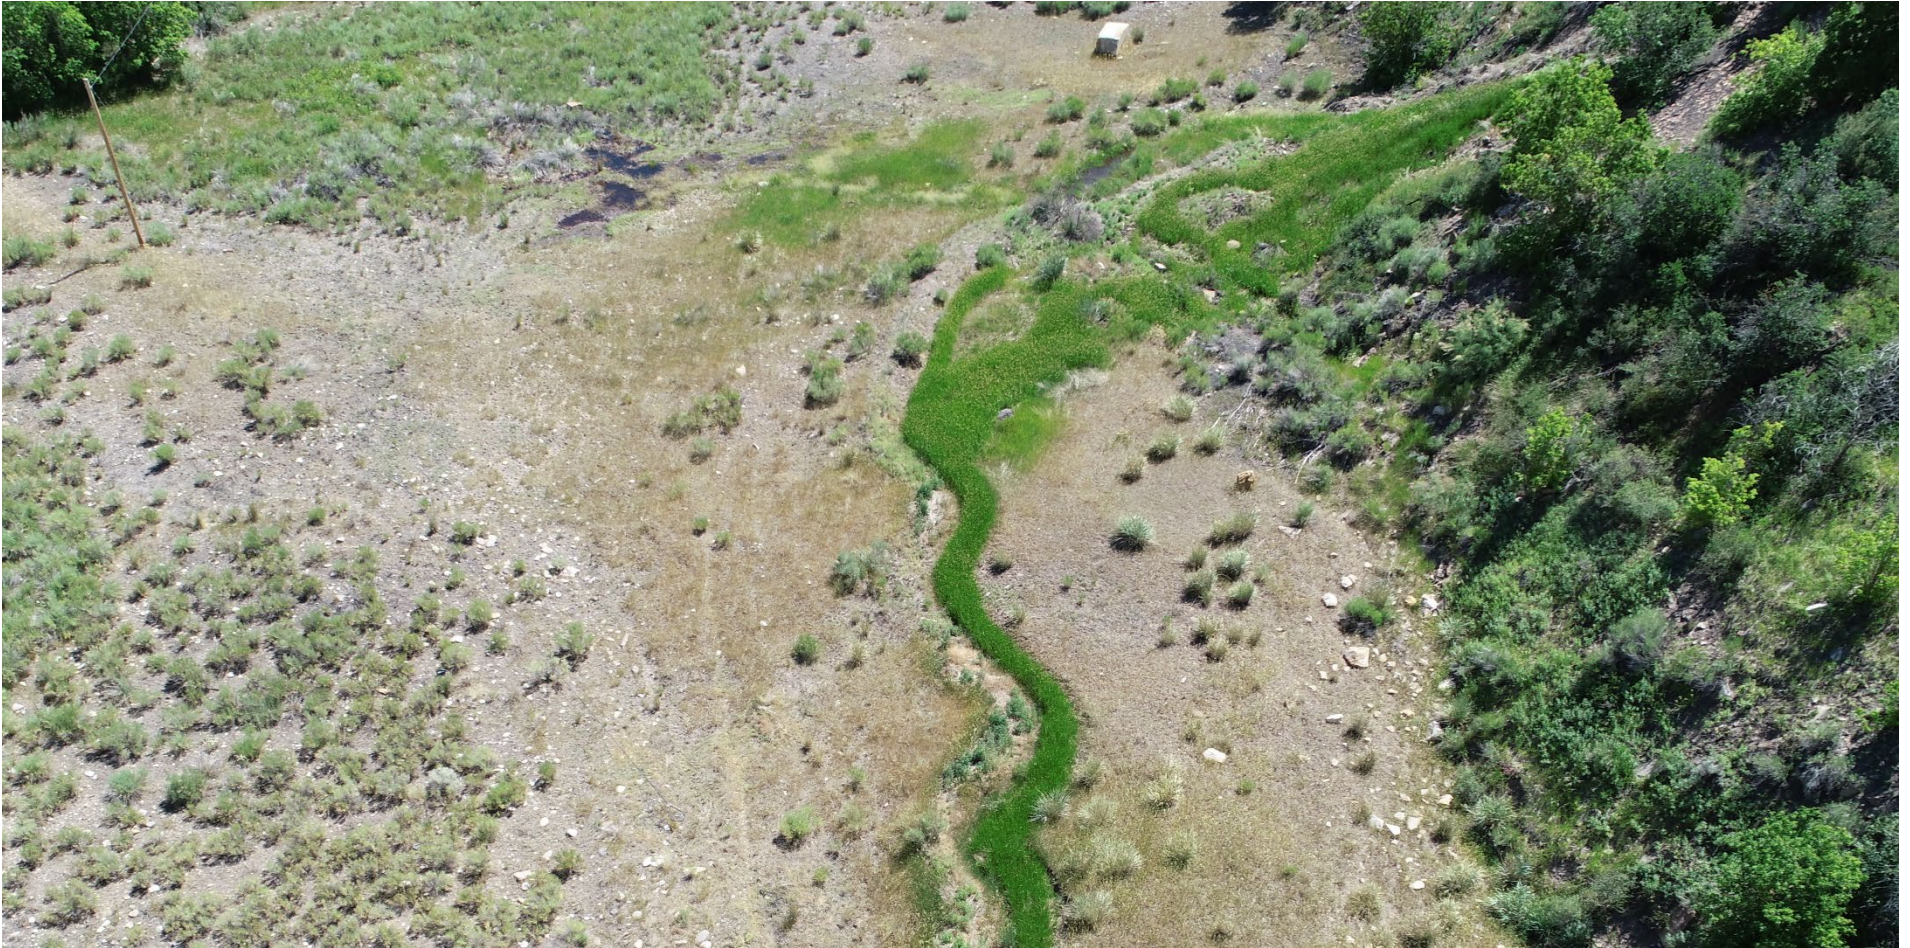
*Figure 4: Seep area, showing partial blockage of channel*

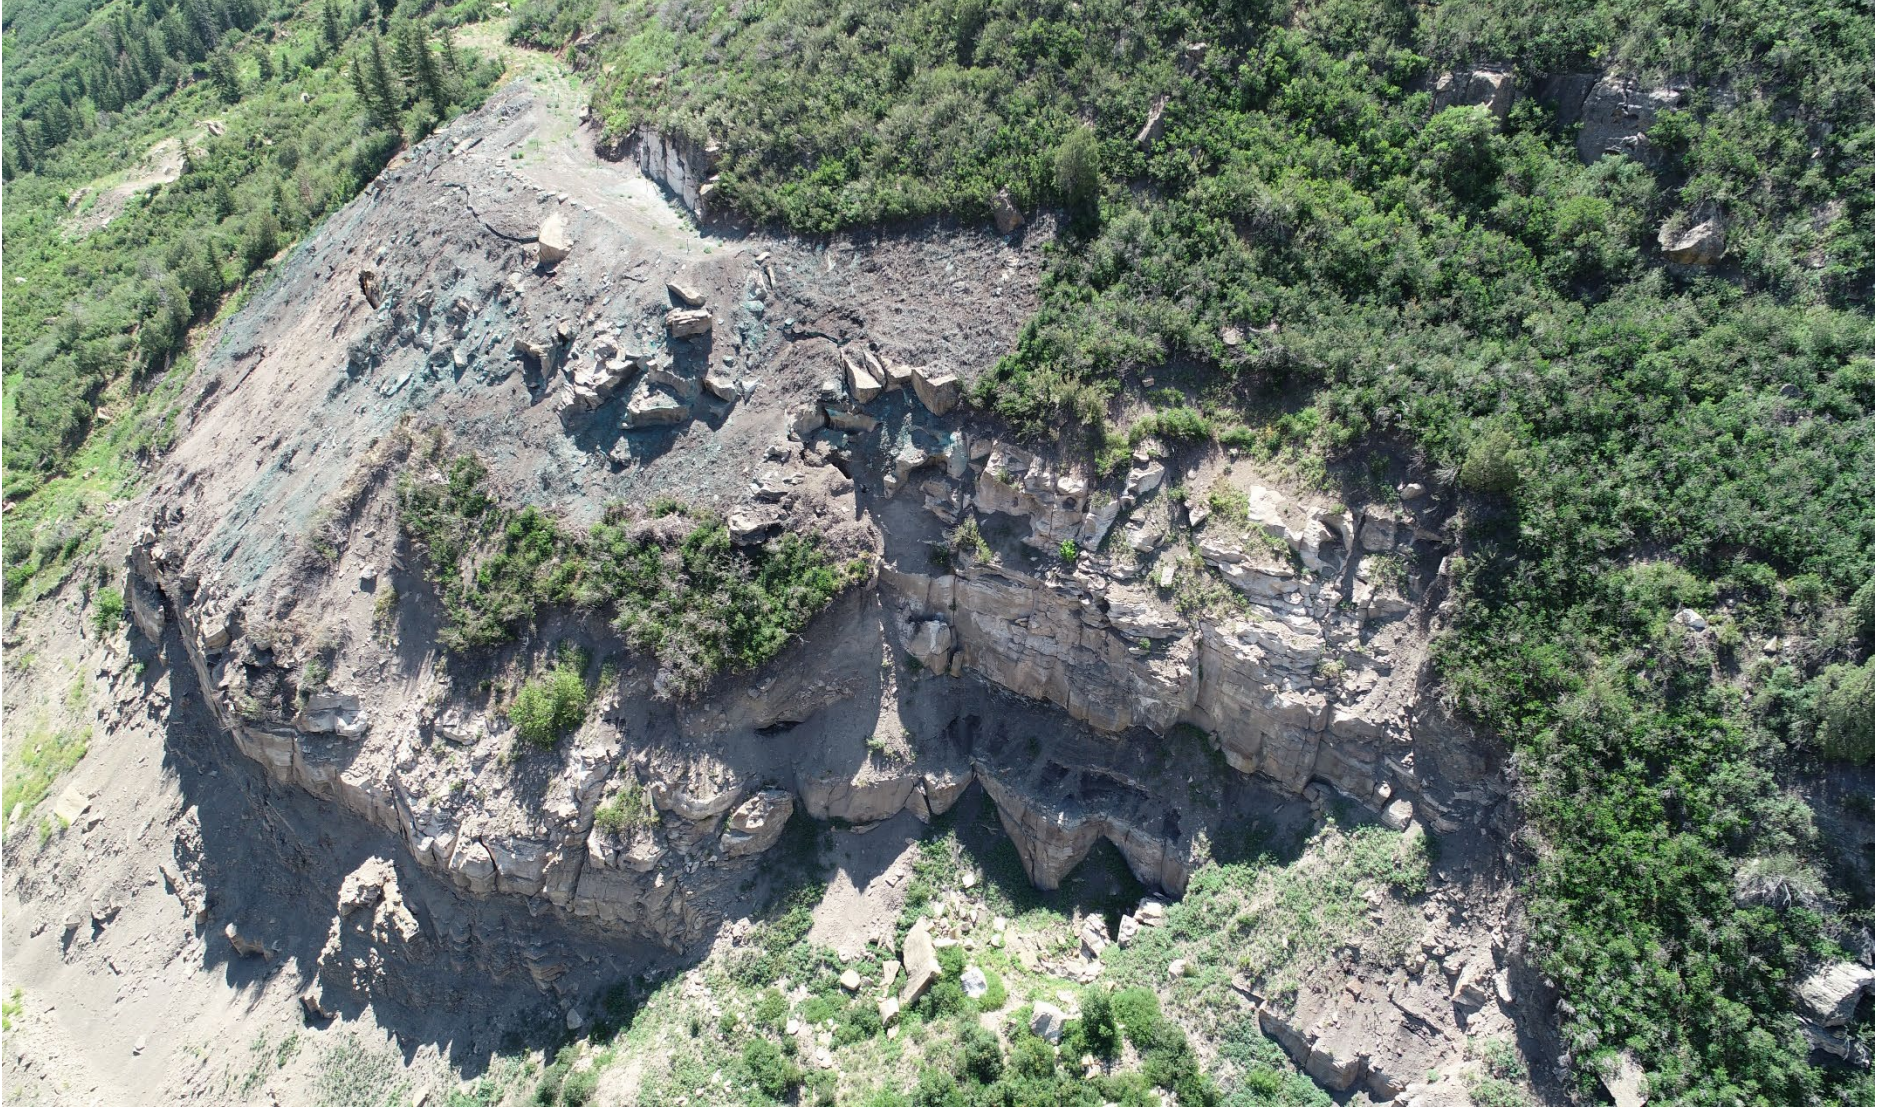
*Figure 8: Slide area, looking south east*

At the time of the inspection there was no sign of a recent increase in either the fire activity or instability of the slide area.
