MINERALS PROGRAM INSPECTION REPORT

MINE NAME: Church Pit	MINE/PROSPECTING ID#: M-1979-045	MINERAL: Clay (general)	COUNTY: Jefferson
INSPECTION TYPE: Preoperation Inspection	WEATHER: Clear	INSP. DATE: May 20, 2025	INSP. TIME: 10:00
OPERATOR: The Lakewood Brick and Tile Company	OPERATOR REPRESENTATIVE:	TYPE OF OPERATION: 112c - Construction Regular Operation

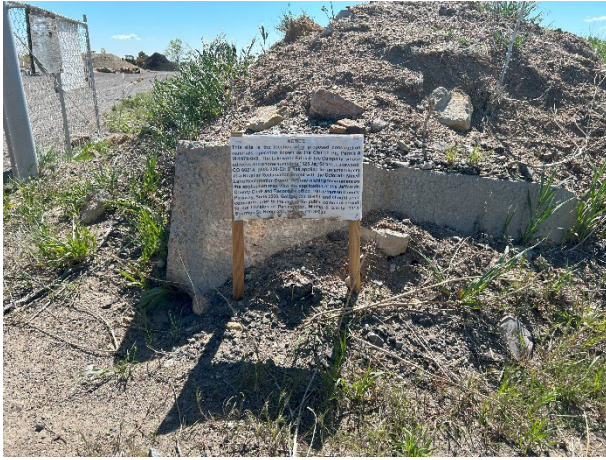
AM2 is planned to modify the existing affected lands boundary to reflect current conditions. This update was reflected clearly by their newly placed site boundaries, which were represented by pvc pipe markers. The public notice sign is adequately posted at the entrance of the Church Pit as well.

Photo 1: Posted amendment notice sign.

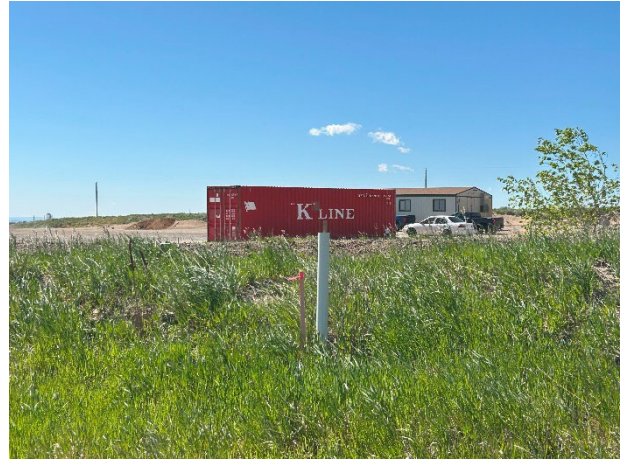
Photo: Example boundary marker.

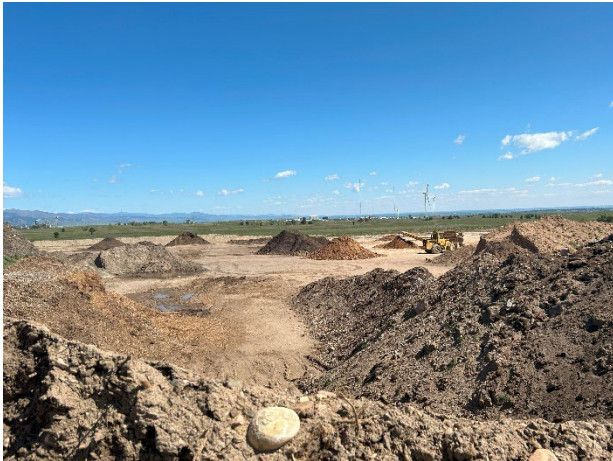
As mentioned in the operator's application, the majority of the clay stockpiles are located on the eastern portion of the site, primarily within the proposed new permit area. Gravel stockpiles are located on the west side of the site. Plant growth material stockpiles are present along the perimeter of the site and appeared stable at the time of inspection. No evidence of sediment runoff was observed during this inspection.

Photo 3: Clay stockpiles and screening area. Located on the new eastern site boundary.

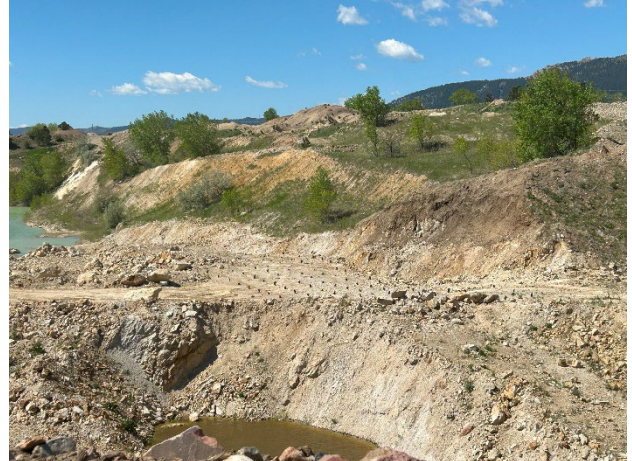
PROBLEM/POSSIBLE VIOLATION: Problem: Per rule 6.4.4(i), the operator must specify if explosives will be used in conjunction with the mining (or reclamation). In consultation with the Office, the Applicant must demonstrate pursuant to Rule 6.5(4), Geotechnical Stability Exhibit, that off-site areas will not be adversely affected by blasting.

During this inspection, the operator stated that blasting has been performed to excavate the sandstone seam located on the west side of the site. Upon review, no approved blasting plan could be found to support this operation. As such, a blasting plan will be required to be submitted as part of the review process for AM2. Please see the problem citation directly for information regarding the applicable rules and requirements.

Photo 4: Example of problematic blasting.

CORRECTIVE ACTIONS: Please include a blasting plan which adequately satisfies the requirements of Rule 6.4.4(i) as part of the adequacy process for AM2.

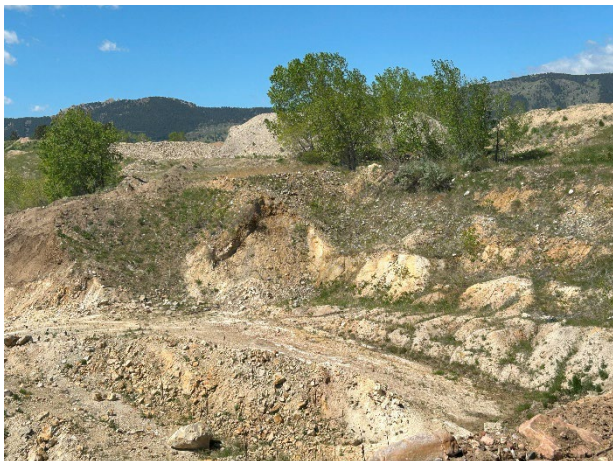
Photo 5: Sandstone seam which is targetted for blasting.

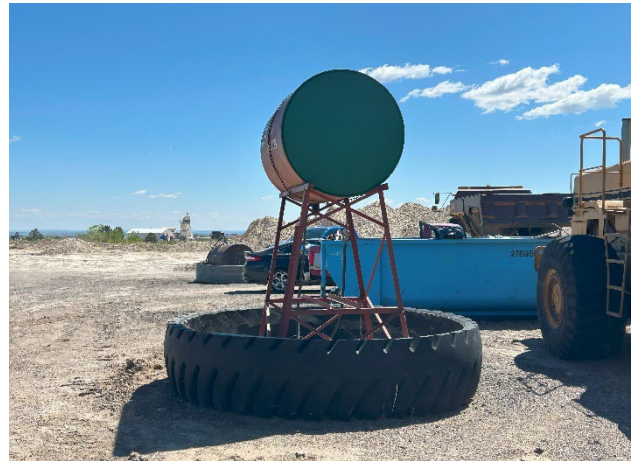
No significant impacts to the local hydrologic balance were observed during this inspection. Standing water was observed within the central mining area, however this was contributed to the recent rainfall which occurred in Jefferson County. All fuel storage was double sealed and appeared to have no leakage at the time of inspection.

Photo 6: Fuel storage with secondary containment.
