Huddleston-Berry
Engineering & Testing, LLC

July 8, 2025
Project#01349-0001

Subject: Summary of Instrumentation Monitoring
2nd Quarter 2025
Bowie Coal Waste Disposal Area No. 2
Paonia, Colorado

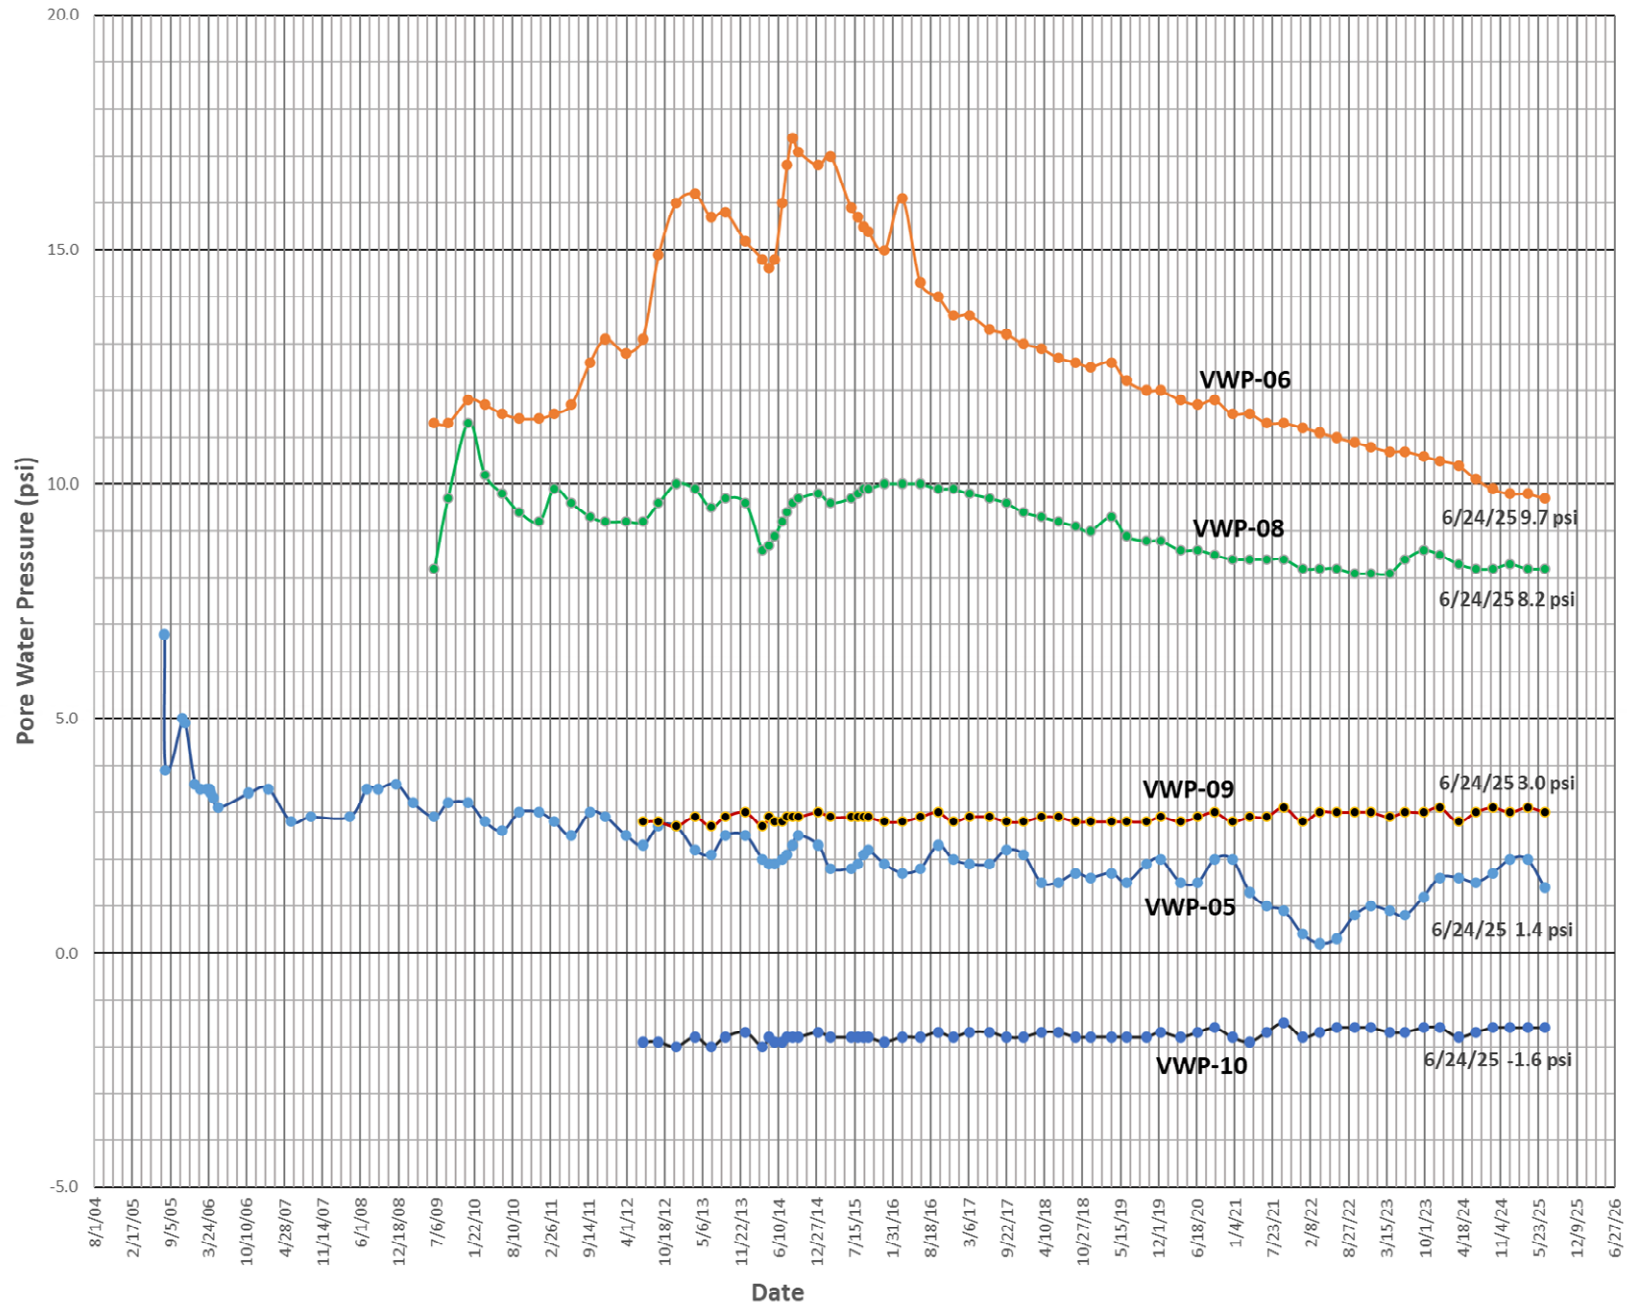
Figure 2 - Bowie Mine #2 - CWDA #2
Active Vibrating Wire Piezometer Data

As seen on Table 1 and Figure 2, the VWP readings and trends are consistent with recent and historic readings. When compared to a year ago (Q2 2024), pore pressure readings in all the VWP's changed by small amounts (-0.4 to 0.1 psi). When compared with last quarter (Q1 2025), pore pressures also changed by relatively small amounts (-0.6 to 0.0 psi) for all five VWP's. Although four of the five VWP's remain steady or have general declining trends in pore pressure over the life of the VWP's, one of the piezometers (VWP-05) has exhibited pronounced seasonal cyclical behavior for its lifespan, except from mid-2021 to mid-2022 where there was a steady decline in pore pressures. This piezometer generally (but not always) shows low pore pressures for Q1 and Q2 and higher pressures for Q3 and Q4, with a net loss of -5.4 psi over the lifetime of that VWP. The other four VWP's have experienced net changes of 0 to -1.6 psi since installation, meaning current readings are very similar to initial readings. For VWP-09 and VWP-10, pressures have been consistent throughout the lifetime of the piezometers; however, for VWP-06 and VWP-08, they experienced wild fluctuations in pore water pressure in the first half of their lifetimes but have settled to pressures similar to the installation pressures in the past several years.

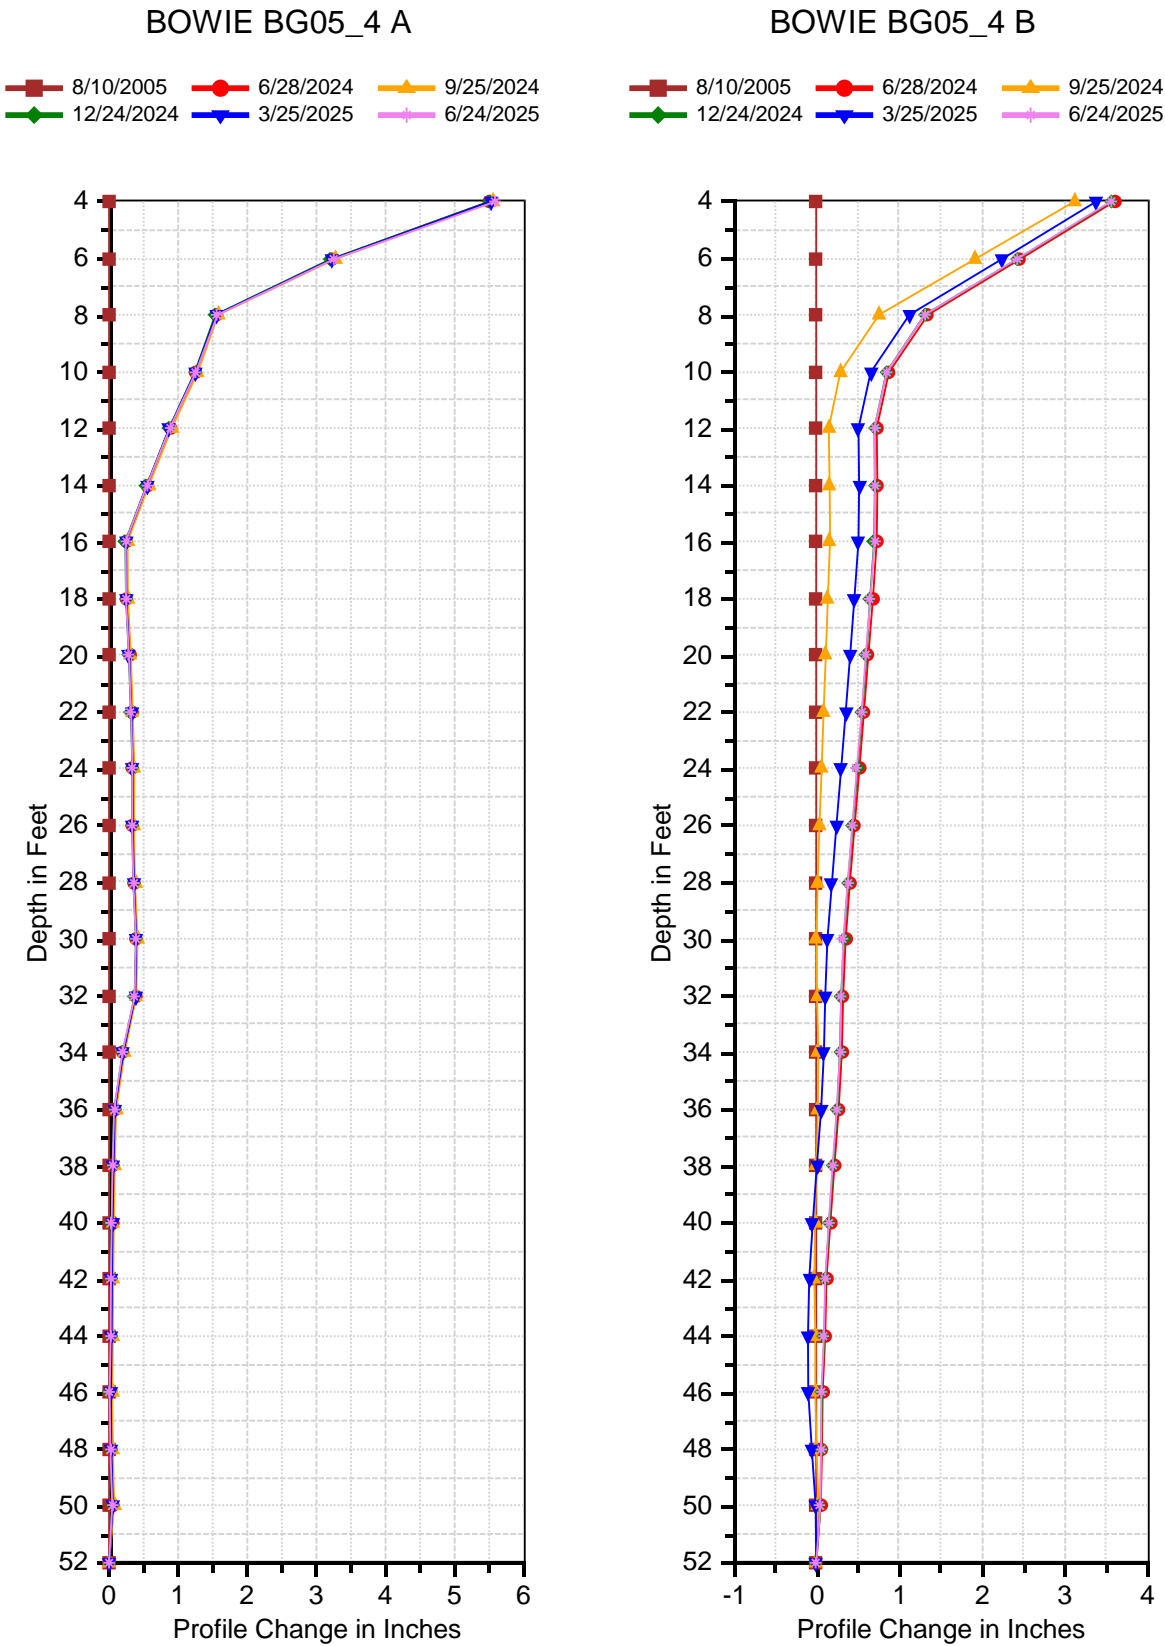
Figure 3 - Inclinator Displacement Curves

As described in previous reports, historic displacements indicated on the plots for the approximate upper 14-16 feet of the inclinometers since installation in 2005 are due to placement of cover soil on the face of the waste pile during revegetation/regrading operations in late 2006 and early 2007. This man-caused displacement is documented in a report by Buckhorn Geotech dated December 22, 2008, to Bowie Resources called *Revised Stability Evaluations for Coal Mine Waste Disposal Area No. 2, Bowie No. 2 Mine*.

Based on the current inclinometer readings, BG05_7 shows near perfect alignment (essentially identical readings for 20 years) with the initial reading in 2005 for the downslope direction (Axis A). Inclinometers BG05_4 and BG05_5, however, show a bulge of less than 1/2-inch in the inclinometer pipes (below the surface regrading). Based on our records, this bulge developed slowly from 2005 to 2010, but no movement has been recorded since then. This suggests there had been some gob pile settlement early in the lifetime of the inclinometers, but no recent or additional movement has occurred. Some "noise" which is understood to be relatively common in orthogonal direction (Axis B) readings, was observed over the past few years for all three inclinometers. This can be due to various mechanical or installation causes that are unrelated to slope movement. For example, grout voids, poor grout coverage, or soil settlement around the instrument can all contribute to vibrations and pipe movement that impacts inclinometer

readings. No software bias adjustments were applied to filter this noise. All readings were consistent with previous readings and the "displacement" error was within equipment tolerances and not deemed to be due to slope movement.
