MINERALS PROGRAM INSPECTION REPORT
PHONE: (303) 866-3567

MINE NAME: Cecil II Gravel Pit	MINE/PROSPECTING ID#: M-1986-124	MINERAL: Sand and gravel	COUNTY: Washington
INSPECTION TYPE: Surety Release Inspection	WEATHER: Clear	INSP. DATE: July 3, 2025	INSP. TIME: 10:30
OPERATOR: James Cecil	OPERATOR REPRESENTATIVE: James Cecil	TYPE OF OPERATION: 110c - Construction Limited Impact	
REASON FOR INSPECTION: Surety Release Requested	BOND CALCULATION TYPE: Complete Bond	BOND AMOUNT: \$7,500.00	
DATE OF COMPLAINT: NA	POST INSP. CONTACTS: None	JOINT INSP. AGENCY: None	
INSPECTOR(S): Ben Hammar	INSPECTOR'S SIGNATURE:

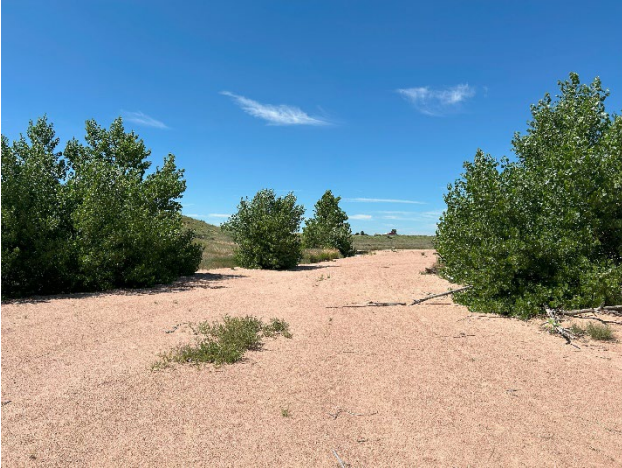
Photo 1: Reclaimed area near the site entrance.

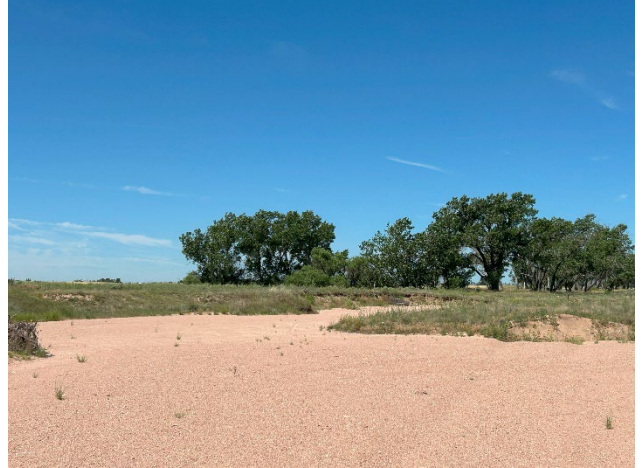
Photo 2: Reclaimed area near the rear of the site.

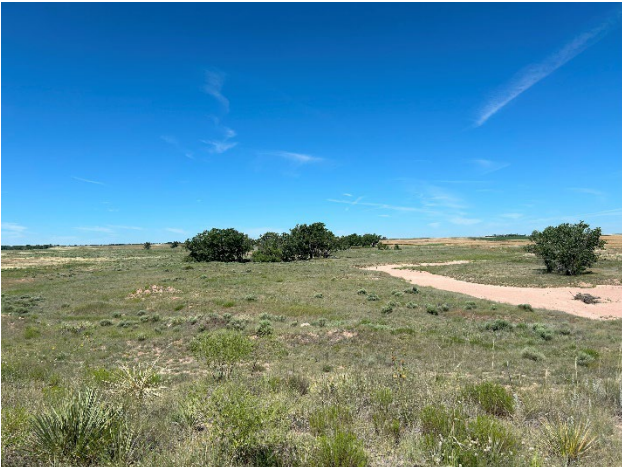
Photo 3: Revegetated area within the permit boundary.
Little to no weed presence and complete cover were observed.
