**MINERALS PROGRAM INSPECTION REPORT**  
**PHONE: (303) 866-3567**

<b>MINE NAME:</b> Rudder Pit	<b>MINE/PROSPECTING ID#:</b> M-2019-008	<b>MINERAL:</b> Sand	<b>COUNTY:</b> Lincoln
<b>INSPECTION TYPE:</b> Surety Release Inspection	<b>WEATHER:</b> Clear	<b>INSP. DATE:</b> July 2, 2025	<b>INSP. TIME:</b> 12:30
<b>OPERATOR:</b> McCormick Excavation & Paving, LLC	<b>OPERATOR REPRESENTATIVE:</b>	<b>TYPE OF OPERATION:</b> 110c - Construction Limited Impact	
<b>REASON FOR INSPECTION:</b> Surety Release Requested	<b>BOND CALCULATION TYPE:</b> Complete Bond	<b>BOND AMOUNT:</b> \$0.00	
<b>DATE OF COMPLAINT:</b> NA	<b>POST INSP. CONTACTS:</b> None	<b>JOINT INSP. AGENCY:</b> None	
<b>INSPECTOR(S):</b> Ben Hammar	<b>INSPECTOR'S SIGNATURE:</b>

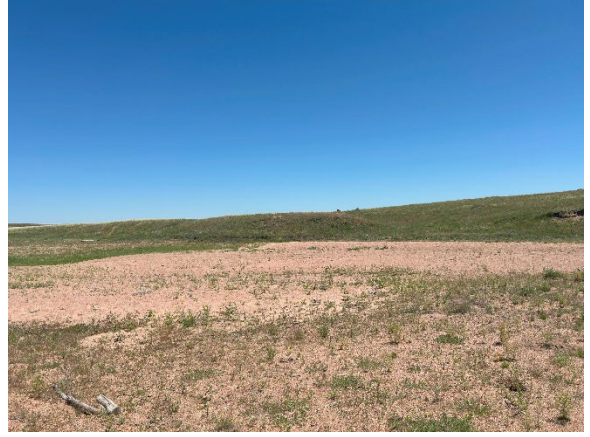
Per conversation with the landowner, this site has not been used in over a year due to Jim McCormick's retirement. Little disturbance was present when the pit was active, and due to regular seasonal flow within the stream there was nearly no disturbance able to be observed at the time of inspection. The access road to the site had grown over to the point of being difficult to find, and no significant impact to the surrounding hydrologic balance was observed.

Photo 2: Center of pit facing east. This is the primary area of disturbance.

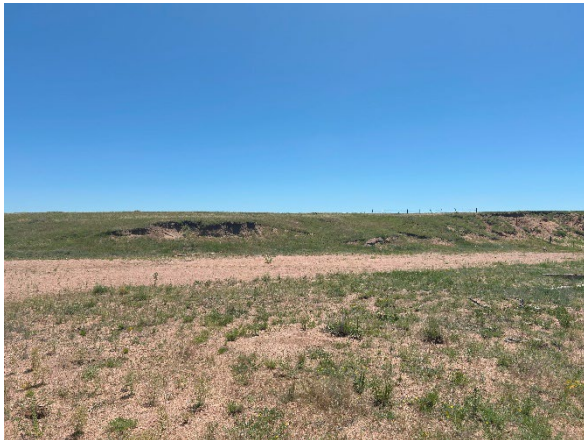
The areas outside of the riverbed appeared to be adequately revegetated, with some sedimentation near the edges of the stream due to recent heavy rainfall. The site currently holds a bond of \$5,270. Based upon the reclamation observed during this inspection and a statement from the landowner during the inspection that the reclamation is acceptable, this release request is approved. A letter detailing the next steps required will be supplied with this report.

Photo 3: Sedimented shoreline and southeastern area of the site.
