MINERALS PROGRAM INSPECTION REPORT
PHONE: (303) 866-3567

MINE NAME: W. Max (Bill Nelson) Borrow Pit	MINE/PROSPECTING ID#: M-2023-010	MINERAL: Borrow material for	COUNTY: Washington
INSPECTION TYPE: Monitoring	WEATHER: Clear	INSP. DATE: July 2, 2025	INSP. TIME: 01:30
OPERATOR: IHC Scott, Inc.	OPERATOR REPRESENTATIVE:	TYPE OF OPERATION: 111 - Construction by Government Agency	
REASON FOR INSPECTION: Normal I&E Program	BOND CALCULATION TYPE: Complete Bond	BOND AMOUNT: \$35,000.00	
DATE OF COMPLAINT: NA	POST INSP. CONTACTS: None	JOINT INSP. AGENCY: None	
INSPECTOR(S): Ben Hammar	INSPECTOR'S SIGNATURE:

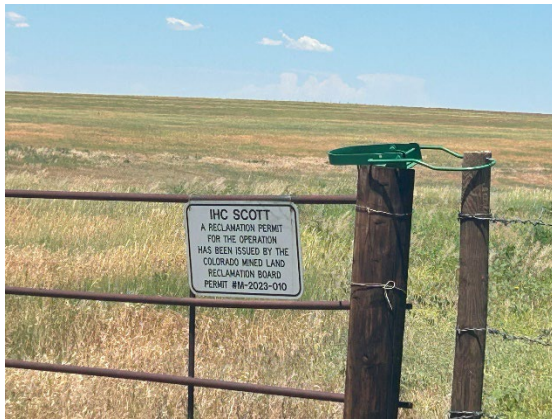
This site was created in support of a local government construction project, and is currently inactive due to the completion of said project. No impacts to the local hydrologic balance were observed during this inspection. The site boundaries were clearly marked and all disturbance was within the current boundary markers. The required mine sign was posted and in reasonable condition.

Photo 1: Posted mine sign

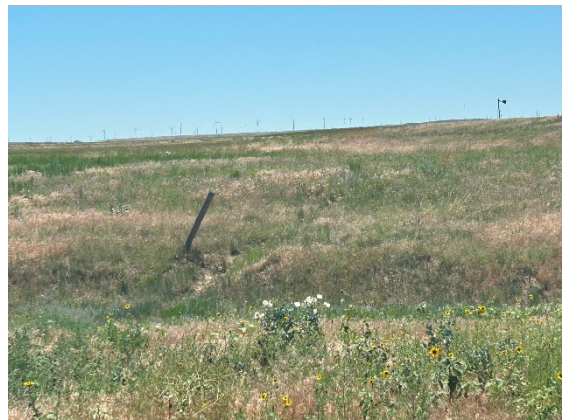
Photo 2: Northern site boundary.

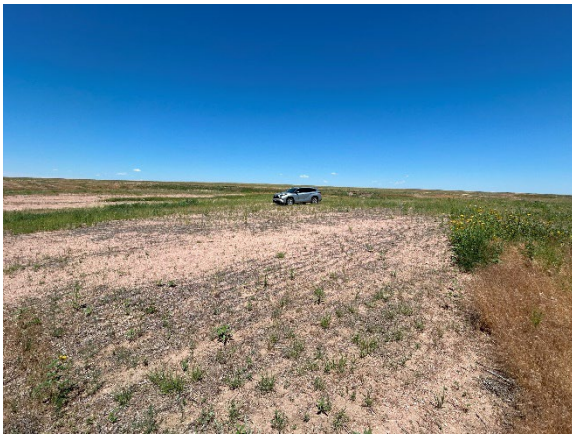
Photo 3: Central pit area with evidence of mulching and drill seeding.

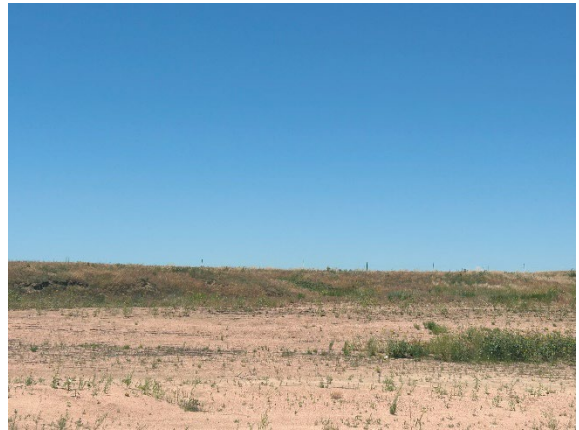
Per correspondence with the operator, the site is currently in reclamation. At the time of inspection, it appears additional seeding is likely necessary to push the site toward complete cover. Areas within the pit floor appear to be relatively unvegetated compared to the surrounding land, and the site likely needs at least an additional growing season to be releasable. Regrading and topsoil placement appears to be complete and performed well, no significant signs of erosion were found.

Photo 4: Pit area with bare spots and western site boundary.

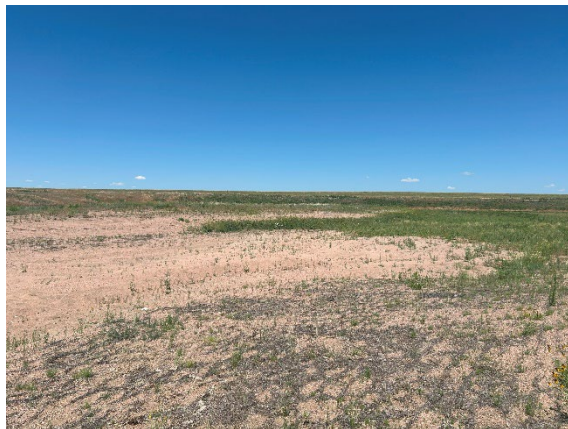
Photo 5: Additional photo of pit area facing northwest.
