McClane CanyonMine, C-1980-004, June Complete Inspection Report

PERMIT INFORMATION

INSPECTION INFORMATION

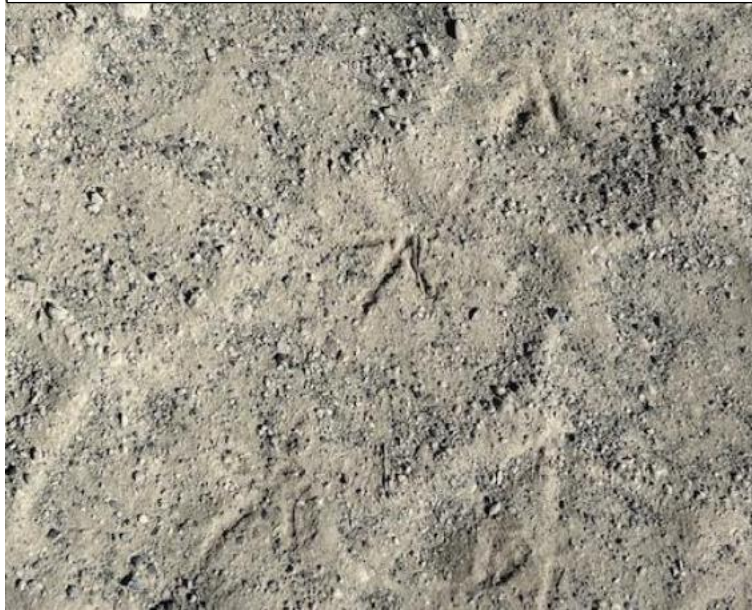
During the inspection of the sediment pond, there were several sets of Turkey tracks observed (Photo 1).

Photo 1: The Turkey tracks adjacent to the sediment pond.

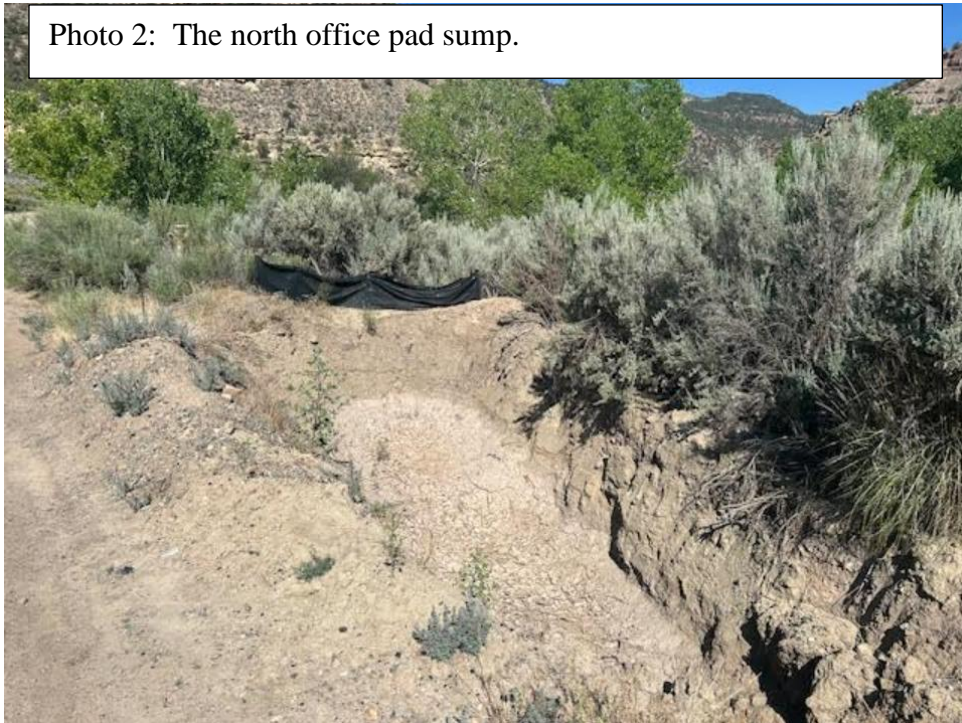
There are two sumps located on the western end of the mine office pad. One sump is on the north side of the haul road and the other is on the south side of the haul road. The northern sump was dry during the inspection (Photo 2). The sump was stable with no erosional concerns. The silt fence at the outlet was observed to be in good repair. The south sump was dry and stable (Photo 3). There were no erosional features. The silt fence for the sump was in good condition.

Photo 2: The north office pad sump.

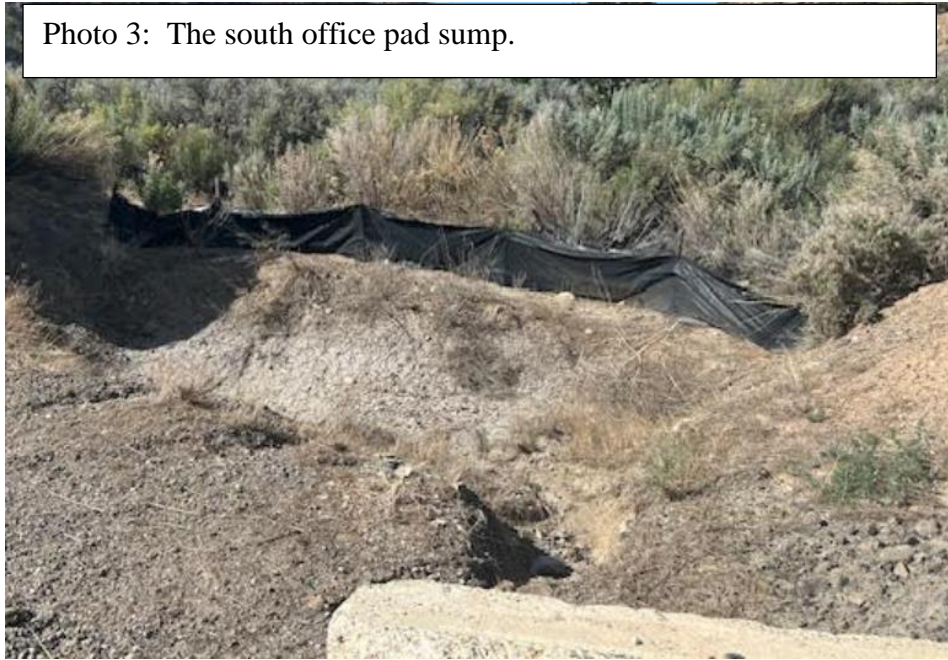
Photo 3: The south office pad sump.

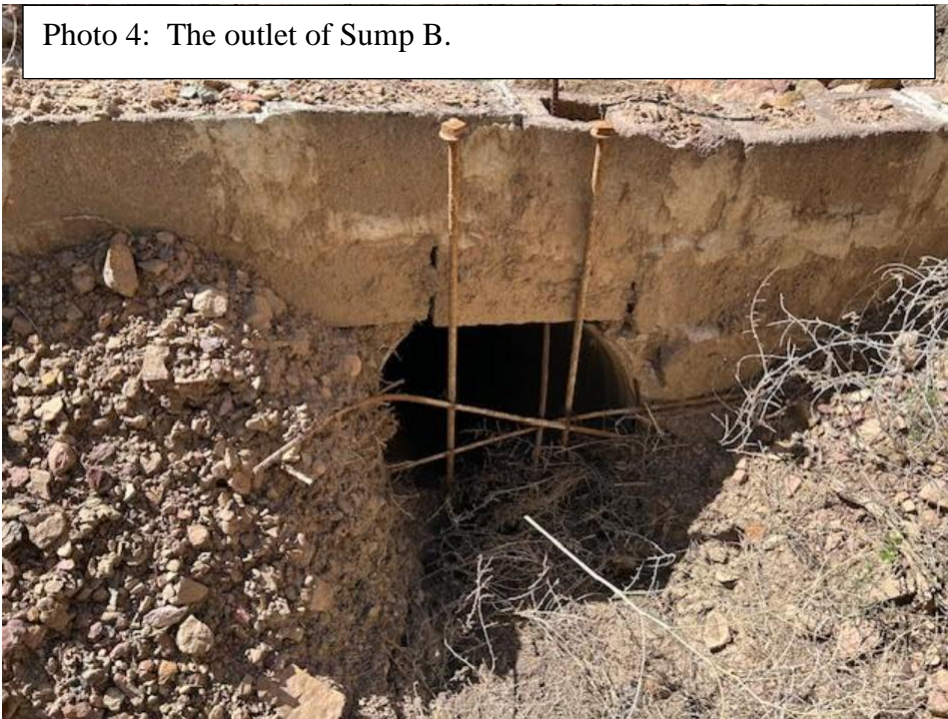
Five clearwater diversions/sumps are located on the portals pad. Each of the diversions/sumps intercept and collect water from undisturbed areas above the portals area and pipe the water underneath the pad. The clearwater is then discharged to Upper McClane Creek. Sump B is located on the northwest side of the portals pad. The sump was dry. There were no indications of instability or erosion. The outlet culvert was clear of debris (Photo 4). Sump A is located on the northeast side of the portals pad, east of Sump B. Sump A was holding water below the discharge outlet (Photo 5). No discharge was occurring. There were no erosional features and the sump was stable. The grate over the discharge pipe was clear from debris. Sump C is located on the east side of the portals pad. Sump C was holding a small puddle of water in it during the inspection (Photo 6). There was no discharge through the outlet. The sump had no indications of erosional features or instability. The grate covering the discharge outlet was clear of debris. Sump E is located on the southeast side of the portals pad. Sump E was dry during the inspection (Photo 7). The culvert outlet was unobstructed. The embankment had been reenforced with large rocks since the previous inspection. The embankment was stable. The D-5 culvert is located west of Sump E. The culvert was observed to be stable with no erosional features. The culvert pipe was in good condition (Photo 8).

Photo 4: The outlet of Sump B.

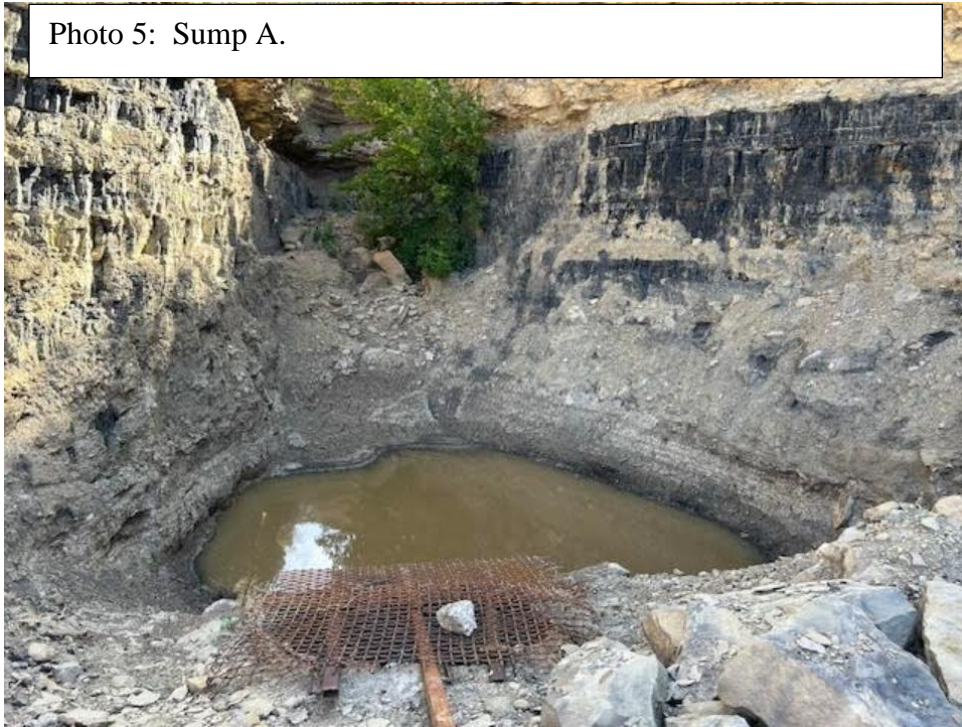
Photo 5: Sump A.

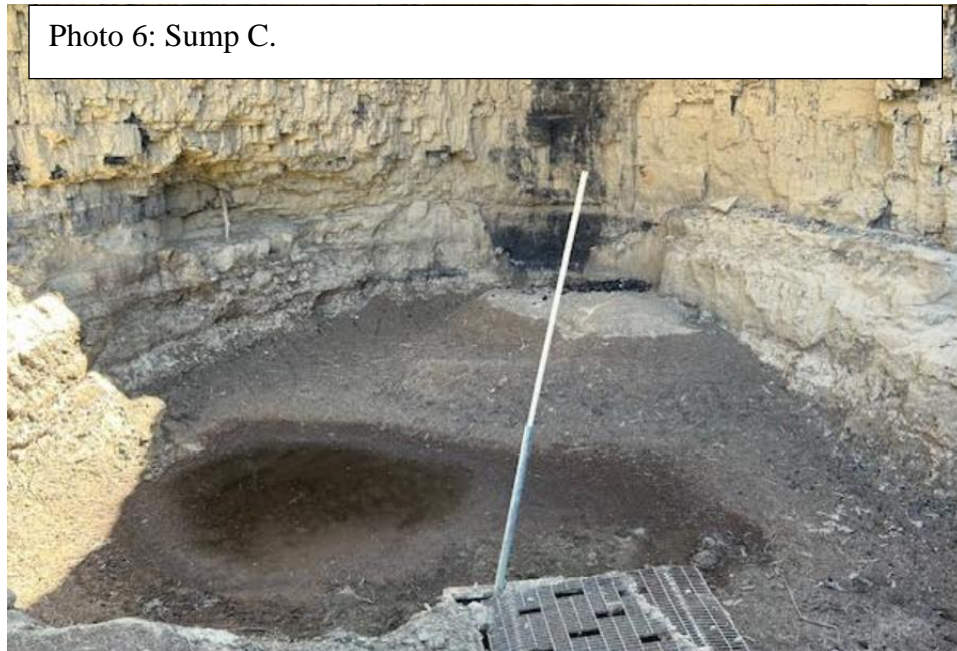
Photo 6: Sump C.

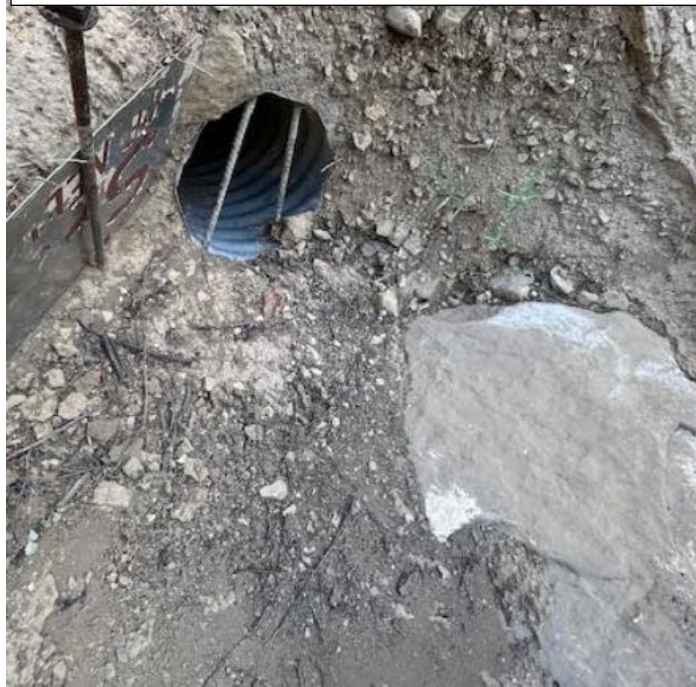
Photo 7: The outlet of Sump E.

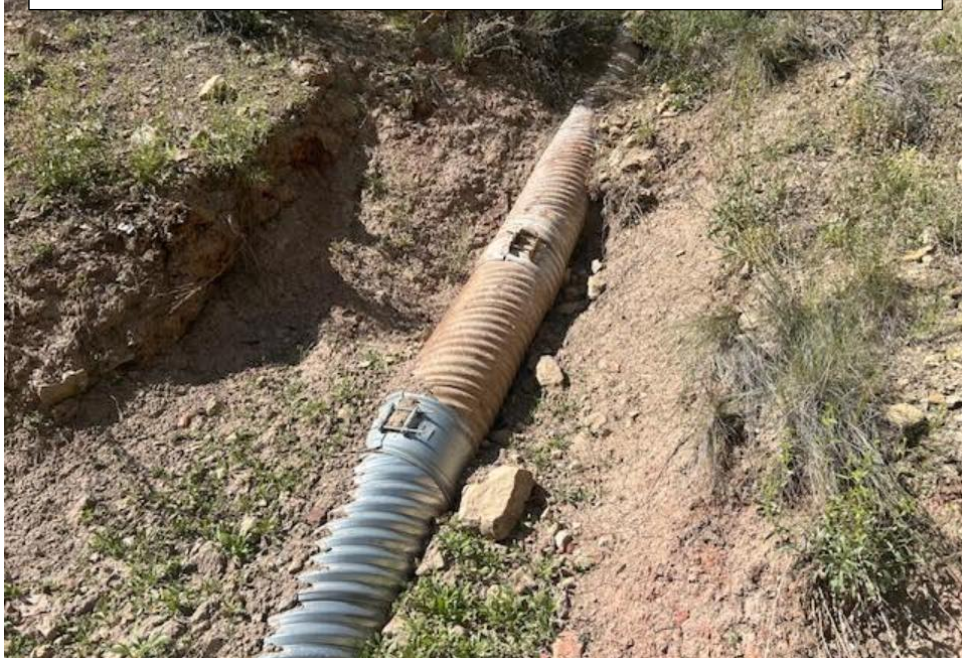
Photo 8: The D-5 Culvert.

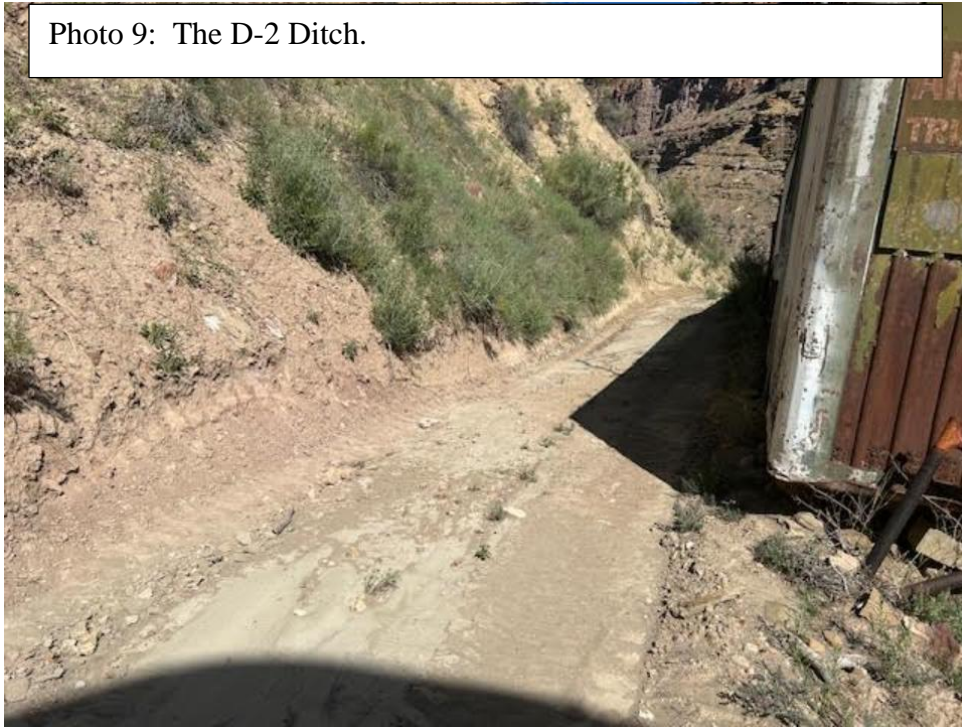
The D-2 ditch connects the upper bench on the south side of the portals pad to the D-3 ditch. The D-2 ditch was clear of debris and dry. Evidence of flow from previous runoff events was evident. The ditch appeared to have functioned as designed (Photo 9). The ditch has become partly filled with sediment. The operator's representative stated that the ditch will be cleaned as a part of ongoing sediment control maintenance in the near future. The open culvert extending down the slope to the D-3 ditch stable with no obstructions observed (Photo 10).

Photo 9: The D-2 Ditch.

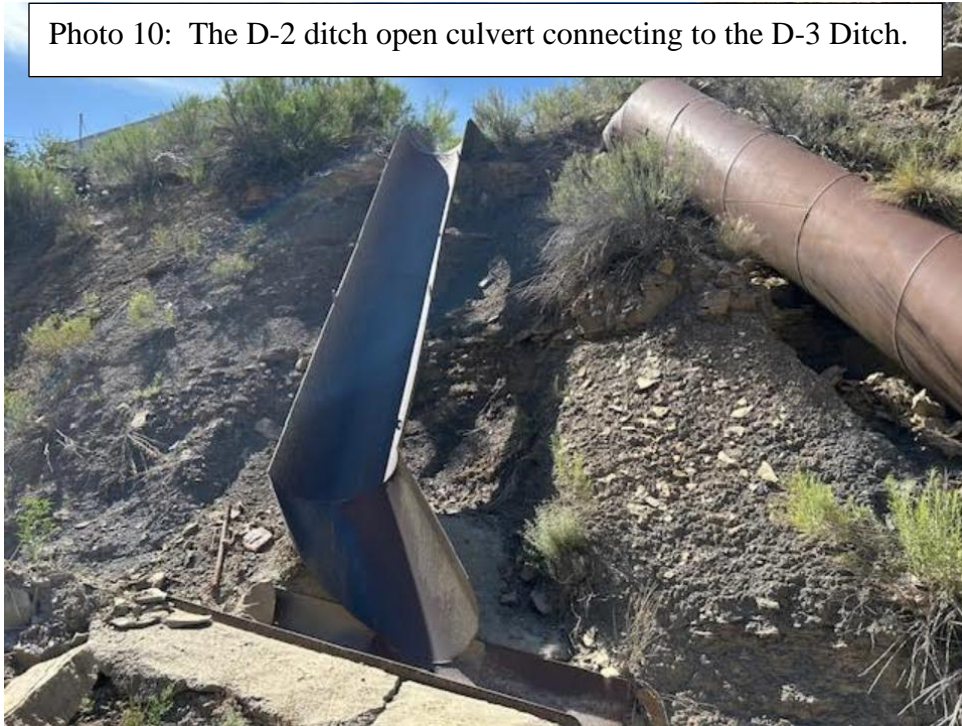
Photo 10: The D-2 ditch open culvert connecting to the D-3 Ditch.

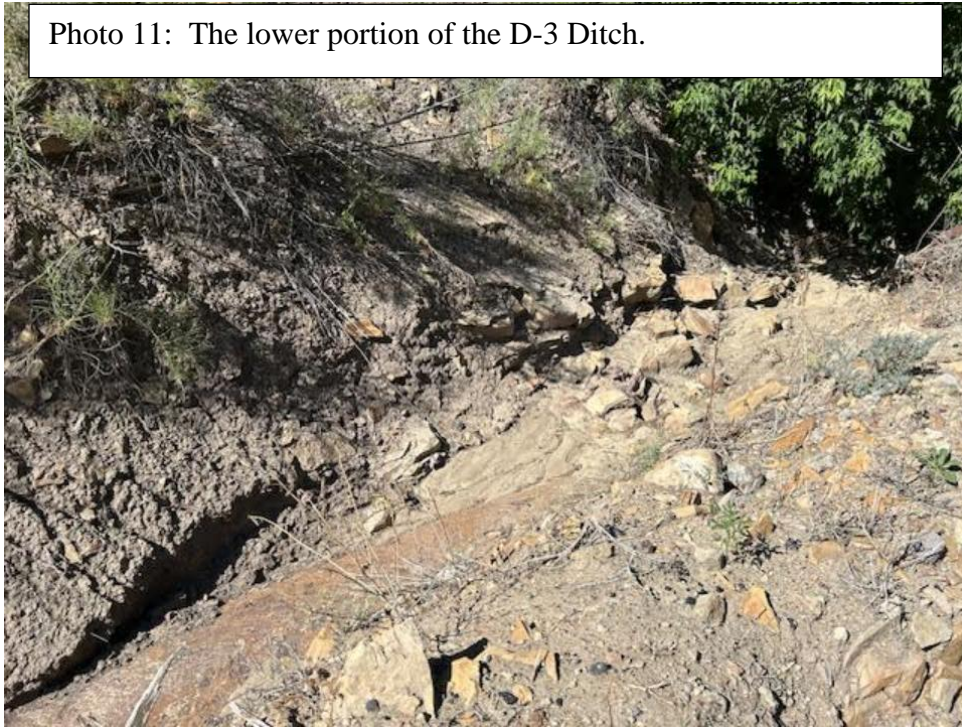
The D-3 ditch is on the south side of the lower bench of the portals pad. The D-3 Ditch was dry with no observed blockages (Photo 11). There were no erosional features or signs of instability.

Photo 11: The lower portion of the D-3 Ditch.

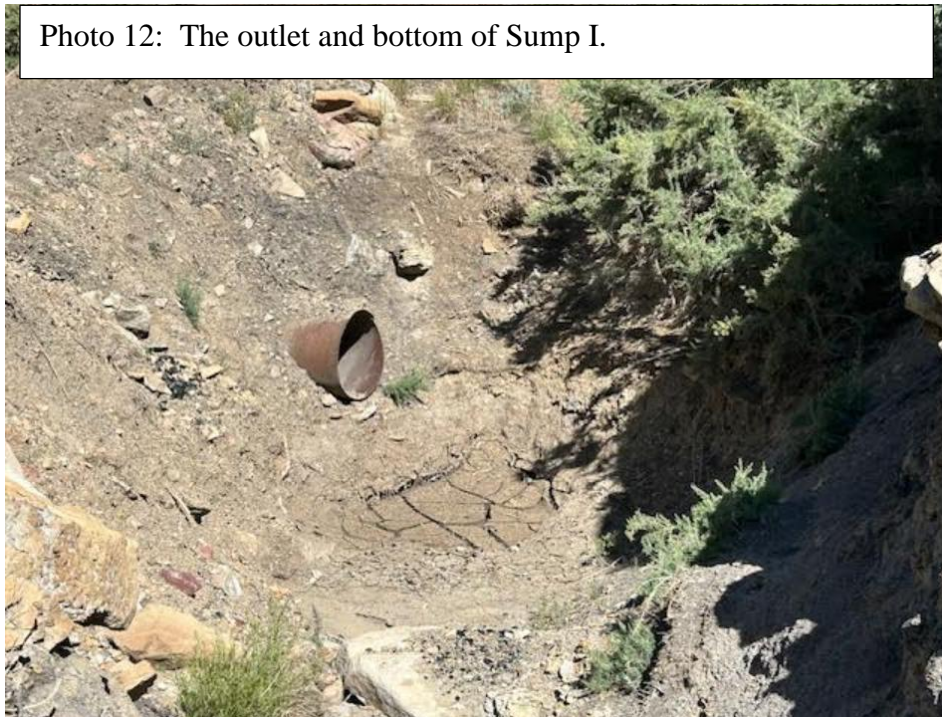
Sump I is located west of the lower bench of the portals area. The sump was dry and stable (Photo 12). The culvert outlet for the sump was unobstructed. No erosional features were identified.

Photo 12: The outlet and bottom of Sump I.

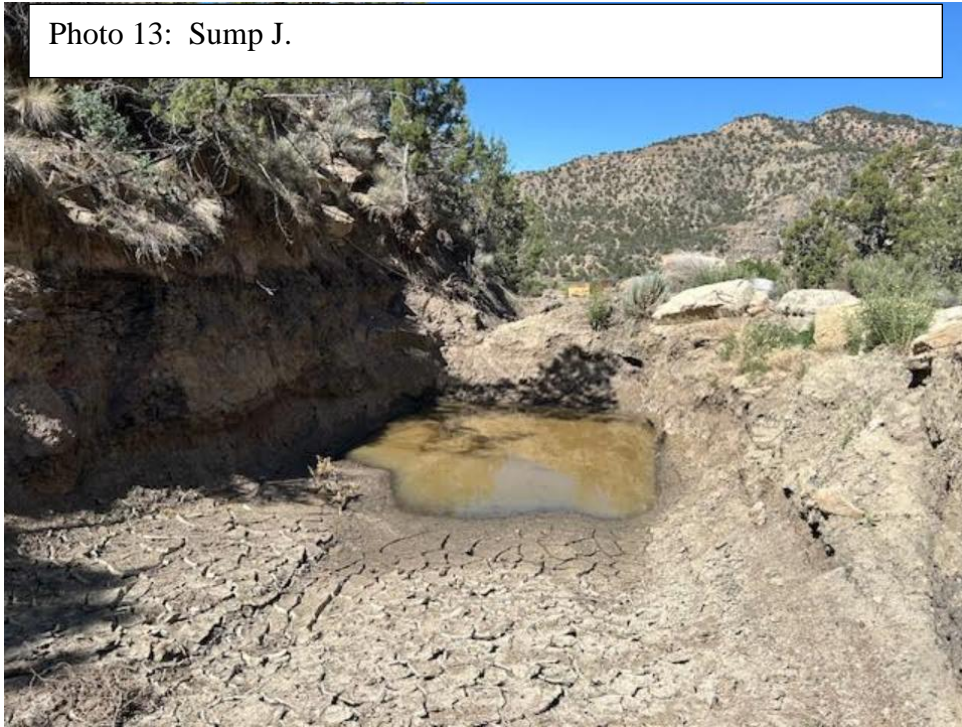
Sump J is located on the south side of the haul road to the east of the sediment pond. Water was being held in Sump J below the discharge outlet (Photo 13). The outlet channel was clear of debris. Sump J was stable with no erosional features.

Photo 13: Sump J.

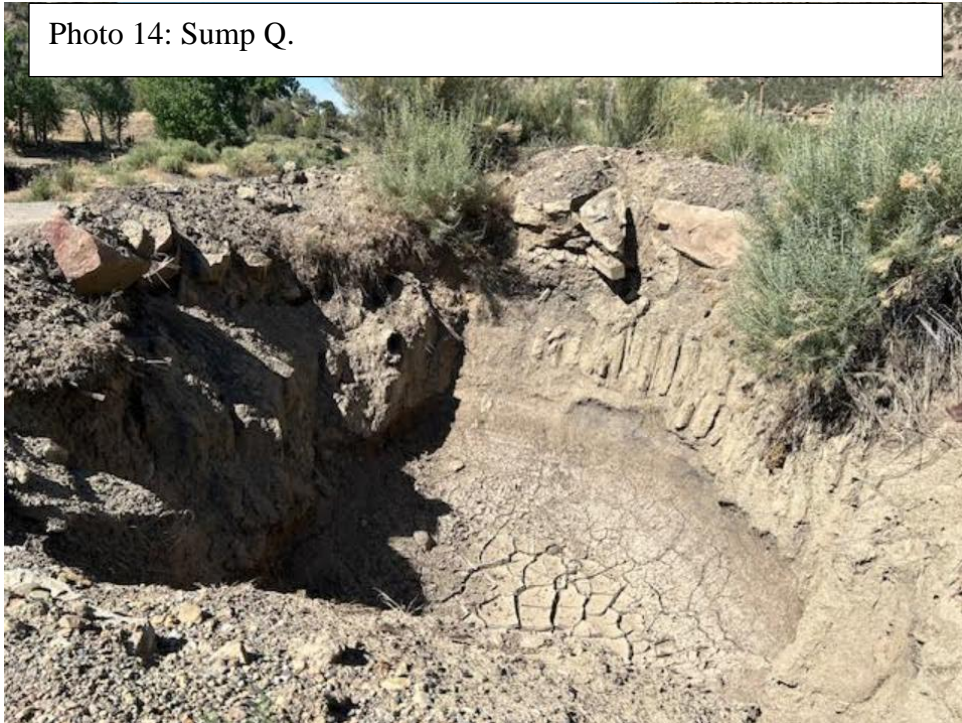
Sump Q was not holding any water (Photo 14). The culvert outlet was clear. Sump Q was stable and had no erosional features.

Photo 14: Sump Q.

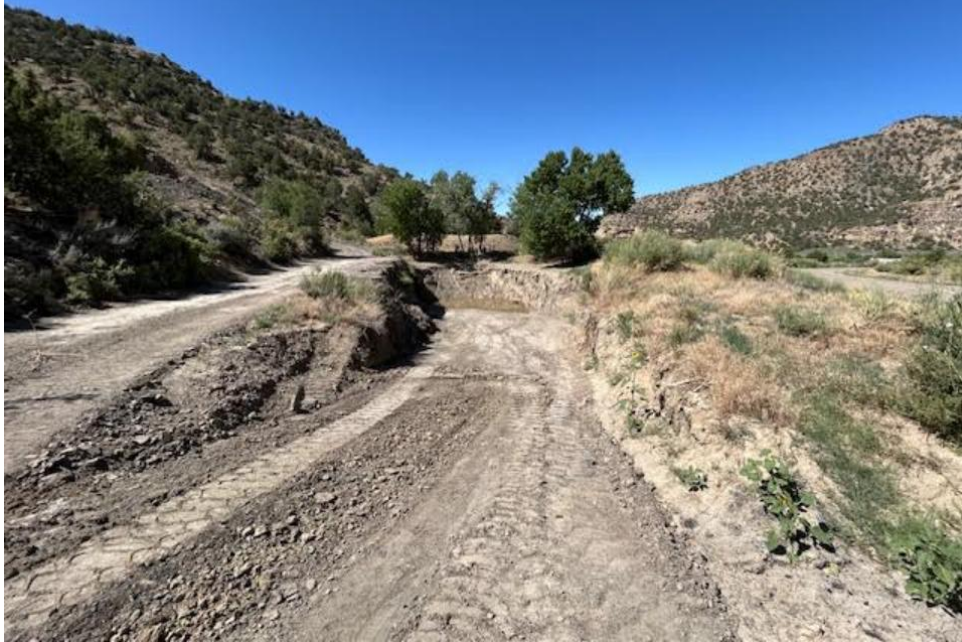
The sediment pond was holding a small puddle of water in it during the inspection (Photo 15). The sediment pond had been cleaned about 90% prior to the date of the inspection. Cleaning will continue as soon as conditions allow the equipment to safely access the remaining material. The primary discharge pipe was clear of debris. The emergency discharge channel was clear of obstructions. The embankment for the pond was stable with vegetative cover. No erosional features identified.

Photo 15: The sediment pond looking to the southwest.

Continued maintenance of the sediment control structures was being conducted as conditions allow. If the sediment gets too damp the equipment runs the risk of getting stuck. **Please continue to clean the sediment control structures as needed and when conditions allow to ensure proper functionality is continued.**

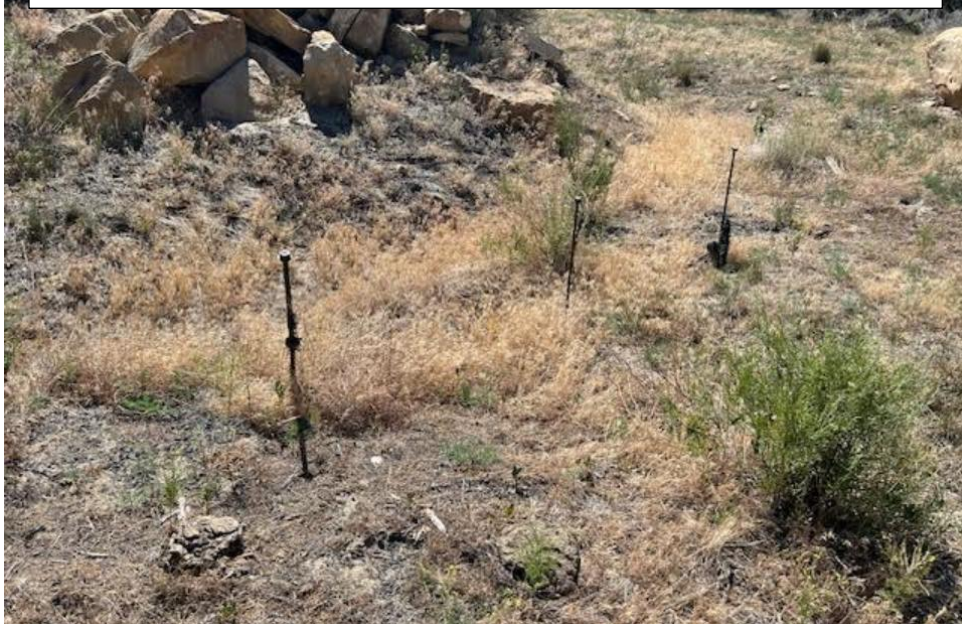
The subsoil stockpile was stable with vegetative cover. There were no erosional concerns identified. The perimeter berm was stable and vegetated. The silt fence at the outlet of the sump on the west side of the pile was torn off and gone (Photo 16). The operator's representative replaced the silt fence on the sump that day (Photo 17).

Photo 16: The torn and missing silt fence at the subsoil stockpile sump.

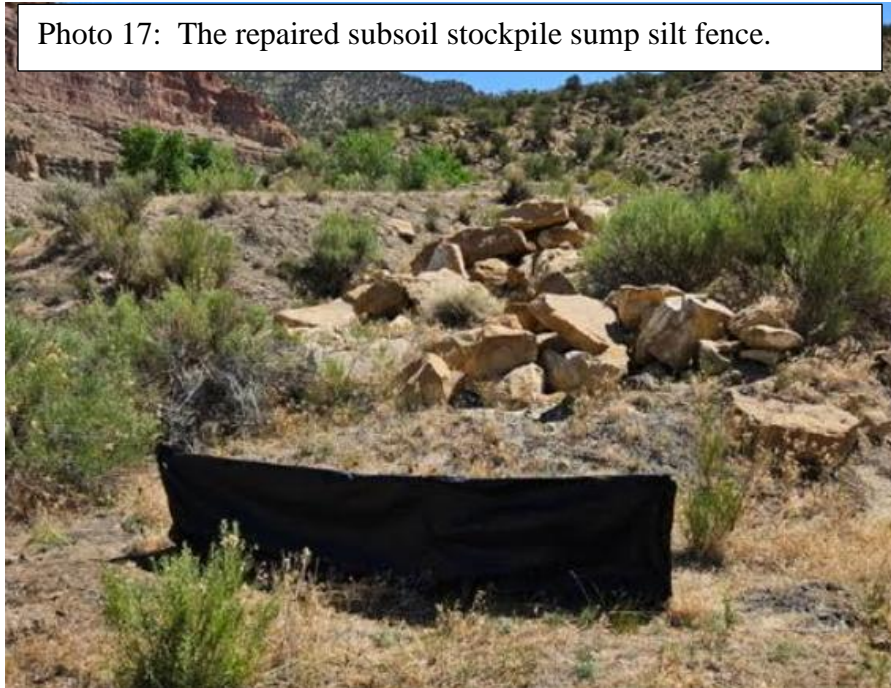
Photo 17: The repaired subsoil stockpile sump silt fence.

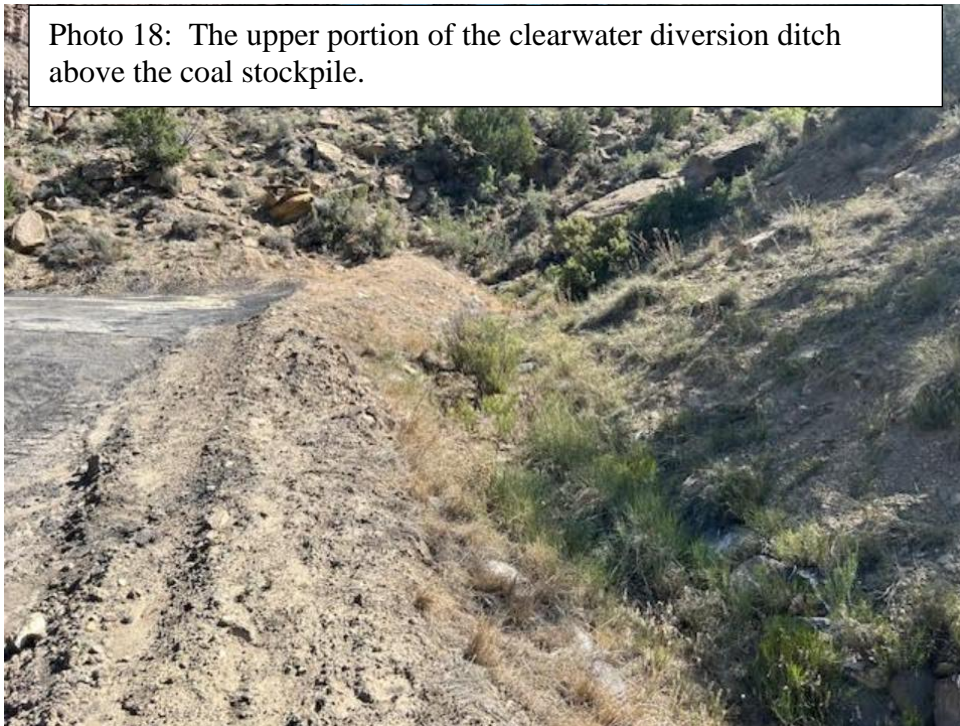
The coal waste pile had a sediment stockpile placed on it from the material cleaned out of the sediment pond. The sediment stockpile was observed to be stable. There were no erosional concerns identified. The clear water diversion ditch on the east side of the pile was dry and stable (Photo 18). There were no indications of erosion.

Photo 18: The upper portion of the clearwater diversion ditch above the coal stockpile.

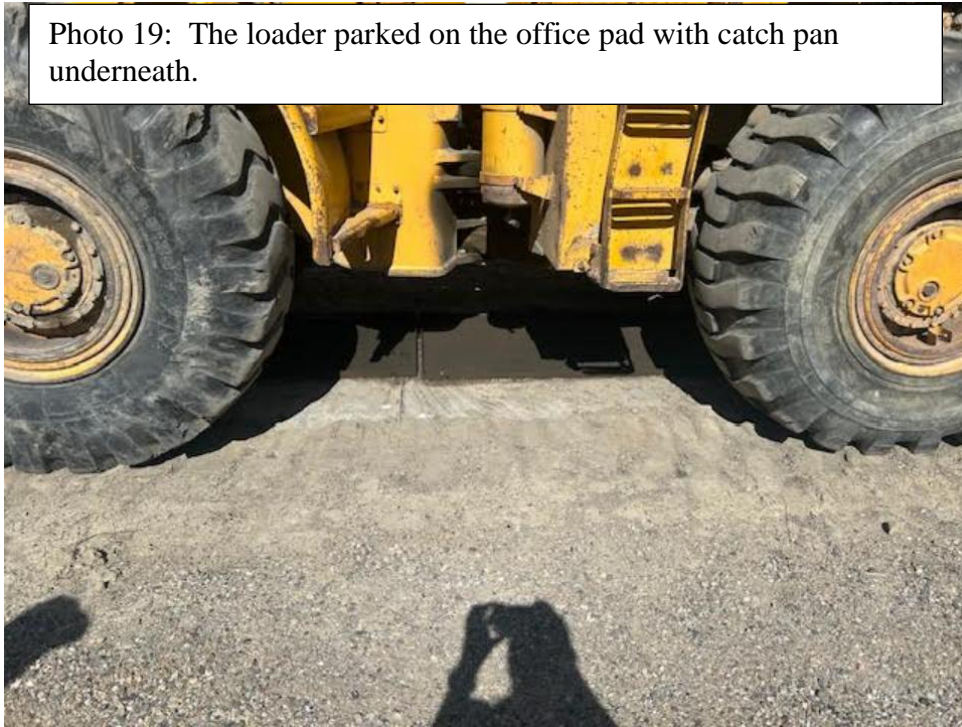
The office pad is on the east side of East Salt Creek. The pad was stable with no erosional features. All hydrocarbons were placed in the appropriate secondary containment and catch pans were spotted underneath the

parked equipment (Photo 19). The berm surrounding the pad was stable with vegetative cover. All mine equipment was organized on the pad (Photo 20)

Photo 19: The loader parked on the office pad with catch pan underneath.

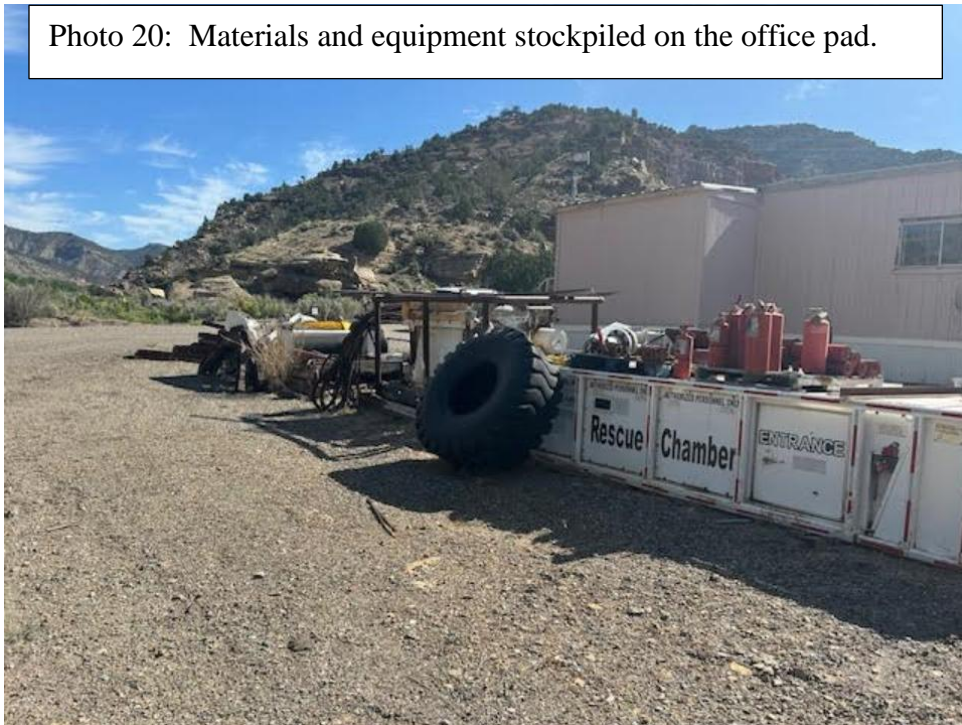
Photo 20: Materials and equipment stockpiled on the office pad.

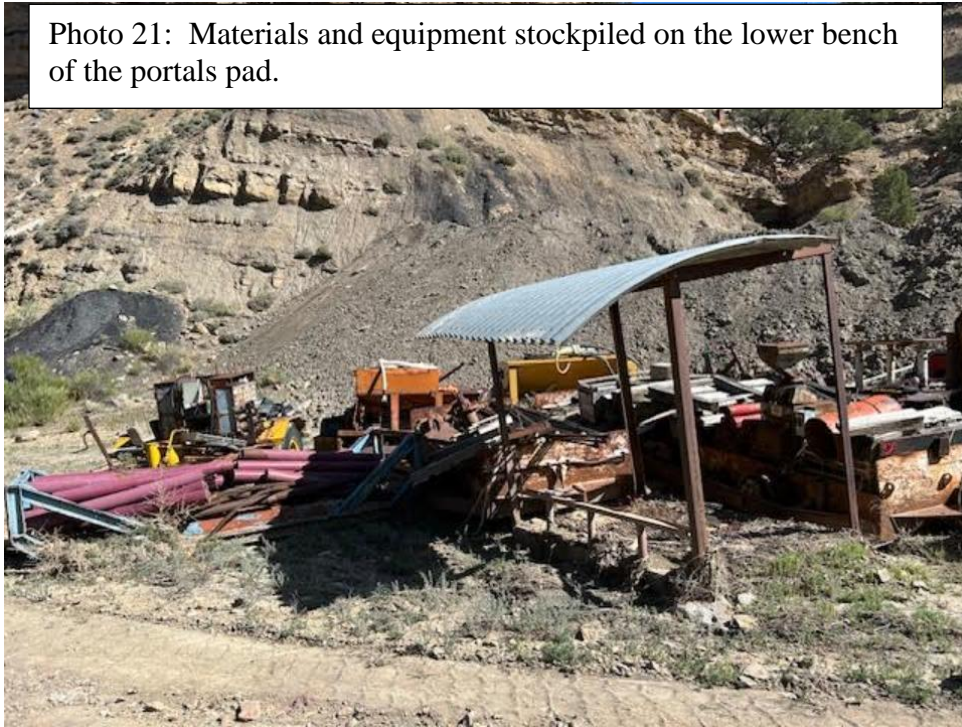
At the portals bench, mine materials were placed in the respective laydown areas (Photo 21). A catch pan was seen beneath the loader parked by the shop. The pad was stable and there were no erosional concerns. Sediment was stockpiled on the middle portals bench. This material's permanent configuration will be addressed with the current TR-20 revision.

Photo 21: Materials and equipment stockpiled on the lower bench of the portals pad.

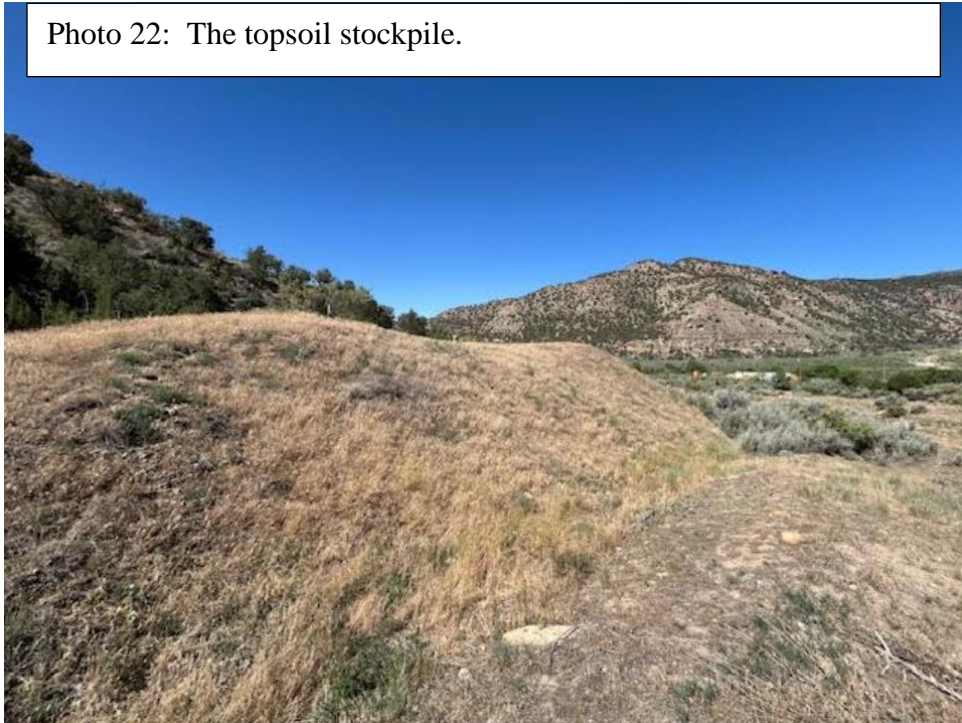
The topsoil stockpile is located on the southwest side of the sediment pond. The pile was covered with vegetation and stable (Photo 22). No indications of erosion were identified. The perimeter berm was also stable with vegetative cover. There was no loss of topsoil resource was observed. The topsoil pile marker was posted on top of the stockpile in an easy to identify location.

Photo 22: The topsoil stockpile.
