**MINERALS PROGRAM INSPECTION REPORT**  
**PHONE: (303) 866-3567**

<b>MINE NAME:</b> Lehr Gravel Pit	<b>MINE/PROSPECTING ID#:</b> M-1983-213	<b>MINERAL:</b> Sand and gravel	<b>COUNTY:</b> Weld
<b>INSPECTION TYPE:</b> Monitoring	<b>WEATHER:</b> Cloudy	<b>INSP. DATE:</b> July 10, 2025	<b>INSP. TIME:</b> 10:00
<b>OPERATOR:</b> Weld County Public Works	<b>OPERATOR REPRESENTATIVE:</b> Nate Gibson	<b>TYPE OF OPERATION:</b> 112c - Construction Regular Operation	
<b>REASON FOR INSPECTION:</b> Normal I&E Program	<b>BOND CALCULATION TYPE:</b> None	<b>BOND AMOUNT:</b> \$0.00	
<b>DATE OF COMPLAINT:</b> NA	<b>POST INSP. CONTACTS:</b> None	<b>JOINT INSP. AGENCY:</b> None	
<b>INSPECTOR(S):</b> Patrick Lennberg	<b>INSPECTOR'S SIGNATURE:</b>

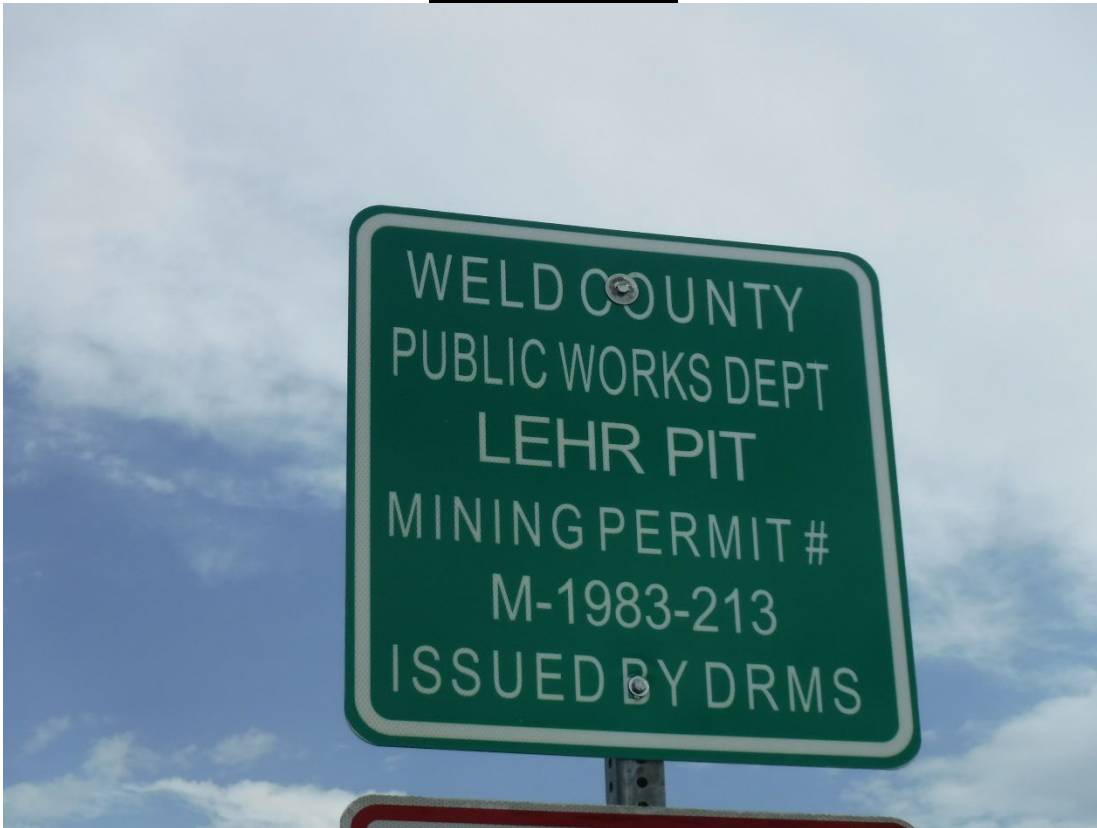
The site is 112c Construction Materials permit for 36.4 acres. The permit area is in Weld County, approximately 11 miles north northwest of Nunn. The site is accessed to the north of Weld County Road (WCR) 120 about 1.8 miles west of the intersection of WCR 120 and US Route 85 (CanAm Highway). The post-mining land use for this site is rangeland. The permit area and affected lands are owned by L.G. Everist Materials. A mine sign was posted along the primary mine entrance as required by Rule 3.1.12.

**Photo 1:** Mine sign at primary mine entrance

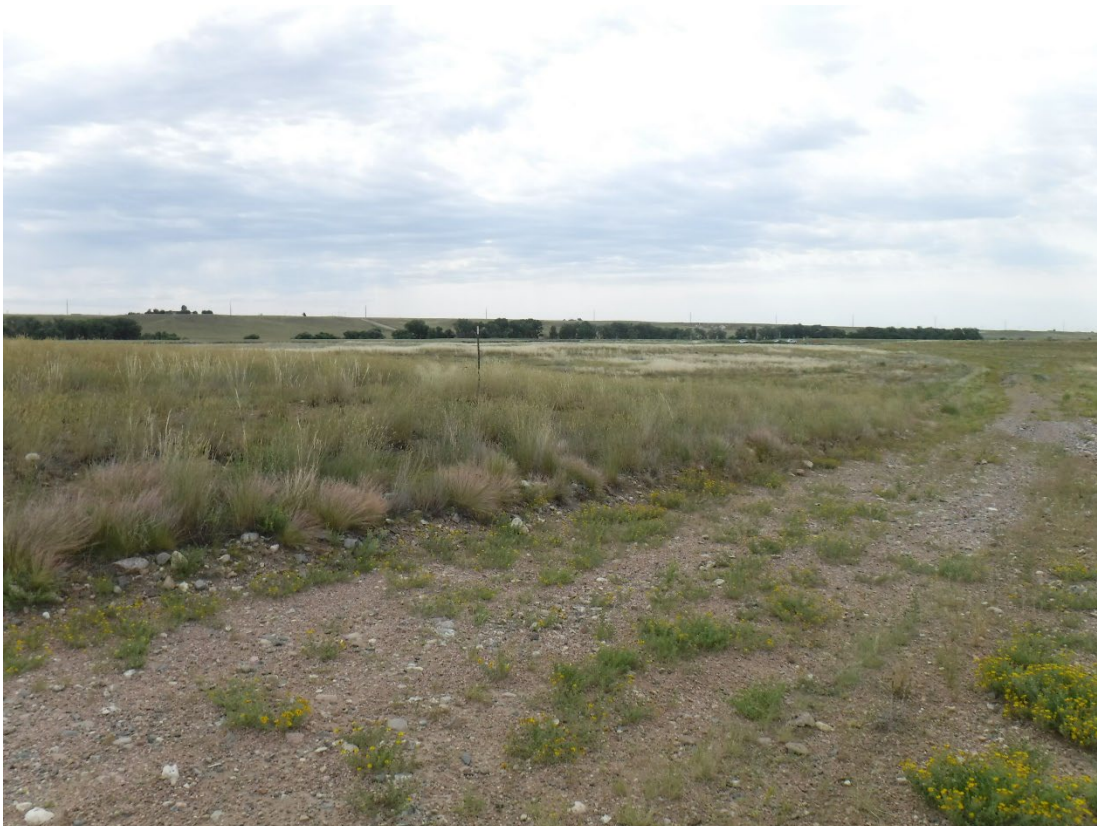
The site has been in final reclamation since 2012 with the first round of seeding being completed in 2013. In 2016 the Division approved Technical Revision 1 which approved the haul road to remain after the completion of reclamation for use by the landowner. The haul road is slowly being naturally reclaimed.

**Photo 2:** Haul road and permit boundary marker

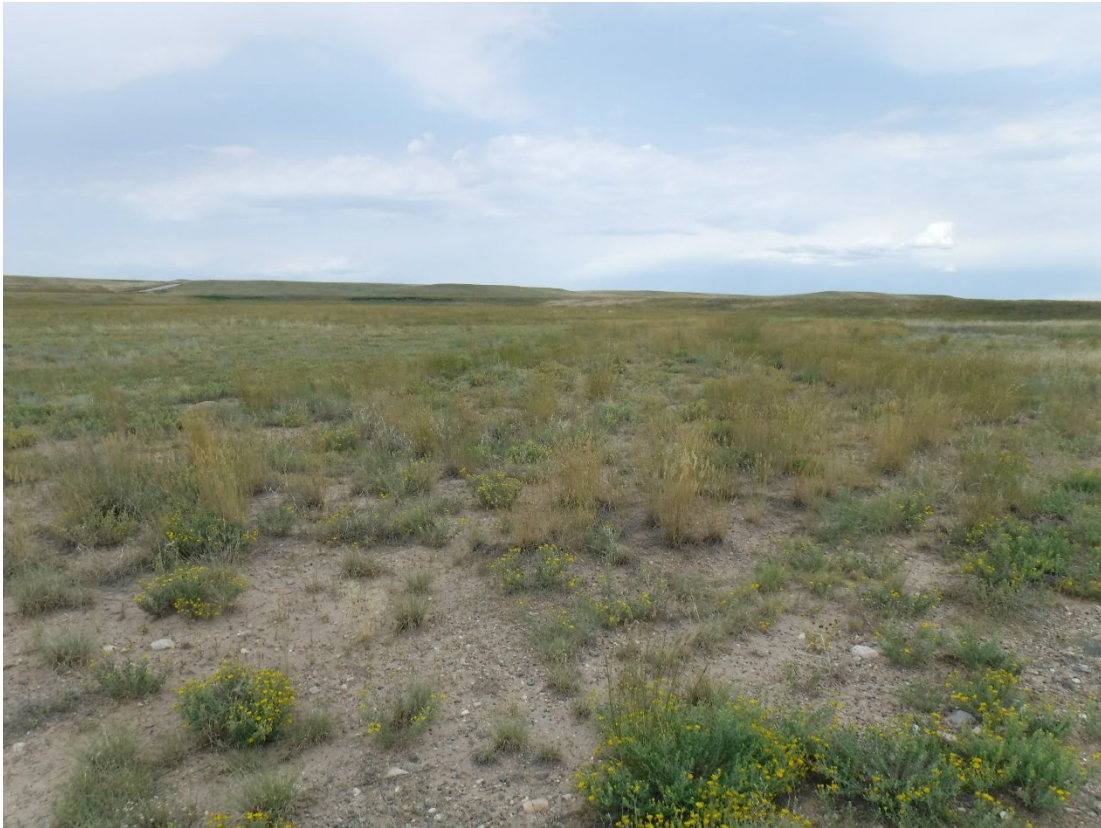
**Photo 3:** Looking west across the reclaimed pit area

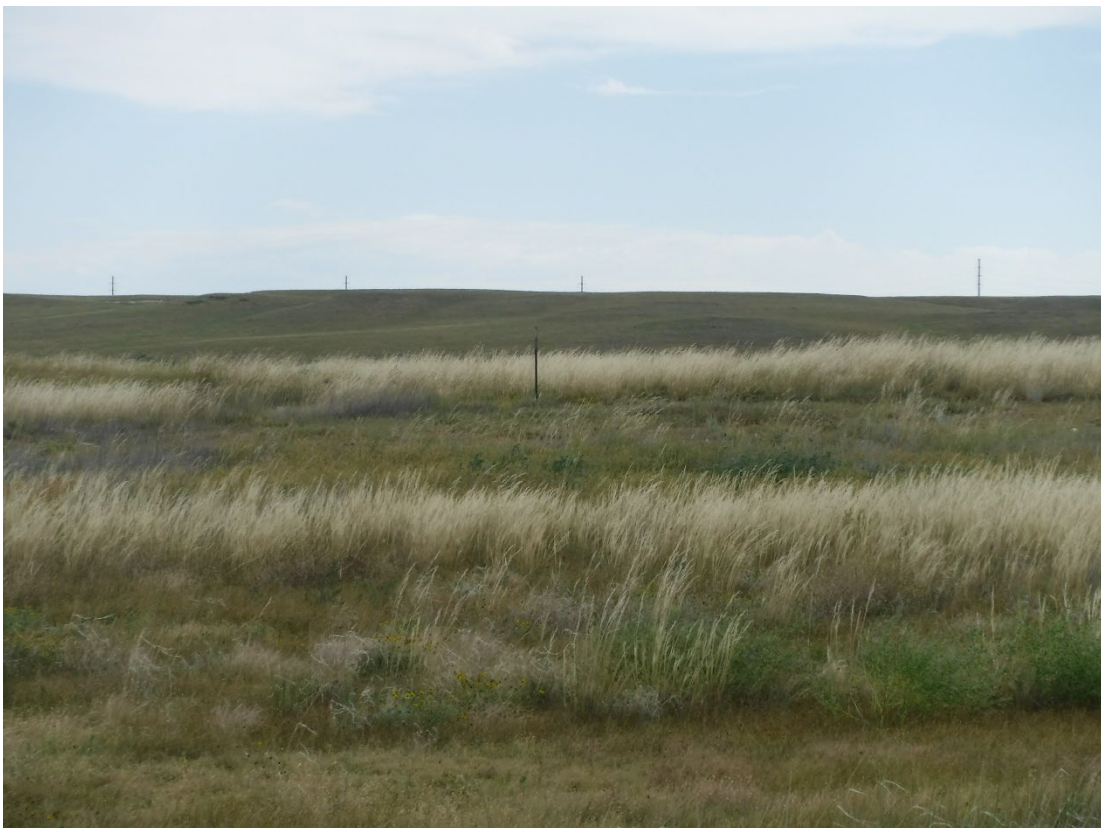
**Photo 4:** Looking east at the eastern permit boundary

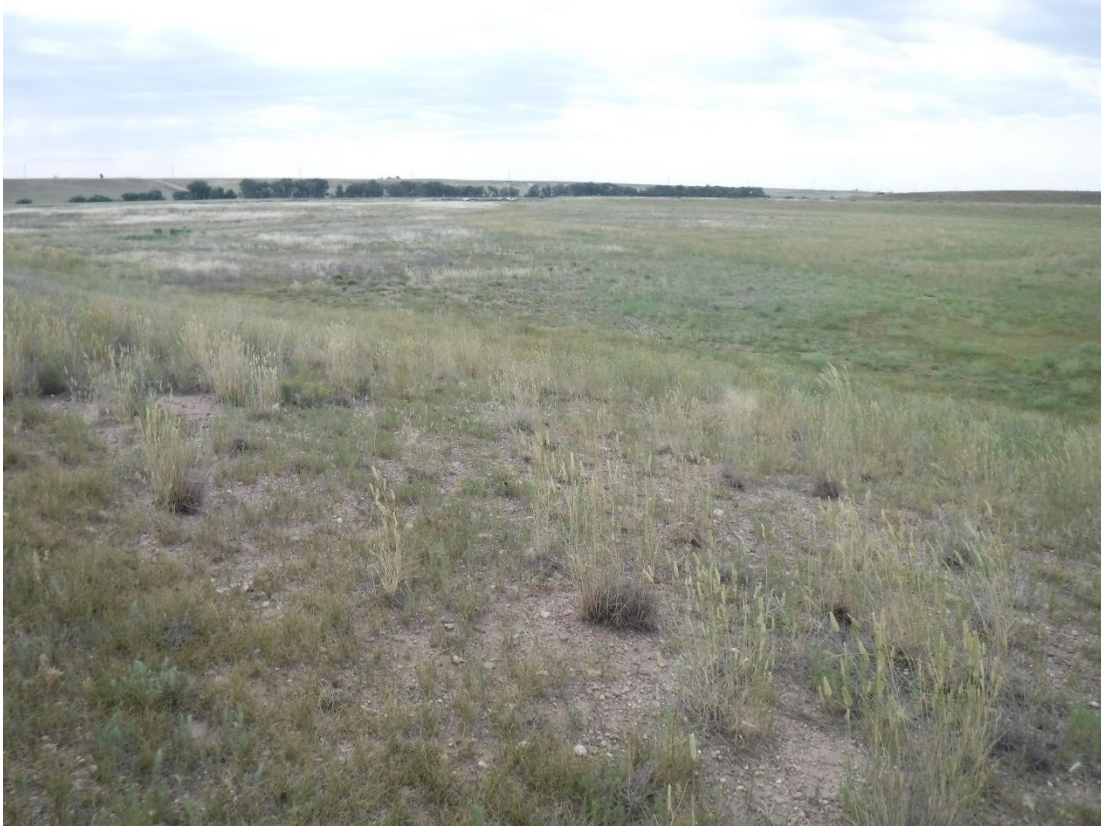
**Photo 5:** Looking southeast across the permit area towards the mine entrance

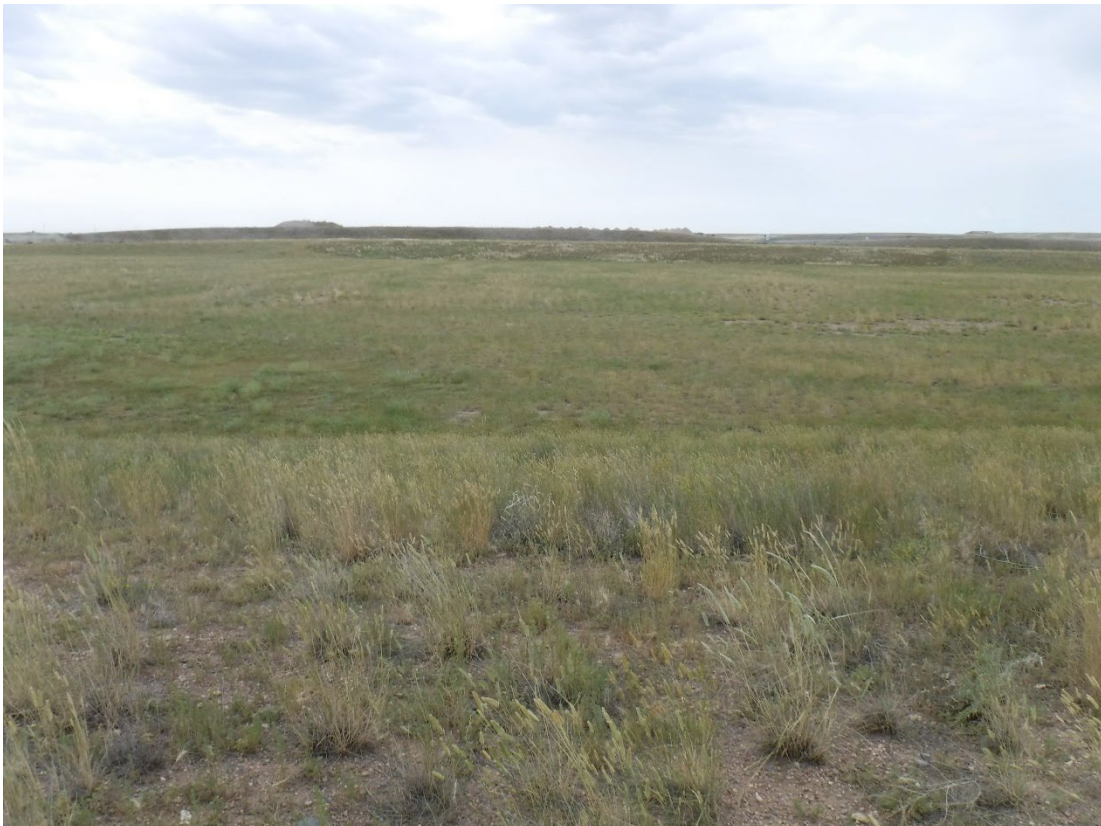
**Photo 6:** Looking south across the permit area, Koskie permit in the background

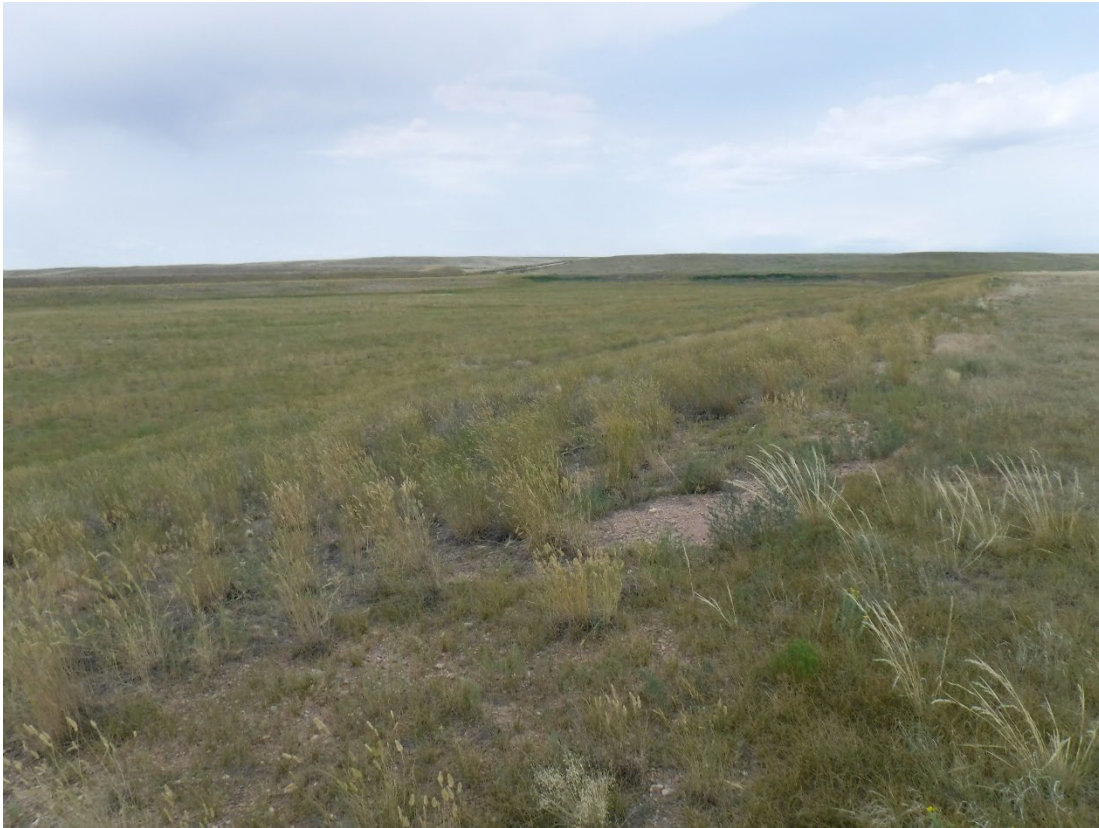
**Photo 7:** Looking southwest across the permit area

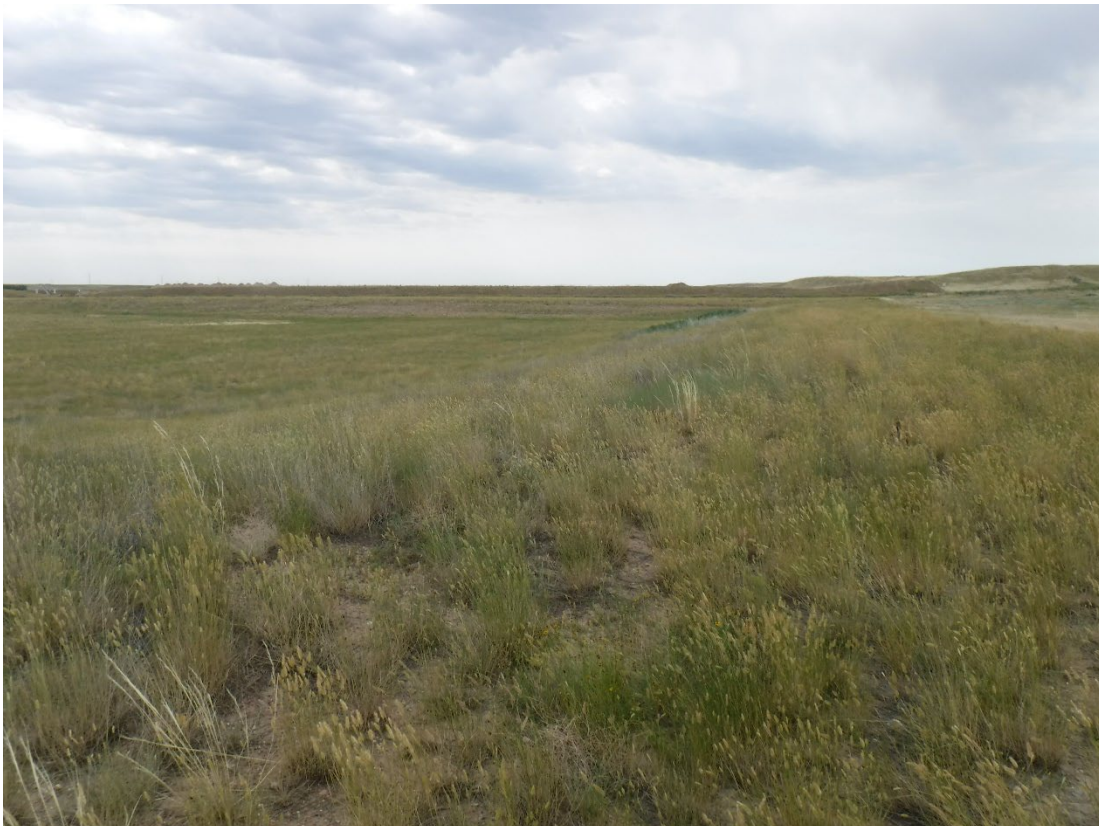
**Photo 8:** Western slope of mined area

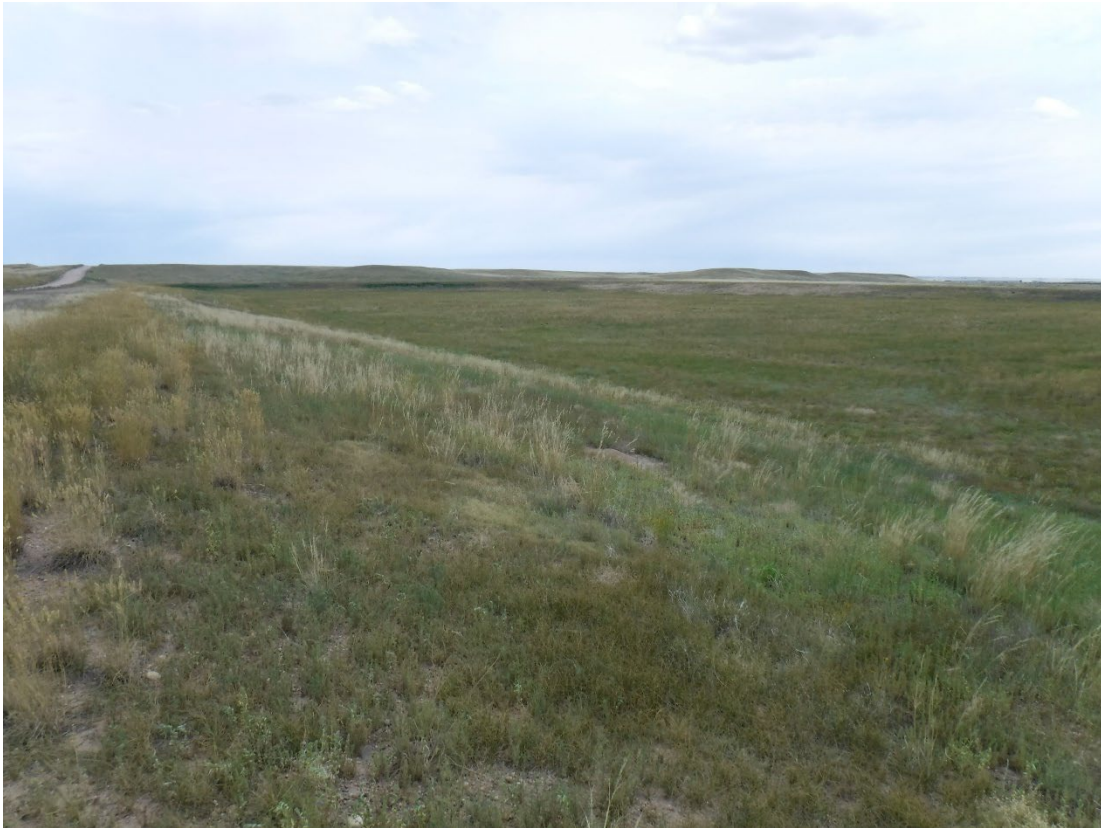
**Photo 9:** Looking northwest across the permit area

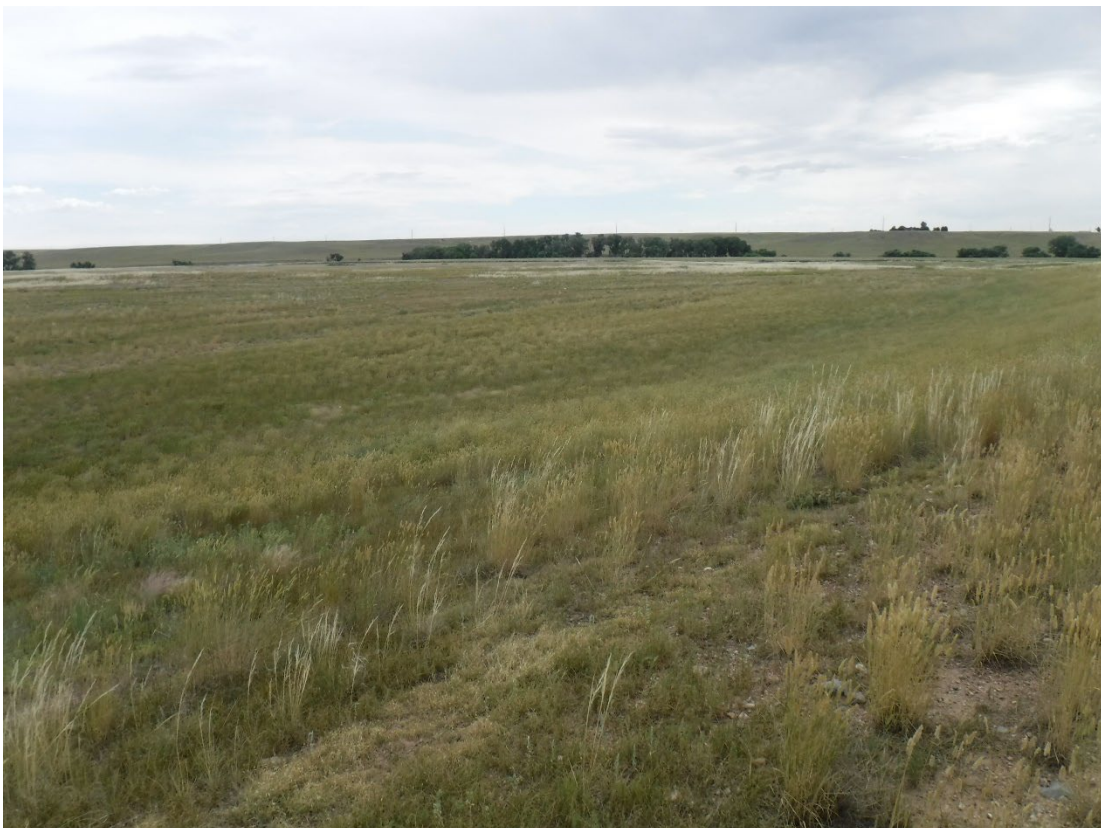
**Photo 10:** Looking northeast across the permit area
