**MINERALS PROGRAM INSPECTION REPORT**  
**PHONE: (303) 866-3567**

<b>MINE NAME:</b> Blair Mesa Pit	<b>MINE/PROSPECTING ID#:</b> M-1996-082	<b>MINERAL:</b> Sand and gravel and borrow material	<b>COUNTY:</b> Rio Blanco
<b>INSPECTION TYPE:</b> Surety Release Inspection	<b>WEATHER:</b> Clear	<b>INSP. DATE:</b> July 3, 2025	<b>INSP. TIME:</b> 09:00
<b>OPERATOR:</b> Oldcastle SW Group, Inc. dba United Companies of Mesa County	<b>OPERATOR REPRESENTATIVE:</b> Jesse Farmer	<b>TYPE OF OPERATION:</b> 112c - Construction Regular Operation	
<b>REASON FOR INSPECTION:</b> Surety Release Requested	<b>BOND CALCULATION TYPE:</b> None	<b>BOND AMOUNT:</b> \$114,211.72	
<b>DATE OF COMPLAINT:</b> NA	<b>POST INSP. CONTACTS:</b> DRMS	<b>JOINT INSP. AGENCY:</b> None	
<b>INSPECTOR(S):</b> Amy Yeldell	<b>INSPECTOR'S SIGNATURE:</b>

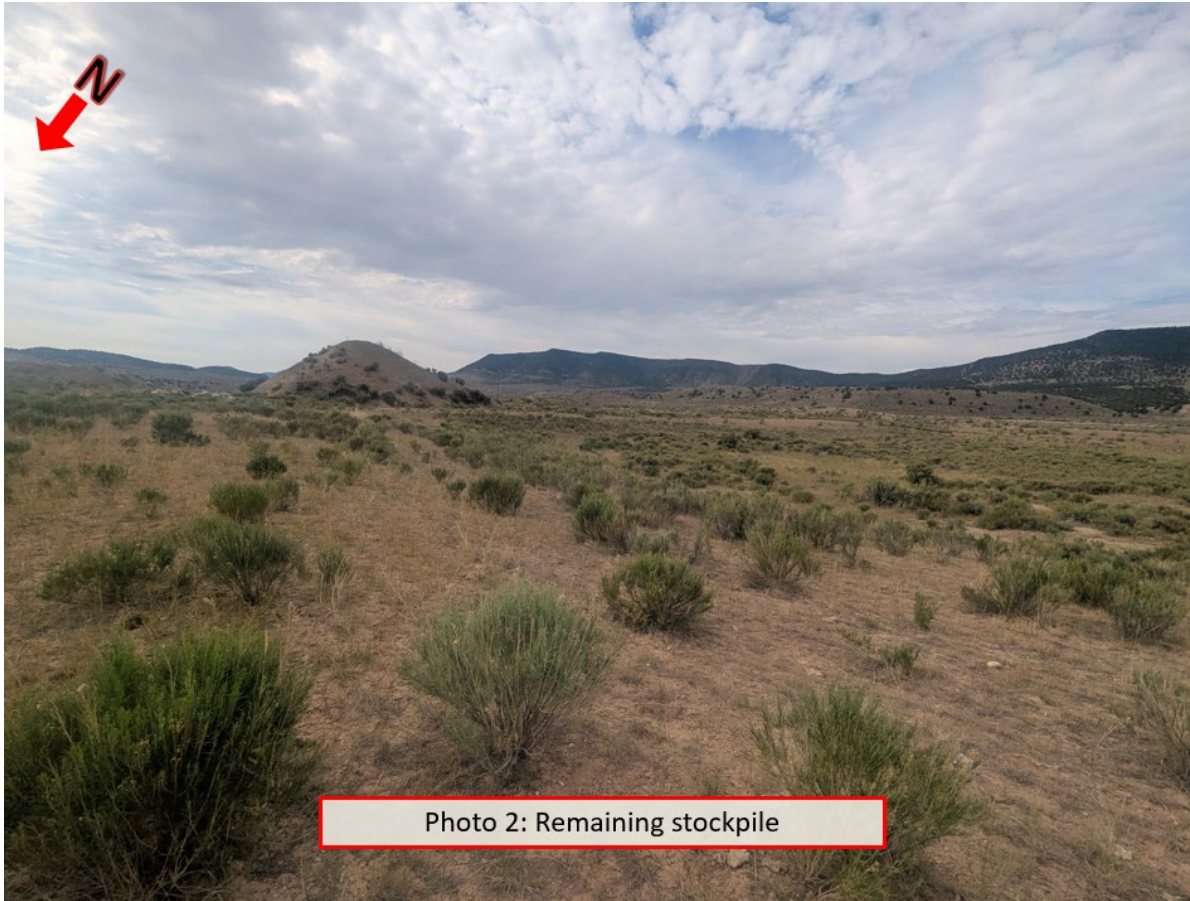
Three stockpiles of processed material remain on site. Mr. Farmer indicated this was per the landowner's request for future use on the ranch. While acceptable this condition has not been added to the permit and therefore the site does not match with the approved Reclamation Plan. In the form of a technical revision please submit a revision to the Reclamation Plan which details the estimated volume, material type and location of any stockpiles to remain. Additionally, please include an updated Reclamation Plan Map which depicts the current site conditions (as-built map). Once this TR is processed the Division can issue a decision on the SL-1 request.

Photo 2: Remaining stockpile

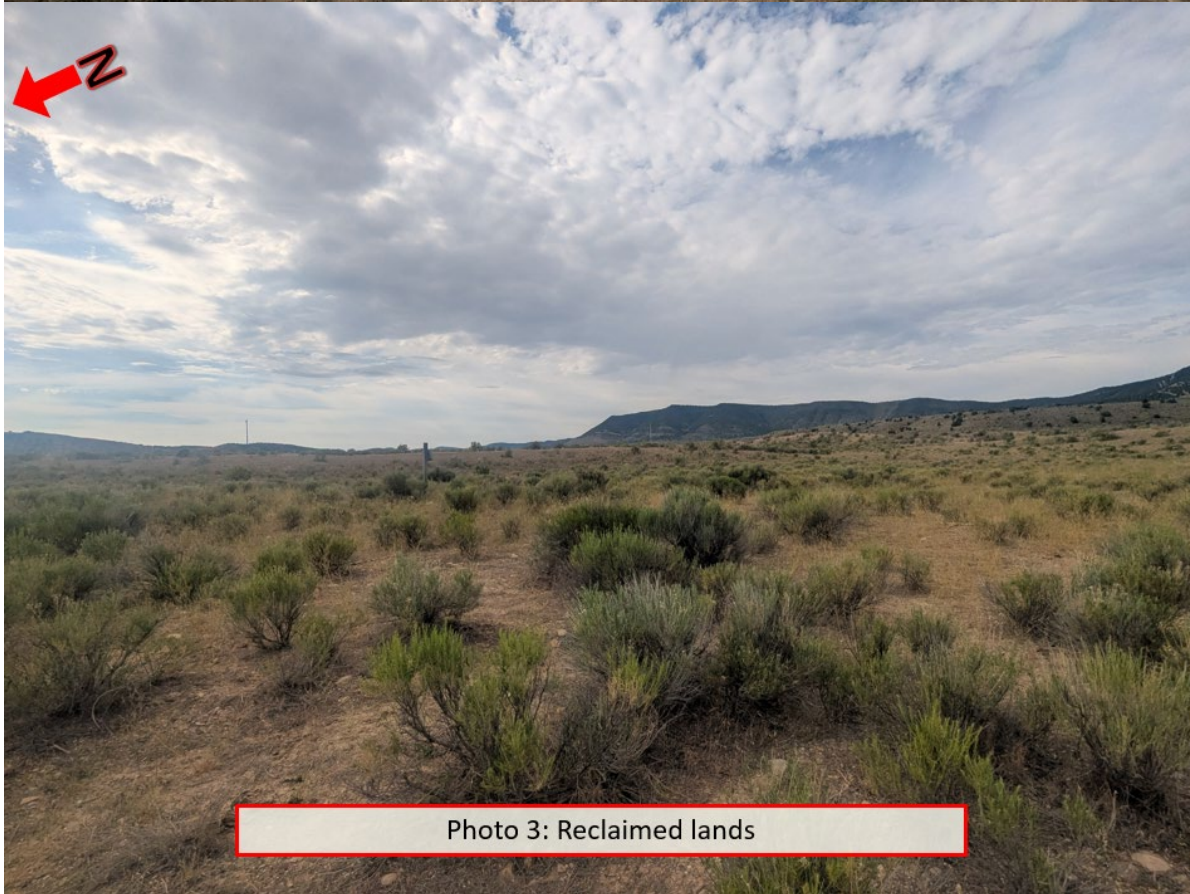
Over all the site has been successfully reclaimed. All contouring naturally blends with the surrounding topography. A diverse and sustainable mix of vegetation has been established, which includes shrub establishment. Vegetation density is comparable to the surrounding undisturbed areas. There are some signs of grazing, but it does not appear to be restricting reclamation success. No noxious weeds were observed.

Photo 3: Reclaimed lands
