MINERALS PROGRAM INSPECTION REPORT
PHONE: (303) 866-3567

MINE NAME: Berry Pit	MINE/PROSPECTING ID#: M-1977-132	MINERAL: Sand and gravel	COUNTY: Rio Blanco
INSPECTION TYPE: Monitoring	WEATHER: Clear	INSP. DATE: July 3, 2025	INSP. TIME: 08:30
OPERATOR: Oldcastle SW Group, Inc. dba United Companies of Mesa County	OPERATOR REPRESENTATIVE: Jesse Farmer	TYPE OF OPERATION: 112c - Construction Regular Operation	
REASON FOR INSPECTION: Normal I&E Program	BOND CALCULATION TYPE: Complete Bond	BOND AMOUNT: \$293,049.00	
DATE OF COMPLAINT: NA	POST INSP. CONTACTS: DRMS	JOINT INSP. AGENCY: None	
INSPECTOR(S): Amy Yeldell	INSPECTOR'S SIGNATURE:

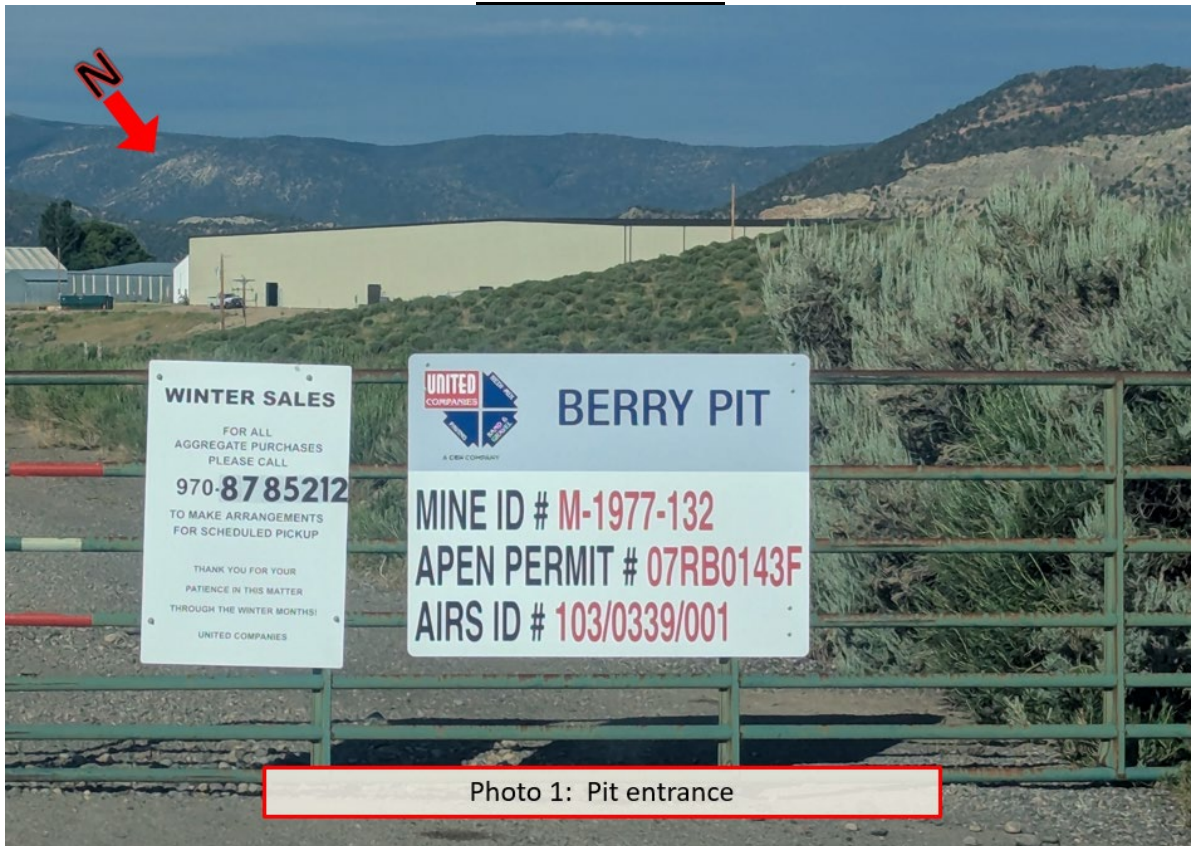
Photo 1: Pit entrance

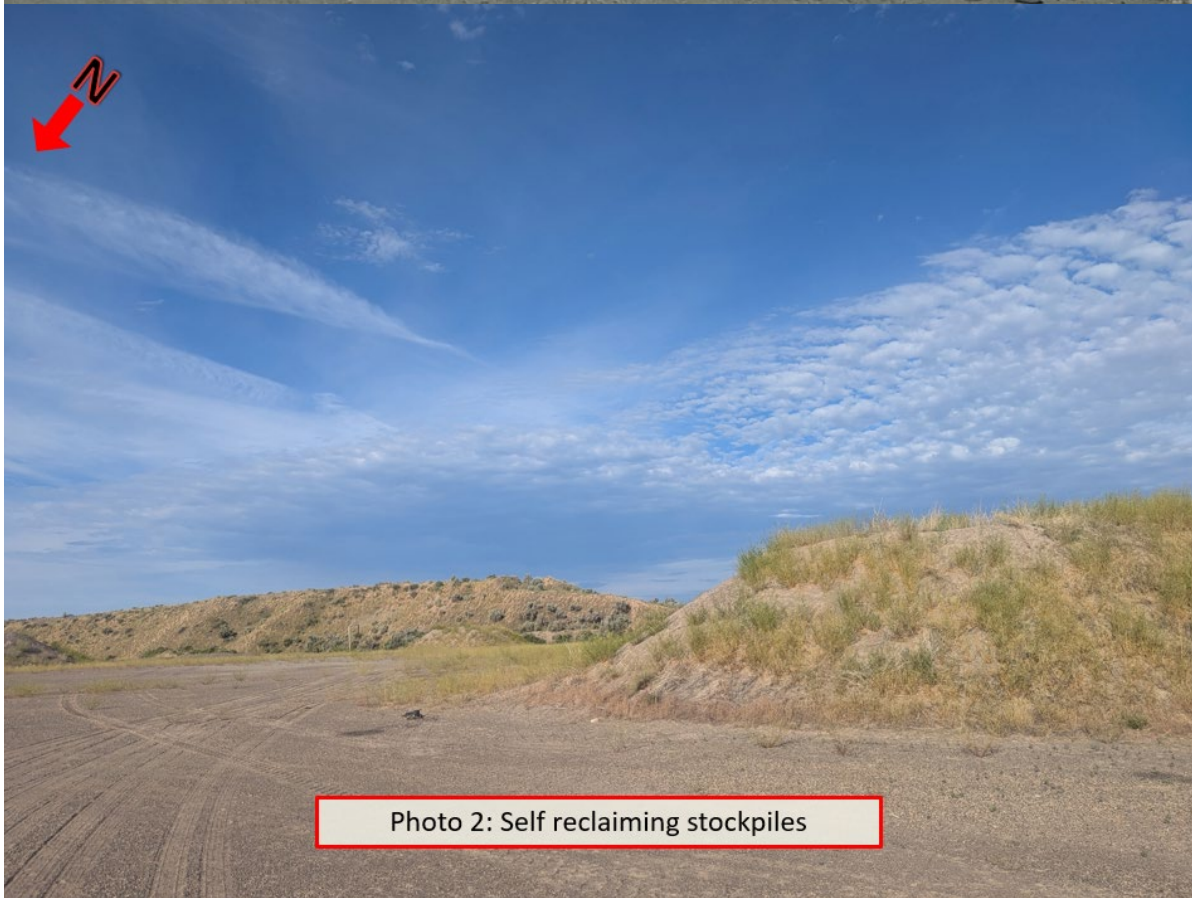
There appears to be minimal activity on site. The site has largely begun to self-reclaim (yellow sweet clover). Evidence of recent hauling from existing stockpiles is evident where vegetation is void. Highwalls all appear to be in similar condition as compared to the previous inspection. No additional excavations have been made. No equipment was on site.

Photo 2: Self reclaiming stockpiles

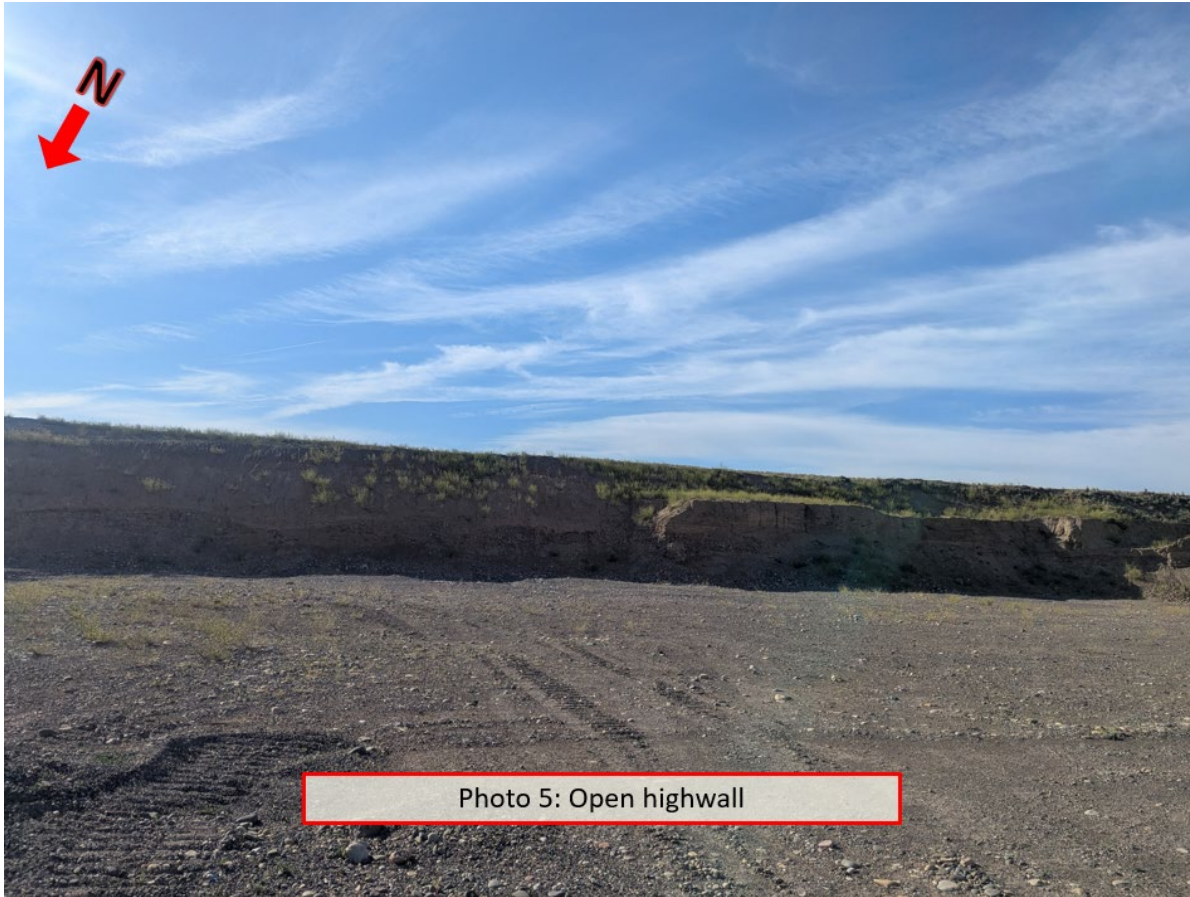
The pit is mined to approximately 40 feet deep. The active highwall is along the eastern side and is approximately 1000 linear feet and near vertical. The majority of the other highwalls in the pit are approximately a 2H: 1V. Most are a continual slope but some have an interstitial bench. Approximately half of the slopes have some sort of vegetation. The approved reclamation plan calls for slopes no greater than 2.5H: 1V so some additional grading may be needed. The pit floor is stabilized with gravel. A small pond was located along the southeast site of the permit boundary.

Photo 5: Open highwall

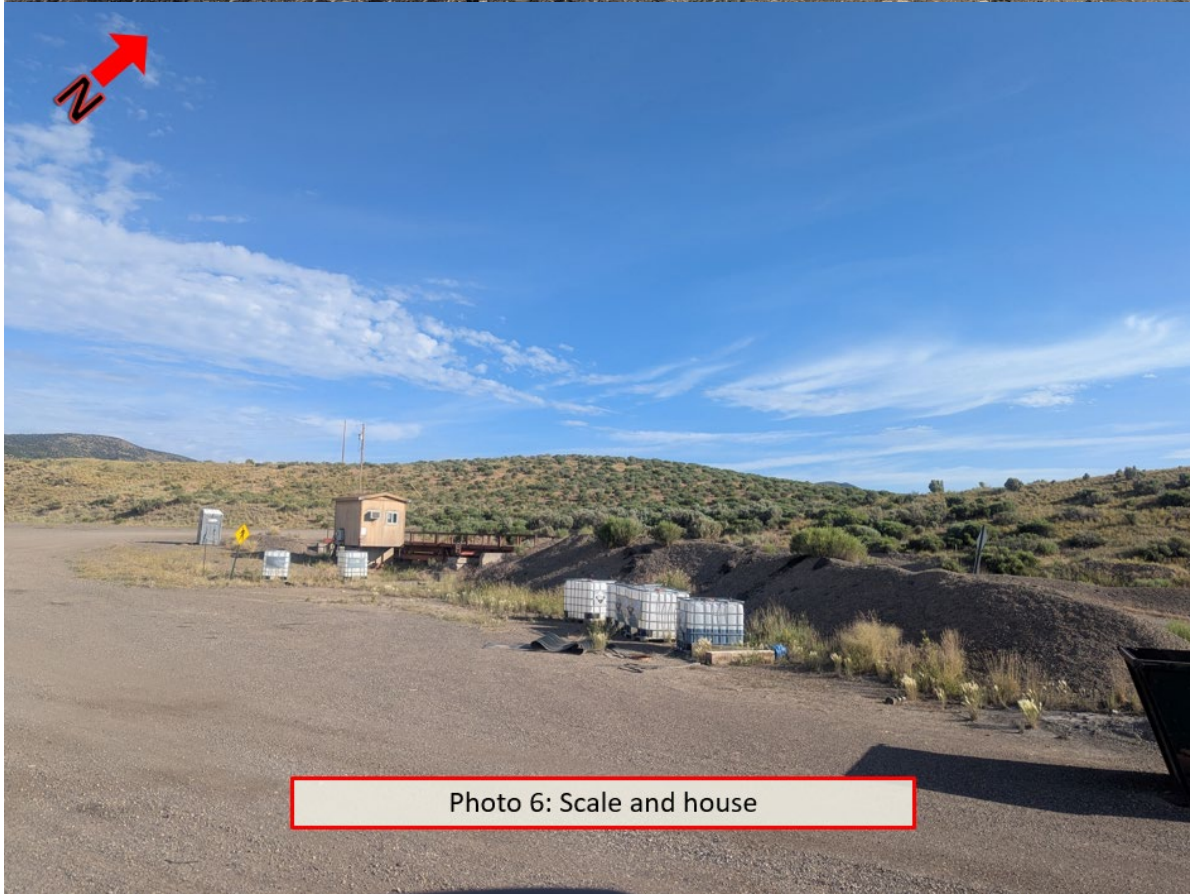
Scale and scale house remain on site.

Photo 6: Scale and house
