**MINERALS PROGRAM INSPECTION REPORT**  
**PHONE: (303) 866-3567**

<b>MINE NAME:</b> Diehl Borrow Pit	<b>MINE/PROSPECTING ID#:</b> M-2018-054	<b>MINERAL:</b> Borrow material for construction	<b>COUNTY:</b> Larimer
<b>INSPECTION TYPE:</b> Surety Release Inspection	<b>WEATHER:</b> Clear	<b>INSP. DATE:</b> June 10, 2025	<b>INSP. TIME:</b> 10:00
<b>OPERATOR:</b> SEMA Construction, Inc.	<b>OPERATOR REPRESENTATIVE:</b> Tyson Geist	<b>TYPE OF OPERATION:</b> 111 - Construction by Government Agency	
<b>REASON FOR INSPECTION:</b> Surety Release Requested	<b>BOND CALCULATION TYPE:</b> None	<b>BOND AMOUNT:</b> \$88,112.00	
<b>DATE OF COMPLAINT:</b> NA	<b>POST INSP. CONTACTS:</b> None	<b>JOINT INSP. AGENCY:</b> None	
<b>INSPECTOR(S):</b> Jocelyn Carter Amy Eschberger	<b>INSPECTOR'S SIGNATURE:</b>

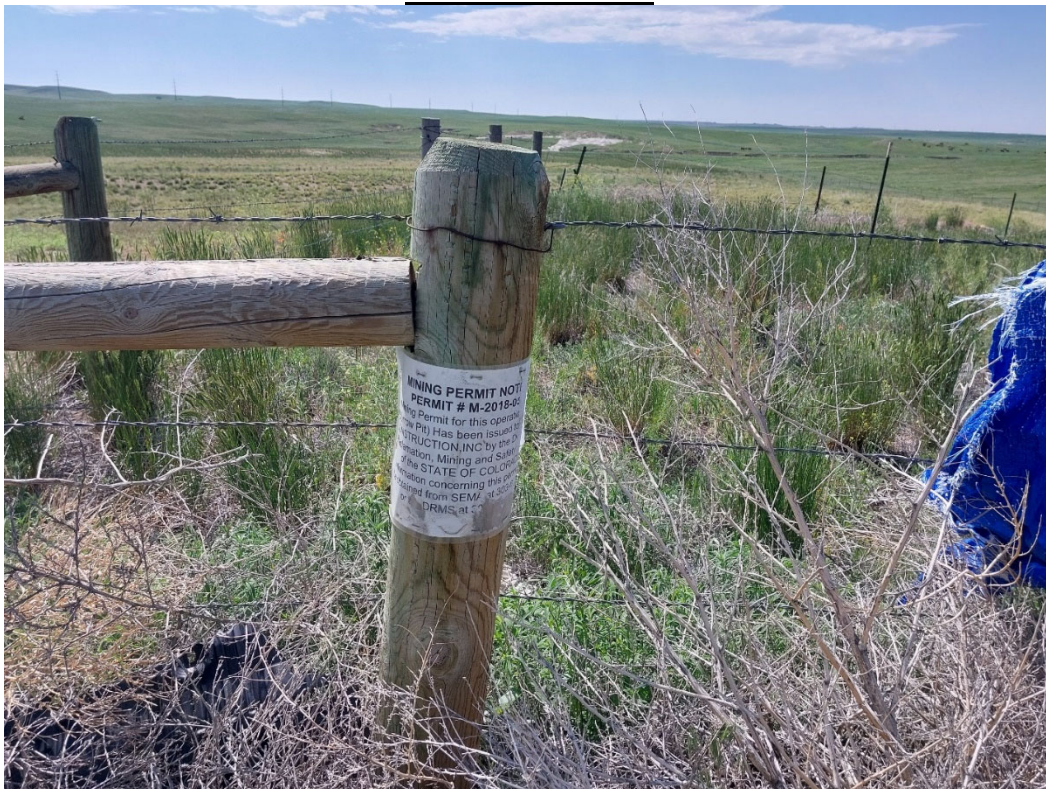
A mine sign was posted at the south entrance of the site.

Photo #1: Mine sign posted at the south entrance of the permit site.

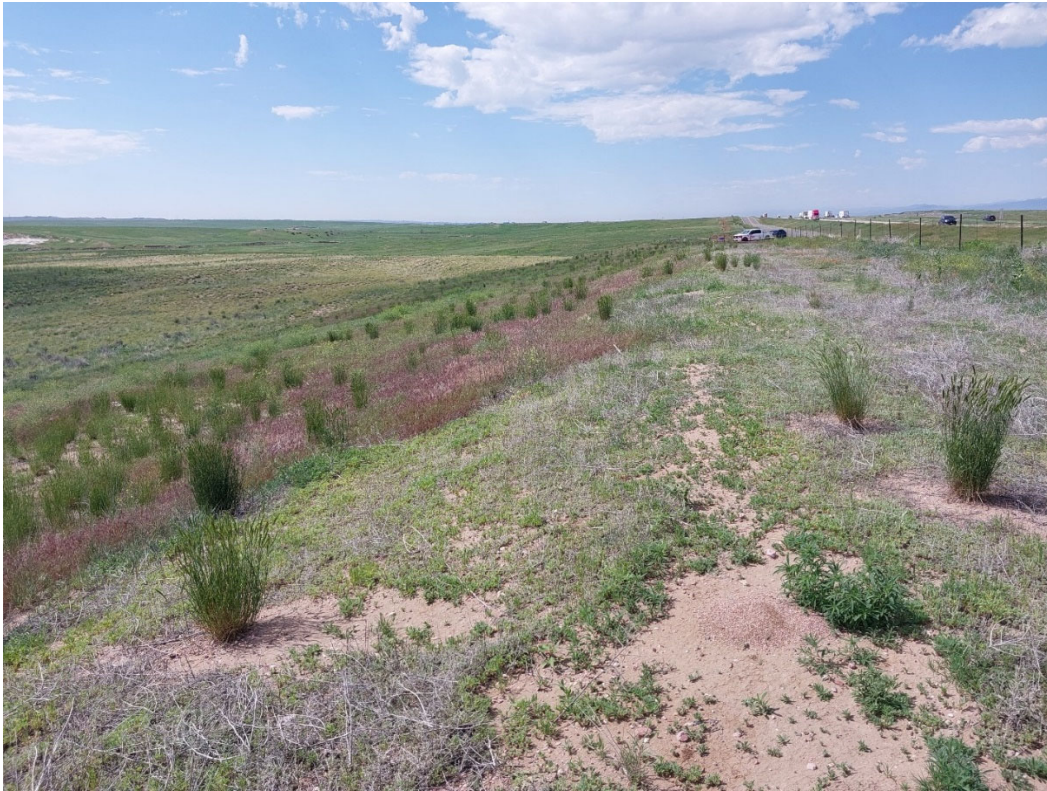
Photo #2: View of the reclaimed south gravel pit from the southcentral western boundary, looking south. The I-25 Frontage Road and I-25 can be seen in the right background of the photo. The slope is at a 3H:1V slope with diverse vegetation and an ant hill can be seen in the right foreground of the photo.

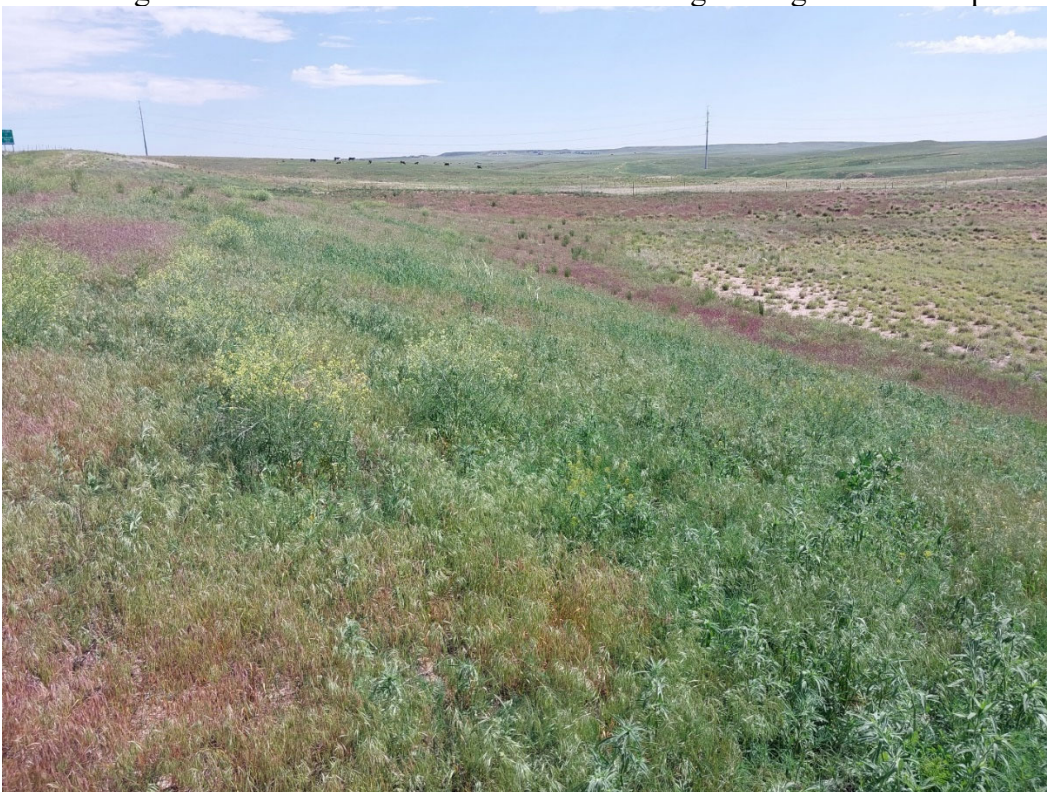
The slopes of the north and south gravel pits appear to have been backfilled and graded to a slope of 3H:1V with the pit floors roughly graded.

Photo #3: View of the reclaimed south gravel pit from the southcentral western boundary, looking northeast. The pit slopes are at a 3H:1V grade, or less, and are stable with well-established and diverse vegetation.

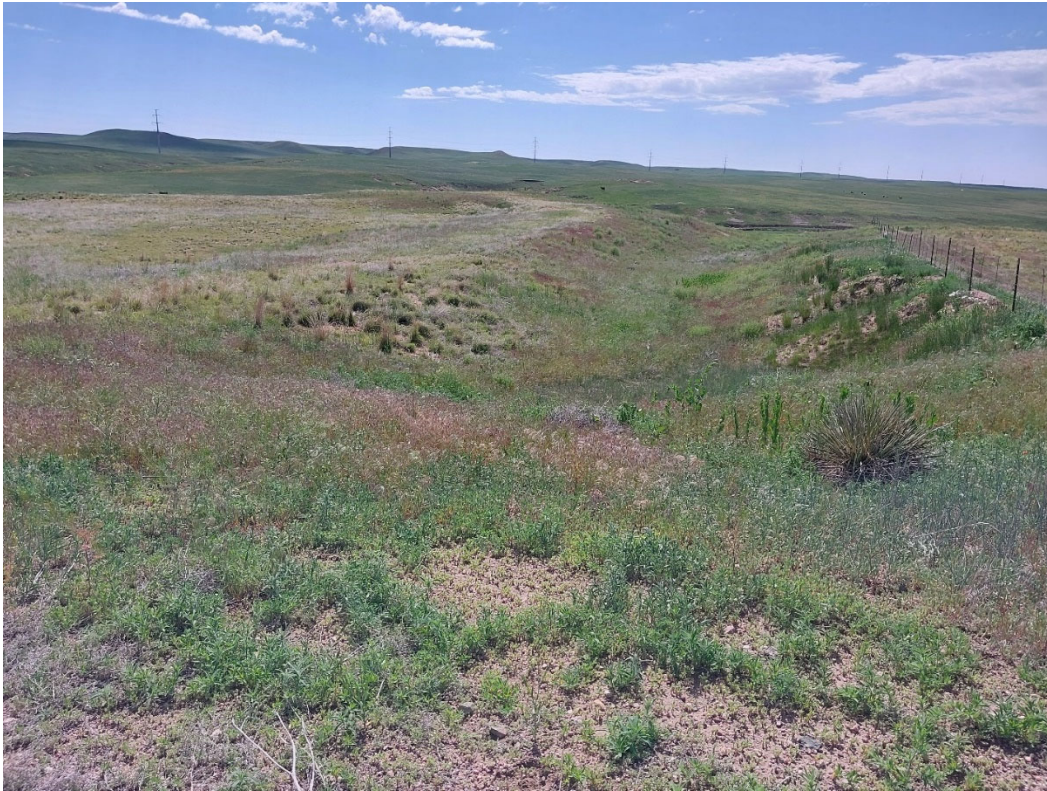
There did not appear to be an issue with the hydrologic balance on the site. There is a drainage that separates the north pit from the south pit; it appeared to be in good condition.

Photo #4: View of the drainage way between the reclaimed north and south gravel pits, looking east.

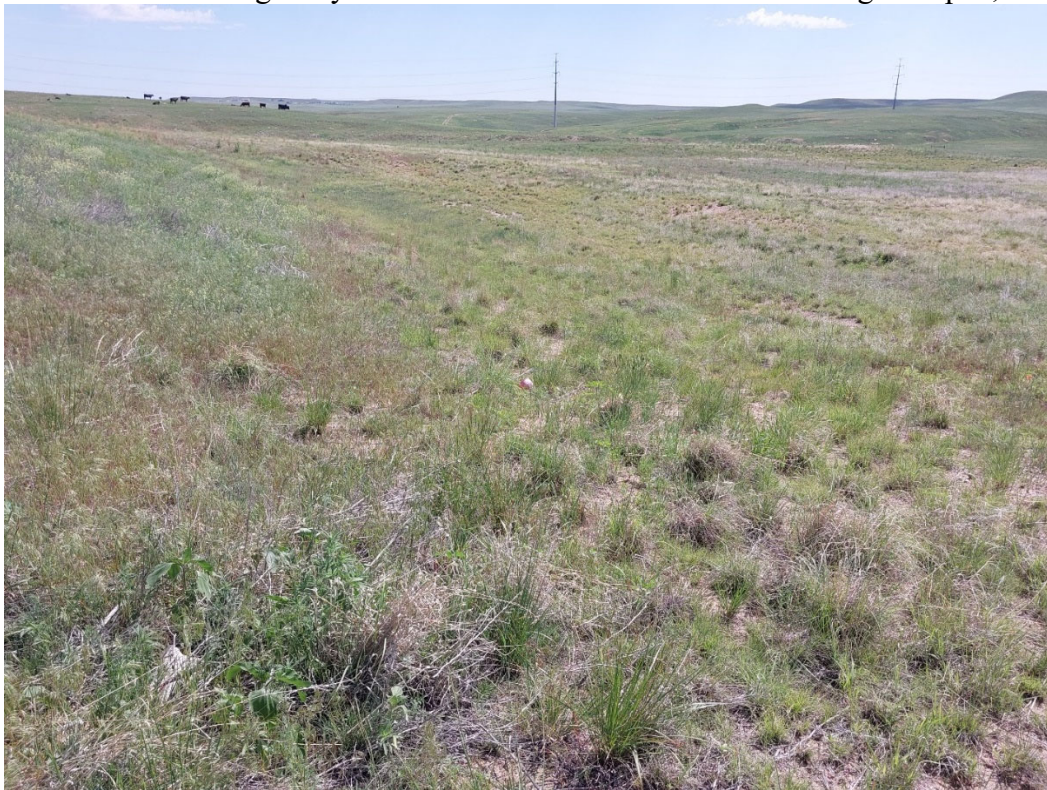
During the time of the inspection, the area appeared to be primarily inhabited by insects, horned lizards were also observed to be inhabiting the area. It appeared that cattle had been able to access the north pit, however, there was no evidence that cattle in the south pit.

Photo #5: View of the reclaimed north gravel pit from the southwestern portion of the pit, north of the drainage way, looking to the northeast. The cattle on the horizon are north of the permit boundary. The slope of the pit is 3H:1V or less and is stable with well-established and diverse vegetation.

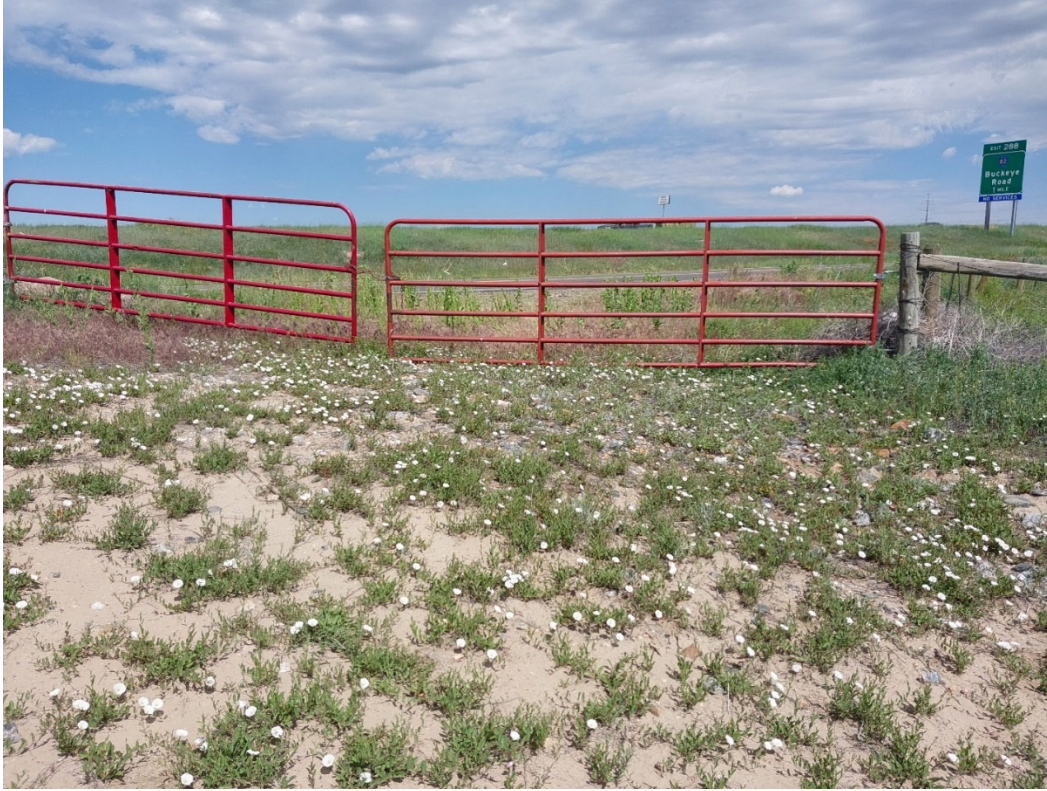
Roads that had been used for the mining operation have been scoured and seeded. The north and south entrances of the permit area have been approved to remain through TR 2 on January 10, 2024.

Photo #6: View of the north entrance gate that will remain in place for the landowner's purposes, approved in TR-2; looking west.

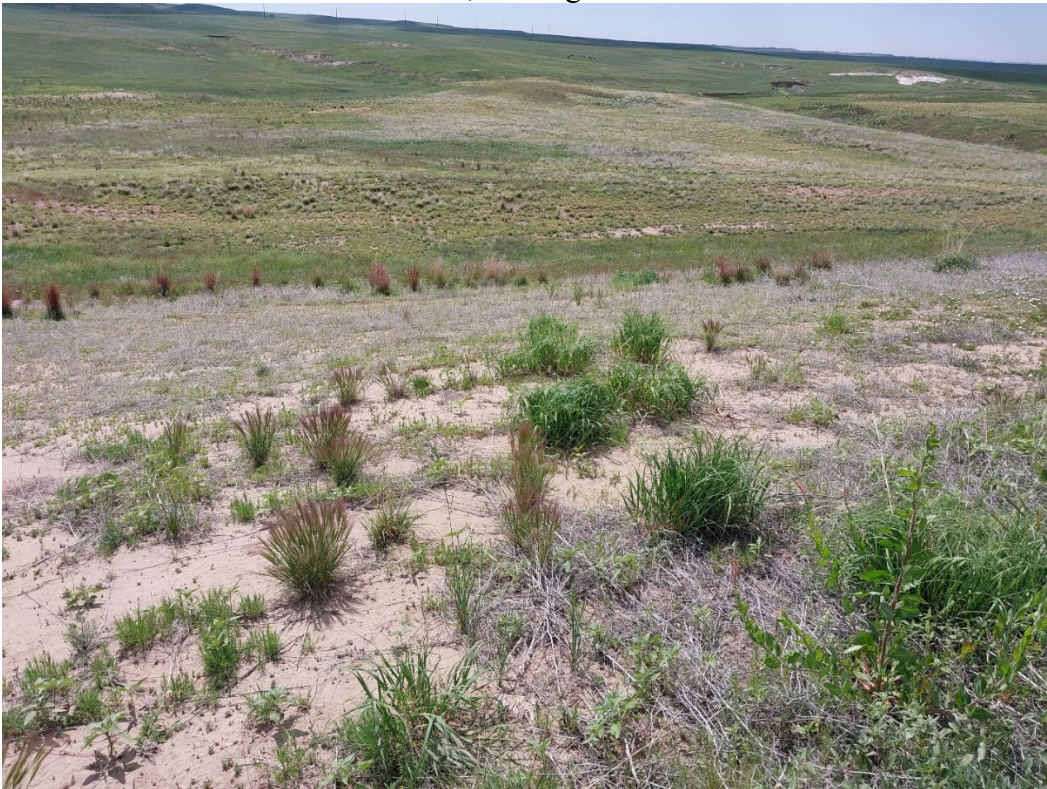
Photo #7: View of the reclaimed north gravel pit from the northwestern boundary, looking to the southeast. The arrow is pointing to the drainage way between the reclaimed north and south gravel pits.

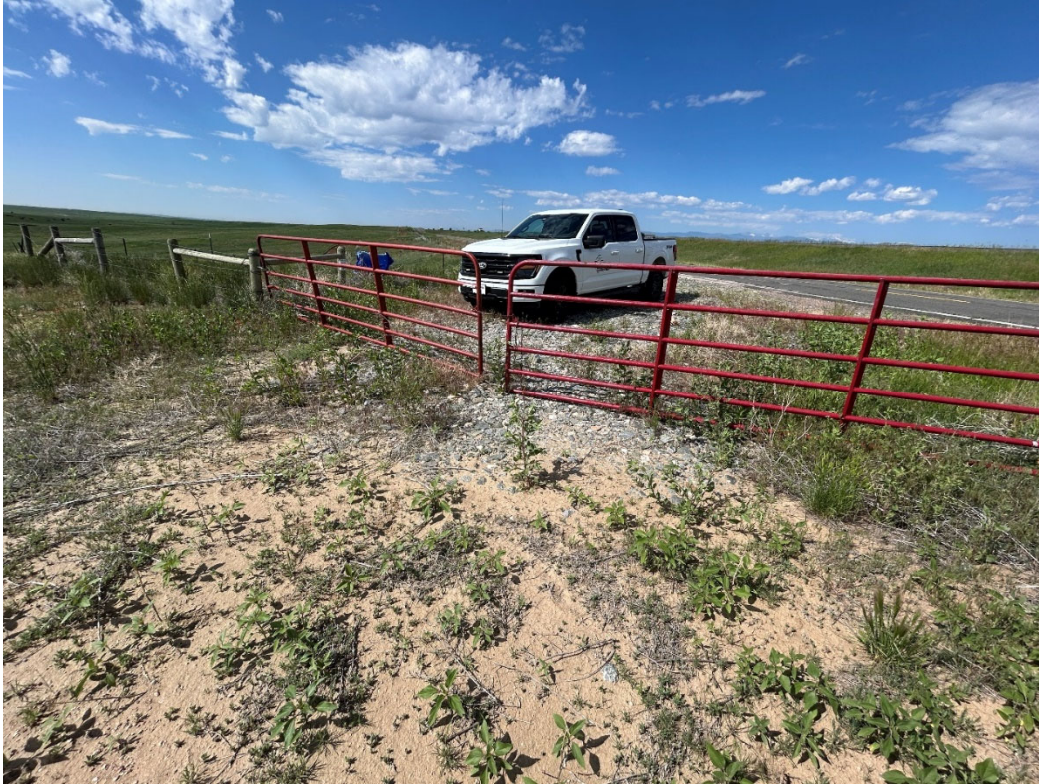
Photo #8: View of the north entrance gate that will remain in place for the landowner's purposes, approved in TR-2, looking southwest.
