July 11, 2025
Project No.: 19125

Regarding: Daniels Sand Pit 2, Permit No. M-1973-007-SG
Slope Stability Monthly Monitoring Report

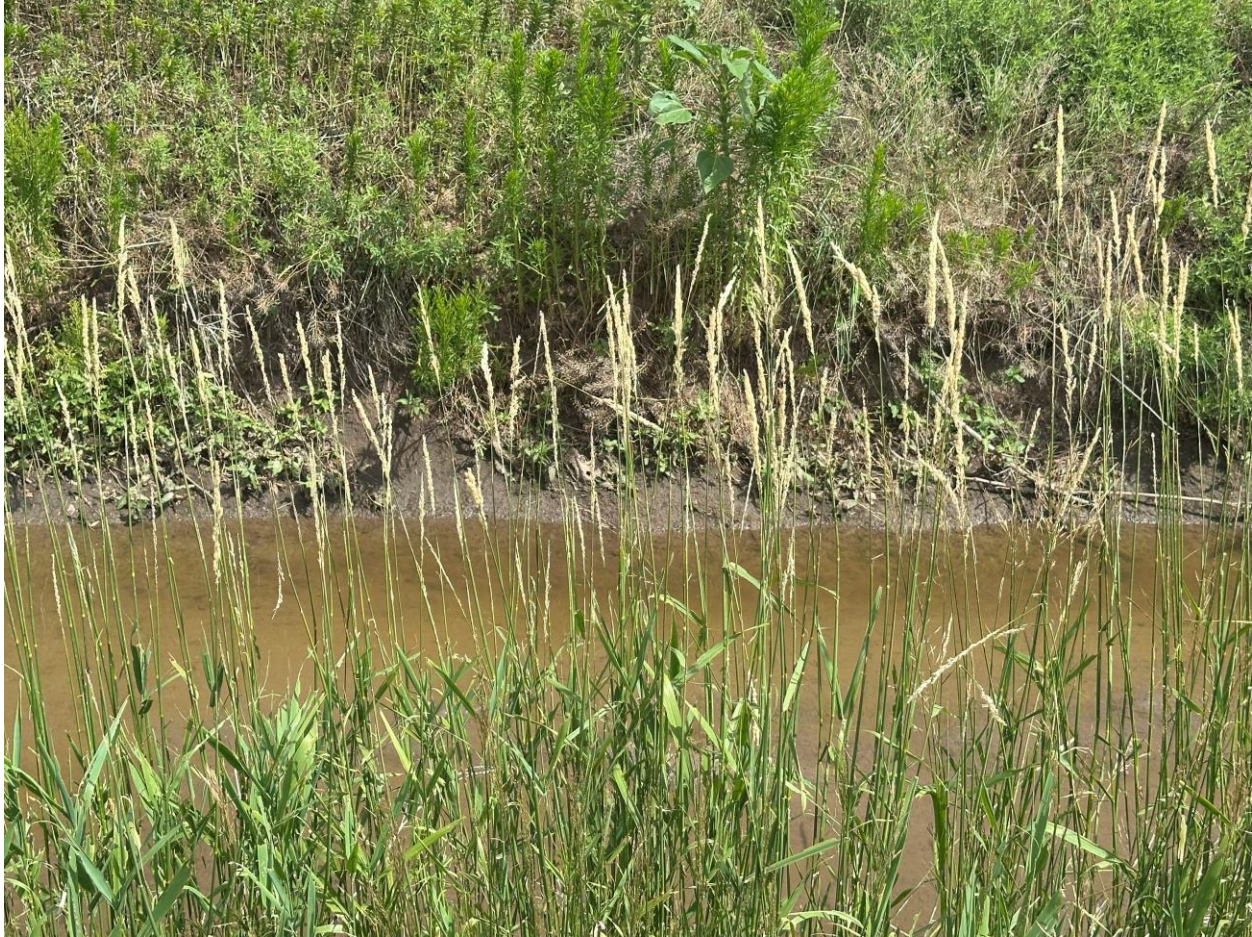
- c) Shallow, flowing water.
 - d) Ditch access road not level/flat in a few areas. Ponding water present in a few locations. Fallen tree branches also present on road.

Photo 1. Water flowing in ditch

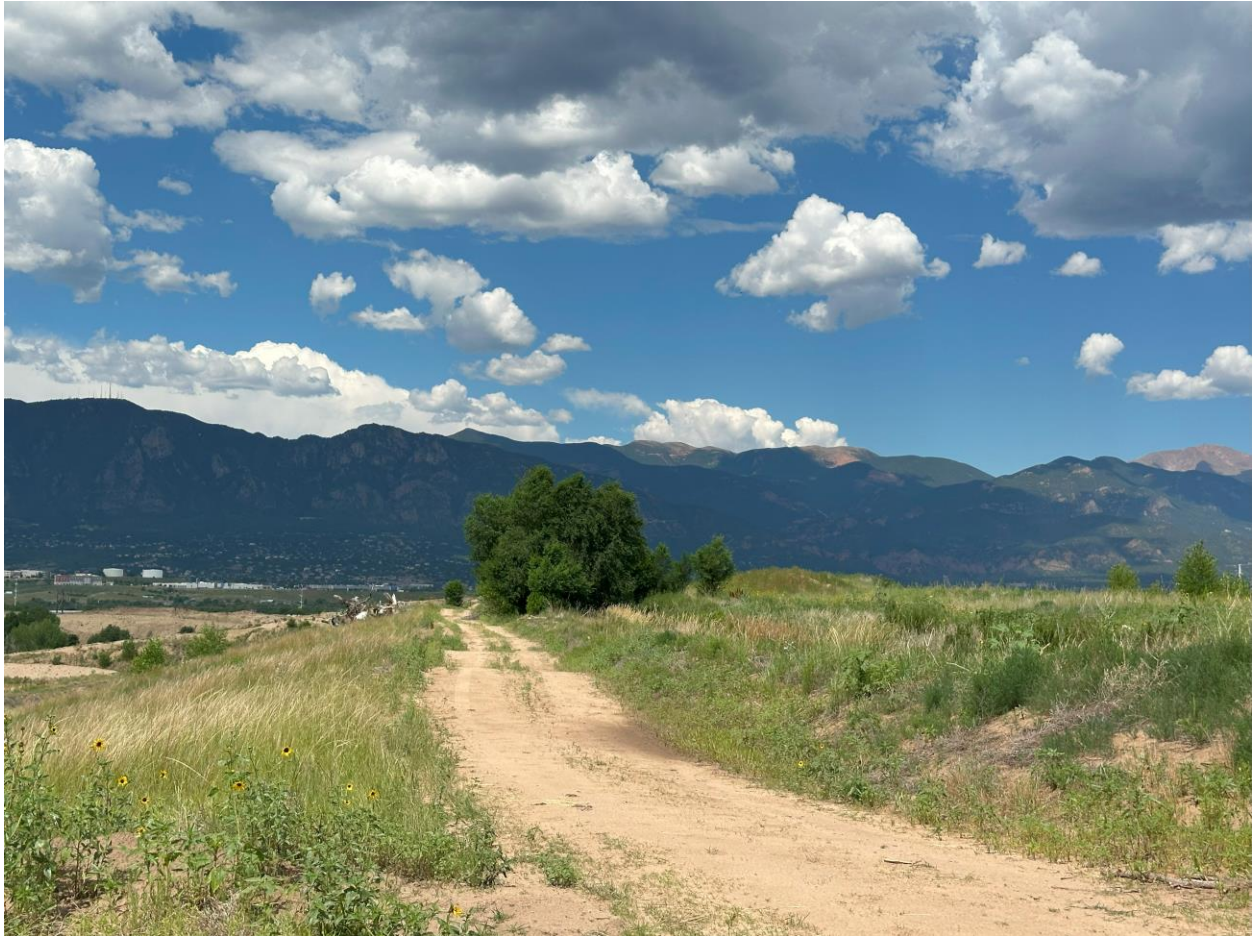
Photo 2. Buttress slope with ditch access road

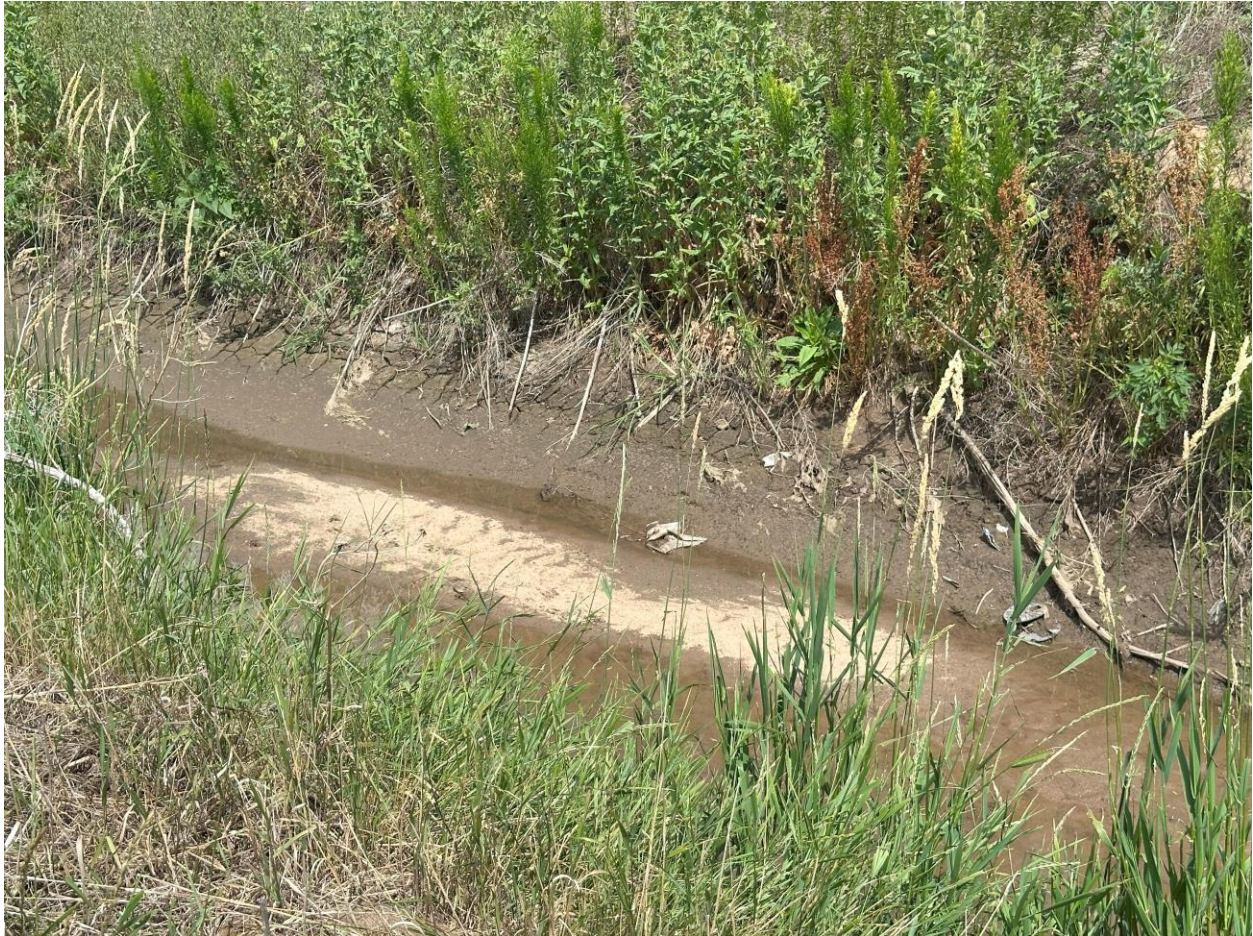
Photo 3. Ditch invert

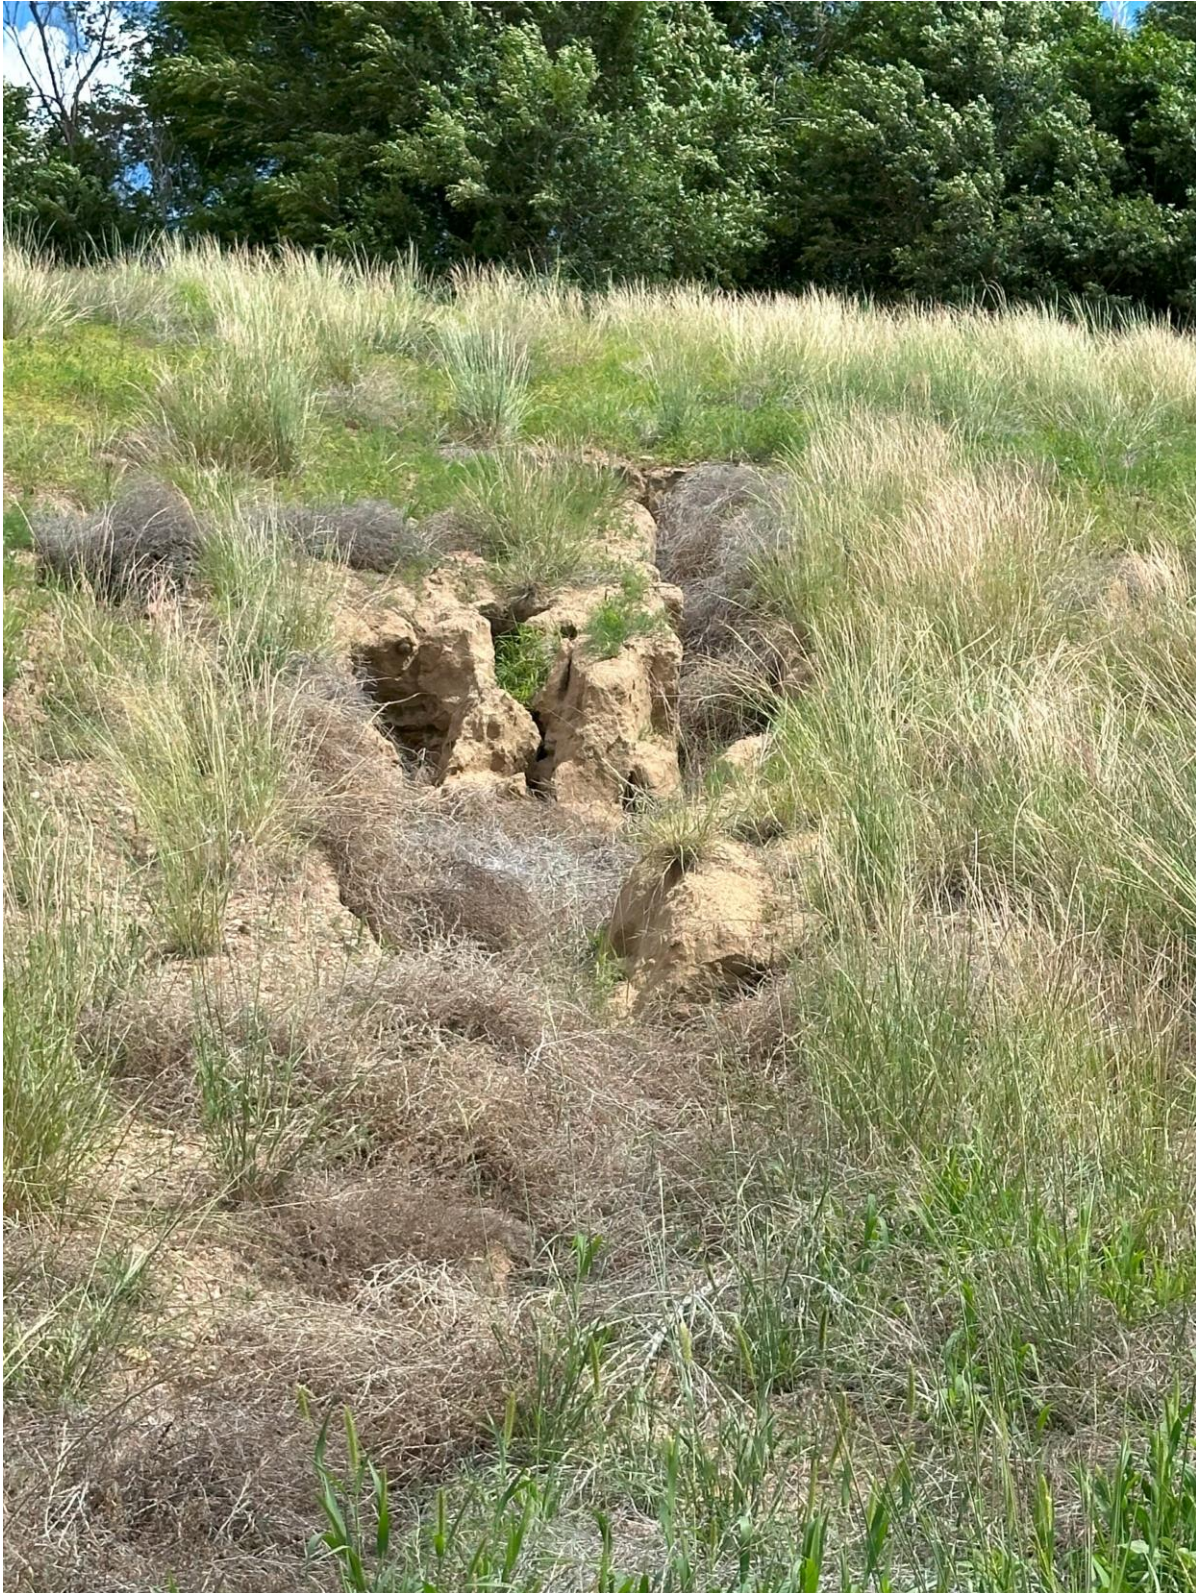
- c) Several locations show visible evidence of surface water runoff and expanding erosion gullies throughout the buttress. The erosion gullies are widespread along the buttress from east to

west, with a few located 2/3 up the slope and several feet wide and deep. The dimensions (width and depth) of individual erosion gullies have increased since the last site visit.

Photo 4. Erosion gullies in buttress

- 1) Several erosion gullies exist within the embankment slope. We recommend those areas be reconstructed ASAP and that the areas be seeded per the reclamation plan.

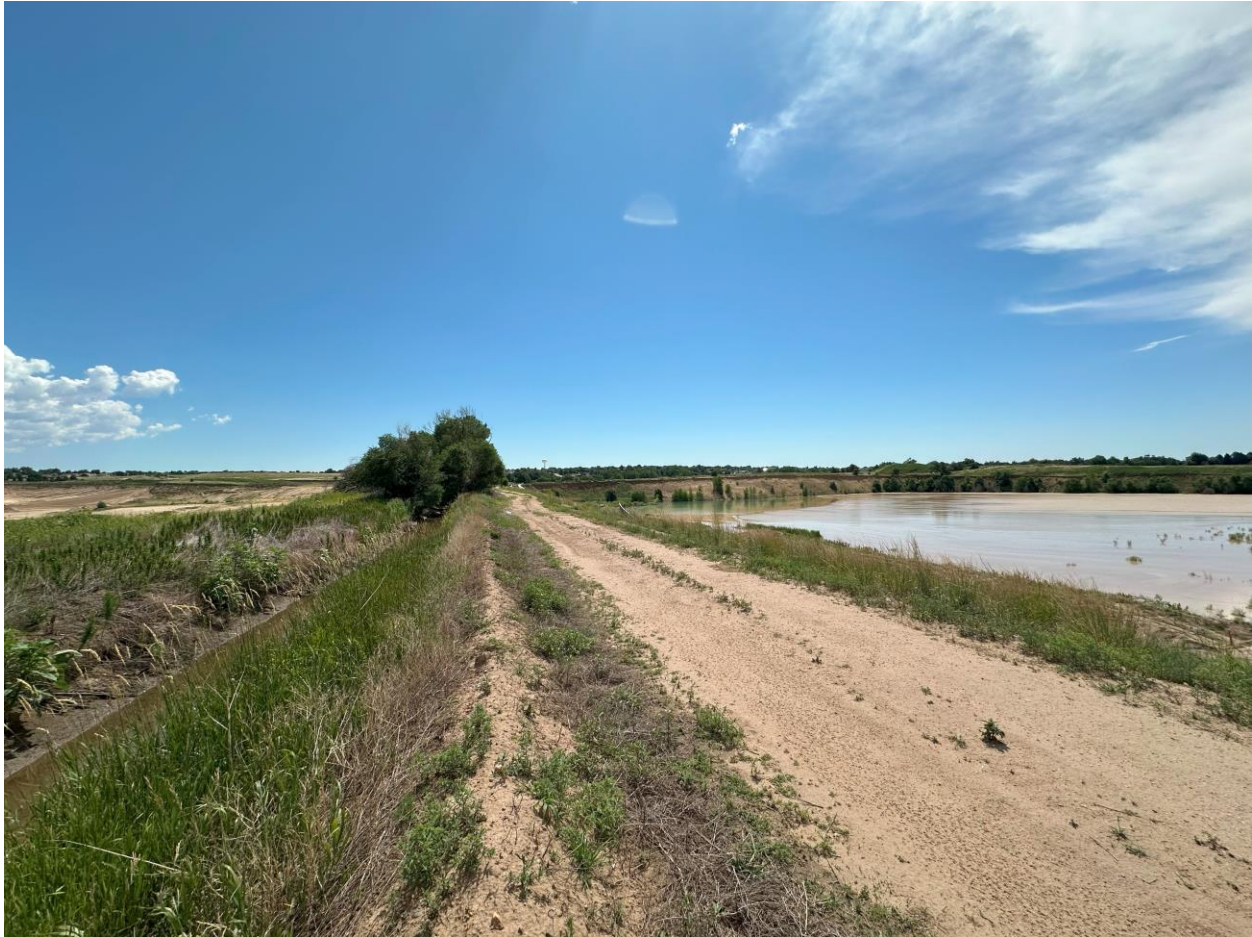
Photo 5. Ditch and access road looking east

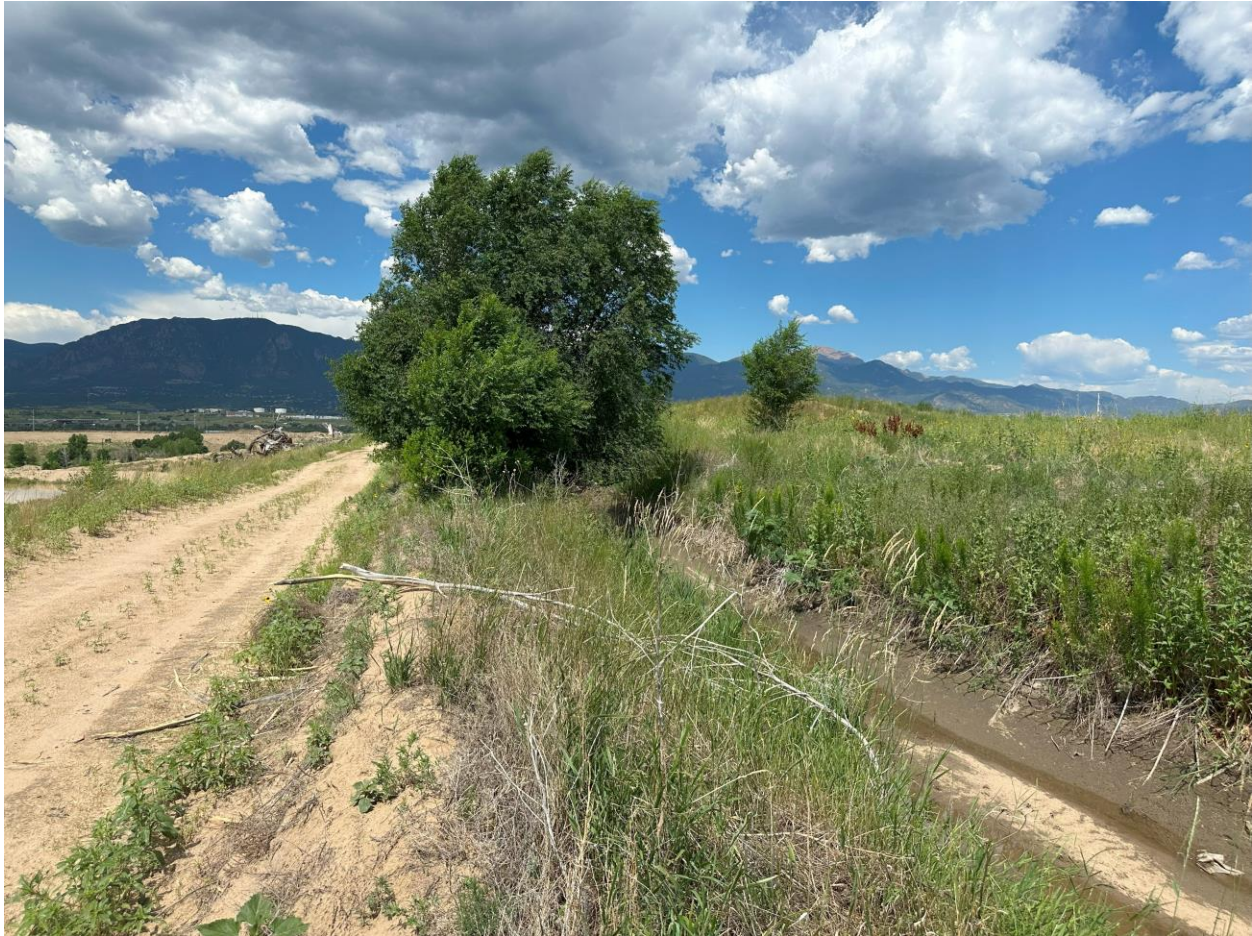
Photo 6. Ditch and access road looking west

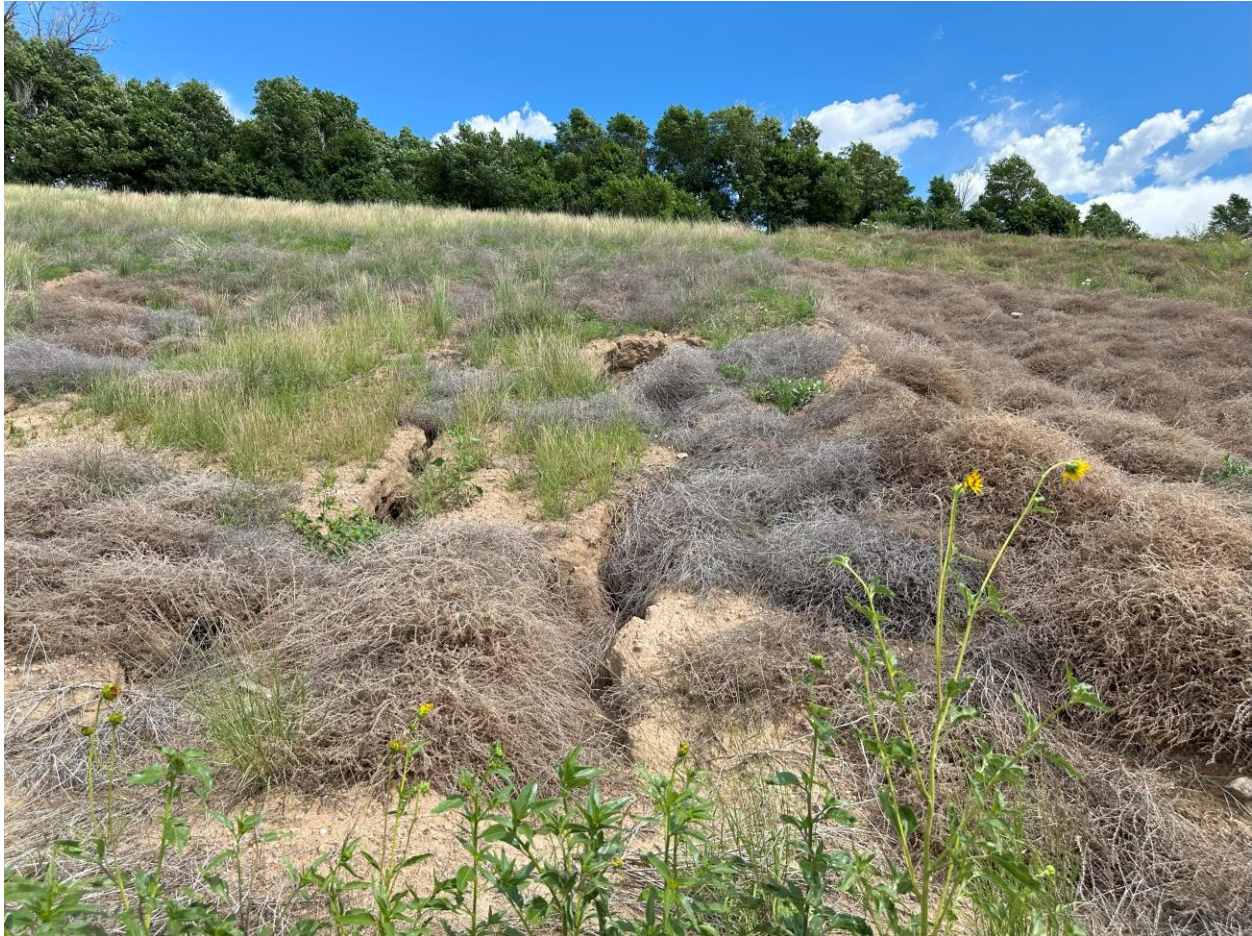
Photo 7. Erosion gullies in buttress

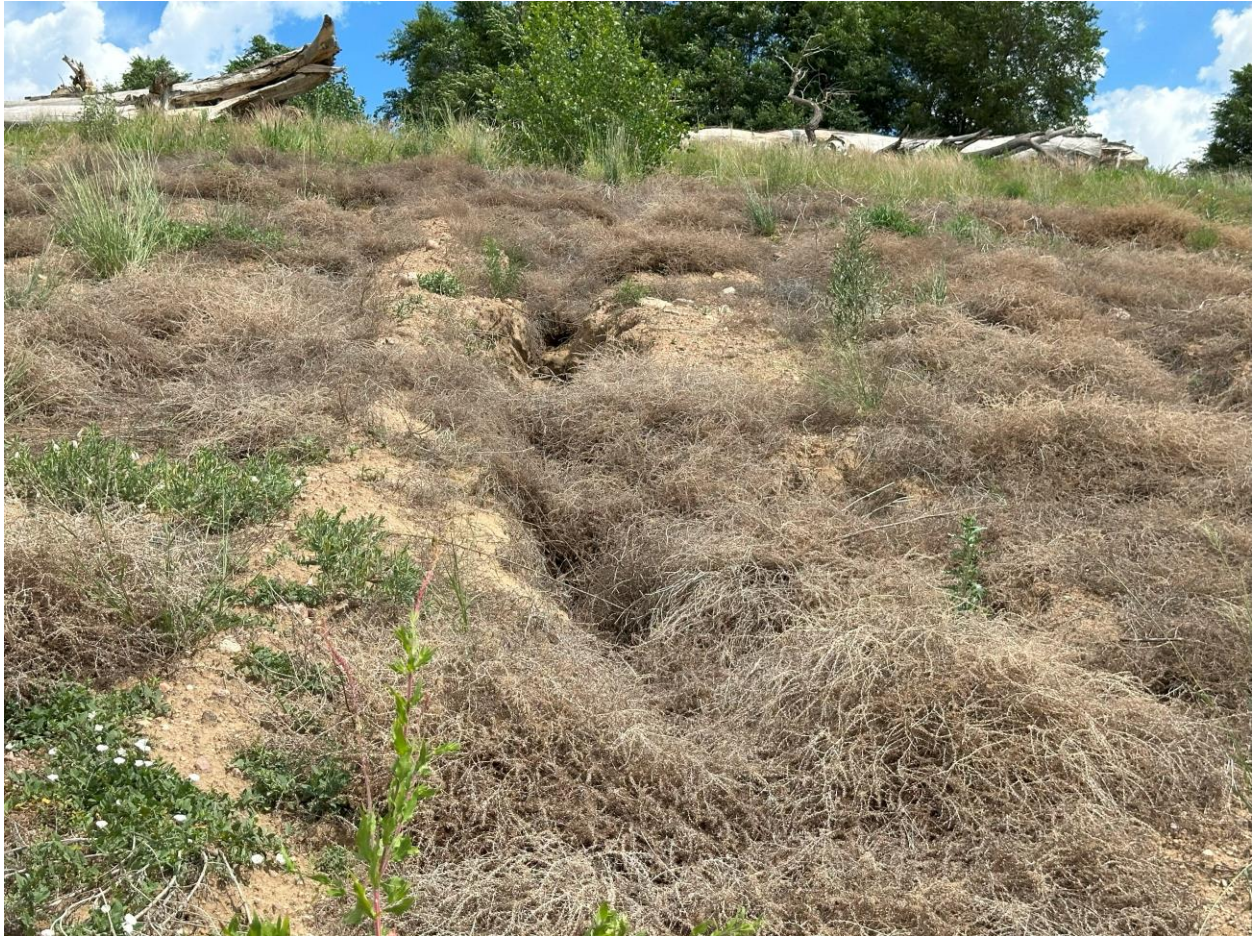
Photo 8. Erosion gullies in buttress

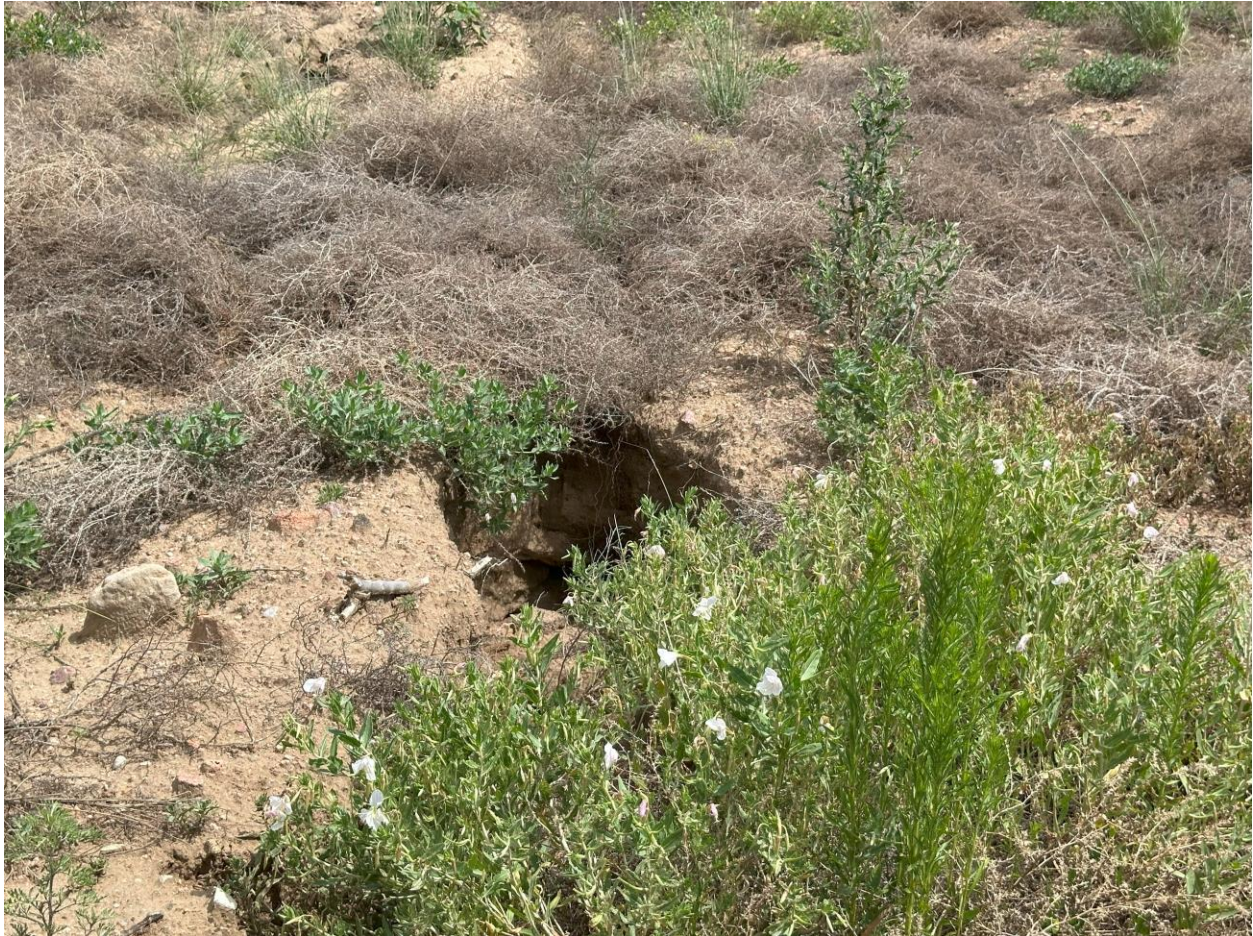
Photo 9. Erosion gully in buttress

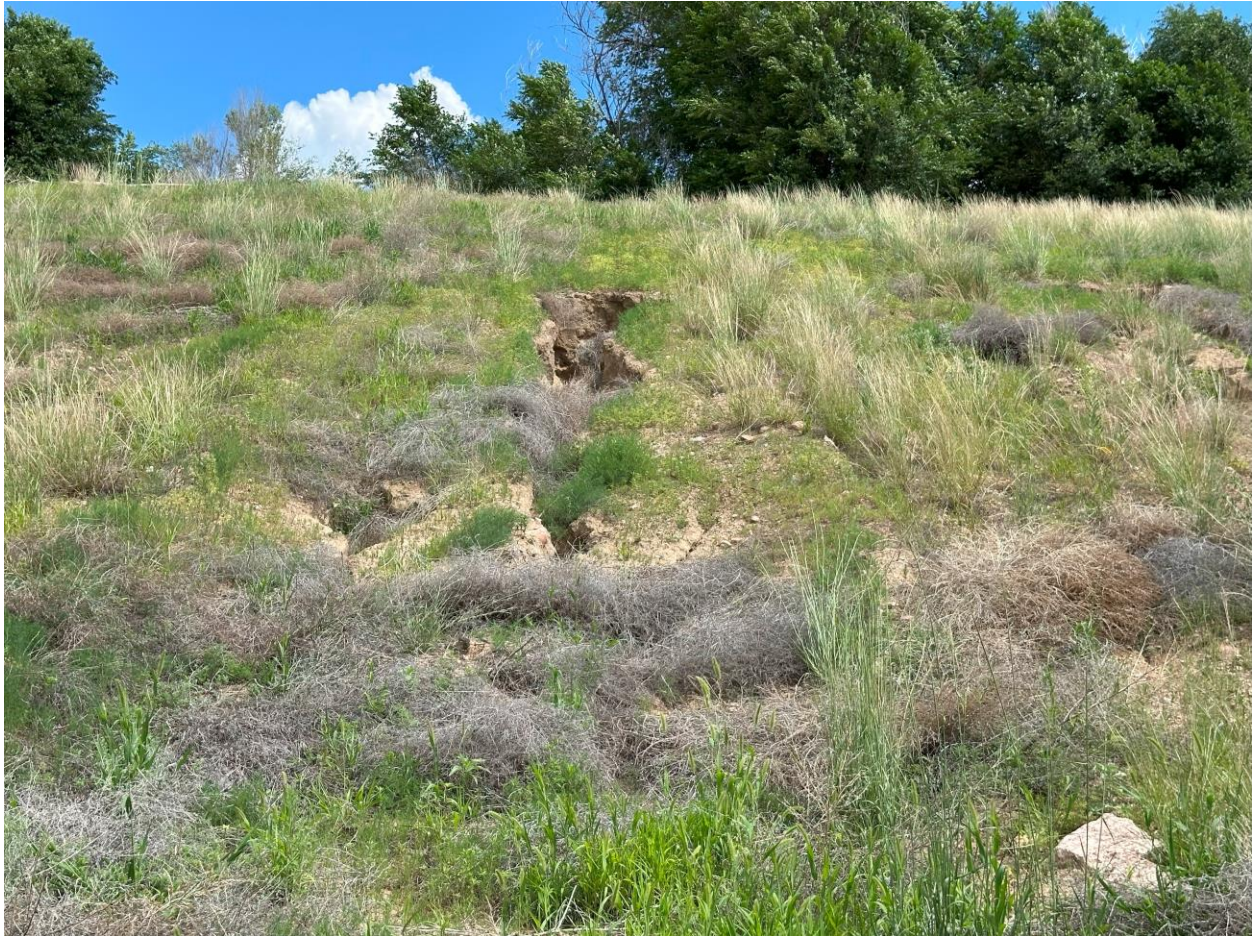
Photo 10. Erosion gullies in buttress

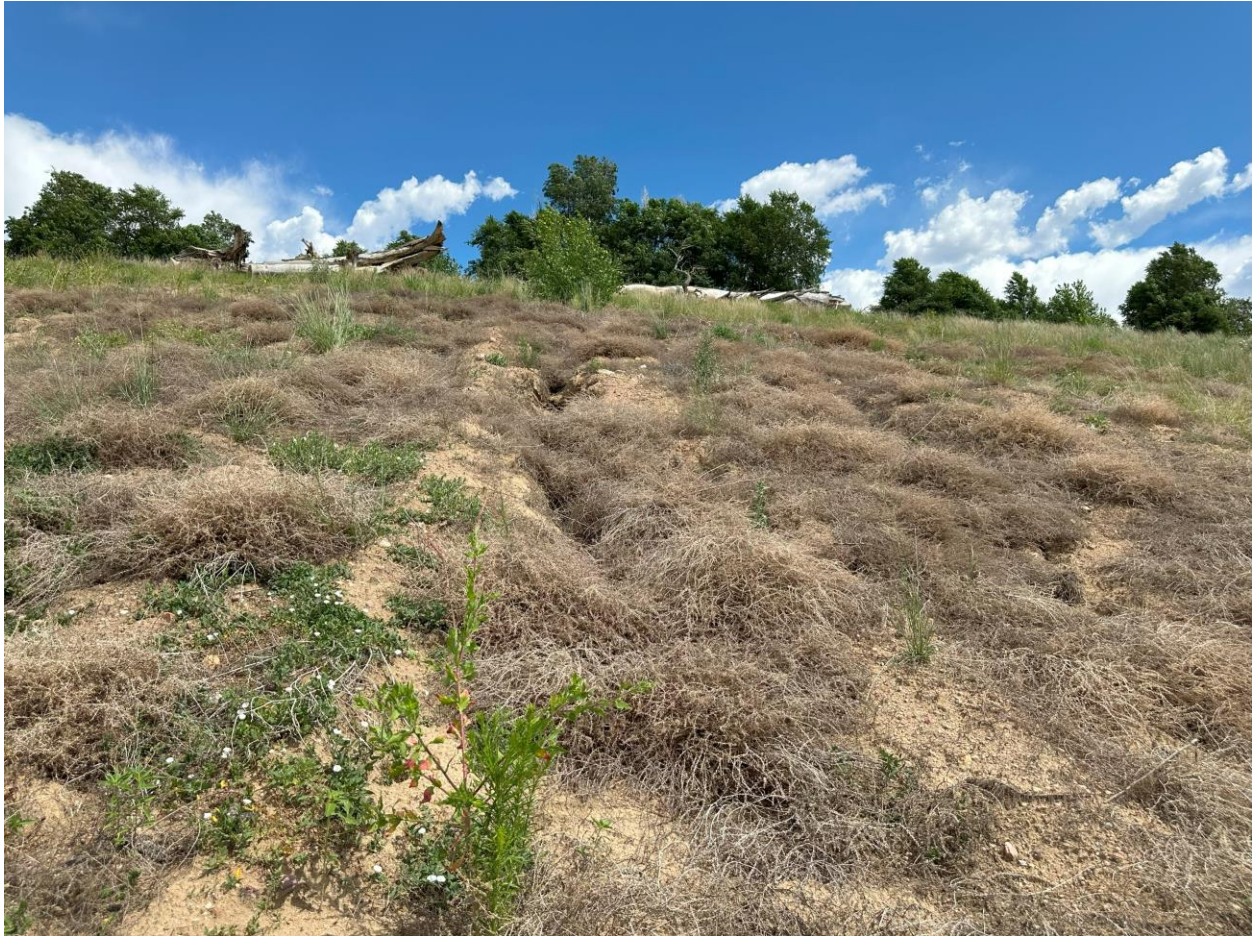
Photo 11. Erosion gullies in buttress

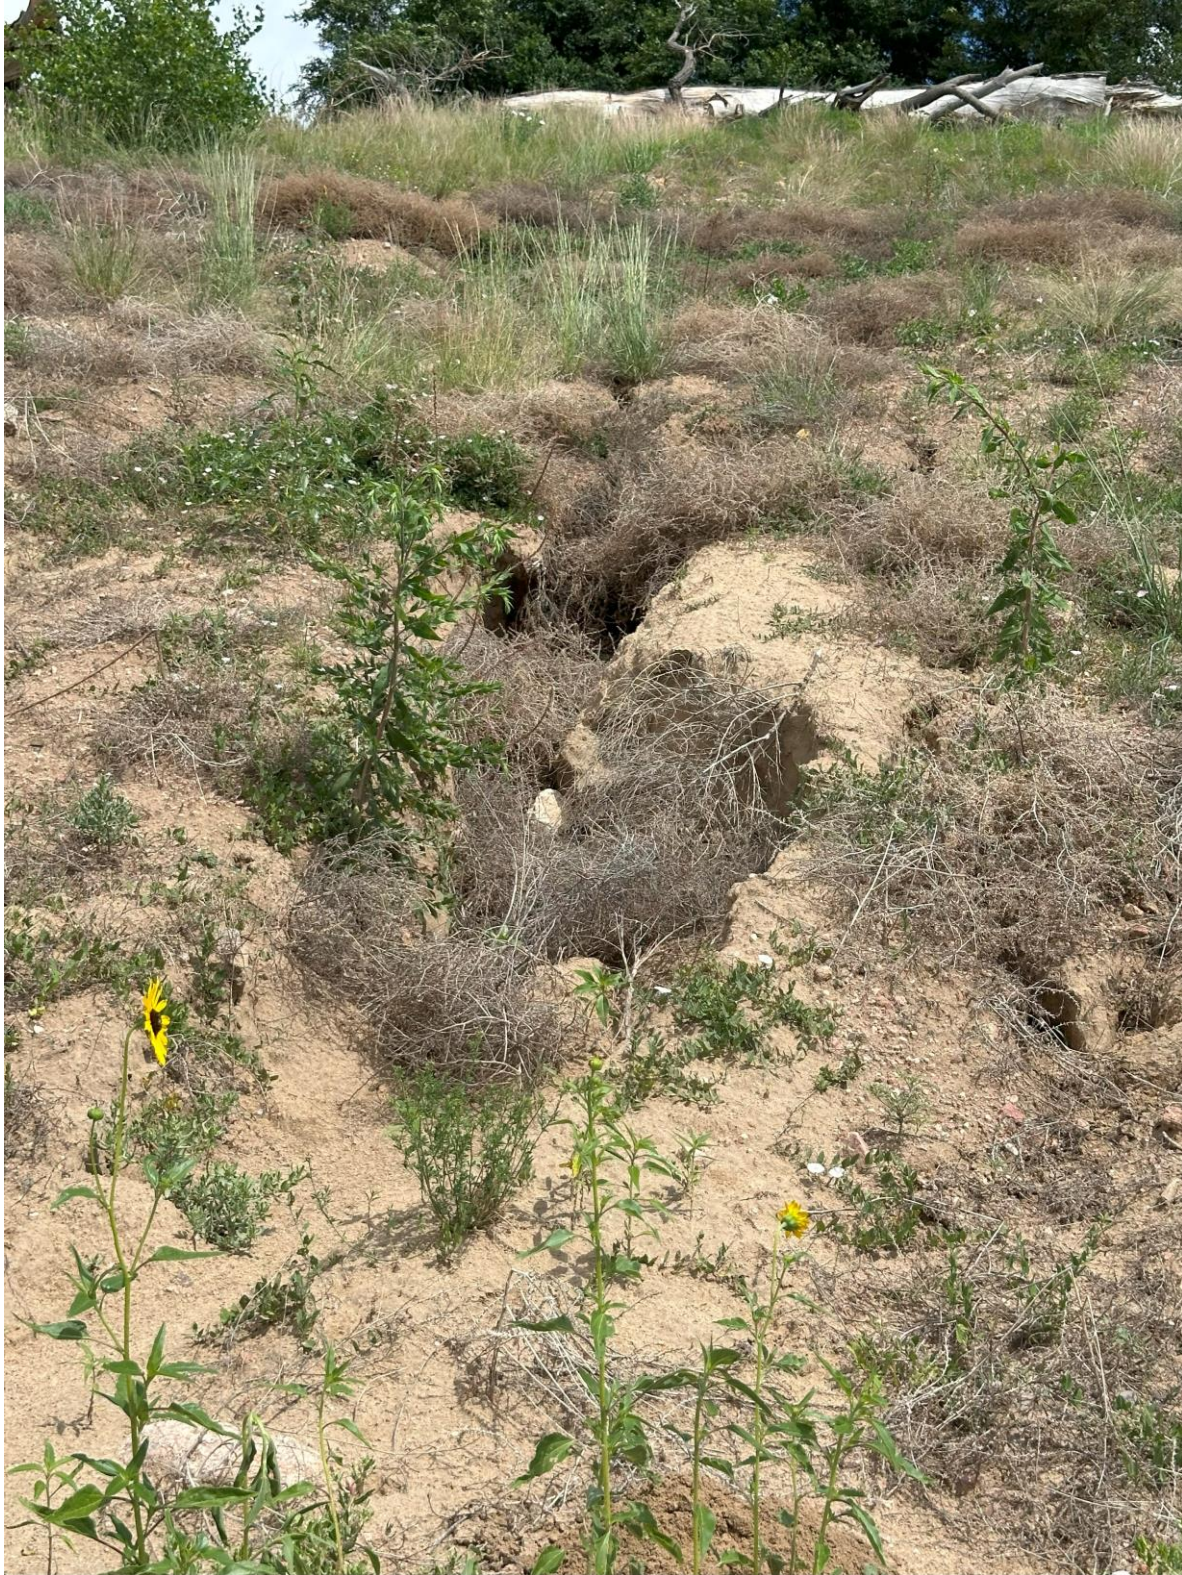
Photo 12. Erosion gullies in buttress

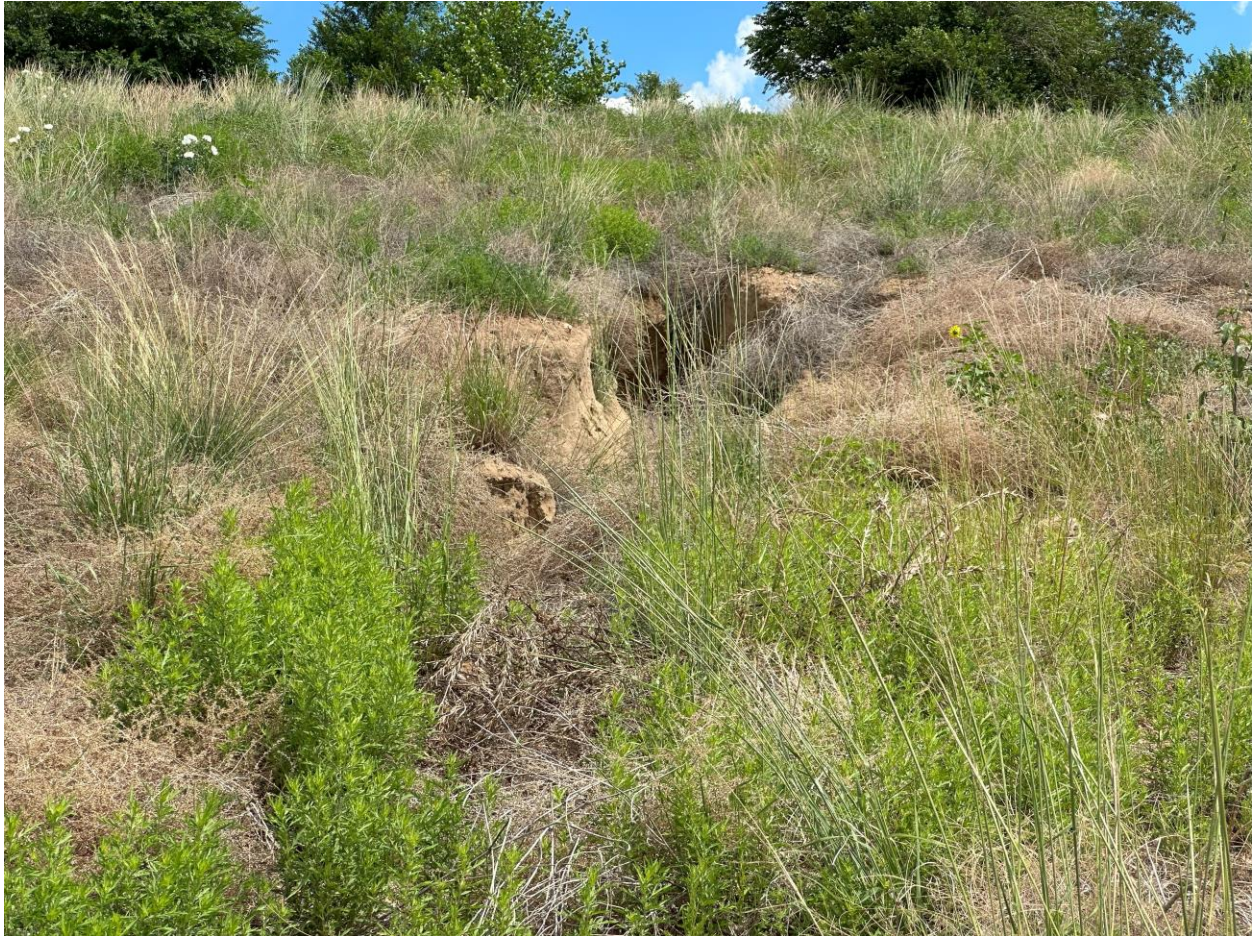
Photo 13. Erosion gully in buttress

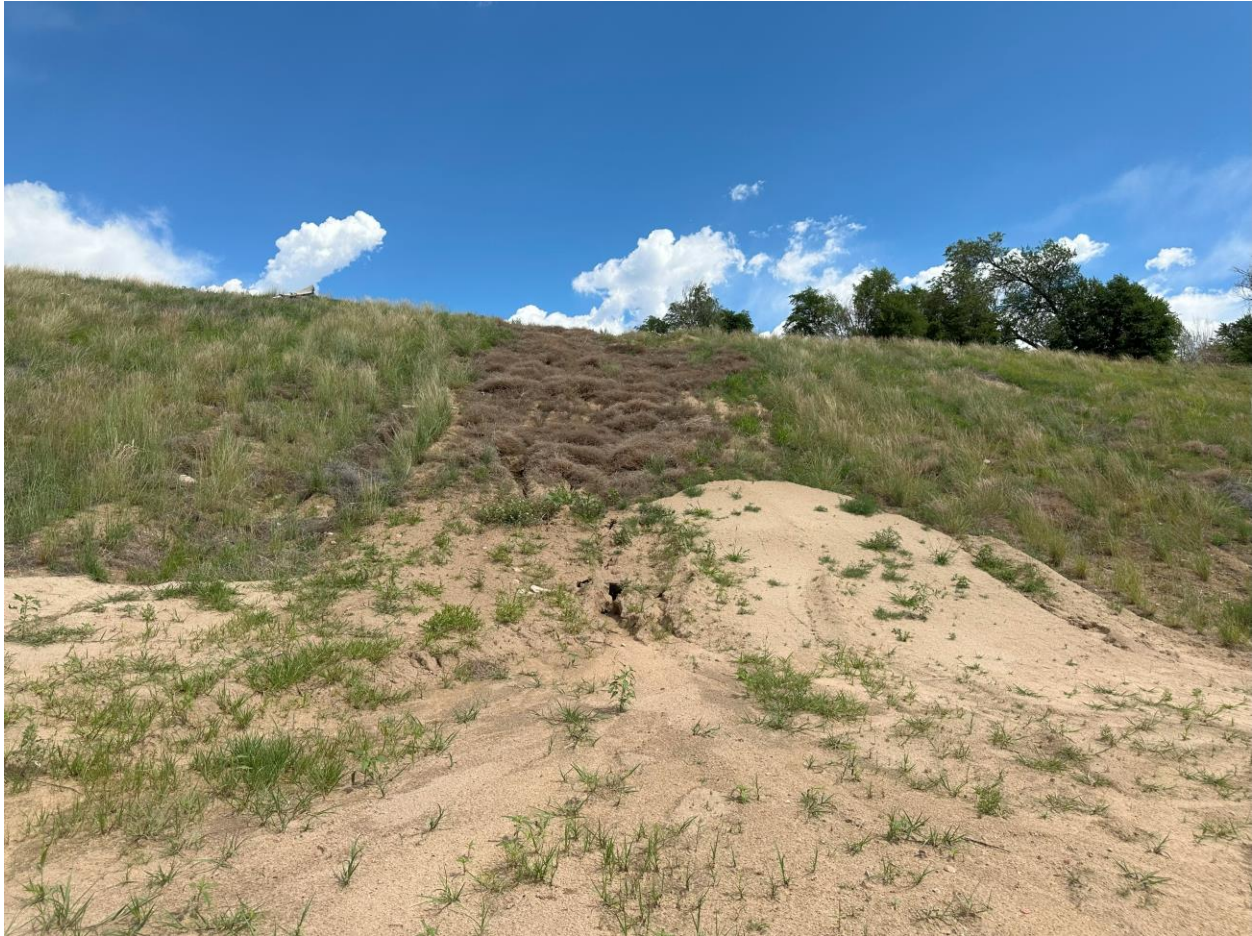
Photo 14. Erosion gullies in buttress

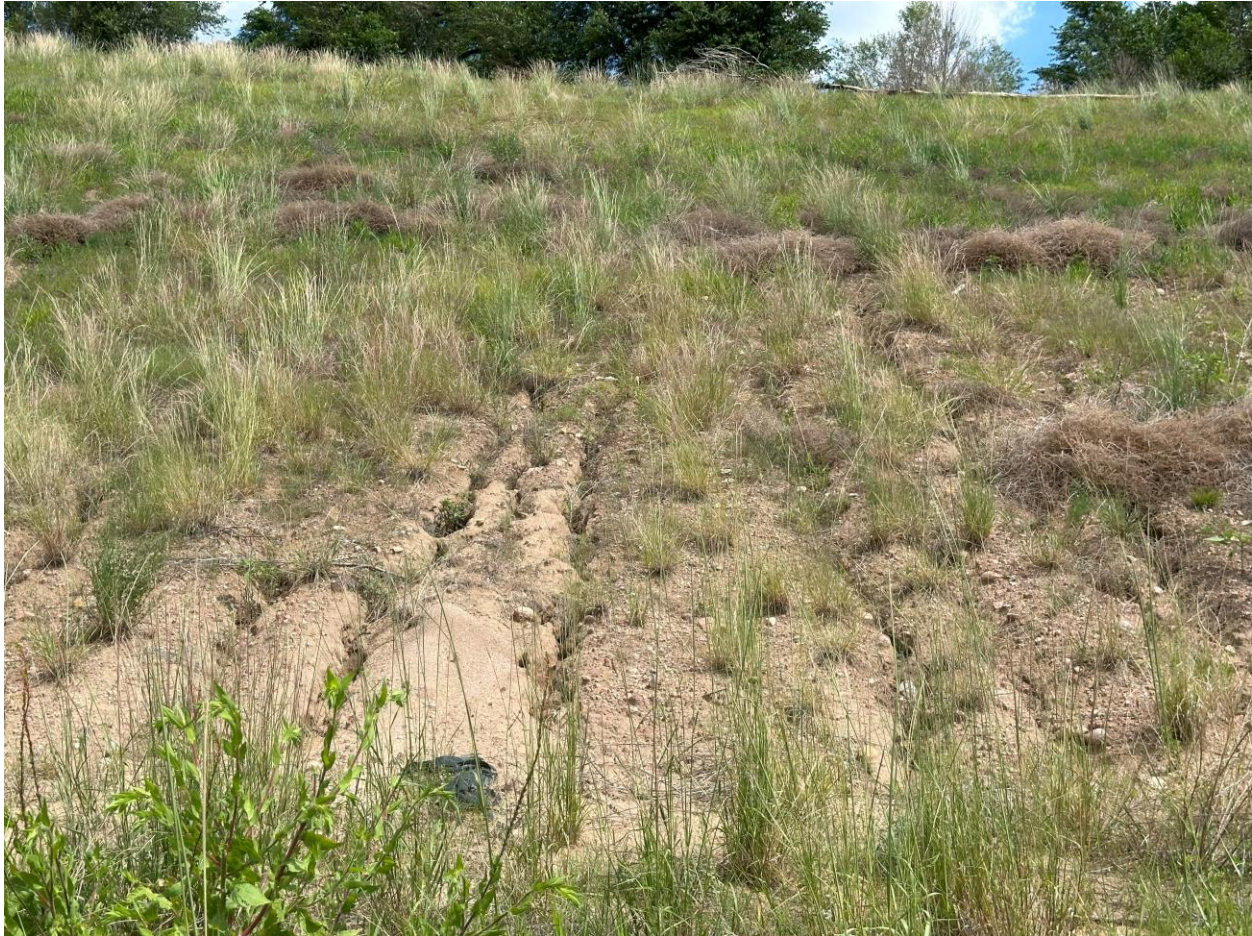
Photo 15. Erosion gullies in buttress

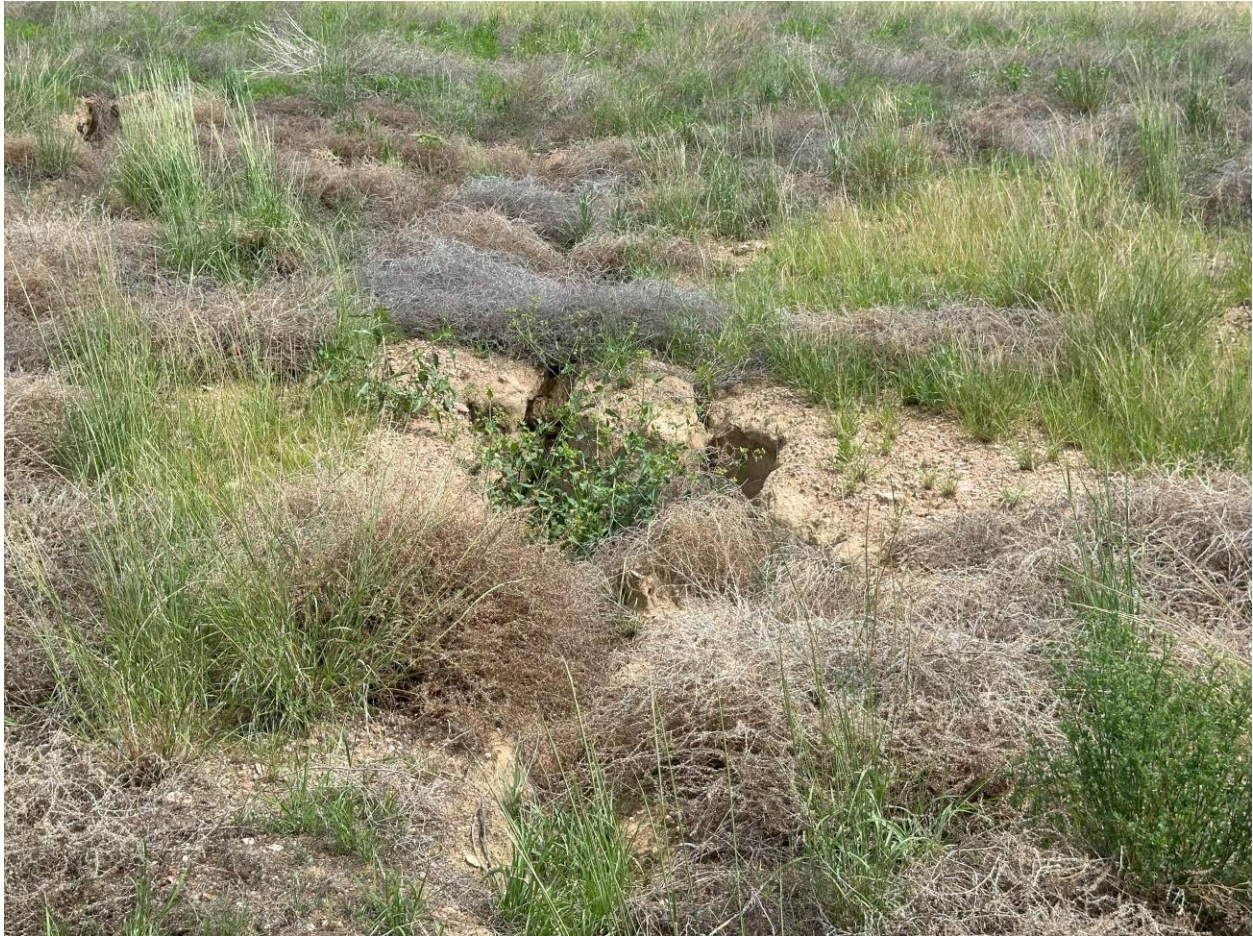
Photo 16. Erosion gully in buttress

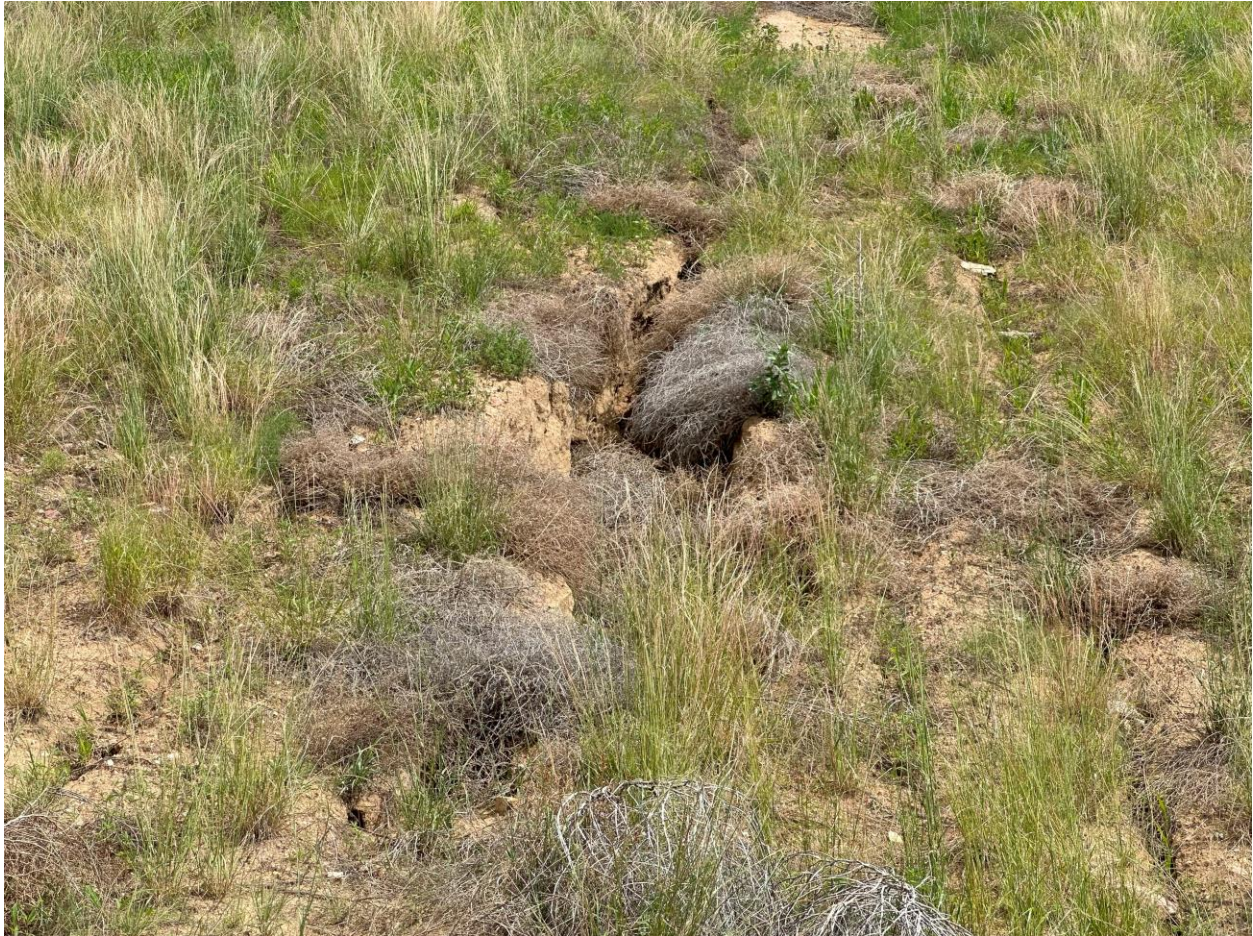
Photo 17. Erosion gully in buttress

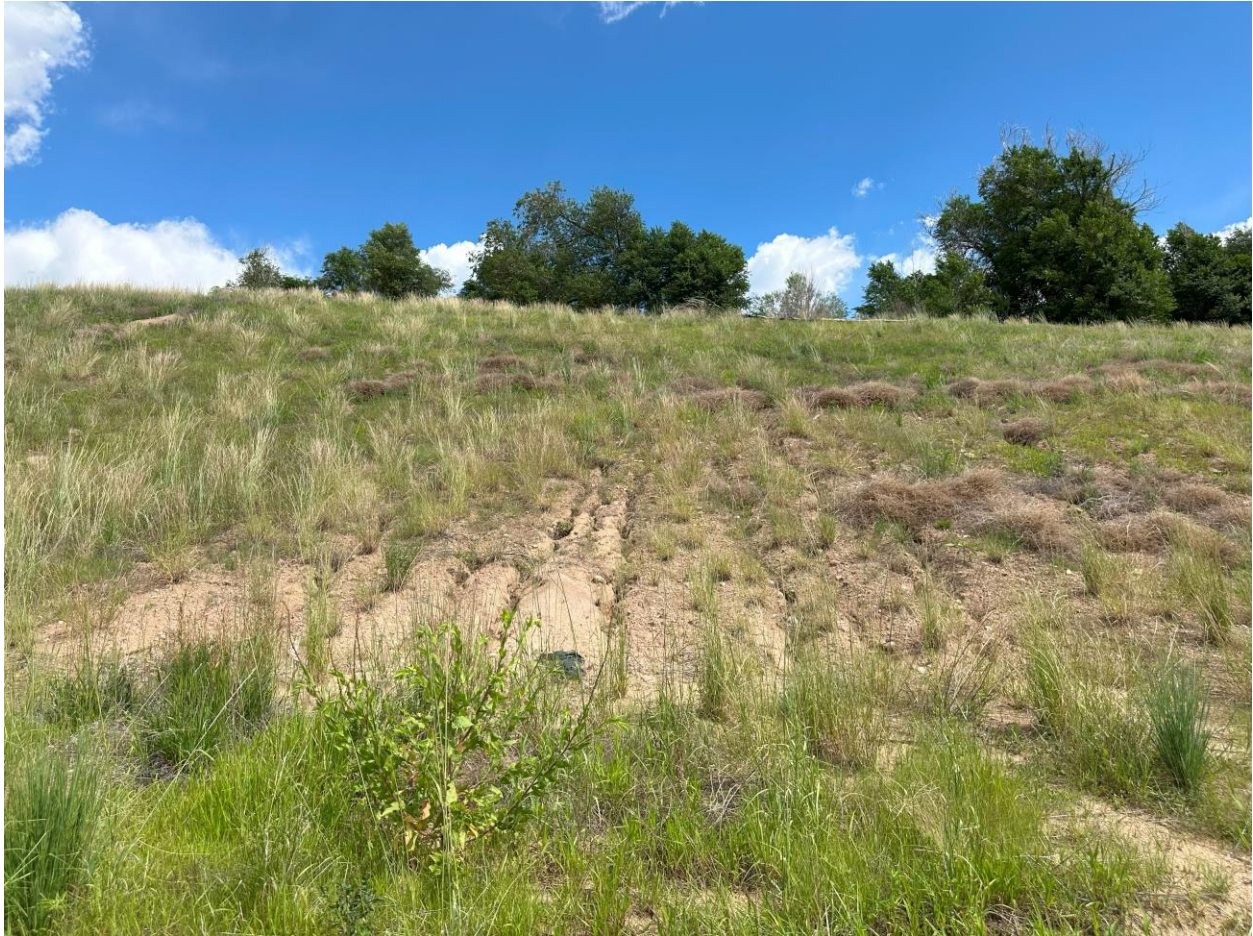
Photo 18. Erosion gullies in buttress
