July 11, 2025
Project No.: 19125

Regarding: Daniels Sand Pit 2, Permit No. M-1973-007-SG
Slope Stability Monthly Monitoring Report

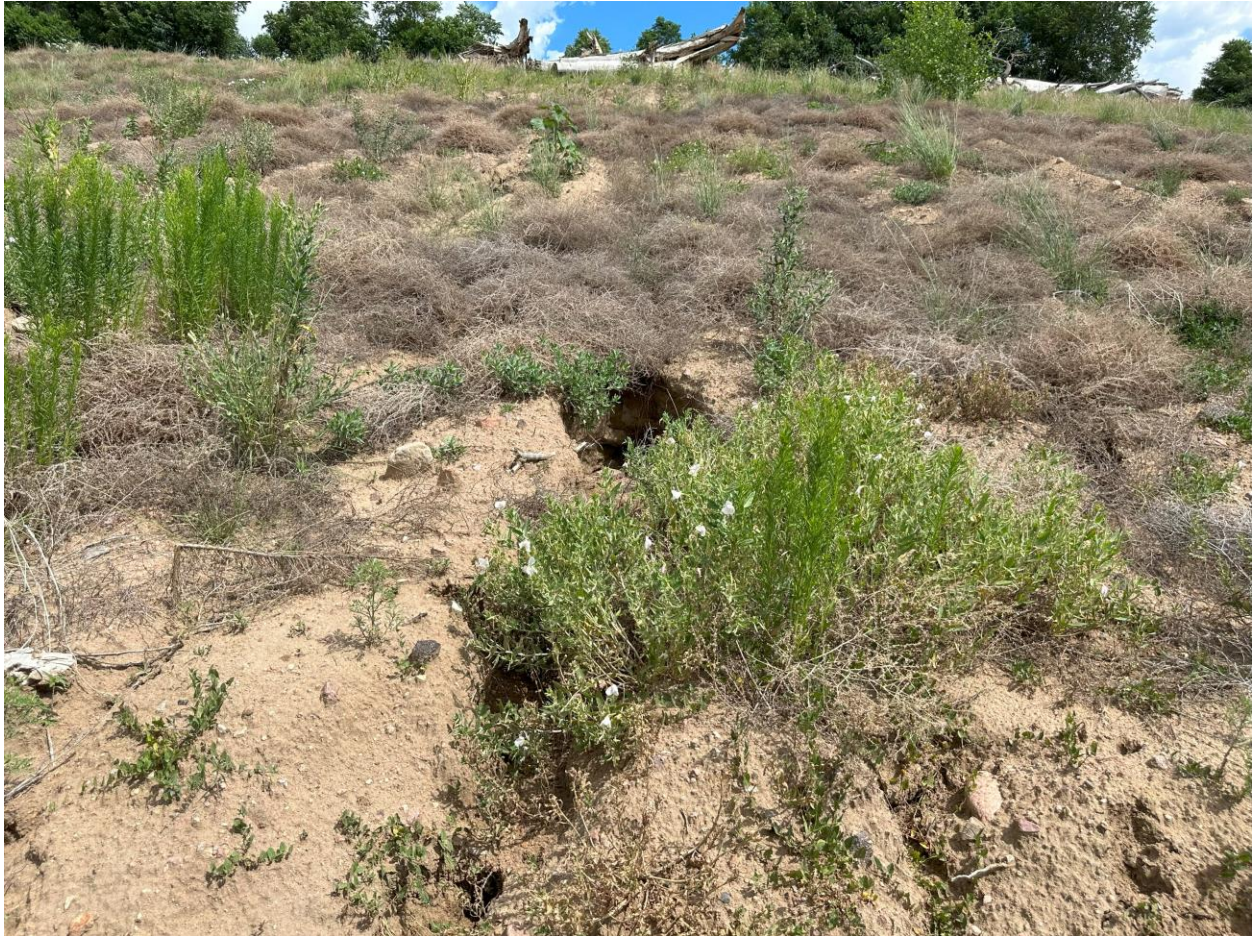
- c) Several locations show visible evidence of surface water runoff and expanding erosion gullies throughout the buttress. The erosion gullies are widespread along the buttress from east to

west, with a few located 2/3 up the slope and several feet wide and deep. The dimensions (width and depth) of individual erosion gullies have increased since the last site visit.

Photo 19. Erosion gully in buttress

- 1) Several erosion gullies exist within the embankment slope. We recommend those areas be reconstructed ASAP and that the areas be seeded per the reclamation plan.

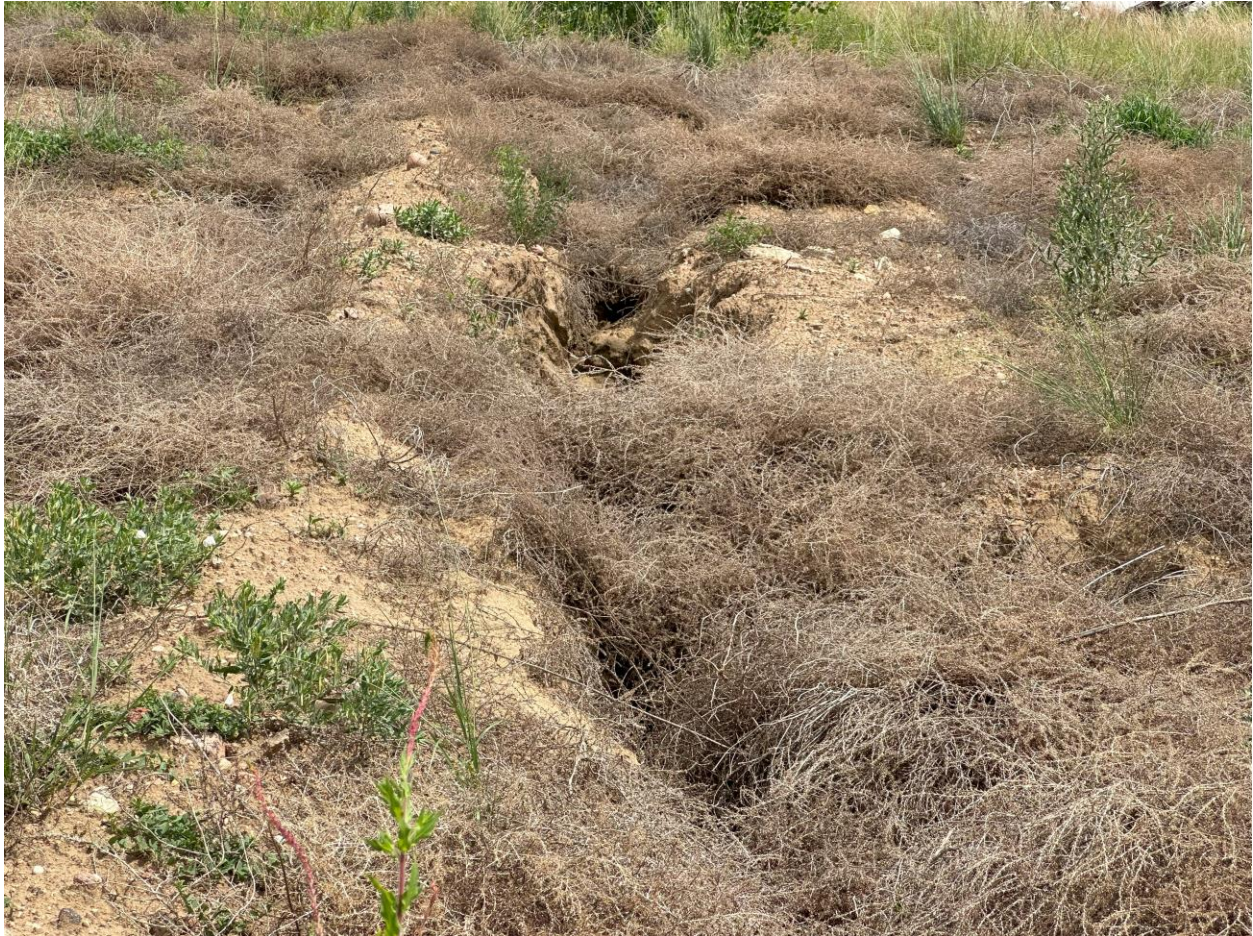
Photo 20. Erosion gully in buttress

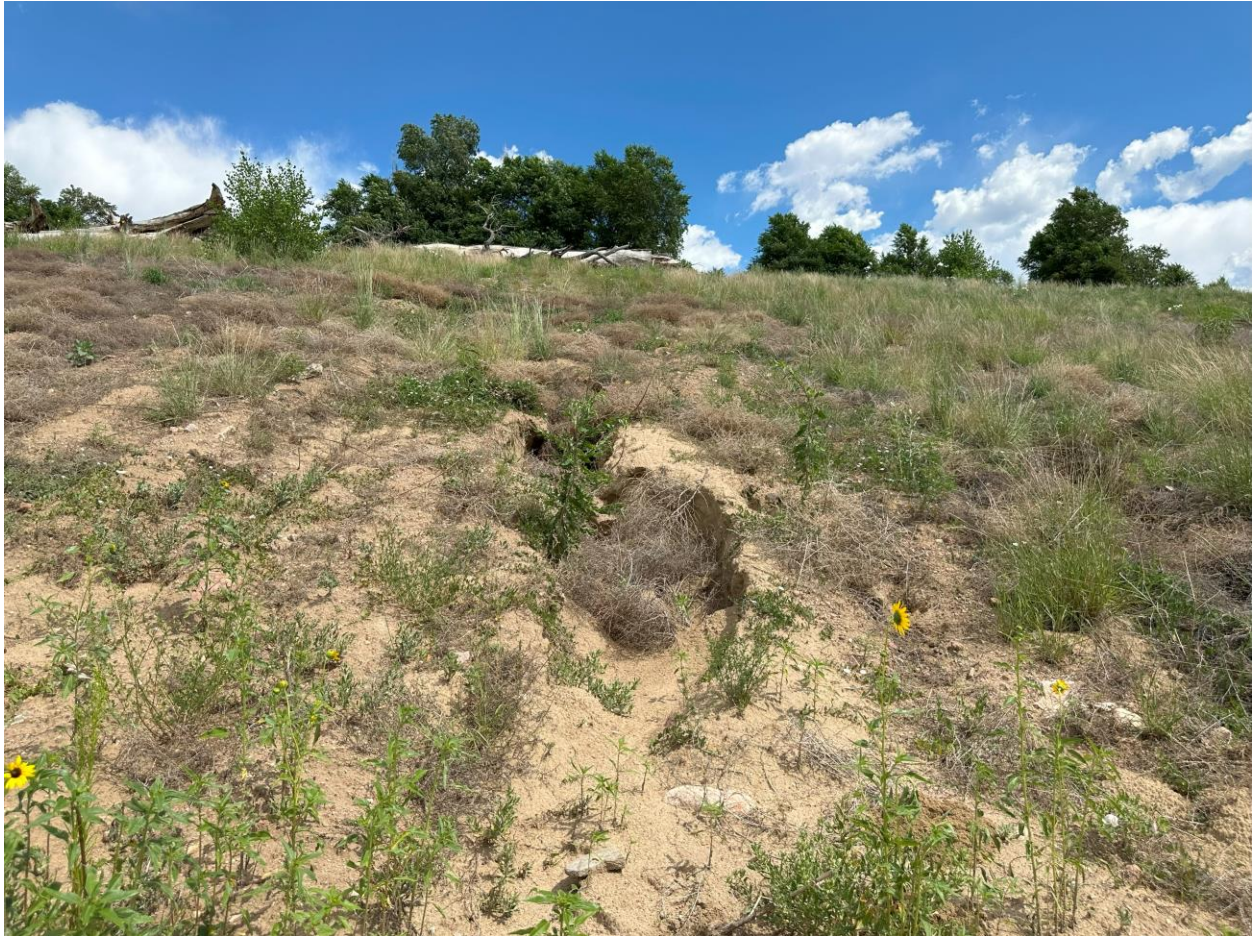
Photo 21. Erosion gullies in buttress

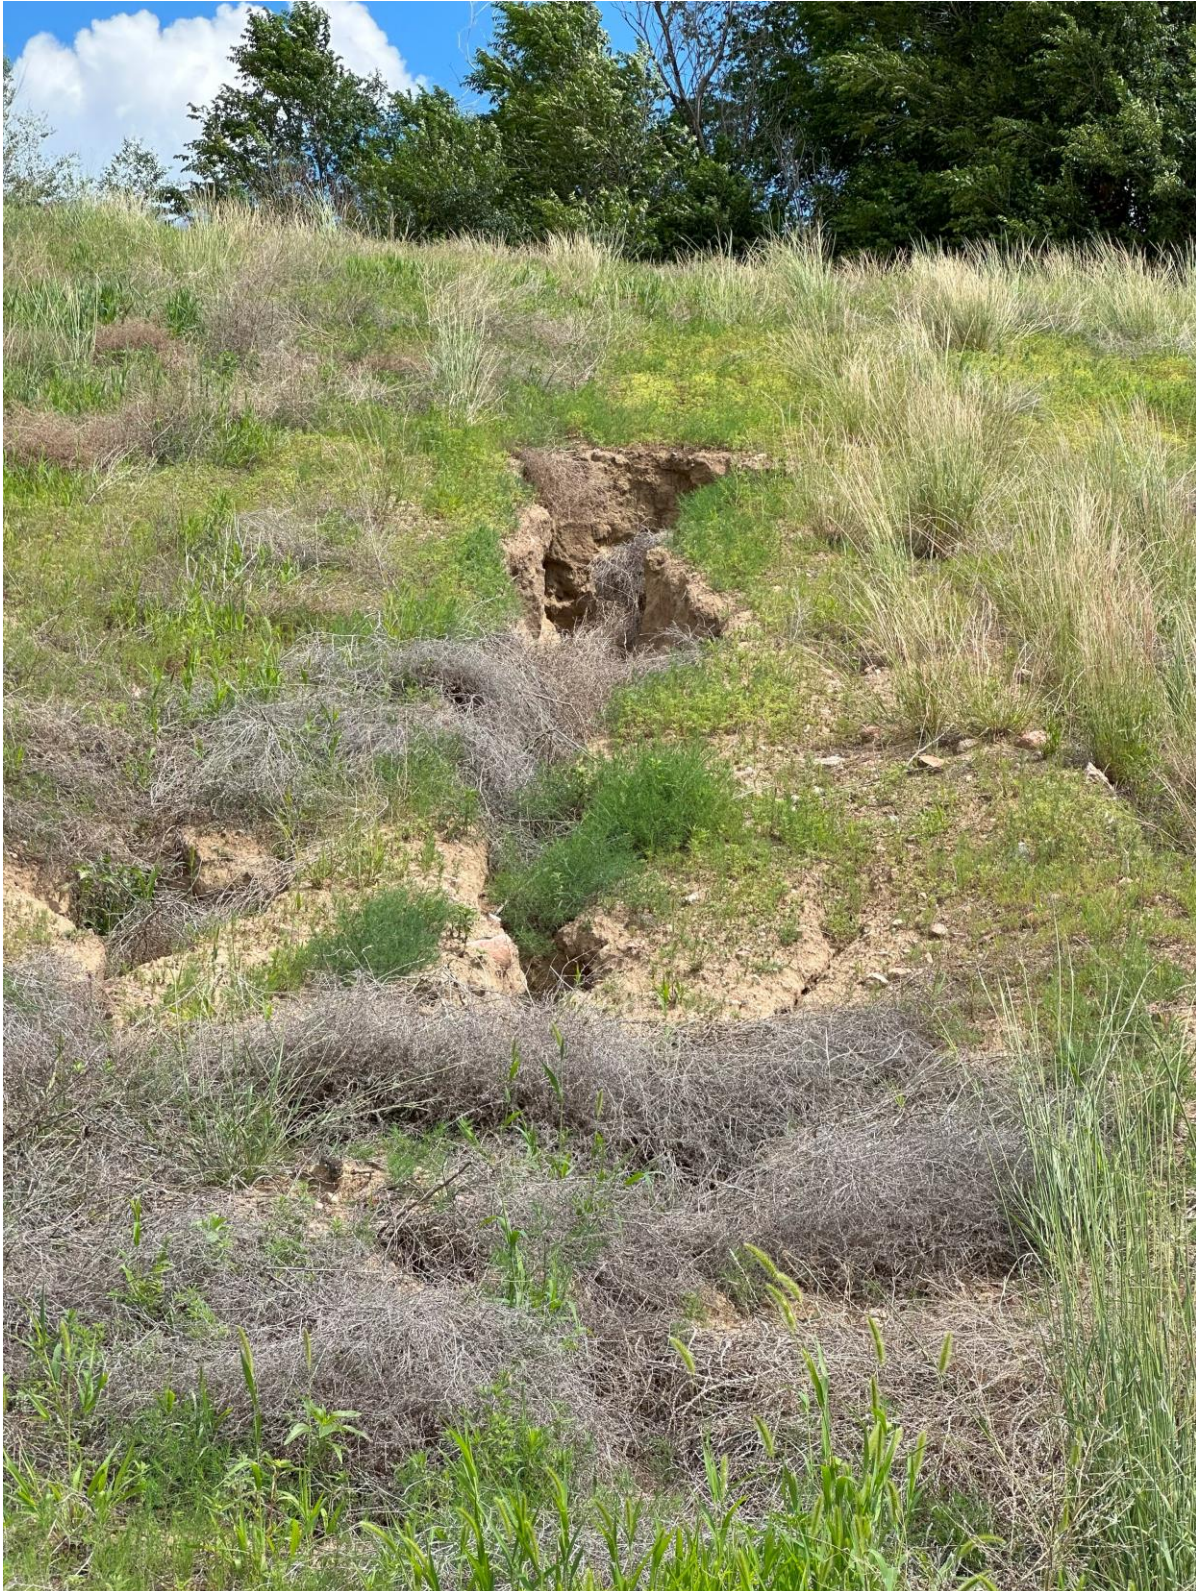
Photo 22. Erosion gully in buttress

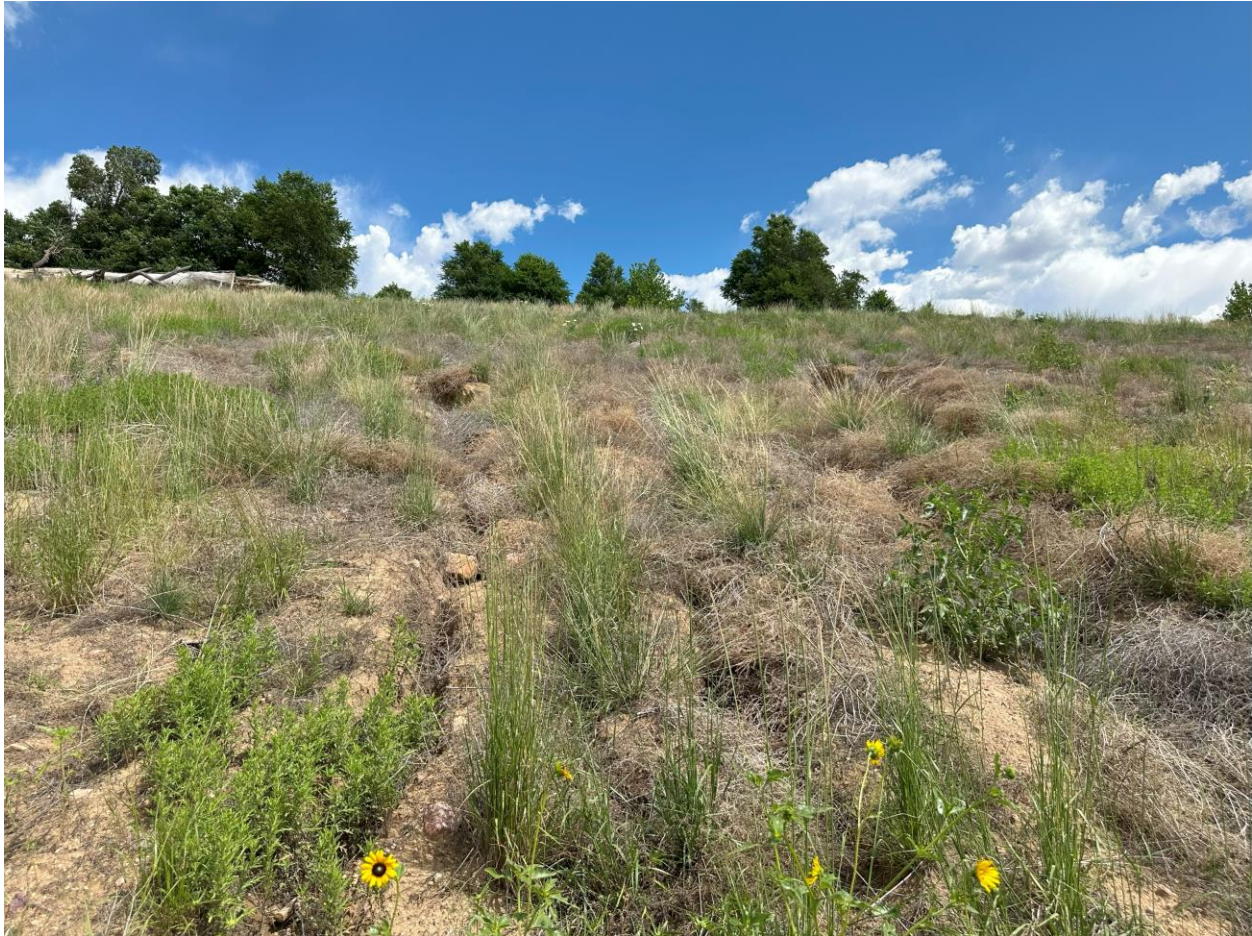
Photo 23. Erosion gullies in buttress
