PERMIT INFORMATION

Permit Number: C-1981-015 Mine Name: Fruita No 1 & 2 Operator: Dorchester Coal Company Operator Address: Greg Lewicki 9054 South Forrest Drive Highlands Ranch, CO 80126	County: Mesa Operation Type: Underground Permit Status: Revoked Ownership: Private
	Operator Representative Present: None
Operator Representative Signature: (Field Issuance Only)

INSPECTION INFORMATION

Inspection Start Date: June 30, 2025 Inspection Start Time: 13:00 Inspection End Date: June 30, 2025 Inspection End Time: 13:45		Inspection Type: Coal Complete Inspection Inspection Reason: Normal I&E Program Weather: Clear	
Joint Inspection Agency: None		Joint Inspection Contacts: None	
Post Inspection Agency: None		Post Inspection Contacts: None	
Inspector(s): Clayton Wein	Inspector's Signature: <i>Clayton Wein</i>		
			Signature Date: 7/14/2025

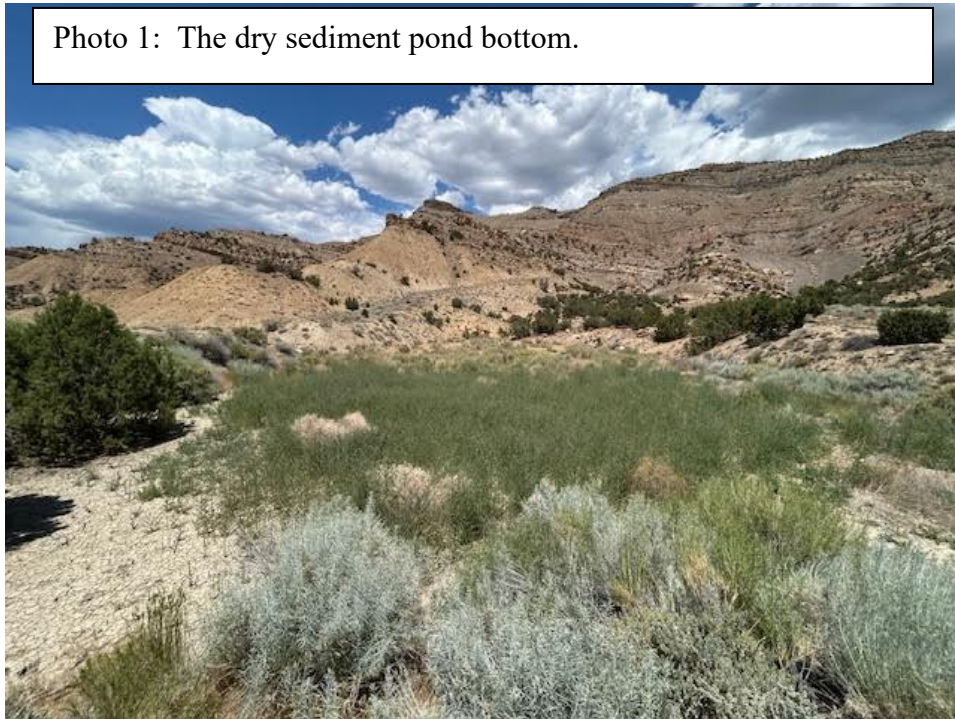
One sediment pond is located in the southern portion of the permit area. The pond treats runoff from the entire reclaimed mine site. The pond was dry during the inspection (Photo 1). The embankments were stable with vegetative cover (Photo 2). No indications of erosion were identified. The pond's outlet is located on the west embankment. The channel was stable with no erosional concerns. The riprap lining was in good condition (Photo 3).

Photo 1: The dry sediment pond bottom.

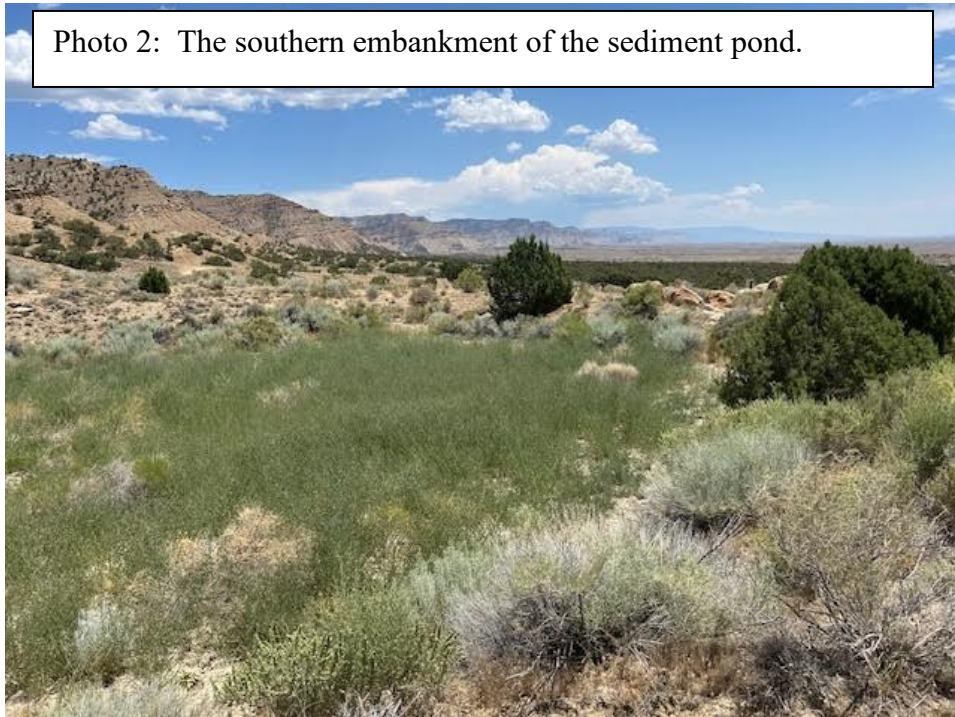
Photo 2: The southern embankment of the sediment pond.

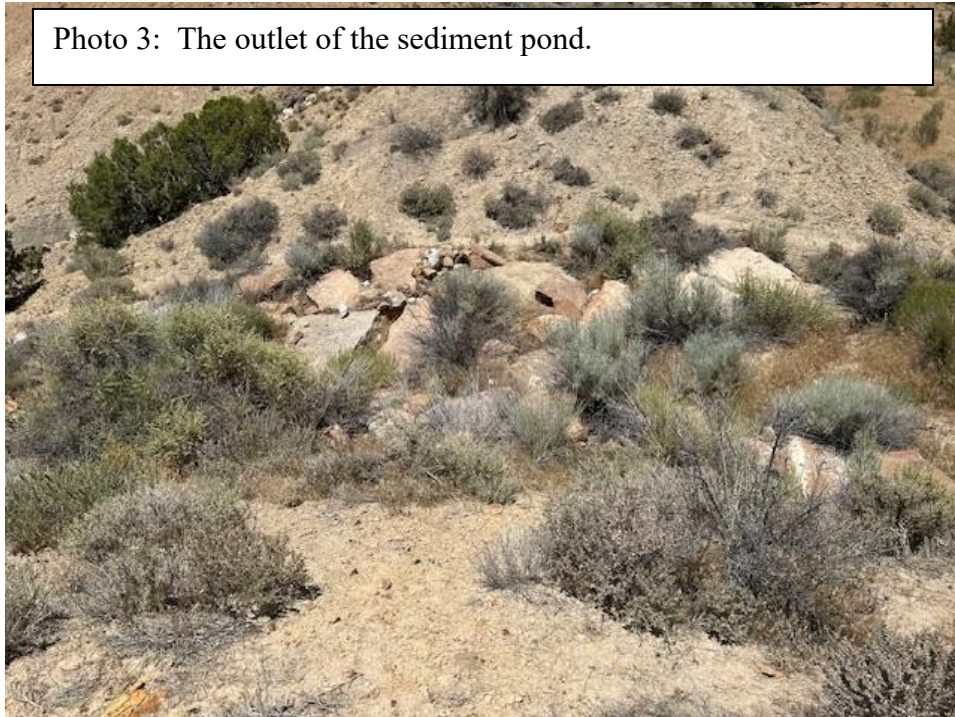
Photo 3: The outlet of the sediment pond.

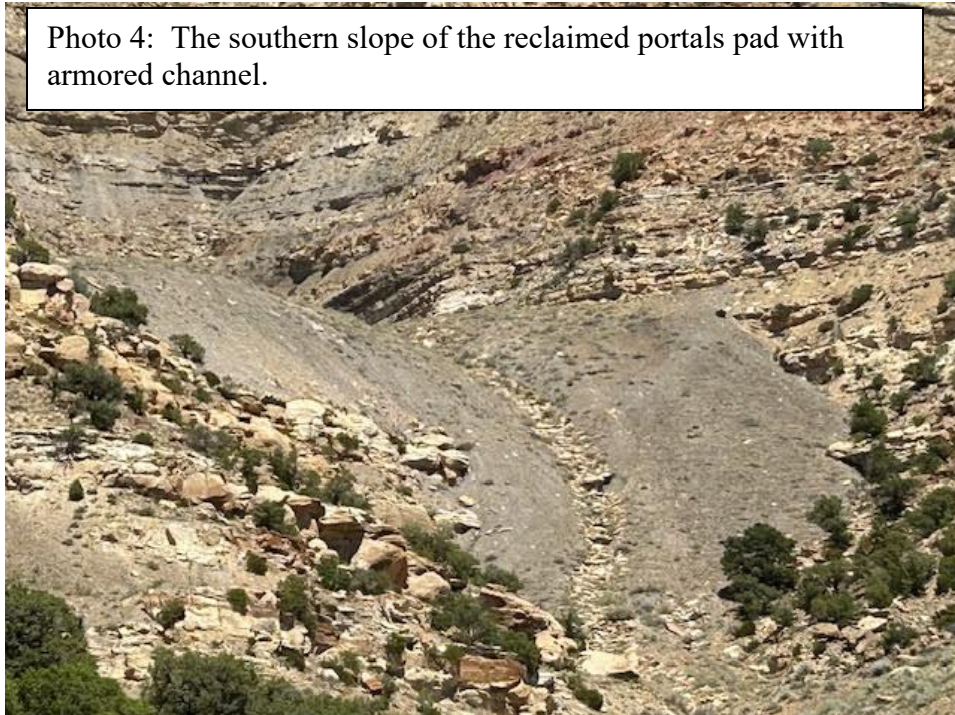
An armored channel extends from the edge of the reclaimed portals bench down to the drainage leading to the sediment pond. The armored channel was in the same condition as the Division's previous site inspection. The channel was stable with no new erosional features. The riprap lining was in good condition (Photo 4). The slope the armored channel is on faces to the south. There is minimal vegetative cover on the slope. Despite this, the slope was stable with no erosional concerns.

Photo 4: The southern slope of the reclaimed portals pad with armored channel.

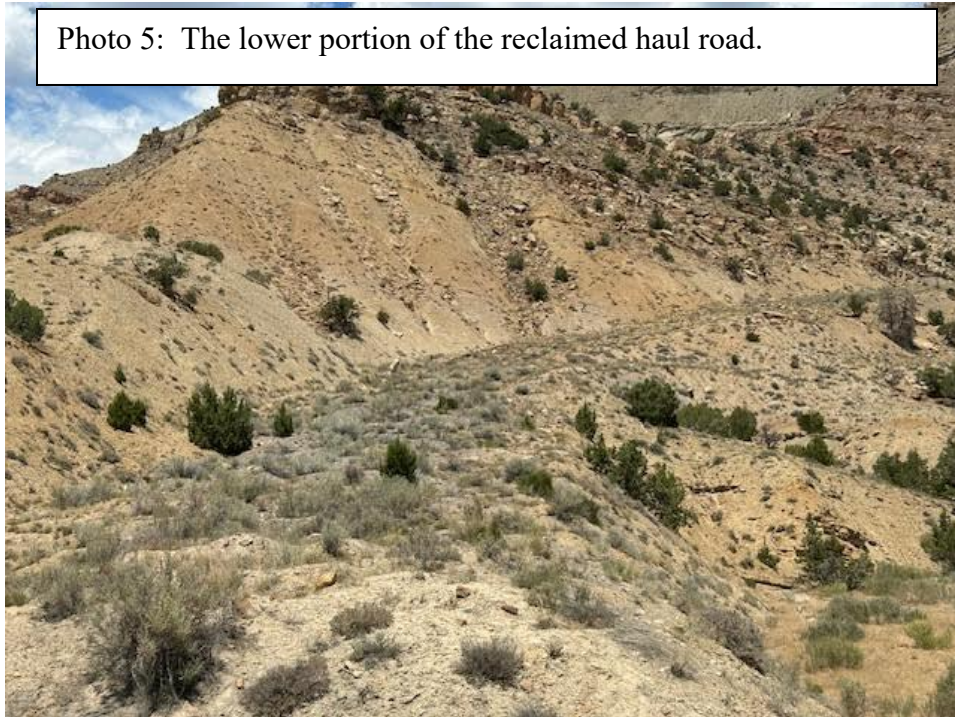
The reclaimed haul road consists of a lower, middle and upper portion. The lower portion extends north from the west embankment of the sediment pond. The lower haul road was stable with no new erosional features (Photo 5). The old erosional rills have been stabilized (Photo 6). Previous Division Inspections have noted the same. The lower haul road reclamation was covered with vegetative growth. The middle portion of the haul road was also stable with vegetative cover (Photo 7). There were no erosional features identified. The upper portion of the reclaimed haul road was vegetated and stable (Photo 8). No erosional concerns were observed. Vegetation on the reclaimed haul road was beginning to dry and brown in the early summer heat. Cut and fill slopes along the length of the reclaimed haul road were stable. There were no erosional features or indications of sloughing observed.

Photo 5: The lower portion of the reclaimed haul road.

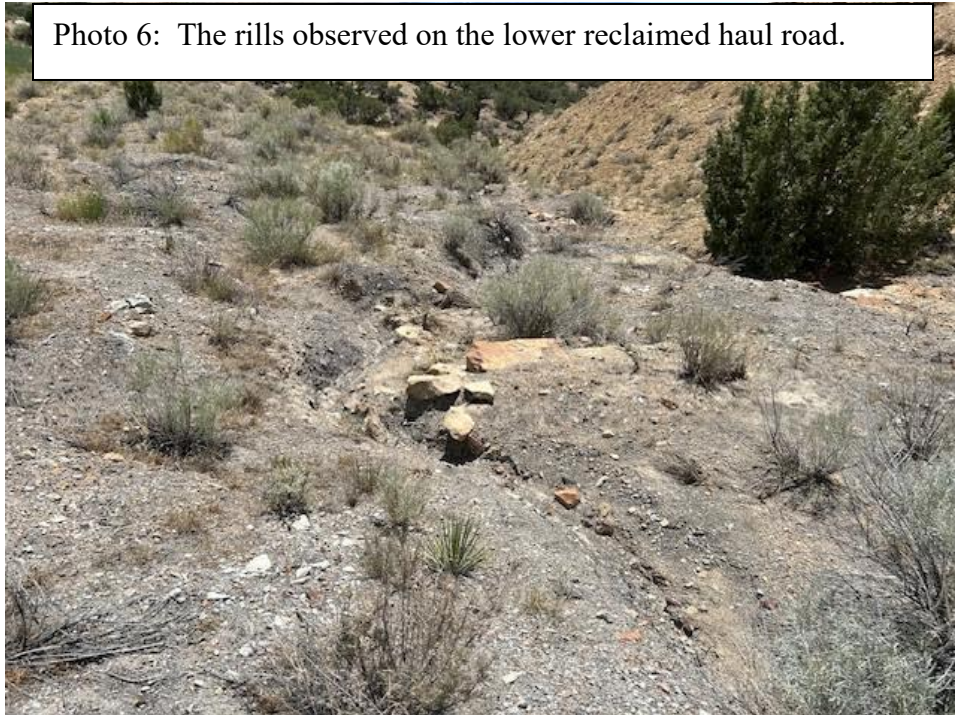
Photo 6: The rills observed on the lower reclaimed haul road.

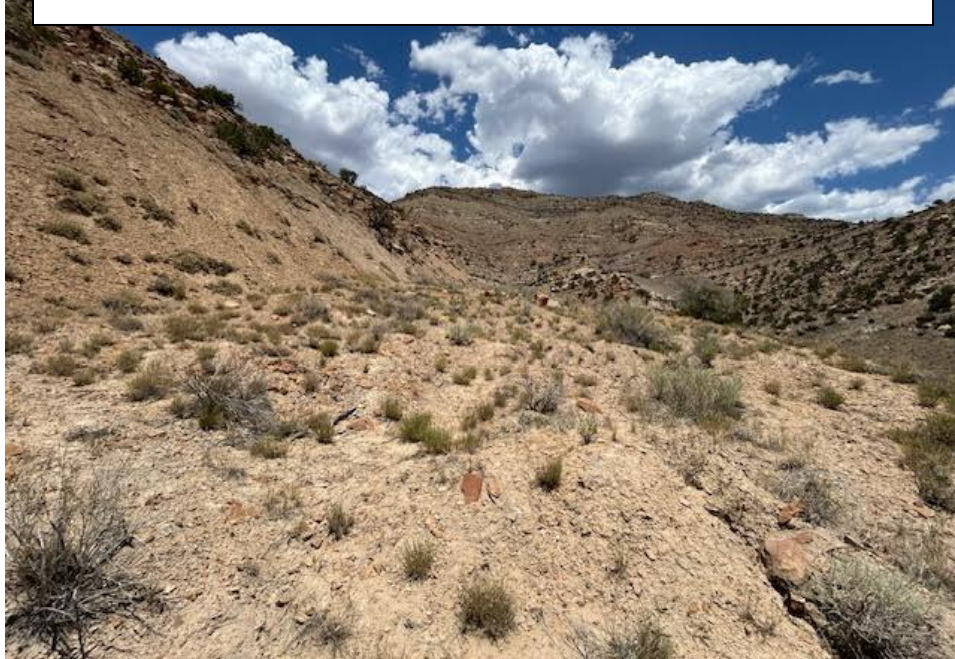
Photo 7: The middle of the reclaimed haul road.

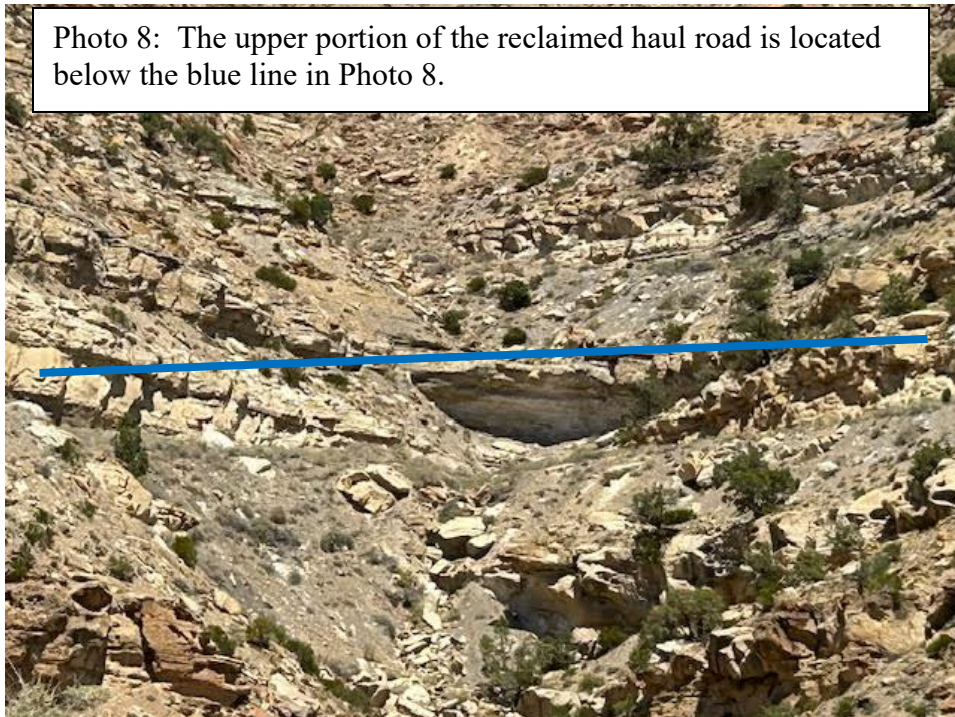
Photo 8: The upper portion of the reclaimed haul road is located below the blue line in Photo 8.
