MINERALS PROGRAM INSPECTION REPORT
PHONE: (303) 866-3567

MINE NAME: White River City Pit	MINE/PROSPECTING ID#: M-2006-084	MINERAL: Gravel and sand	COUNTY: Rio Blanco
INSPECTION TYPE: Monitoring	WEATHER: Clear	INSP. DATE: July 3, 2025	INSP. TIME: 09:15
OPERATOR: Oldcastle SW Group, Inc. dba United Companies	OPERATOR REPRESENTATIVE: Jese Farmer	TYPE OF OPERATION: 112c - Construction Regular Operation	
REASON FOR INSPECTION: Normal I&E Program	BOND CALCULATION TYPE: Complete Bond	BOND AMOUNT: \$539,225.00	
DATE OF COMPLAINT: NA	POST INSP. CONTACTS: DRMS	JOINT INSP. AGENCY: None	
INSPECTOR(S): Amy Yeldell	INSPECTOR'S SIGNATURE:

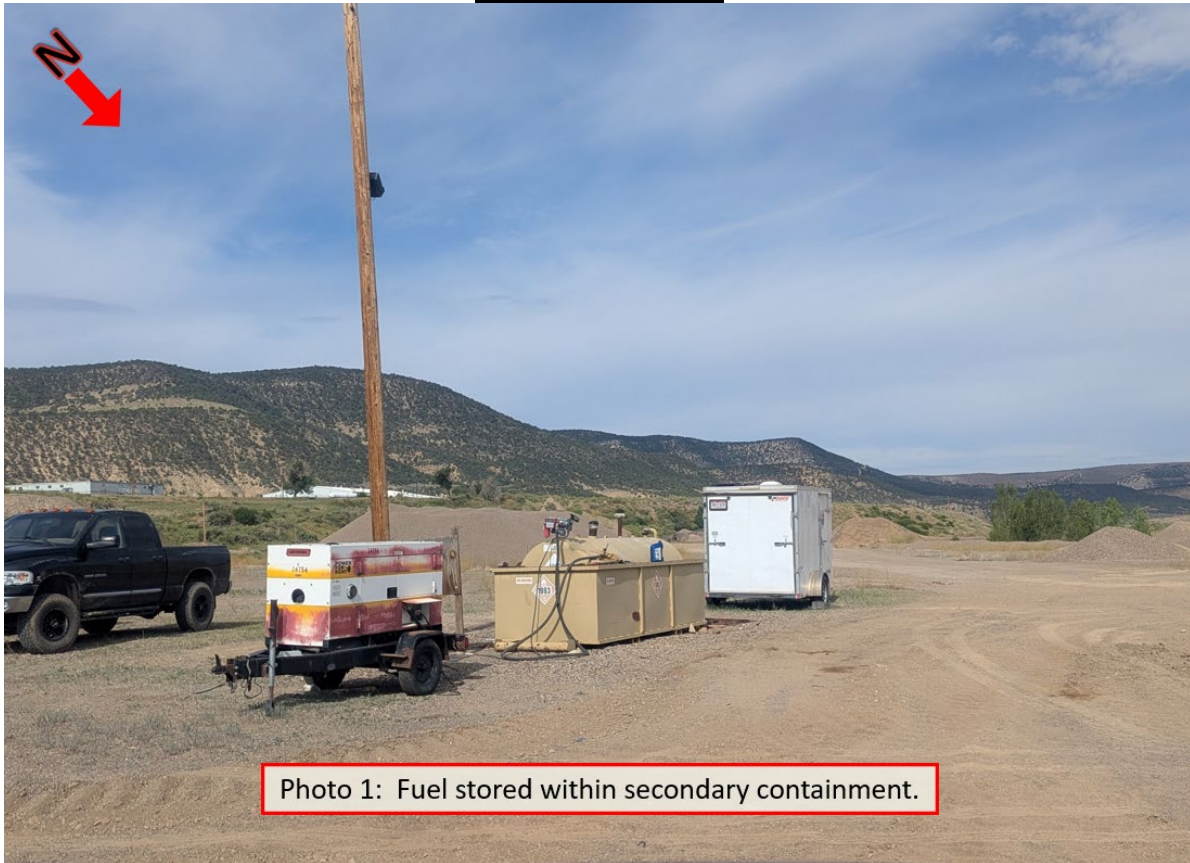
The fuel is stored within secondary containment near the scale house (Photo One). No other hazardous or toxic materials were observed on site.

Photo 1: Fuel stored within secondary containment.

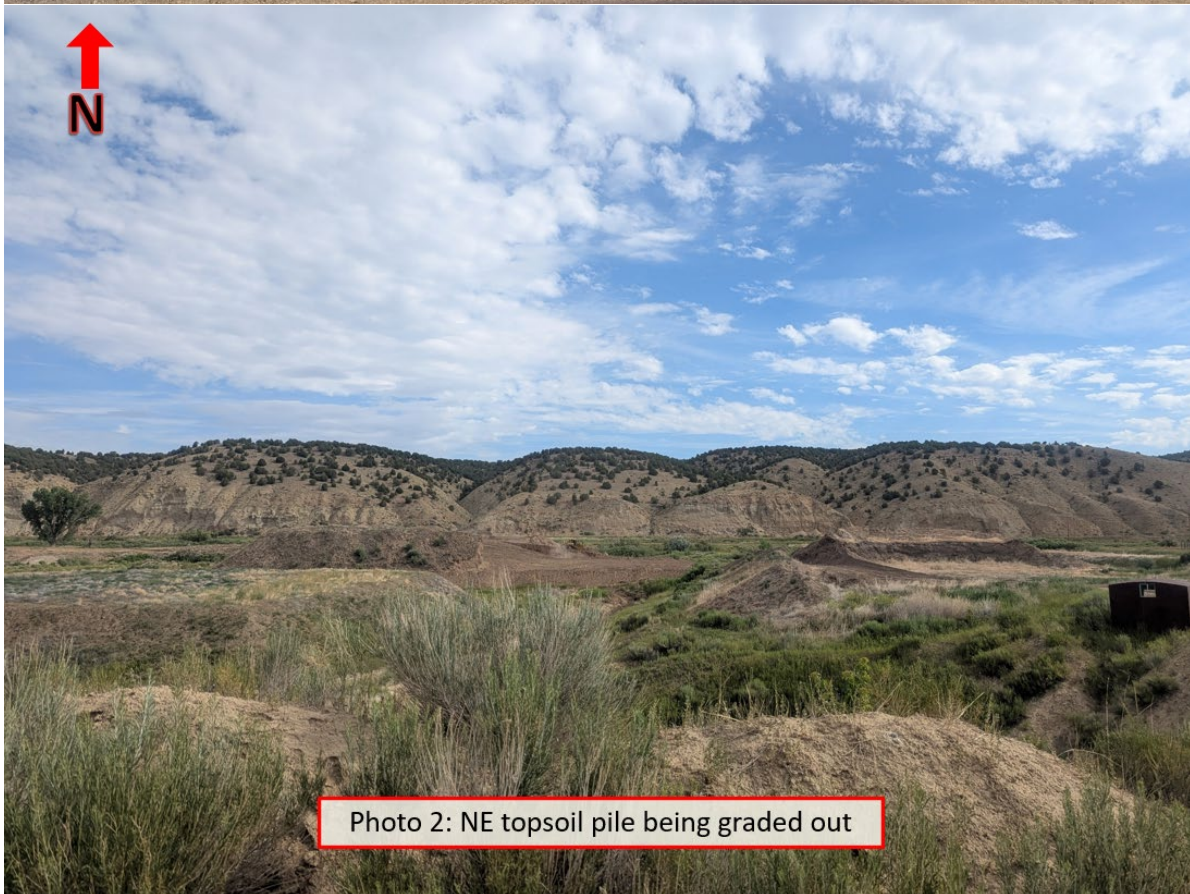
Backfilling and grading was being conducted in the northeast portion of the pit (Photo Two). Topsoil was being reapplied. Some minor regarding to blend is still required. The pit has been mined to a depth of approximately 20 feet.

Photo 2: NE topsoil pile being graded out

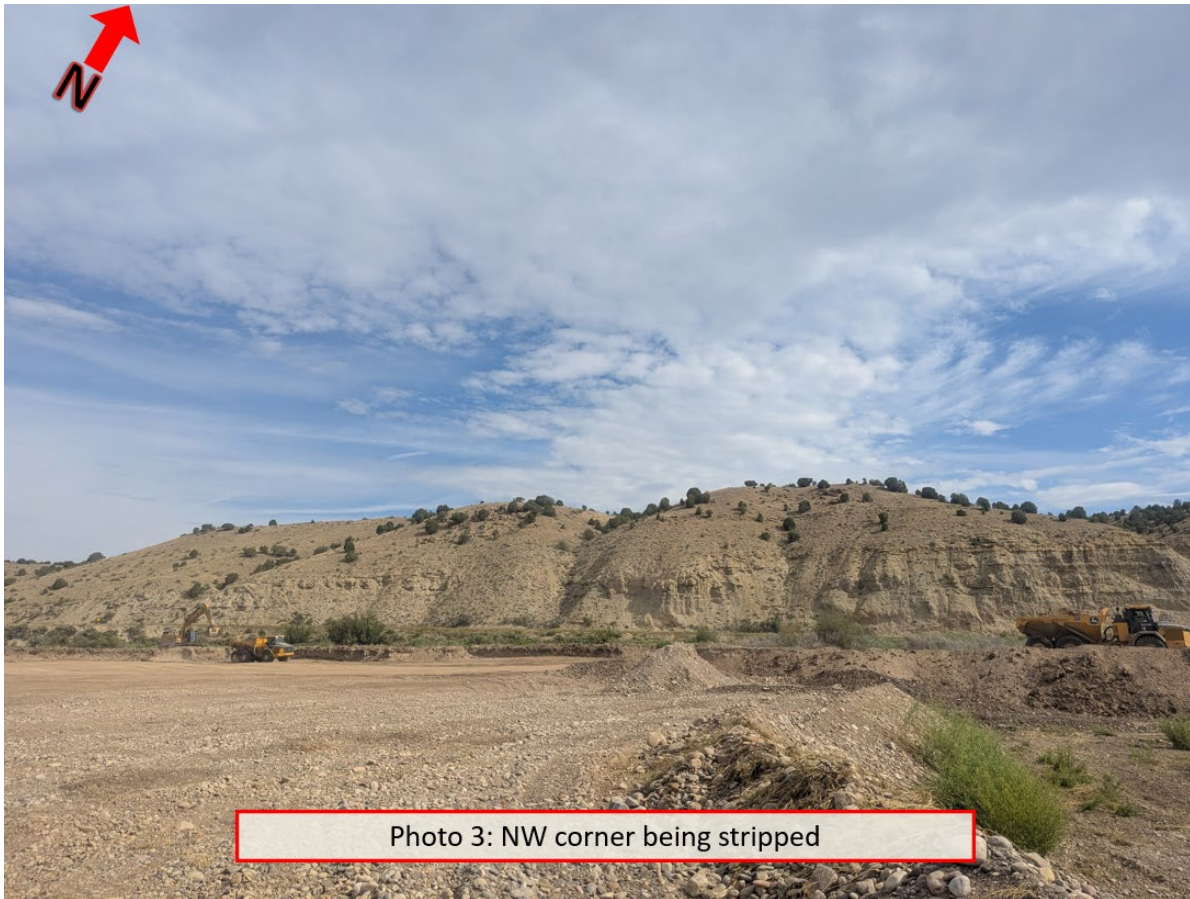
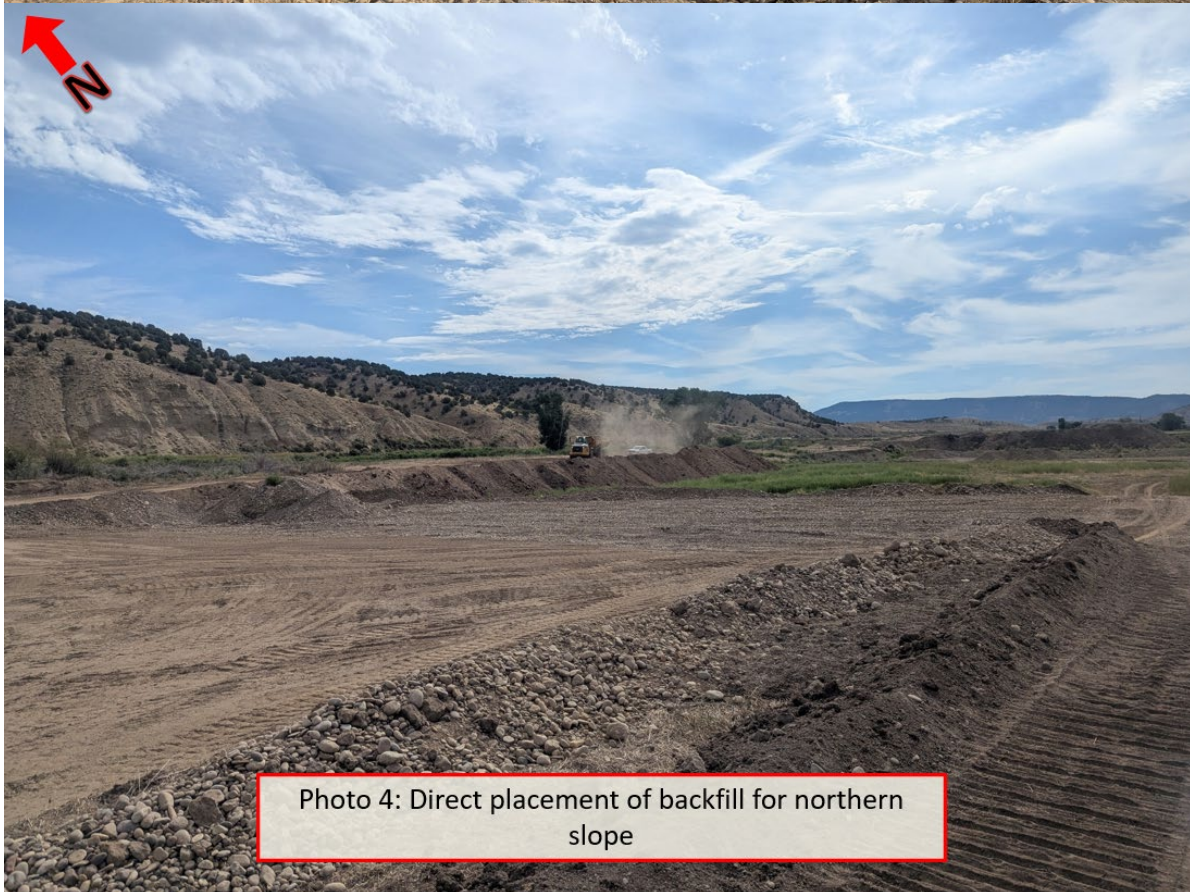
Stripping was occurring in the northwest section of the mine. Overburden was being transported directly to its final placement along the norther portion of the site (Photos Three and Four). Several small piles in a windrow were present approximately 8 feet wide by 200 feet long that require flattening. Additionally in the stripped area a small highwall was present. It is approximately 300 linear feet long cut/fill.

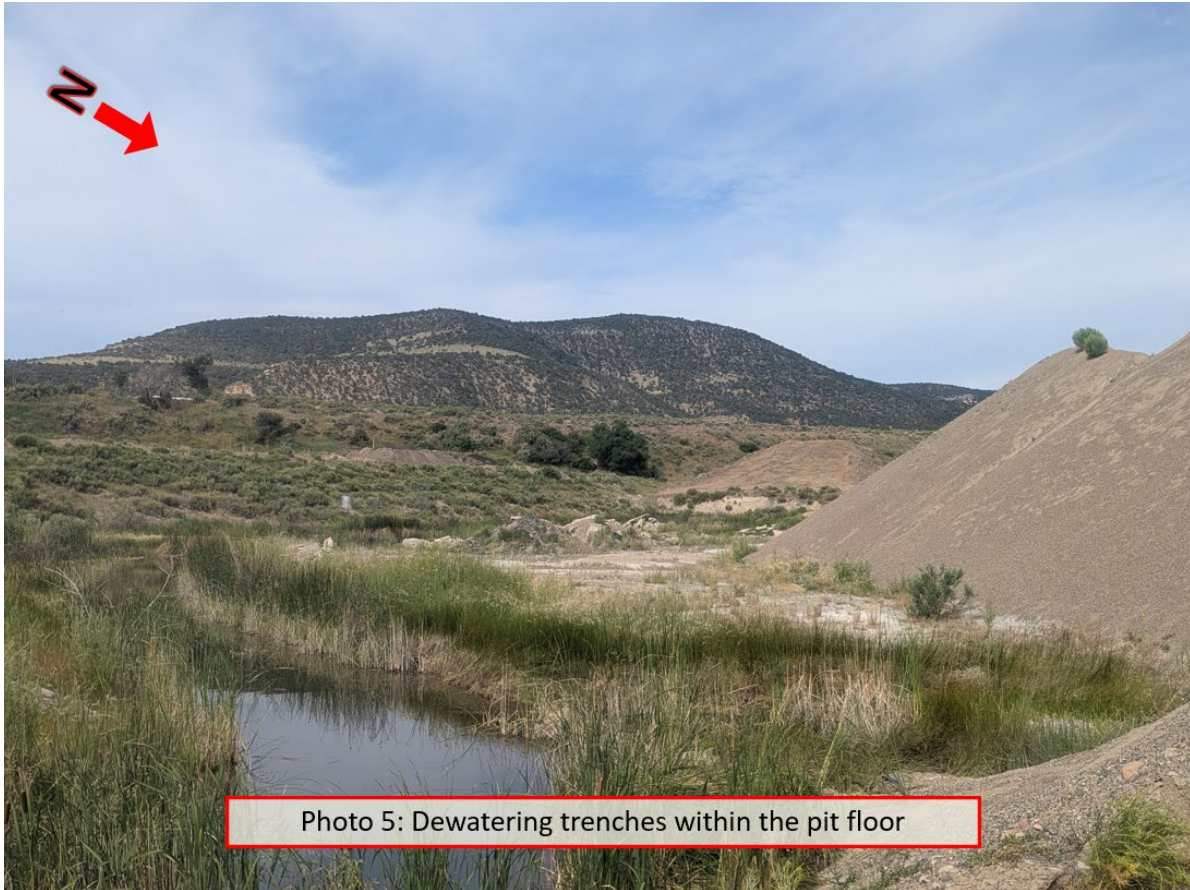
The active mine areas are dewatered via a series of trenches (Photo Five).

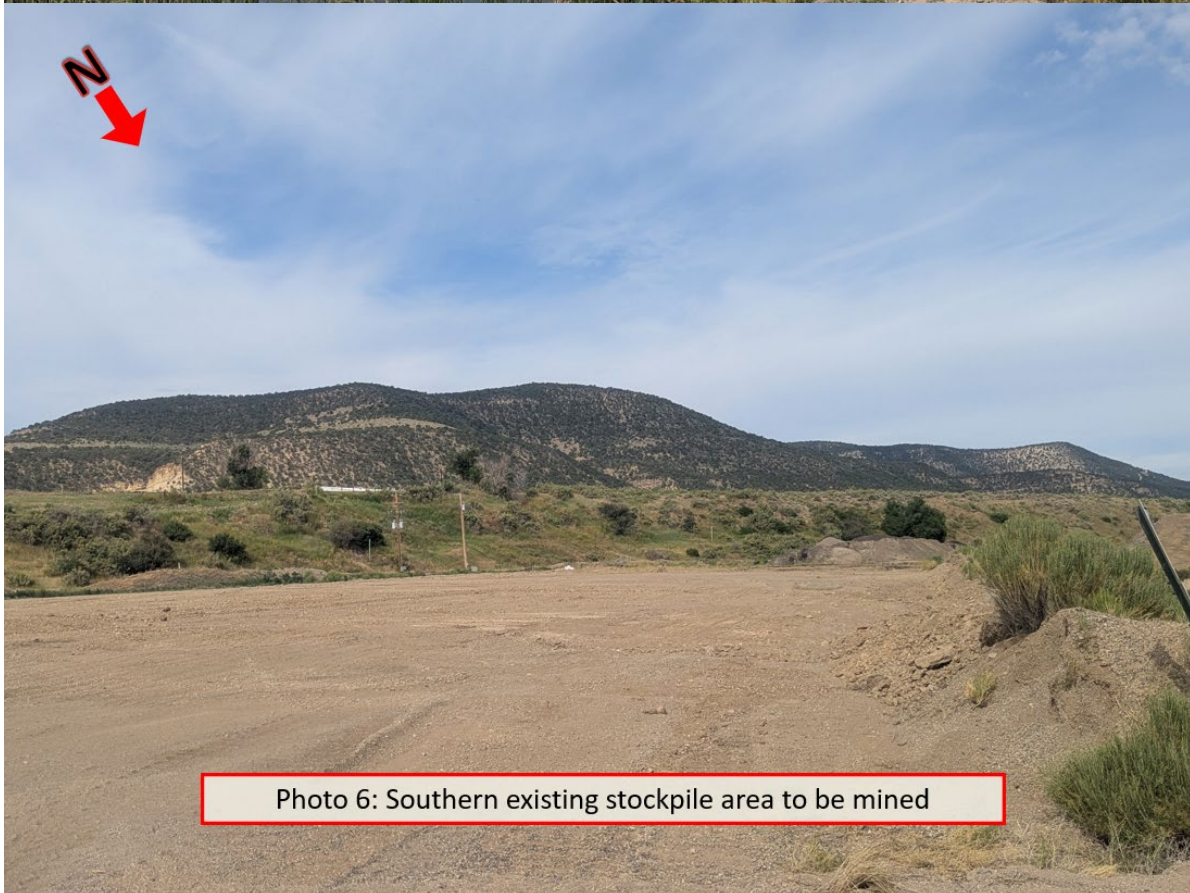
Southern pad bench area remains in place. Currently there are no stockpiles in this area. Per TR-1 portions of this will be mined in the future (Photo Six). No processing equipment was on site. Crushed last occurred over a year ago. Several large stockpiles are present on the pit floor. Some stockpiles of processed material as well as stripped overburden were located along the eastern middle. (Photos Seven through Nine)

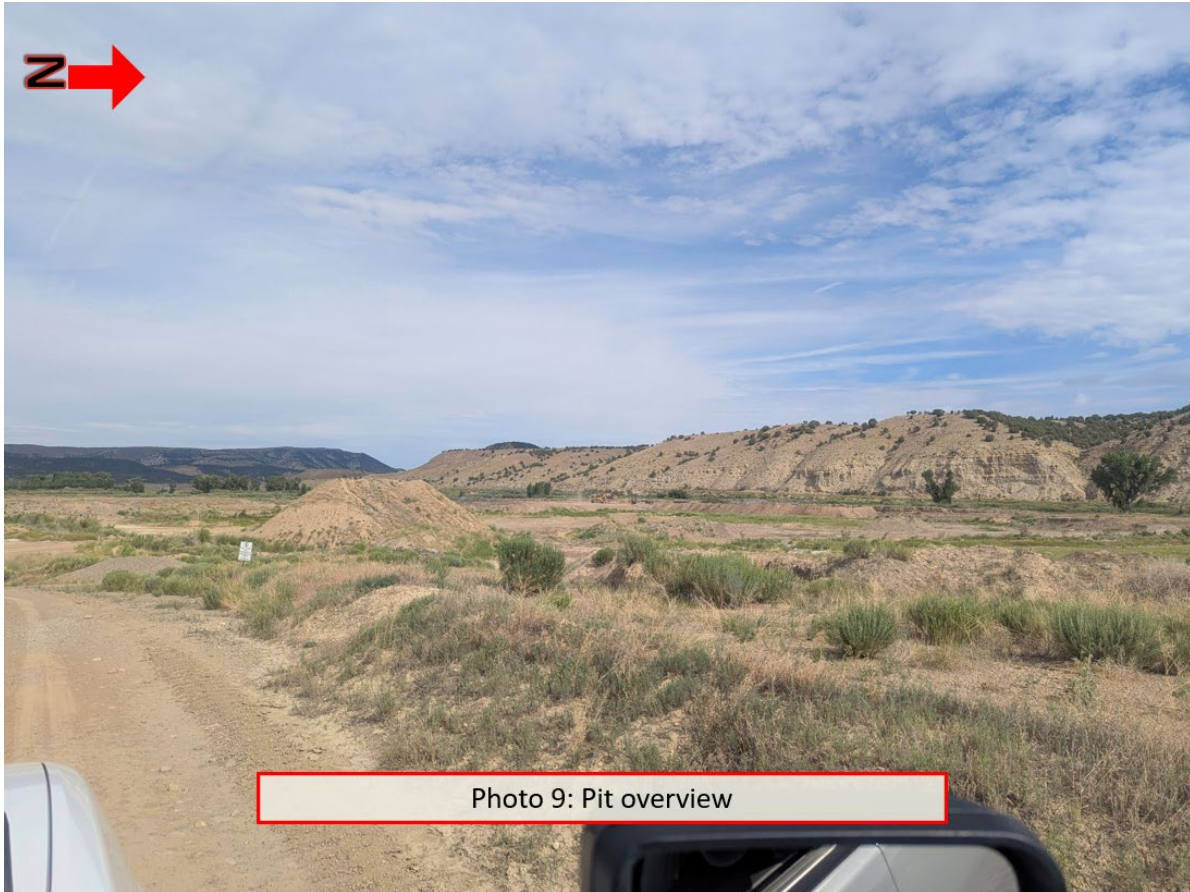
Photo 9: Pit overview

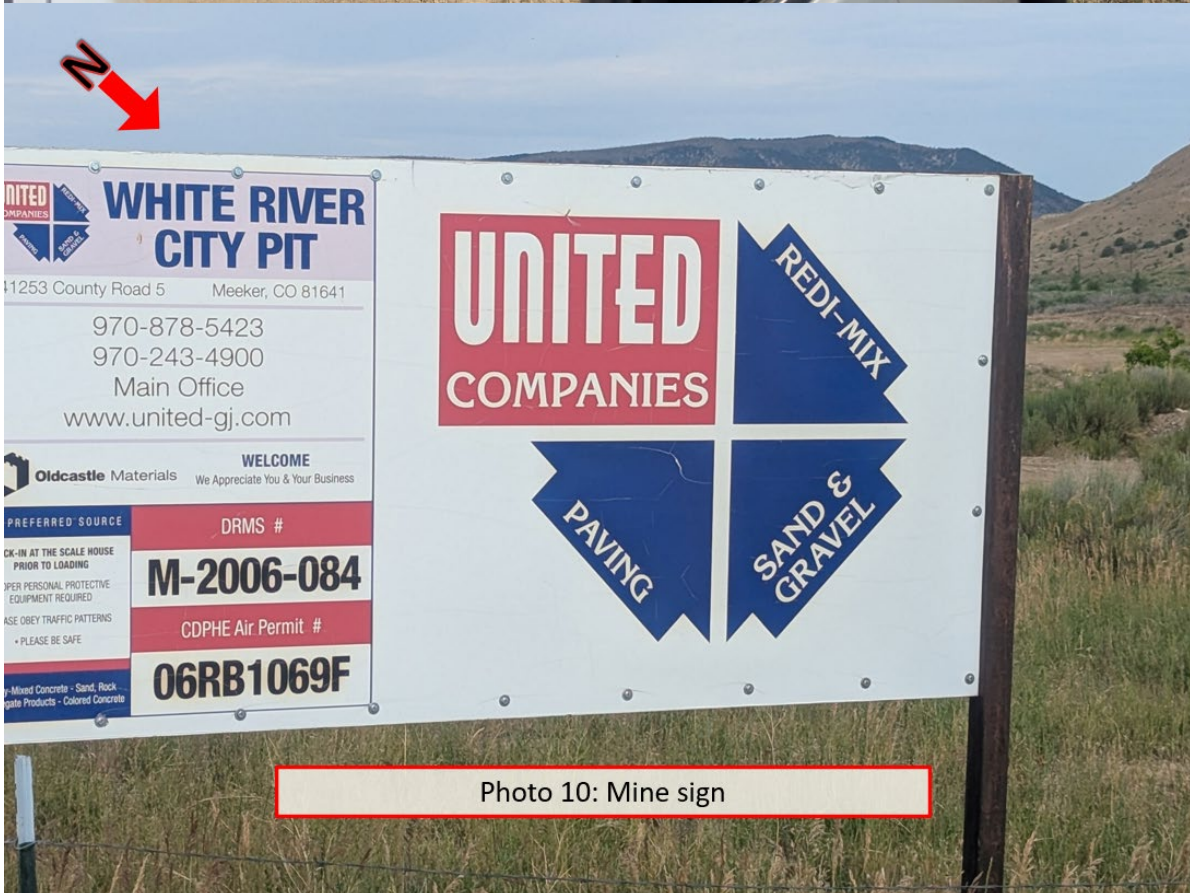
A mine sign was posted at the entrance to the mine site as required by Rule 3.1.12(1). The information depicted was correct/ up to date and the sign was of sufficient size (Photo Ten). The permit boundary of the affected land was clearly delineated primarily by a t-posts pursuant to Rule 3.1.12(2).

Photo 10: Mine sign
