MINERALS PROGRAM INSPECTION REPORT
PHONE: (303) 866-3567

MINE NAME: 31 Road Pit	MINE/PROSPECTING ID#: M-1987-178	MINERAL: Sand and gravel	COUNTY: Mesa
INSPECTION TYPE: Monitoring	WEATHER: Clear	INSP. DATE: July 8, 2025	INSP. TIME: 09:00
OPERATOR: Parkerson Construction, Inc.	OPERATOR REPRESENTATIVE: Eric Valdez	TYPE OF OPERATION: 112c - Construction Regular Operation	
REASON FOR INSPECTION: Normal I&E Program	BOND CALCULATION TYPE: Complete Bond	BOND AMOUNT: \$505,455.00	
DATE OF COMPLAINT: NA	POST INSP. CONTACTS: DRMS	JOINT INSP. AGENCY: None	
INSPECTOR(S): Amy Yeldell	INSPECTOR'S SIGNATURE:

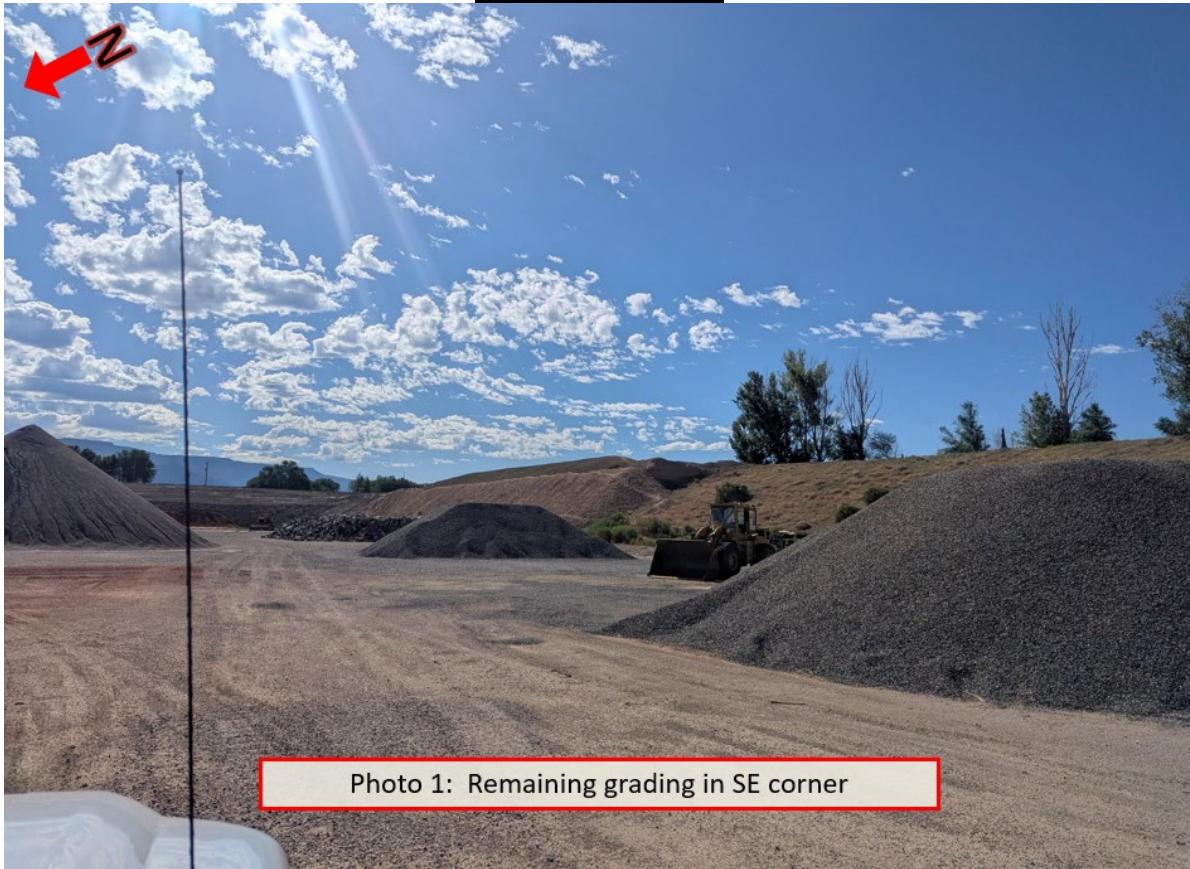
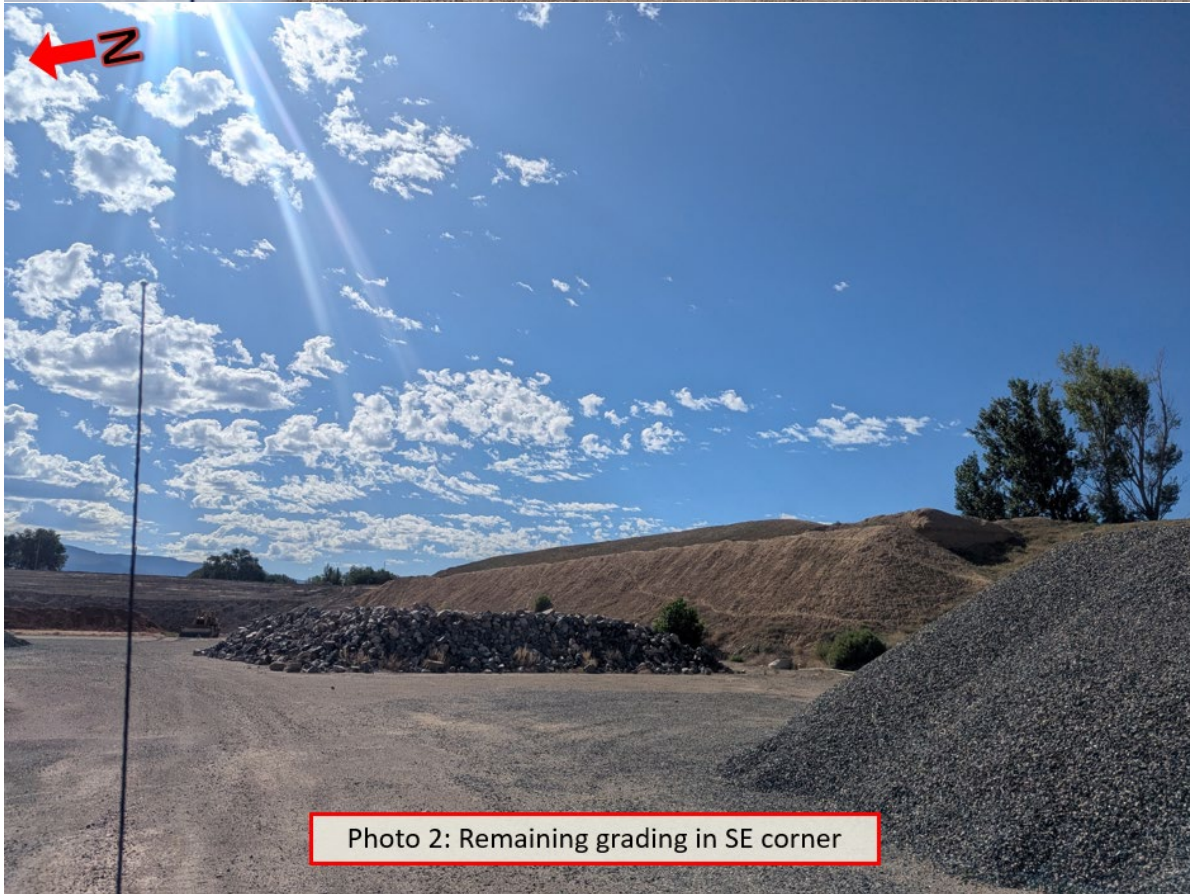
Since the previous inspection, the majority of grading in the southeast corner has taken place. Approximately 100 yard of 1H: 1V slope remains and can be pushed down (Photo One Thru Three). Topsoil stockpiled above the slope has not been replaced yet. Highwalls along the northeast corner also require some regarding as well as the final MSHA berm along the north side of the pit (Photo Four). The western permit boundary abuts to already release agricultural fields and also have no additional grading necessary.

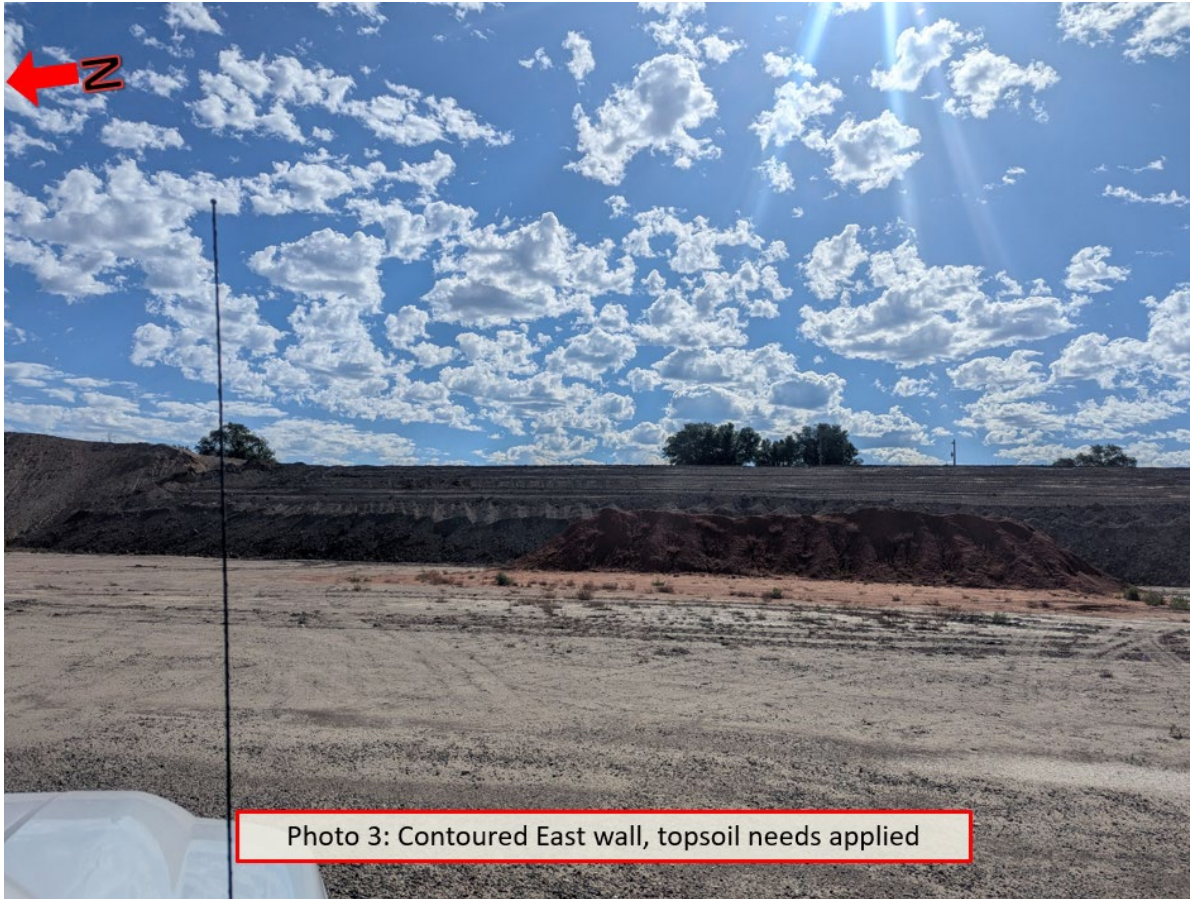
Photo 3: Contoured East wall, topsoil needs applied

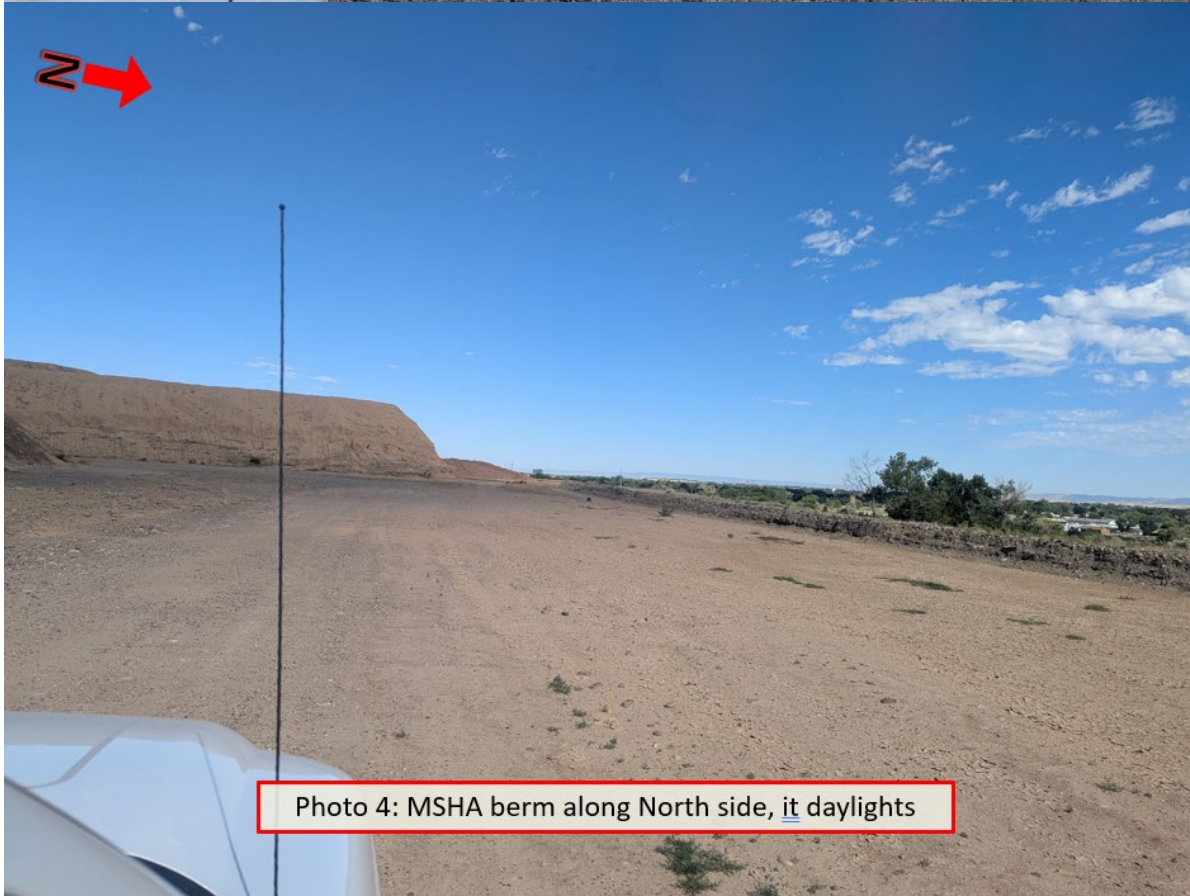
Photo 4: MSHA berm along North side, it daylights

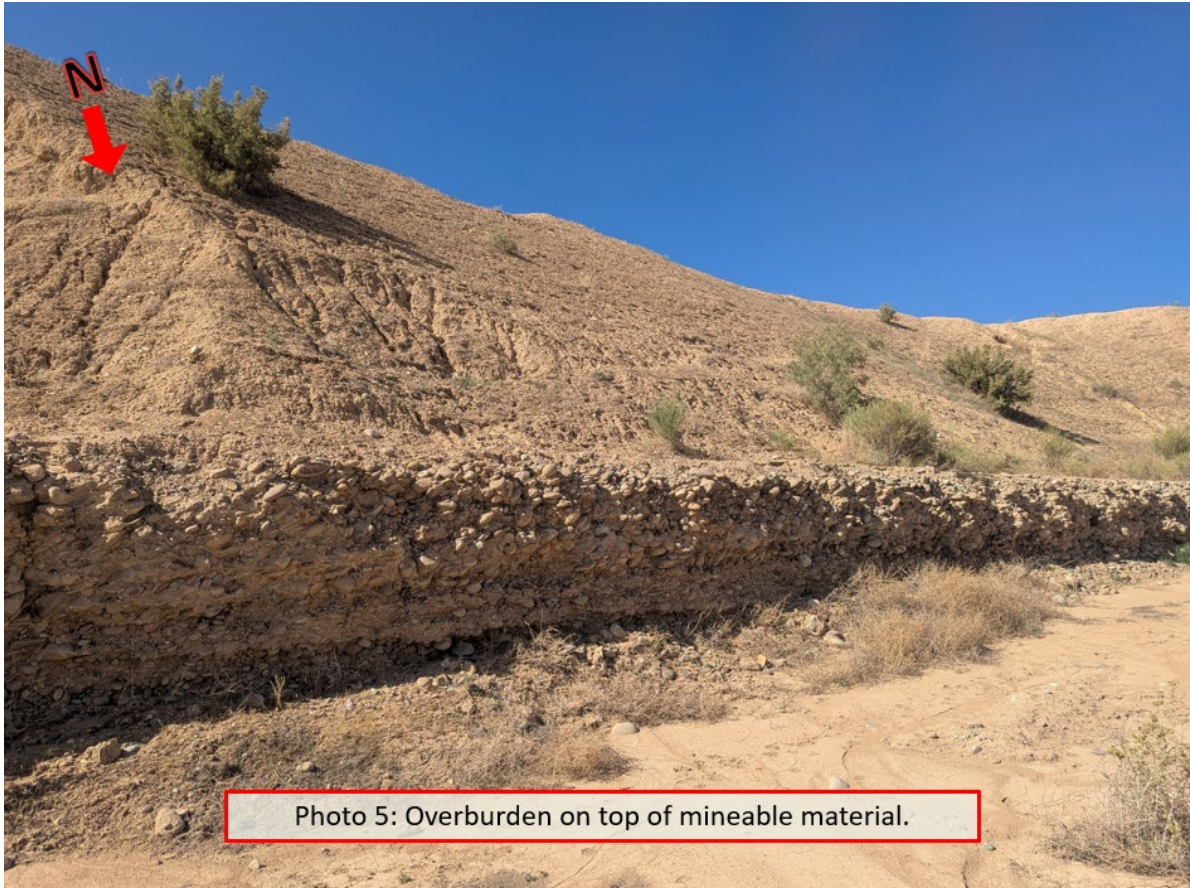
Two large stockpiles of overburden remain in the northeast corner to be applied over the pit floor. Similarly along the northern side of the pit is a stockpile. There is minable material under this pile (Photo Six).

Photo 5: Overburden on top of mineable material.

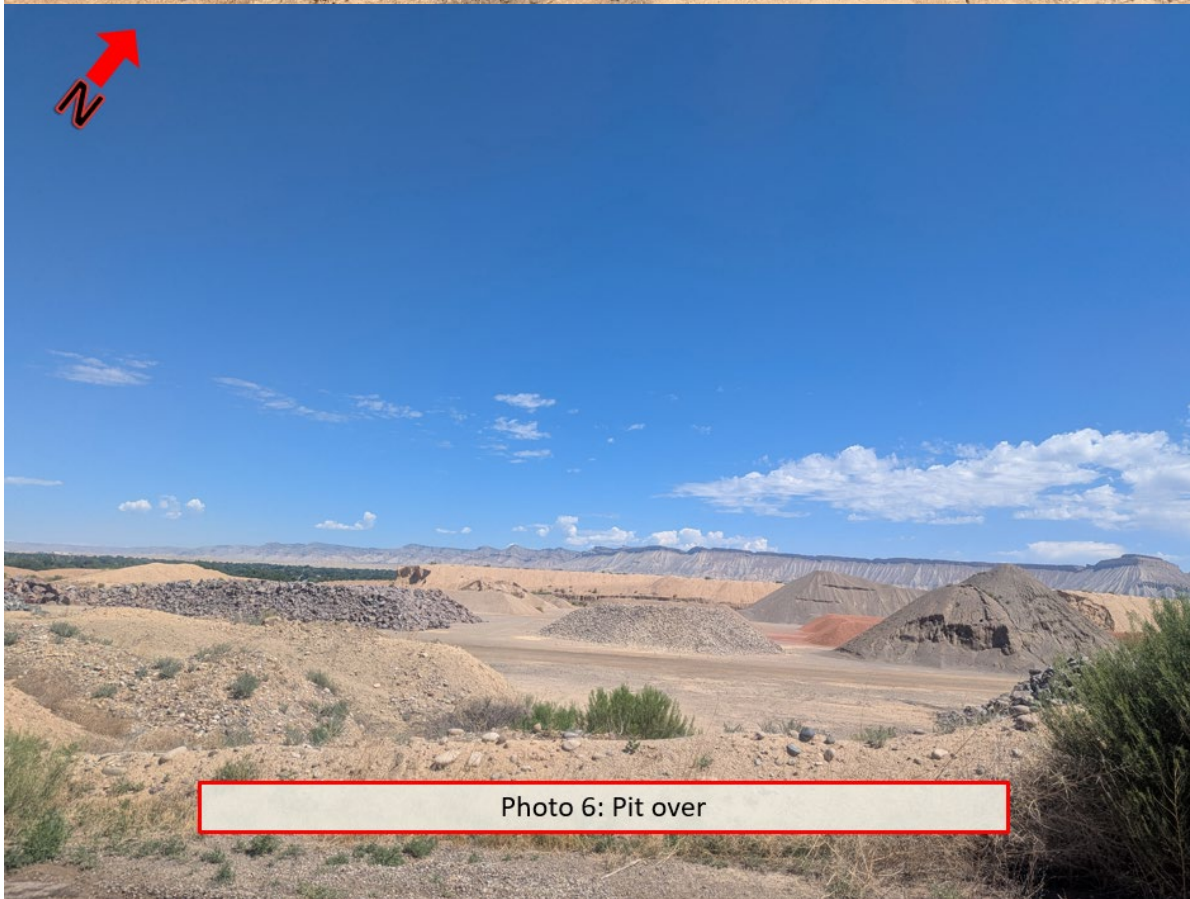
The site was active at the time of the inspection. To date the entire permit area has been affected and the site is nearly completely mined out. There is some remaining material under an overburden stockpile along the northeast side of the pit (approximately 4 ac). (Photos Six thru Eight)

Photo 6: Pit over
