MINERALS PROGRAM INSPECTION REPORT
PHONE: (303) 866-3567

MINE NAME: Valley Vista Pit	MINE/PROSPECTING ID#: M-1981-229	MINERAL: Sand and gravel	COUNTY: Mesa
INSPECTION TYPE: Monitoring	WEATHER: Clear	INSP. DATE: July 8, 2025	INSP. TIME: 10:30
OPERATOR: Parkerson Construction, Inc.	OPERATOR REPRESENTATIVE: Eric Valdez	TYPE OF OPERATION: 112c - Construction Regular Operation	
REASON FOR INSPECTION: Normal I&E Program	BOND CALCULATION TYPE: Partial Bond	BOND AMOUNT: \$77,800.00	
DATE OF COMPLAINT: NA	POST INSP. CONTACTS: DRMS	JOINT INSP. AGENCY: None	
INSPECTOR(S): Amy Yeldell	INSPECTOR'S SIGNATURE:

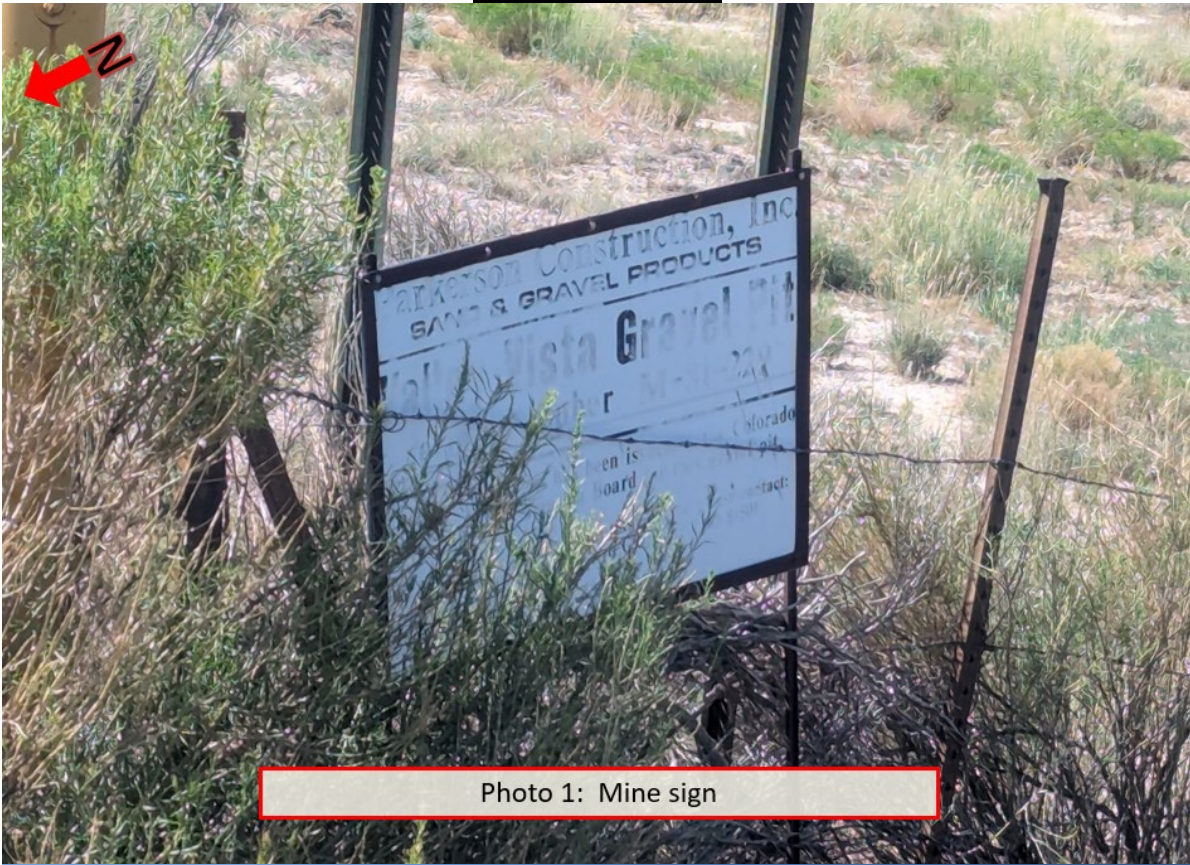
A mine sign was posted at the entrance to the mine site as required by Rule 3.1.12(1). The information depicted was correct/ up to date and the sign was of sufficient size . The permit boundary of the affected land was clearly delineated pursuant to Rule 3.1.12(2).

Photo 1: Mine sign

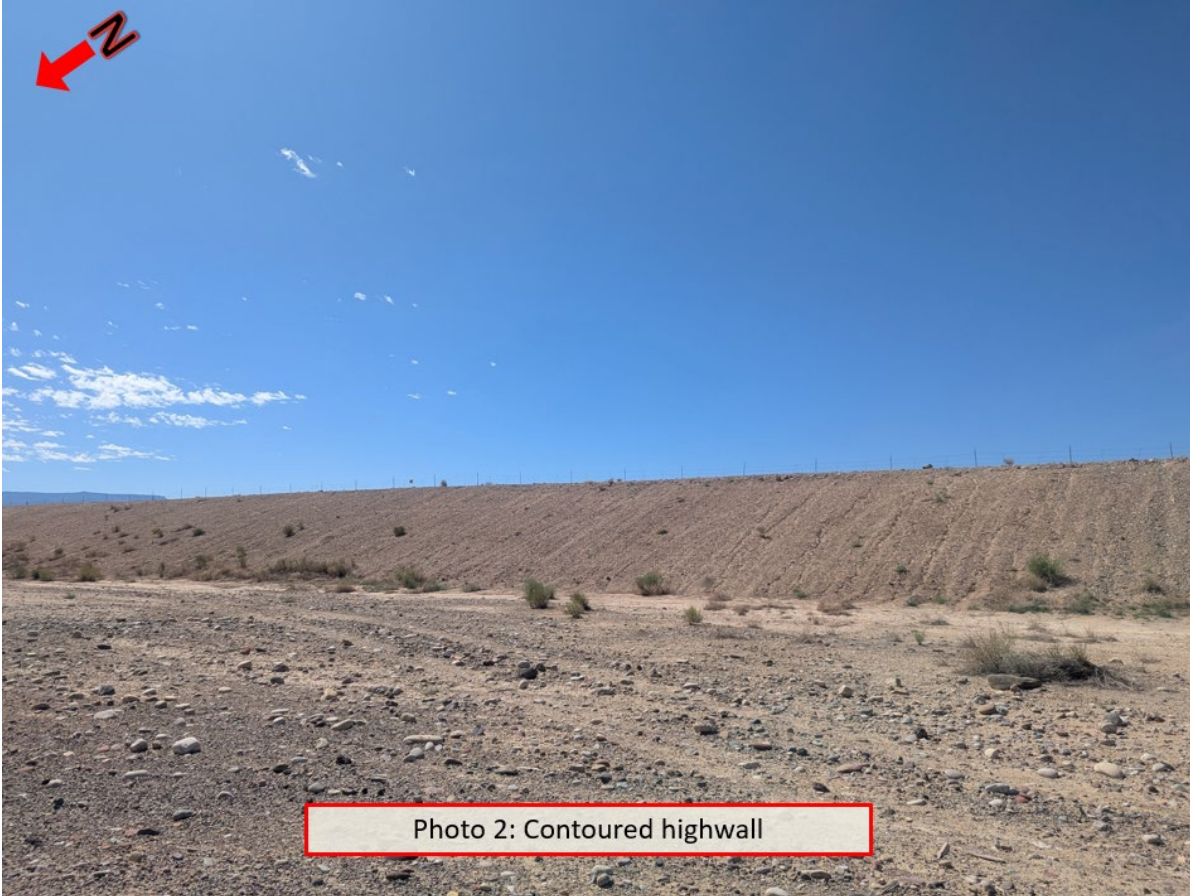
All slopes have been graded to a 3H:1V or less and blend well with the surrounding topography.

Photo 2: Contoured highwall

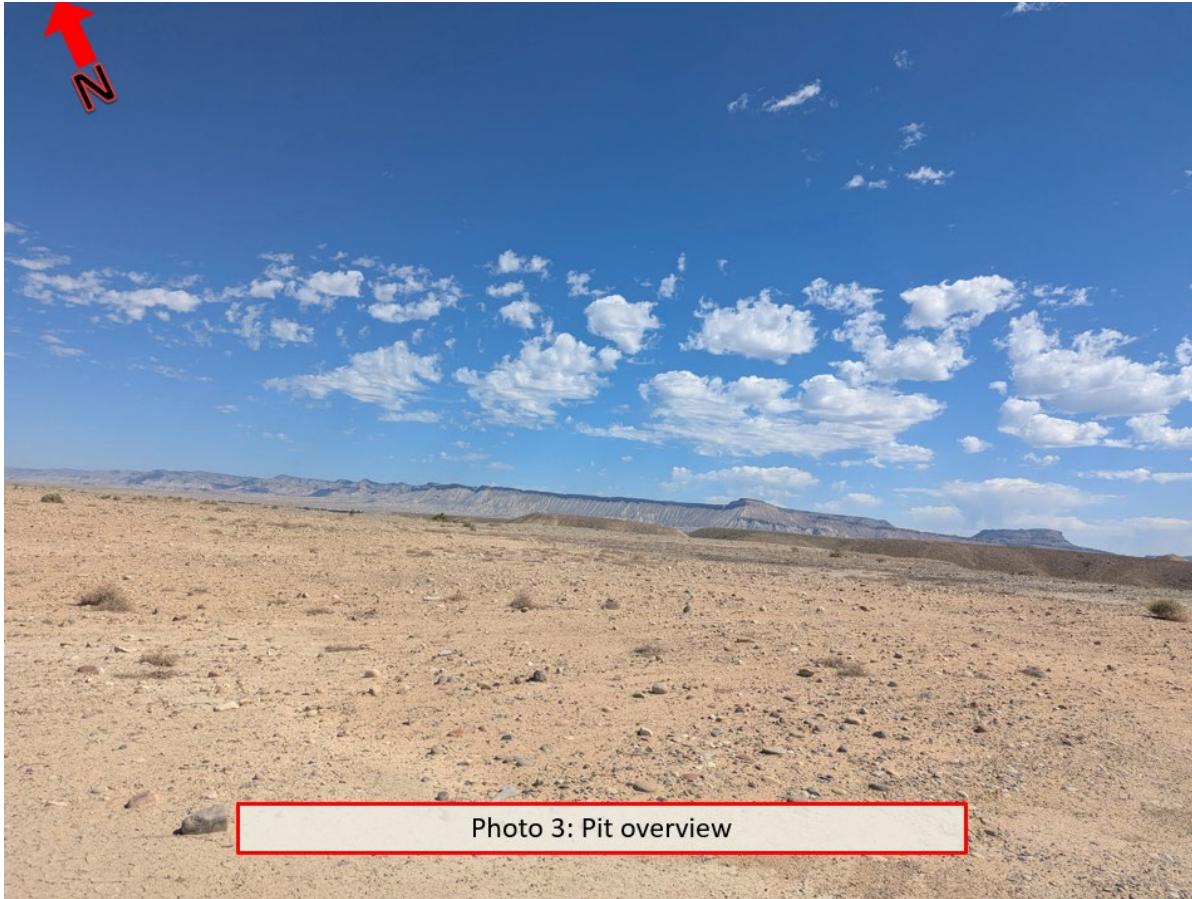
Photo 3: Pit overview

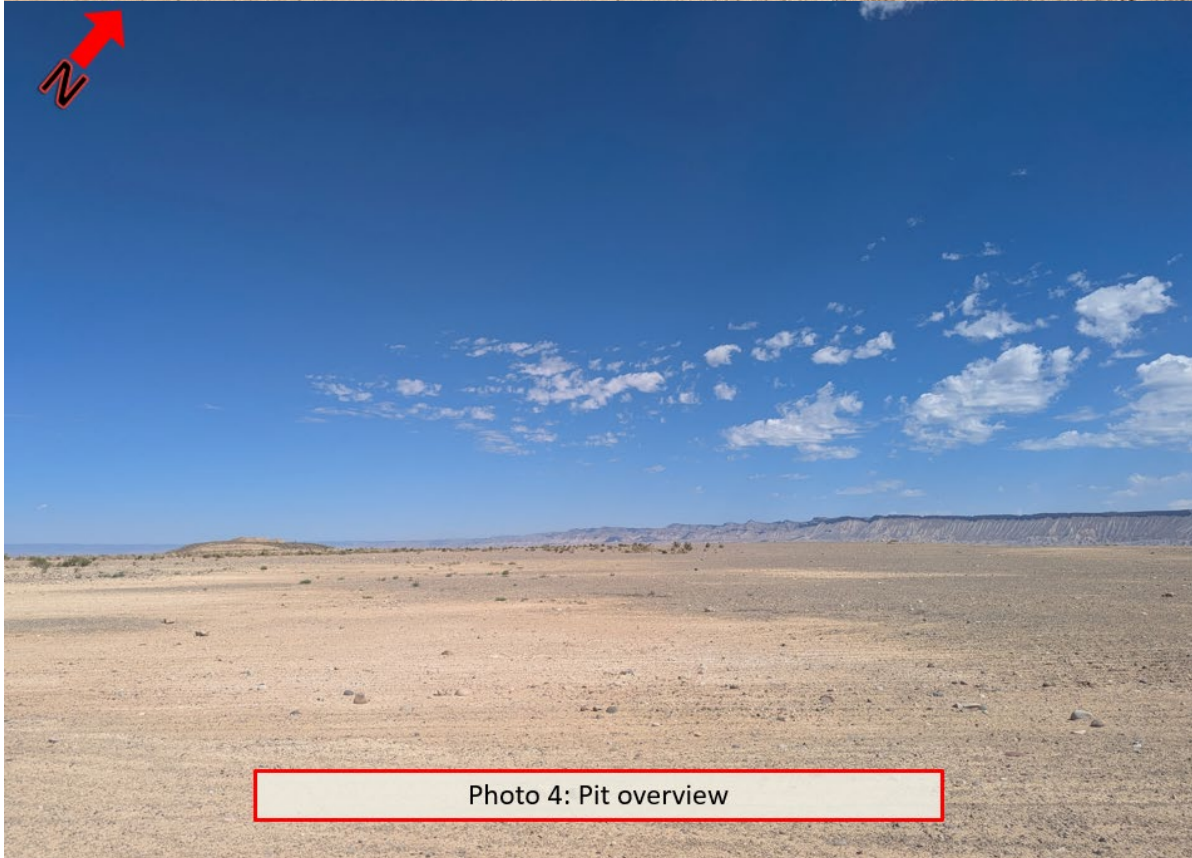
Photo 4: Pit overview
