Inspection reports

COLORADO

Division of Reclamation,
Mining and Safety

Permit Number: C-1992-081 Mine Name: Hayden Gulch Loadout Operator: Hayden Gulch Terminal, LLC Operator Address: Ms. Miranda Kawcak 29515 Routt County Road 27 Oak Creek, CO 80467	County: Routt Operation Type: Loadout Permit Status: Active Ownership: Private
	Operator Representative Present: N/a
Operator Representative Signature: (Field Issuance Only)

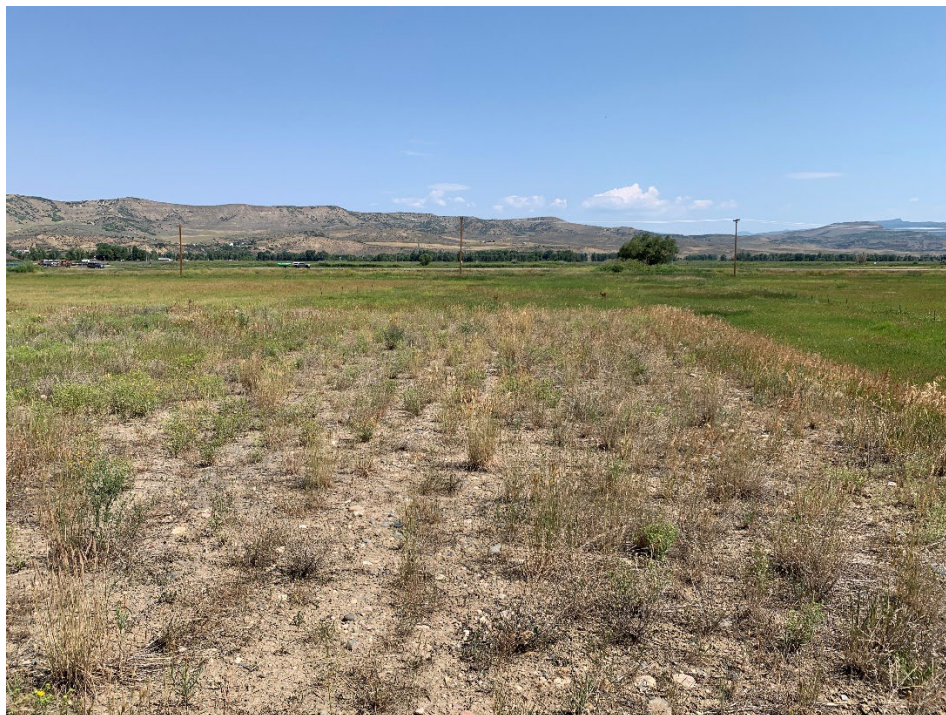
The grasses on the lower section of the reclamation were green. The grasses in the upland areas, especially near the trailhead parking lot were dry and beginning to turn brown (photo 1). Several Canada thistle, bull thistle and houndstongue plants were seen that need to be treated.

Photo 1- Upland areas is turning brown, subirrigated areas are still green.

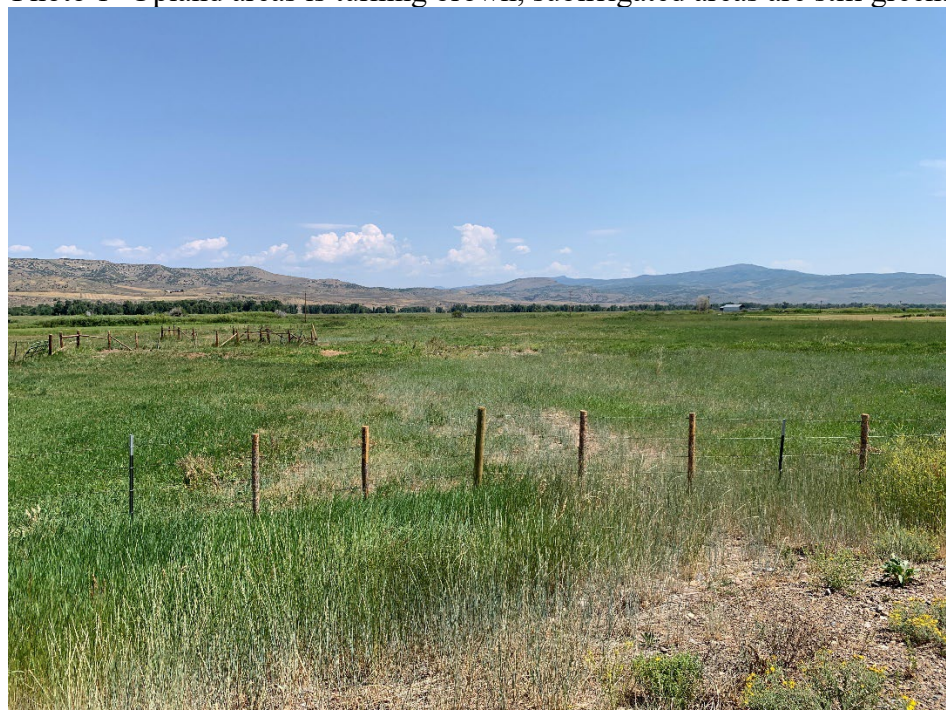
No cattle were seen grazing on the reclamation north of Hwy 40, although the gates to the adjacent field were open. The grasses were green on the northern area indicating the groundwater was still high enough for subirrigation (photo 2).

Photo 2- Reclamation area north of Hwy 40.
