M2018057, Old Town Reclamation Project, July 2025 Inspection Report

MINERALS PROGRAM INSPECTION REPORT
PHONE: (303) 866-3567

MINE NAME: Old Town Reclamation Project	MINE/PROSPECTING ID#: M-2018-057	MINERAL: Silver, gold, lead, zinc	COUNTY: Gilpin
INSPECTION TYPE: Monitoring	WEATHER: Clear	INSP. DATE: July 18, 2025	INSP. TIME: 09:00
OPERATOR: Venture Resources, Inc.	OPERATOR REPRESENTATIVE: N/A	TYPE OF OPERATION: 110d - Designated Limited Impact	
REASON FOR INSPECTION: Citizen Complaint	BOND CALCULATION TYPE: None	BOND AMOUNT: \$24,387.00	
DATE OF COMPLAINT: NA	POST INSP. CONTACTS: None	JOINT INSP. AGENCY: None	
INSPECTOR(S): Leigh Simmons	INSPECTOR'S SIGNATURE:

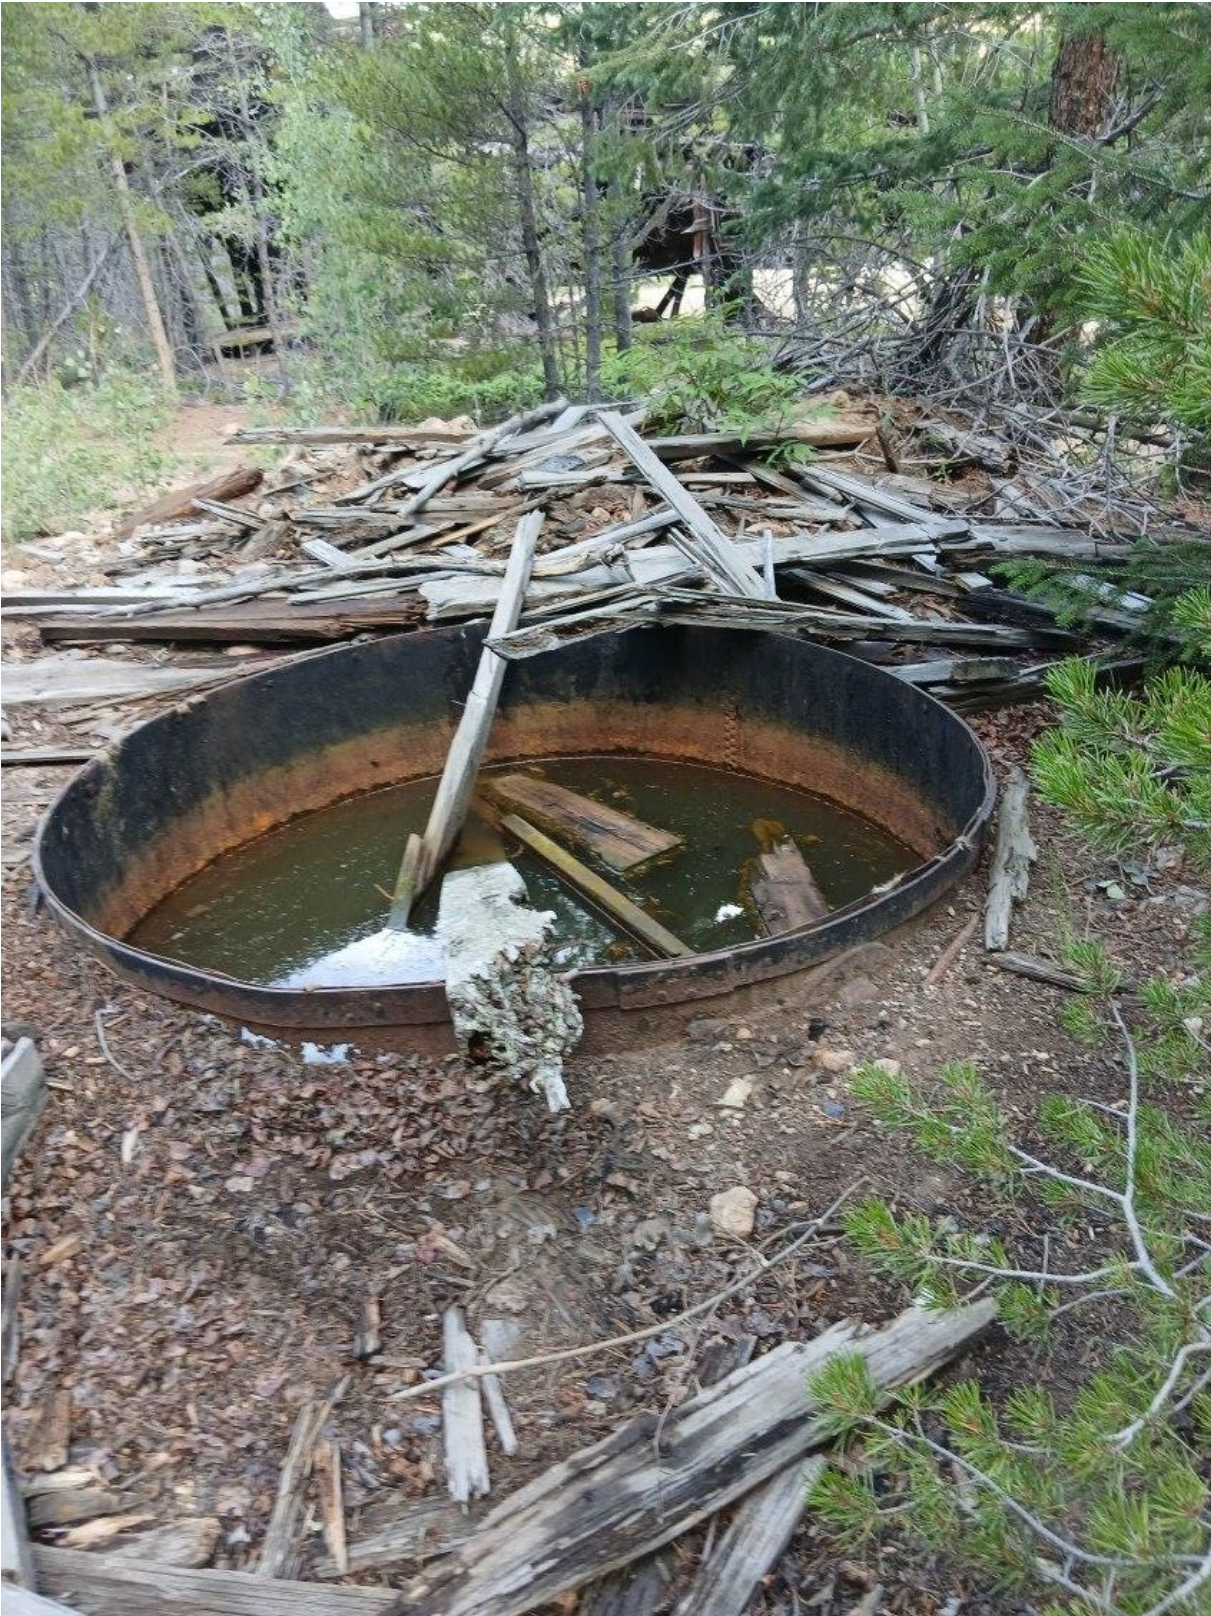
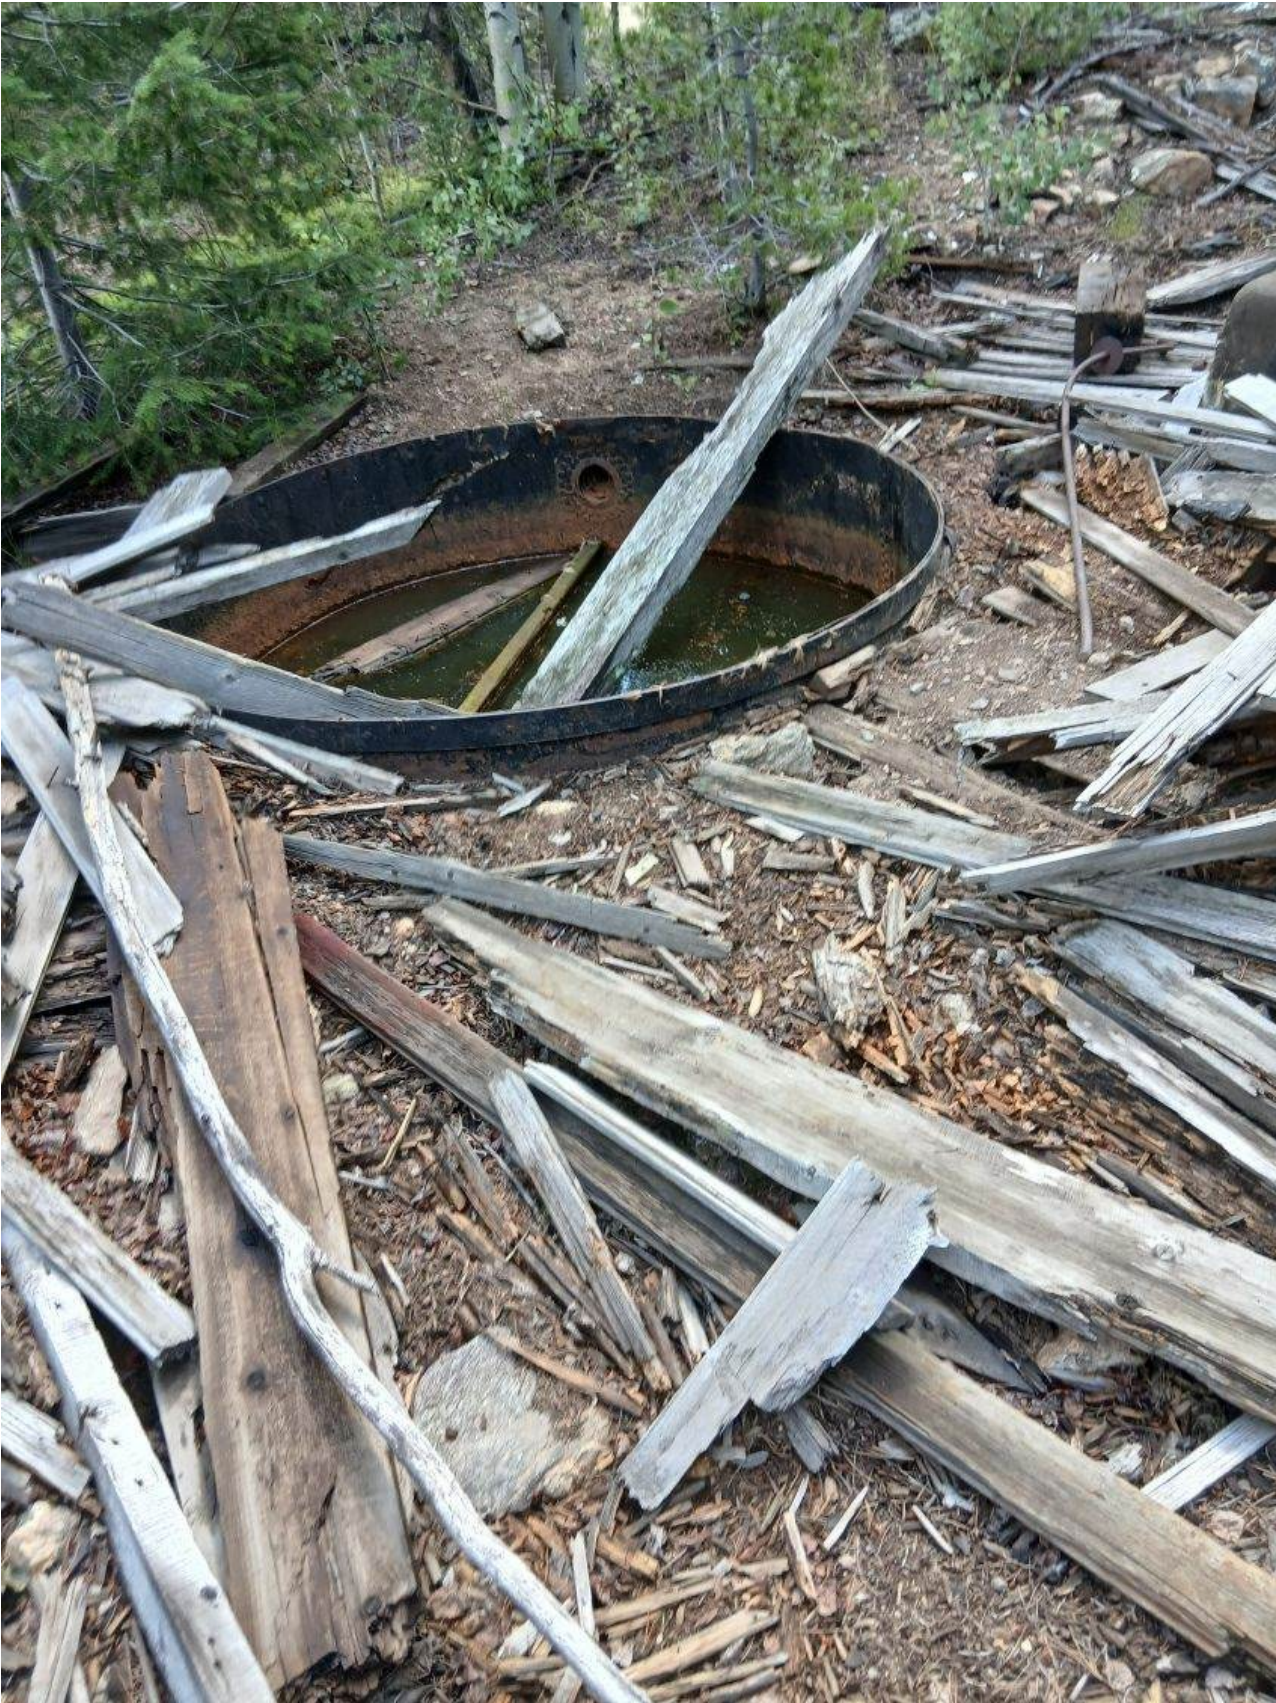
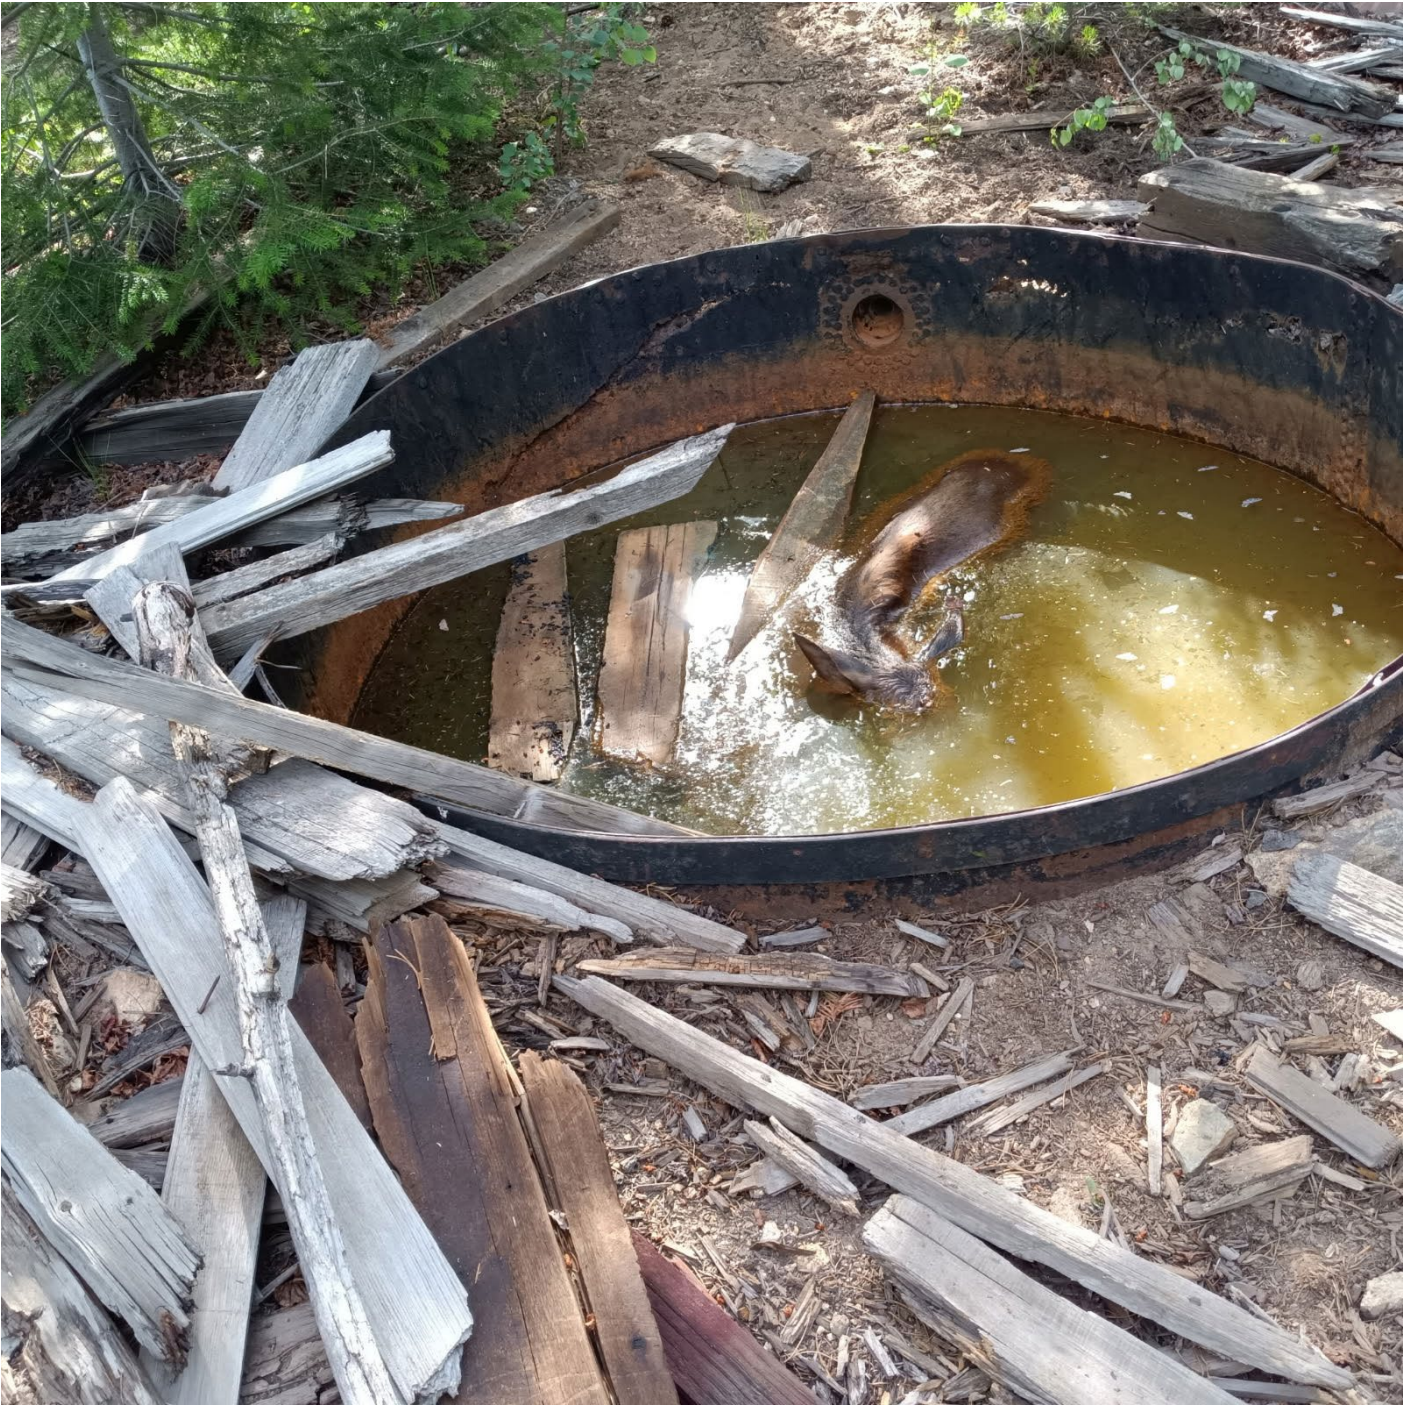
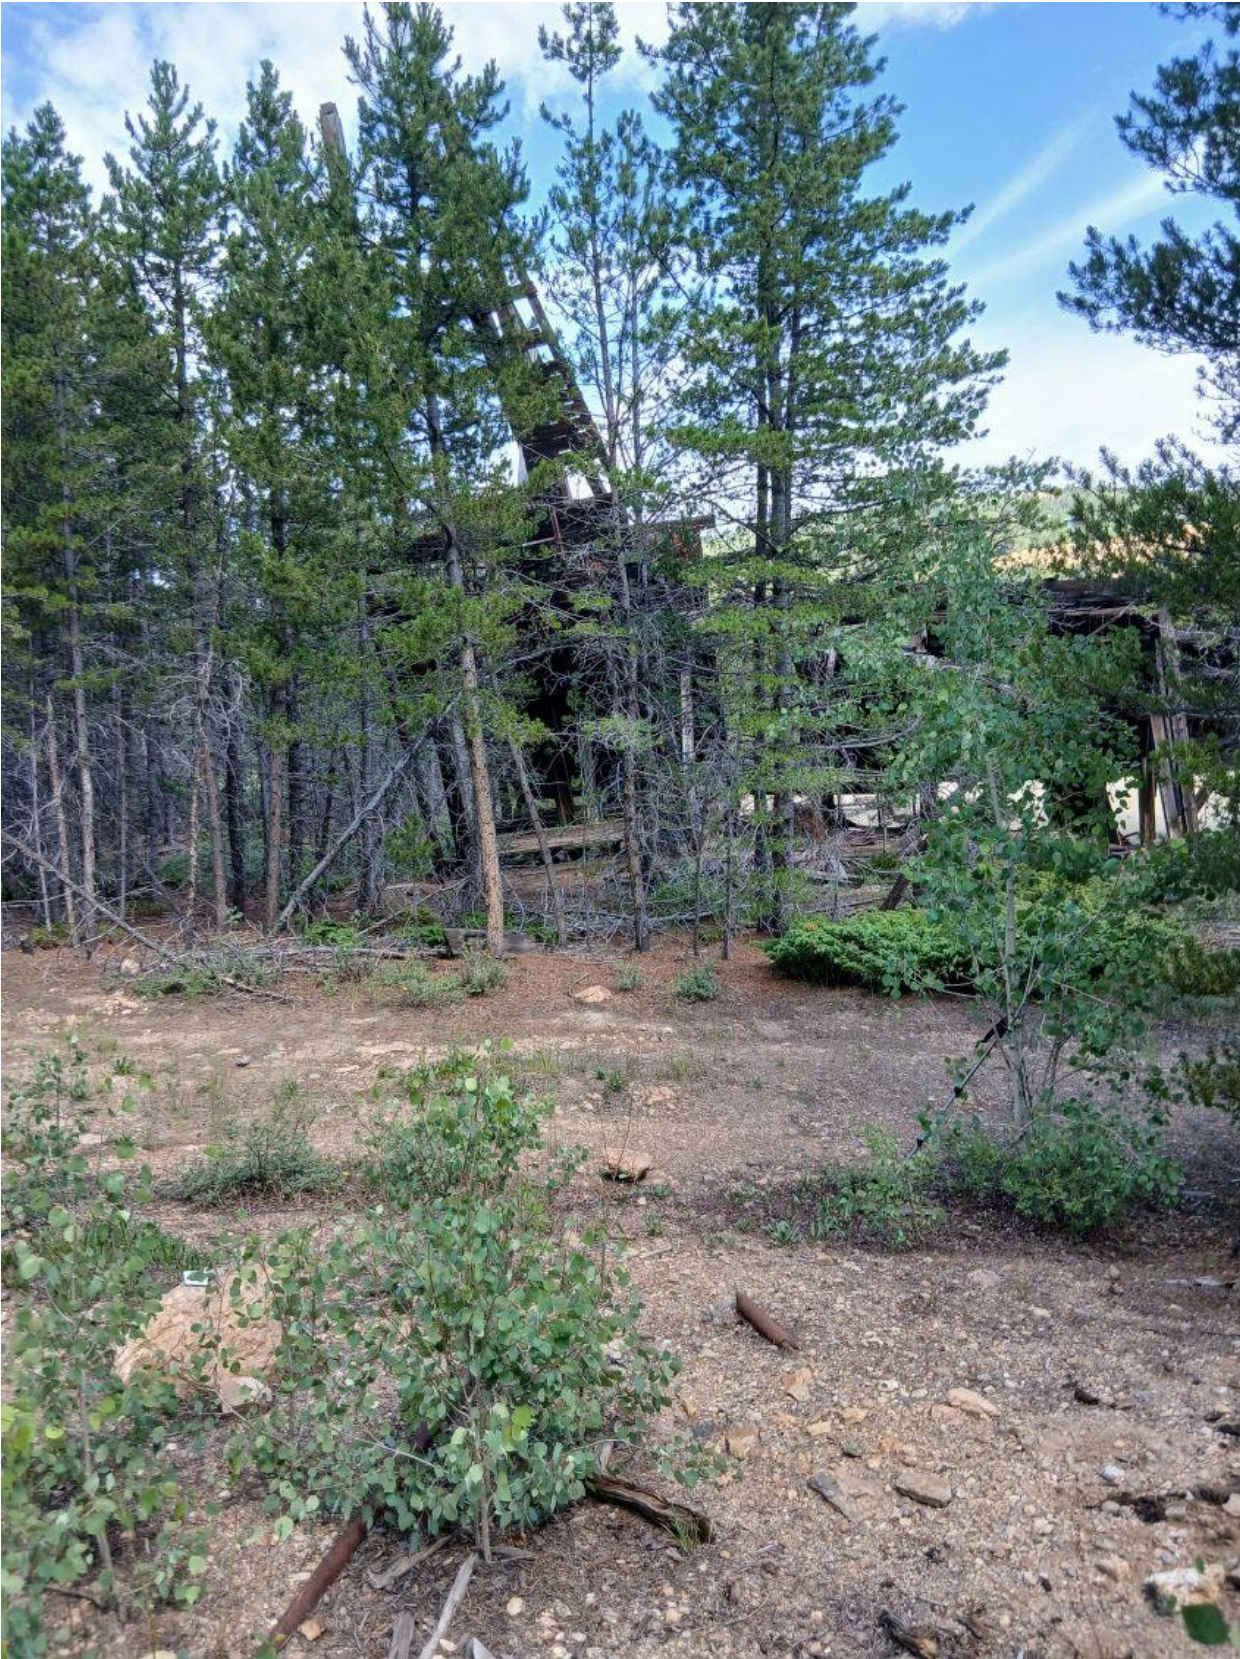
On Thursday July 17, 2025 the Division received a complaint by phone from a local resident who does not wish to be identified. The complainant stated that there was an open water cistern on the Old Town Reclamation Project property in which baby moose had drowned on two separate occasions. The complainant described the approximate location of the cistern, and later shared by text message several photographs (see figures 1-4).

Figure 1: Complaint photo (1 of 4)

Figure 2: Complaint photo (2 of 4)

Figure 3: Complaint photo (3 of 4)

Figure 4: Complaint photo (4 of 4)

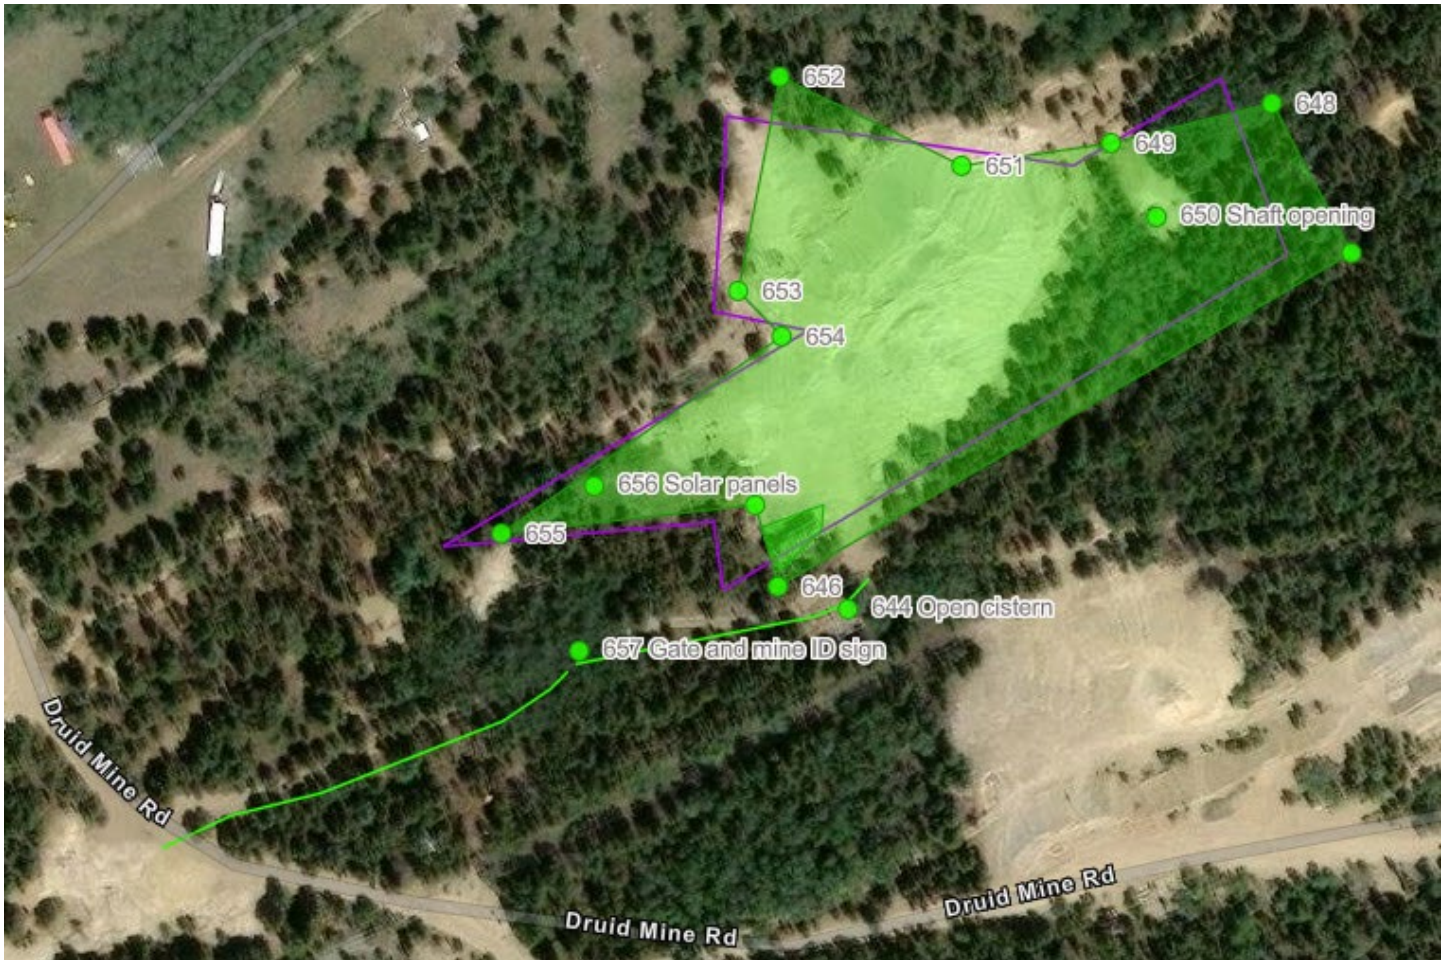
The complaint was shared with the operator who asserted that the cistern was not within the permit area. On Friday July 18, 2025, Leigh Simmons of the Division conducted an inspection of the site. The approximate permit area boundary had previously been digitized from georeferenced maps, and is shown on the field map in figure 5 in purple.

In the field, locations of the staked corners of the permit area were recorded using the Esri Field Maps app, running on an iPhone 14. (Each point was recorded as the average of 10 locations, when the GPS location accuracy met a threshold of 20ft.) The points are shown in green on figure 5 and are joined to make a green polygon. The locations of other features noted during the inspection were also recorded and are labelled. The site was accessed by a driveway from Pewabic Mine Road (AKA Druid Mine Road). Approximately 300ft down the driveway was a gate, with a mine ID sign. From this point it was approximately another 220ft to the edge of the permit area. On the right side of the driveway was what appeared to be historic mine-related debris (broken timbers, concrete foundations, old pipe and an open metal tank/cistern with water in it (point 644).

Figure 5: Screenshot of field map used during inspection

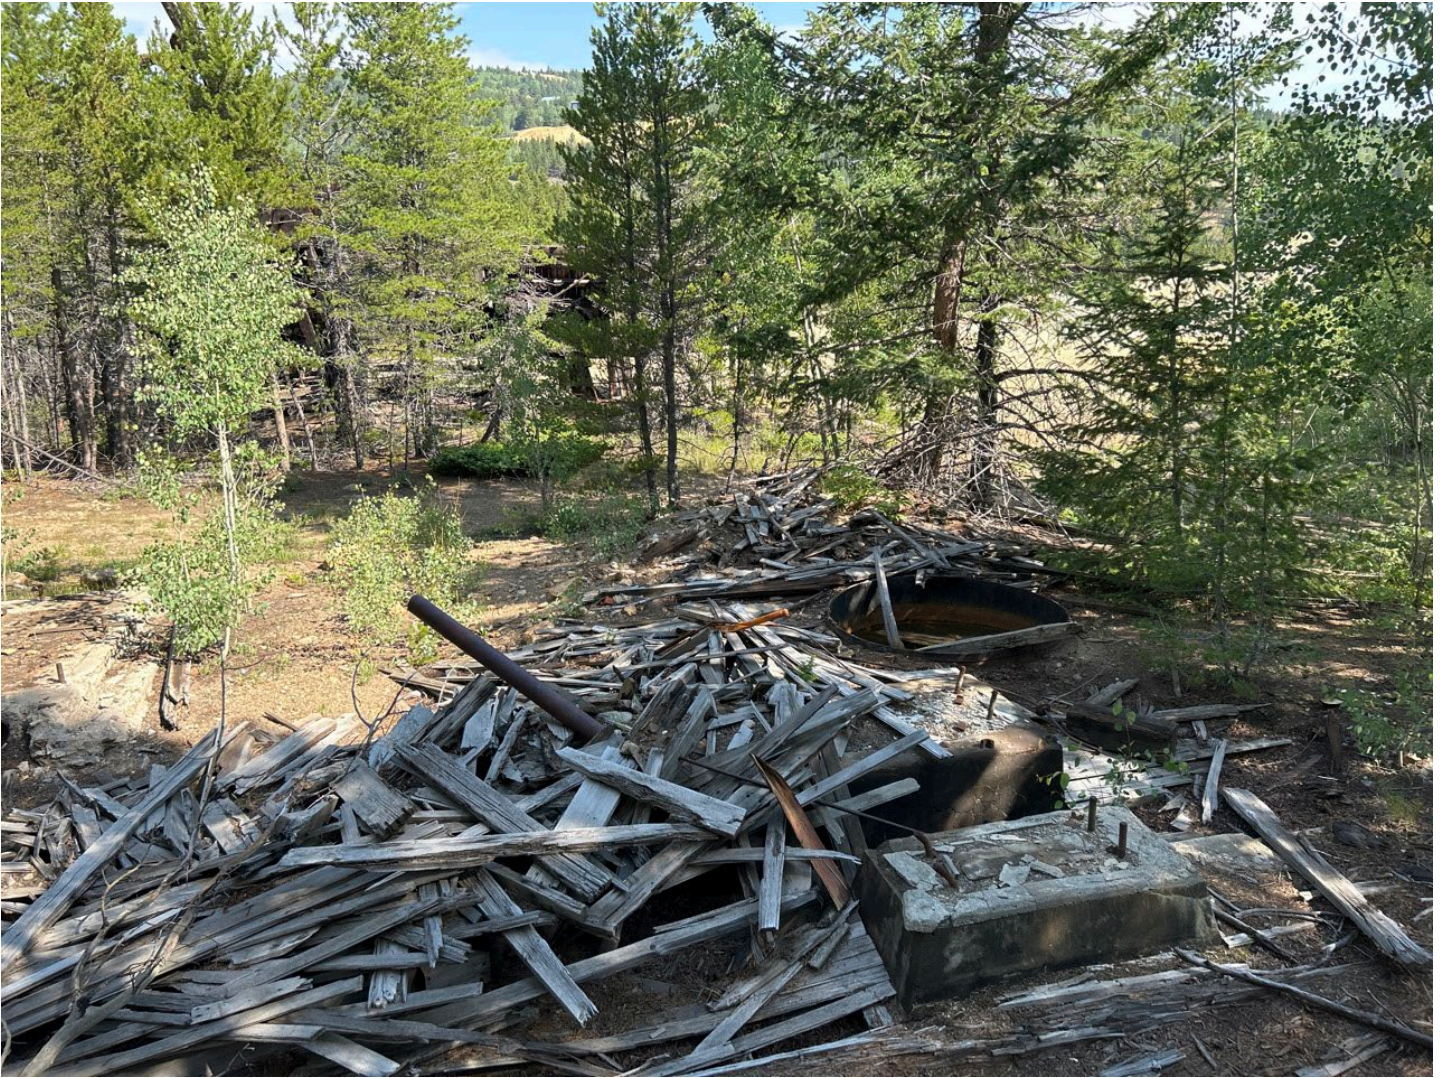
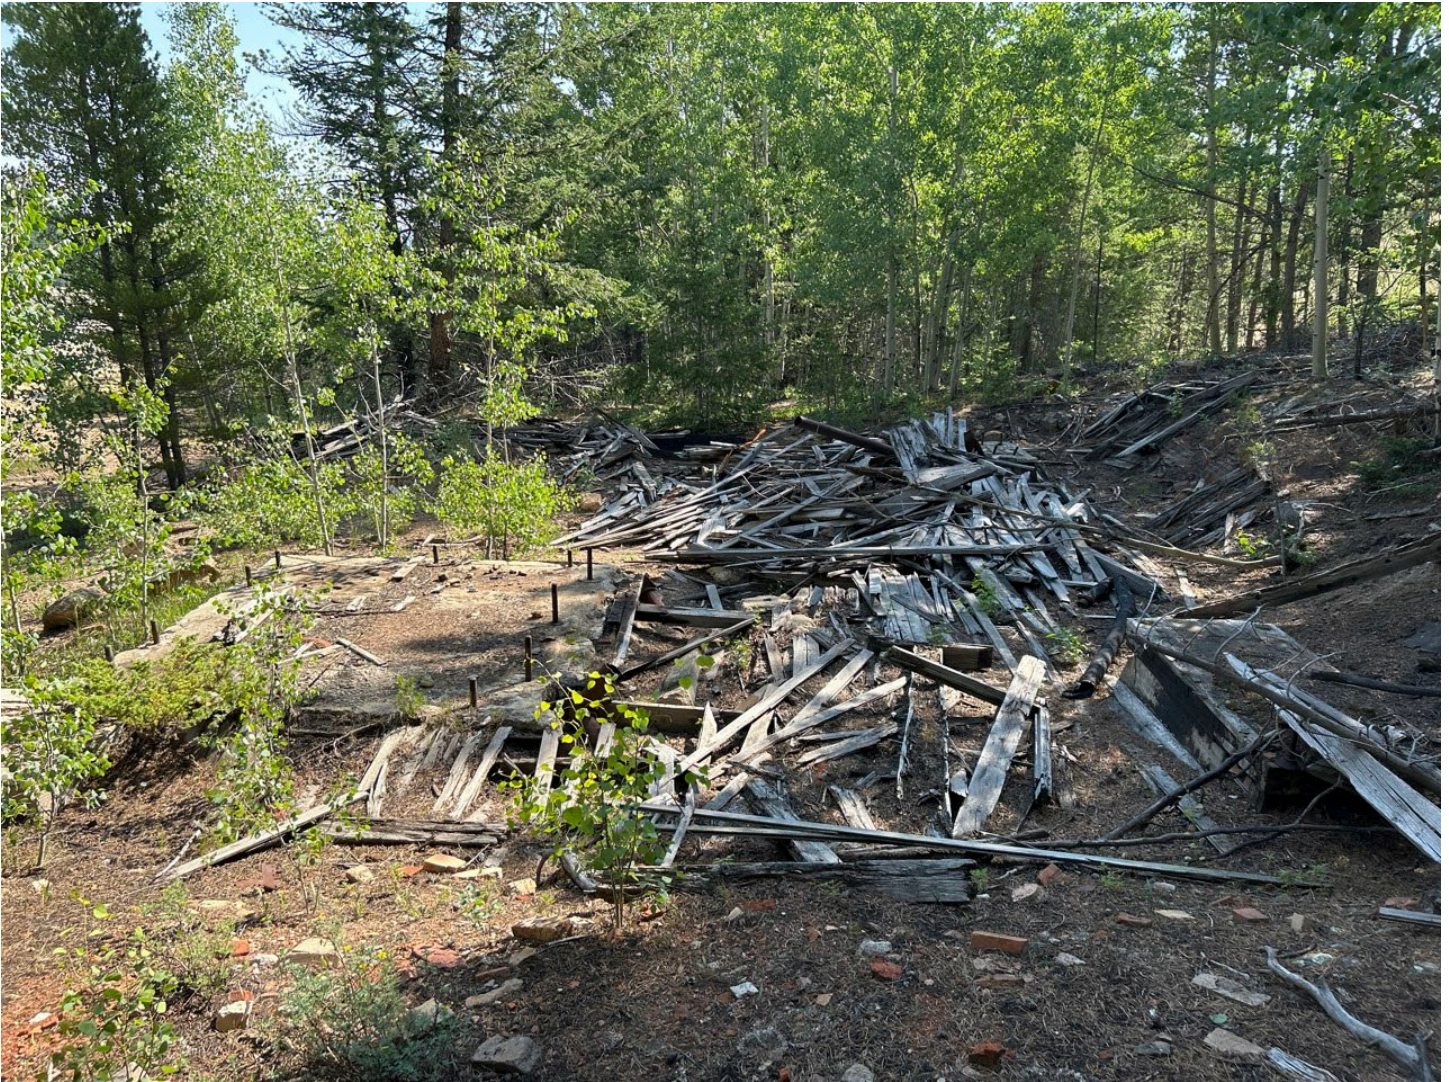
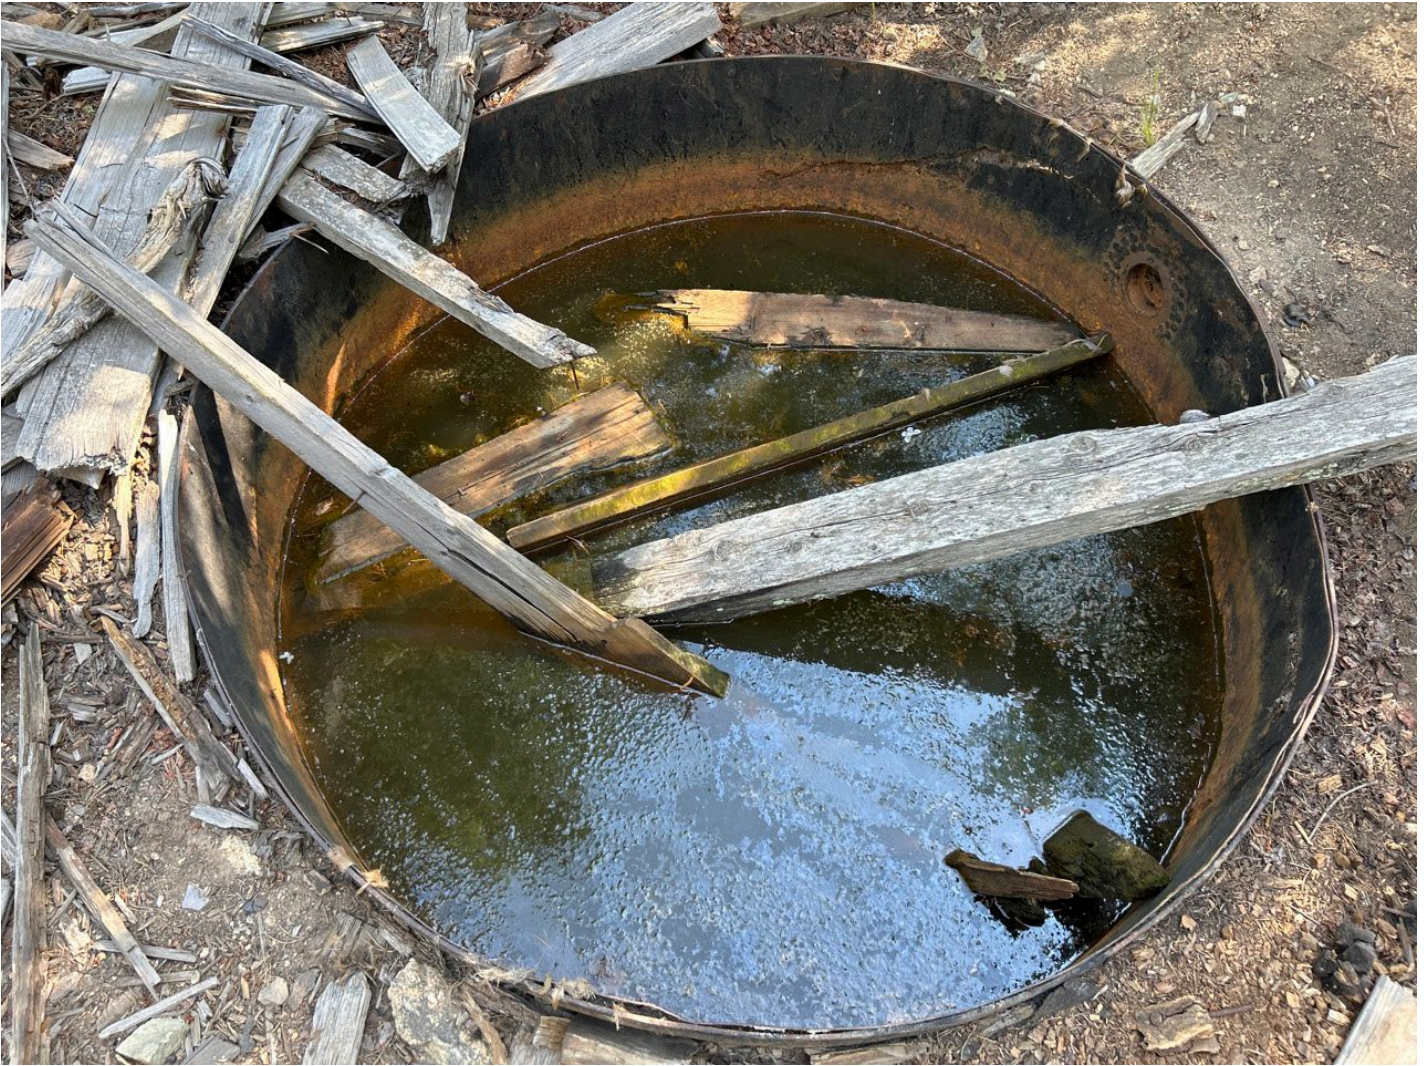
Although the accuracy of points recorded in the field is limited by the accuracy of a cell phone GPS receiver, and the staked boundary does not coincide perfectly with the boundary digitized from maps, it is clear that the location of the open cistern is outside of the permit area by 40-60ft. However, the location of the gate and Mine ID sign would suggest to a visitor that the land past the gate is associated with mine permit M-2018-057 and is the responsibility of Venture Resources Inc.

Figure 6: Point 644, outside permit area (1 of 3)

Figure 7: Point 644, outside permit area (2 of 3)

Figure 8: Point 644, outside permit area (3 of 3)

The Division does not have jurisdiction over the cistern, or the land that it is located on. Furthermore, the Division does not engage in issues related to property ownership. Nevertheless, if the cistern is determined to be on land owned or in any way controlled by Venture Resources Inc. it would be advisable to contact the Division of Water Resources (which regulates cisterns in Colorado) and Gilpin County, to seek advice on applicable regulations and guidelines for abandonment or hazard mitigation.

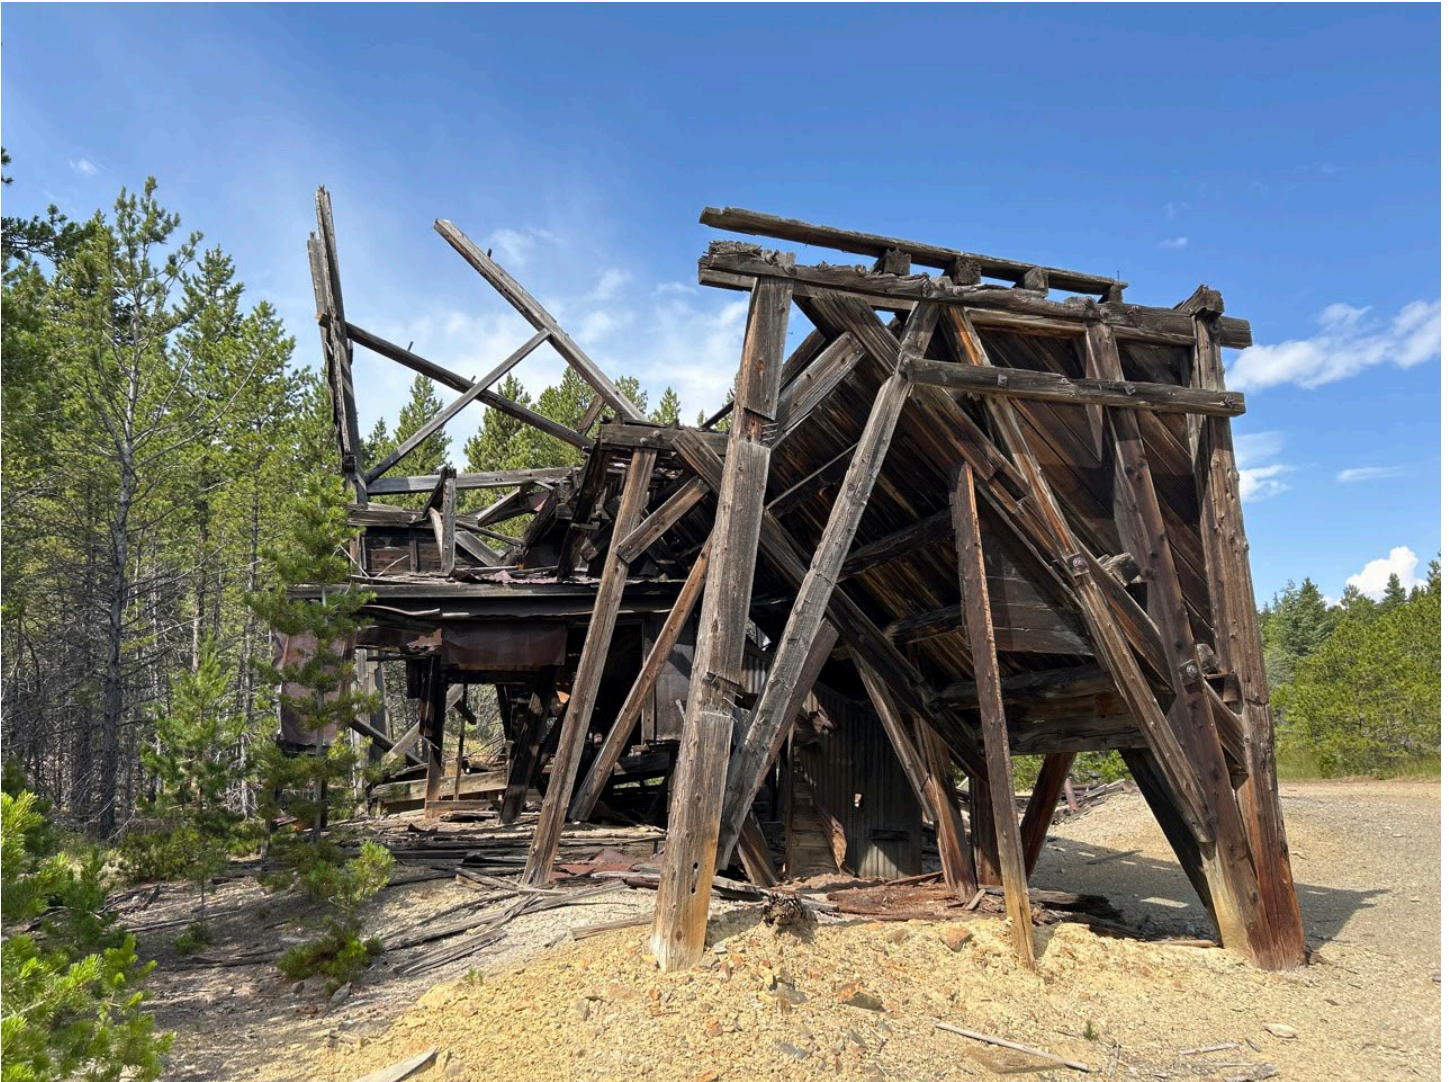
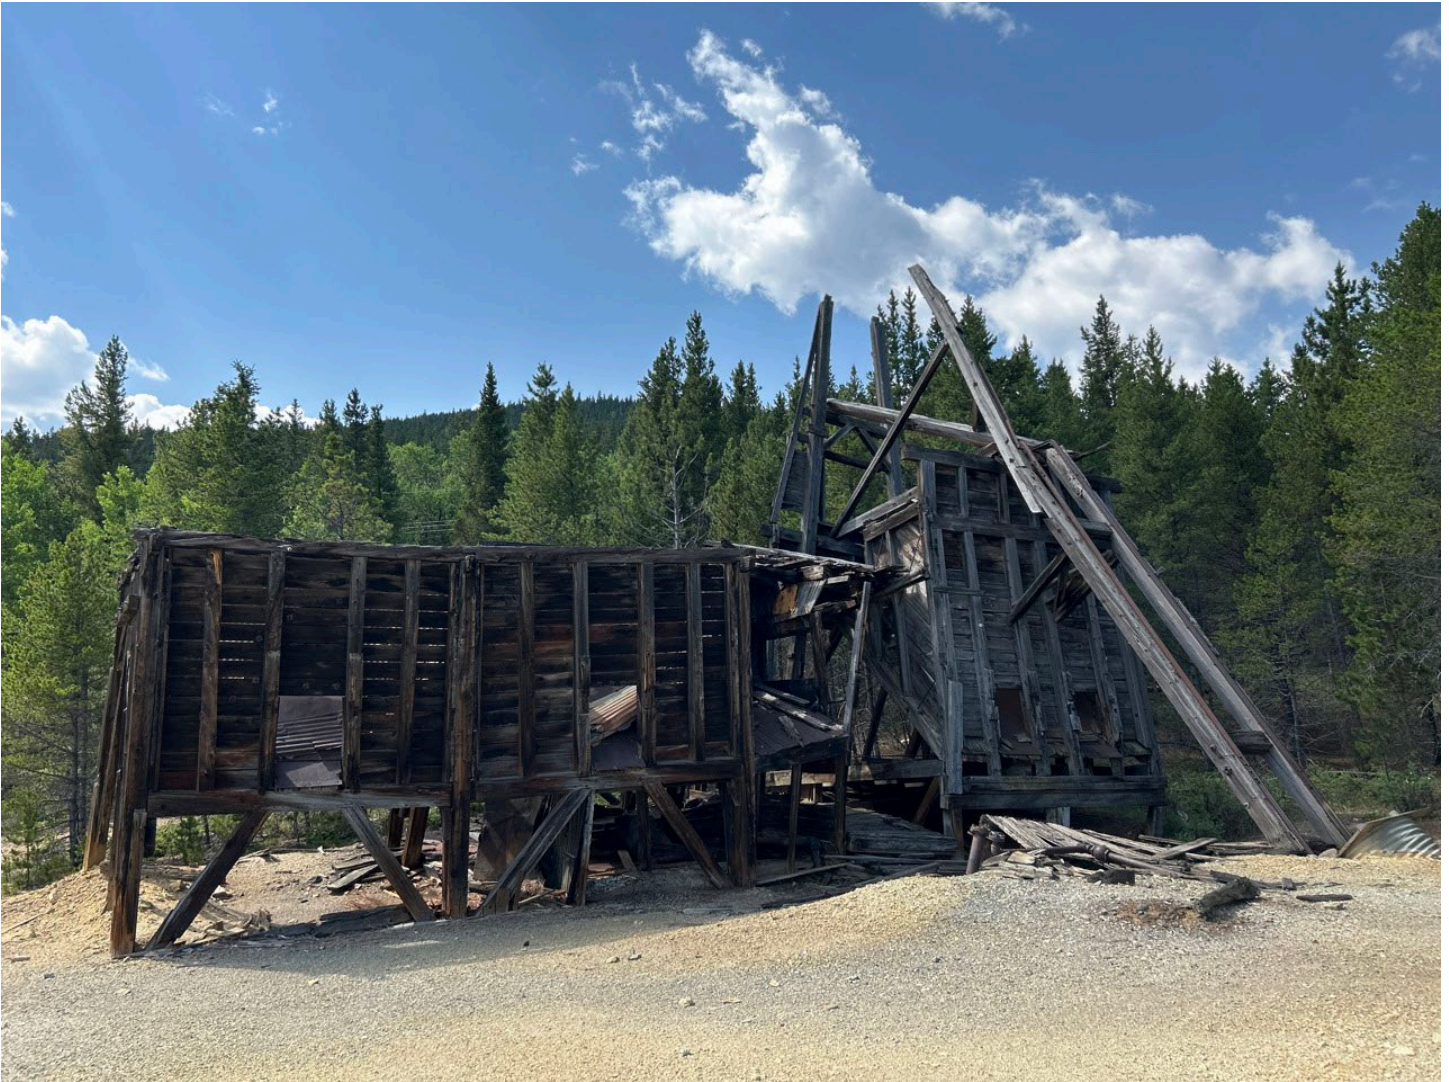
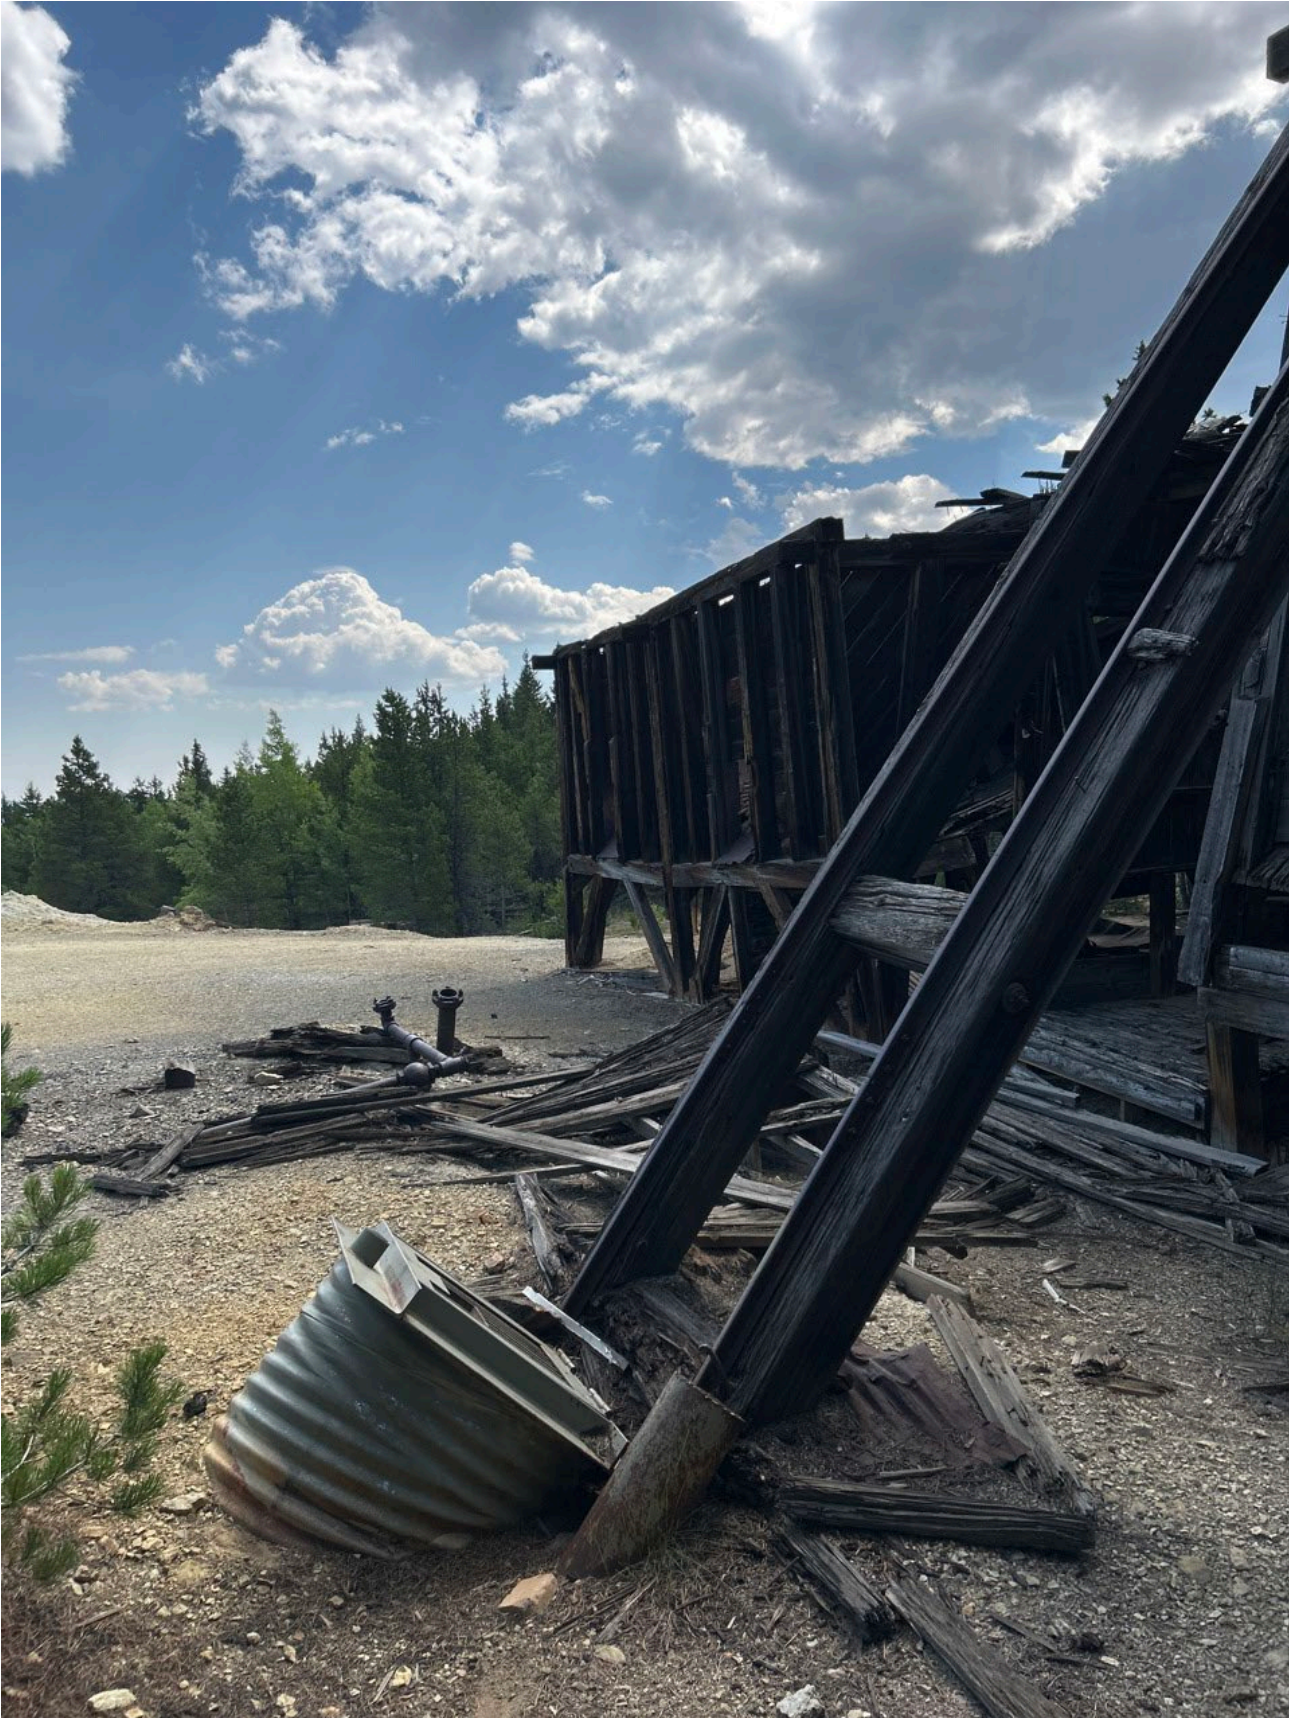
Figure 9: Historic mine disturbance within permit area, north of point 646 (1 of 3)

Figure 10: Historic mine disturbance within permit area, north of point 646 (2 of 3)

Figure 11: Historic mine disturbance within permit area, north of point 646 (3 of 3)
