M2018057, Old Town Reclamation Project, July 2025 Inspection Report

MINERALS PROGRAM INSPECTION REPORT
PHONE: (303) 866-3567

MINE NAME: Old Town Reclamation Project	MINE/PROSPECTING ID#: M-2018-057	MINERAL: Silver, gold, lead, zinc	COUNTY: Gilpin
INSPECTION TYPE: Monitoring	WEATHER: Clear	INSP. DATE: July 18, 2025	INSP. TIME: 09:00
OPERATOR: Venture Resources, Inc.	OPERATOR REPRESENTATIVE: N/A	TYPE OF OPERATION: 110d - Designated Limited Impact	
REASON FOR INSPECTION: Citizen Complaint	BOND CALCULATION TYPE: None	BOND AMOUNT: \$24,387.00	
DATE OF COMPLAINT: NA	POST INSP. CONTACTS: None	JOINT INSP. AGENCY: None	
INSPECTOR(S): Leigh Simmons	INSPECTOR'S SIGNATURE:

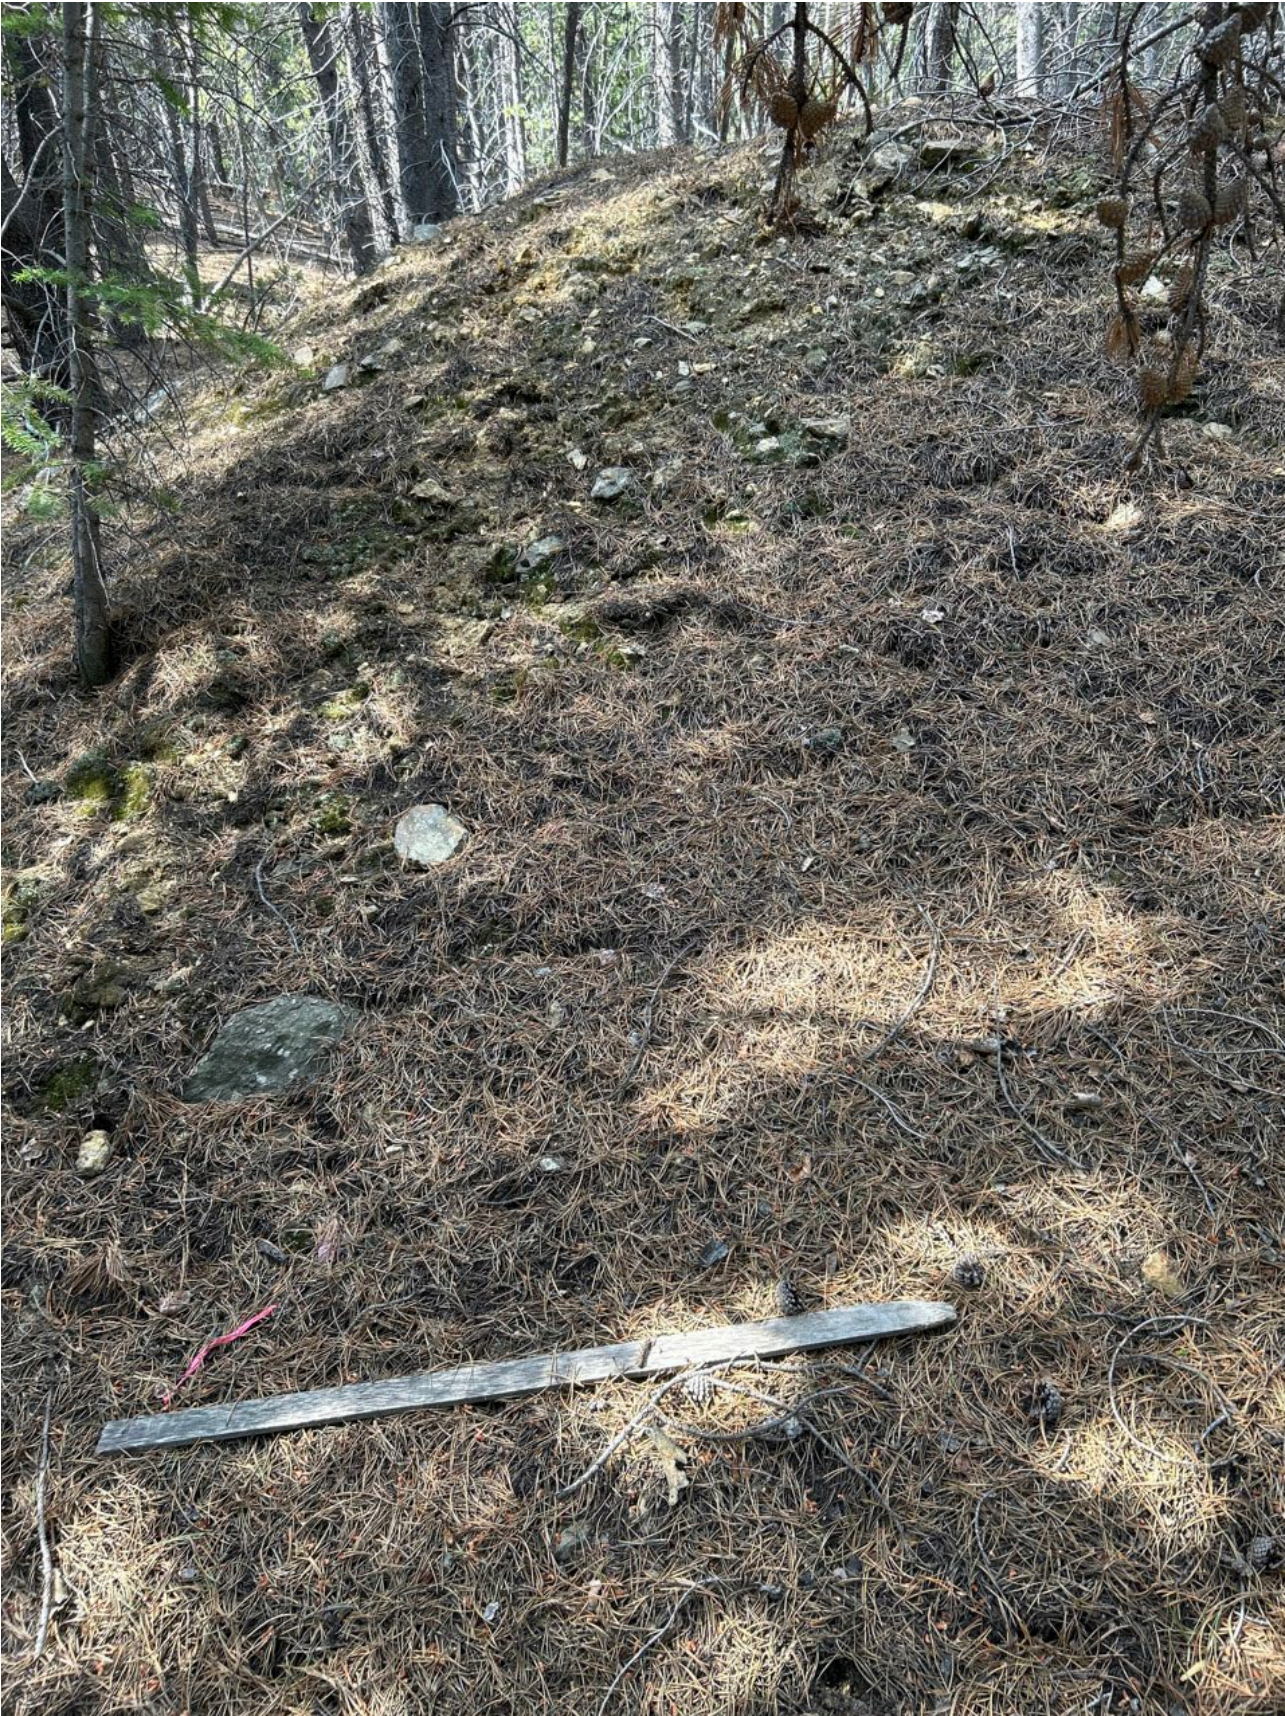
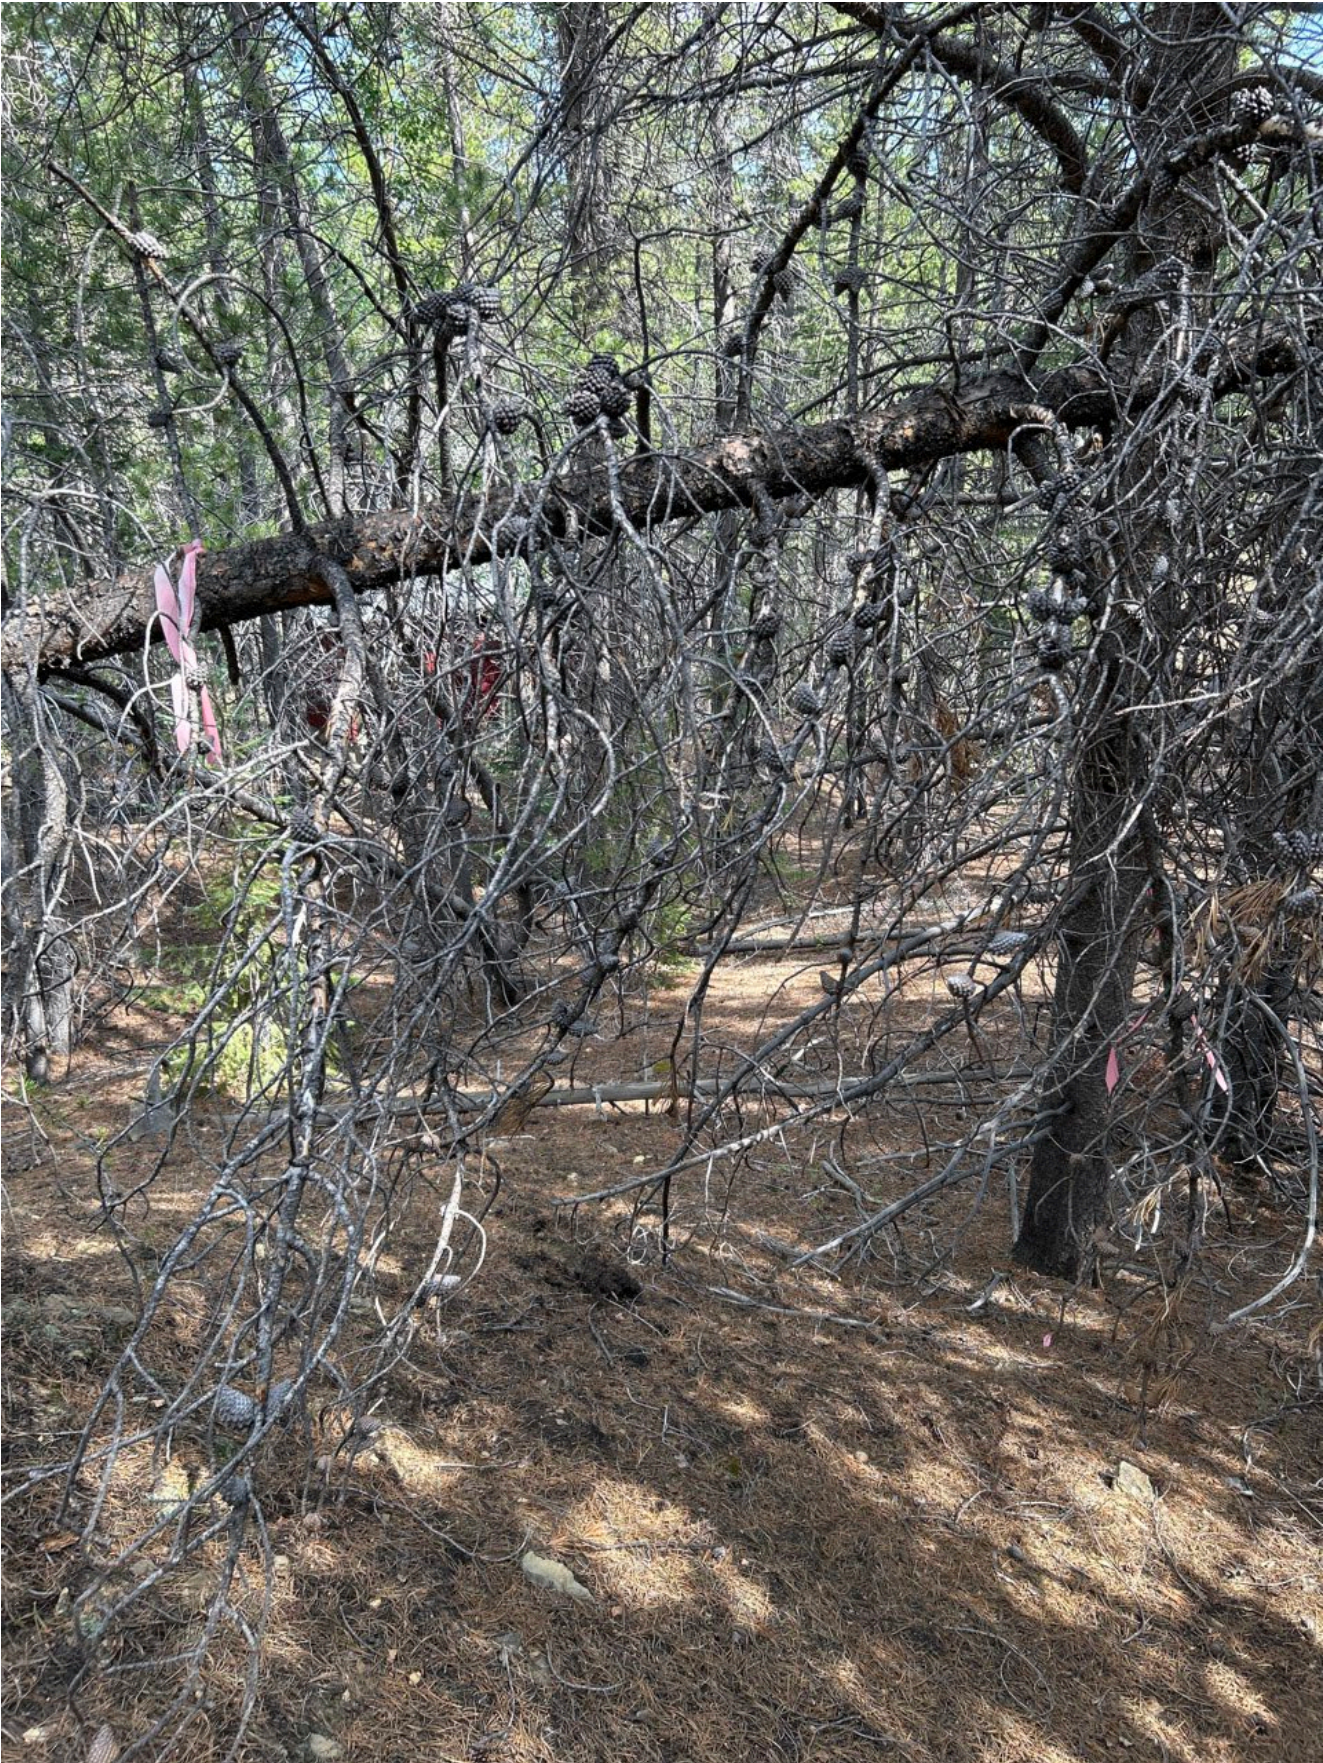
Figure 12: Survey stake needs replacing, point 647 (1 of 2)

Figure 13: Survey stake needs replacing, point 647 (2 of 2)

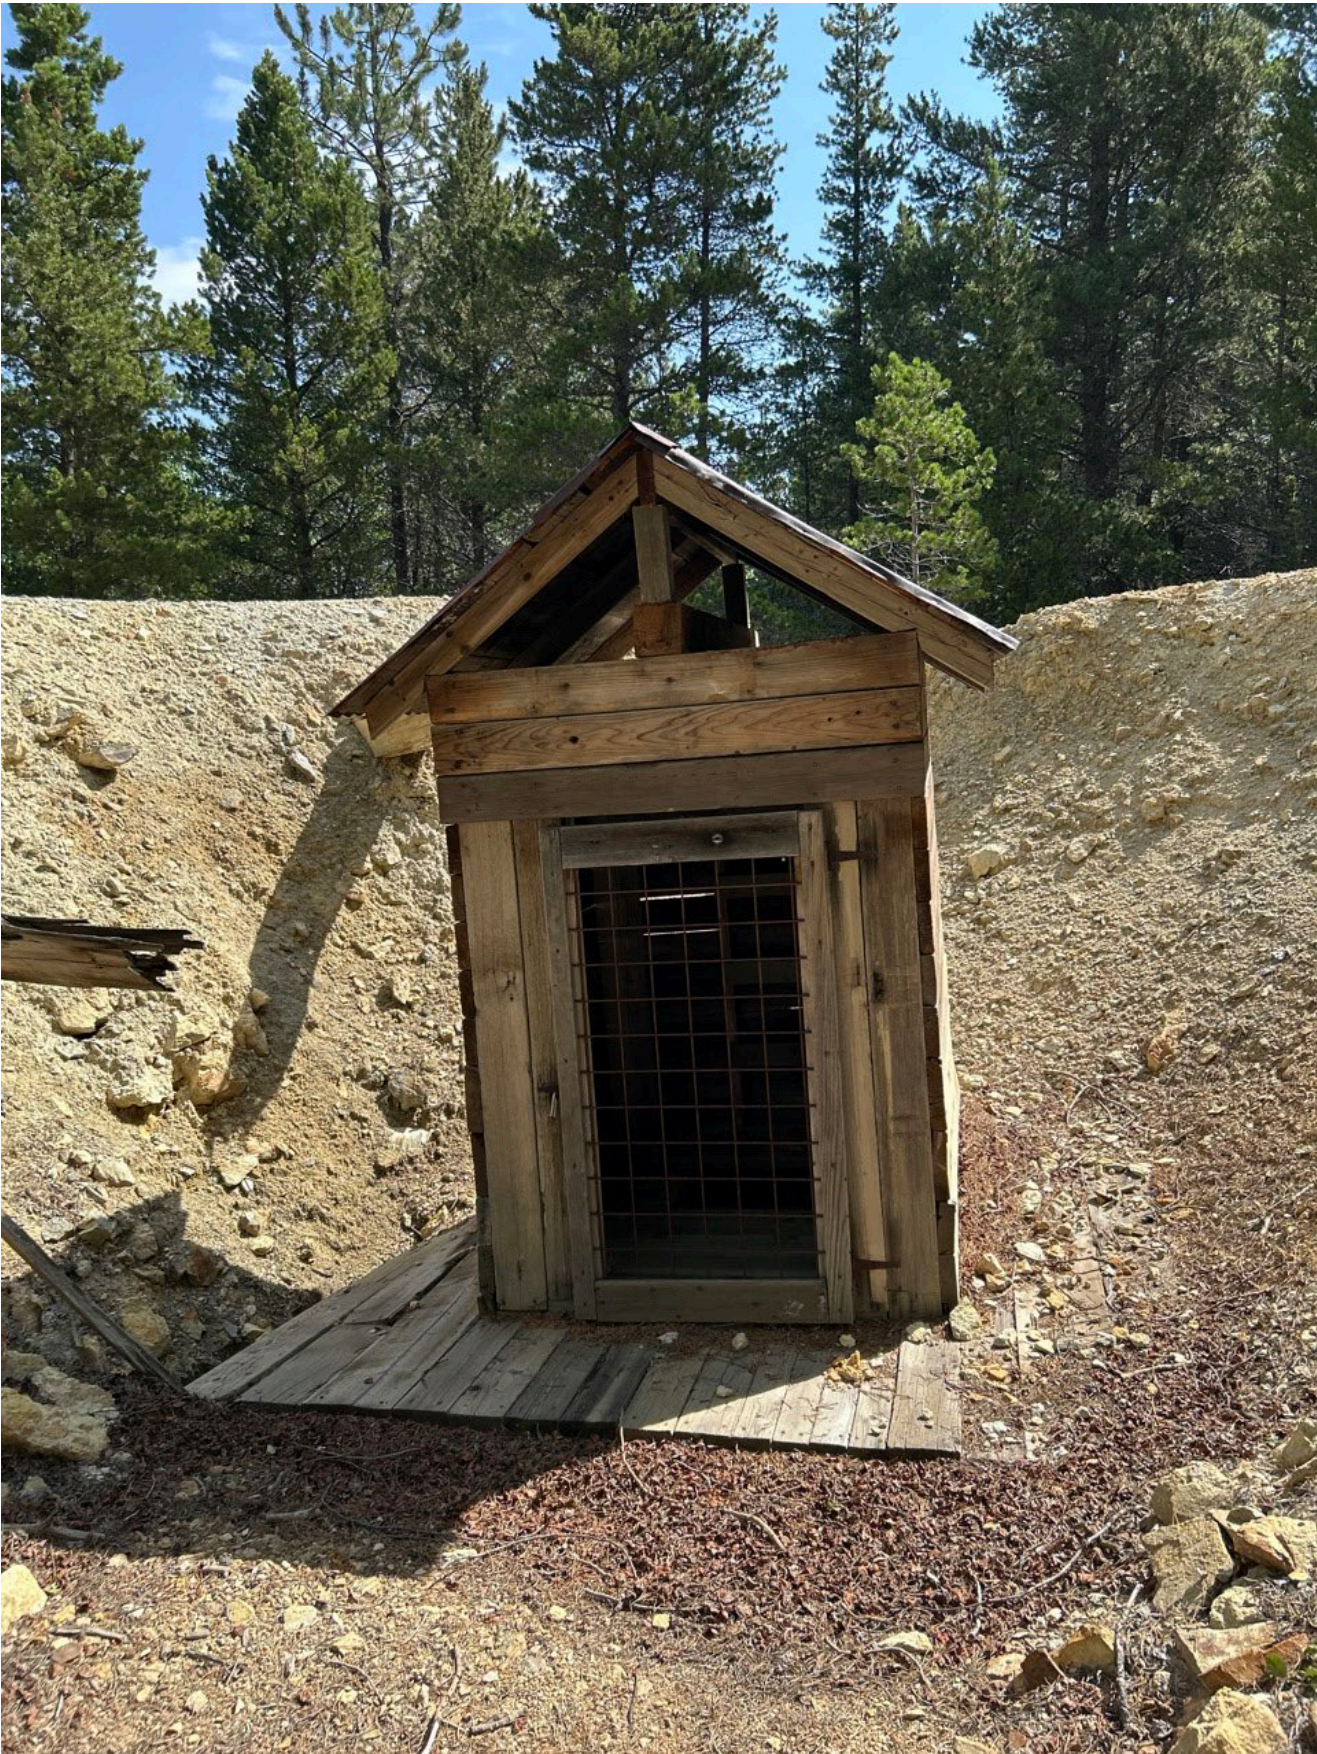
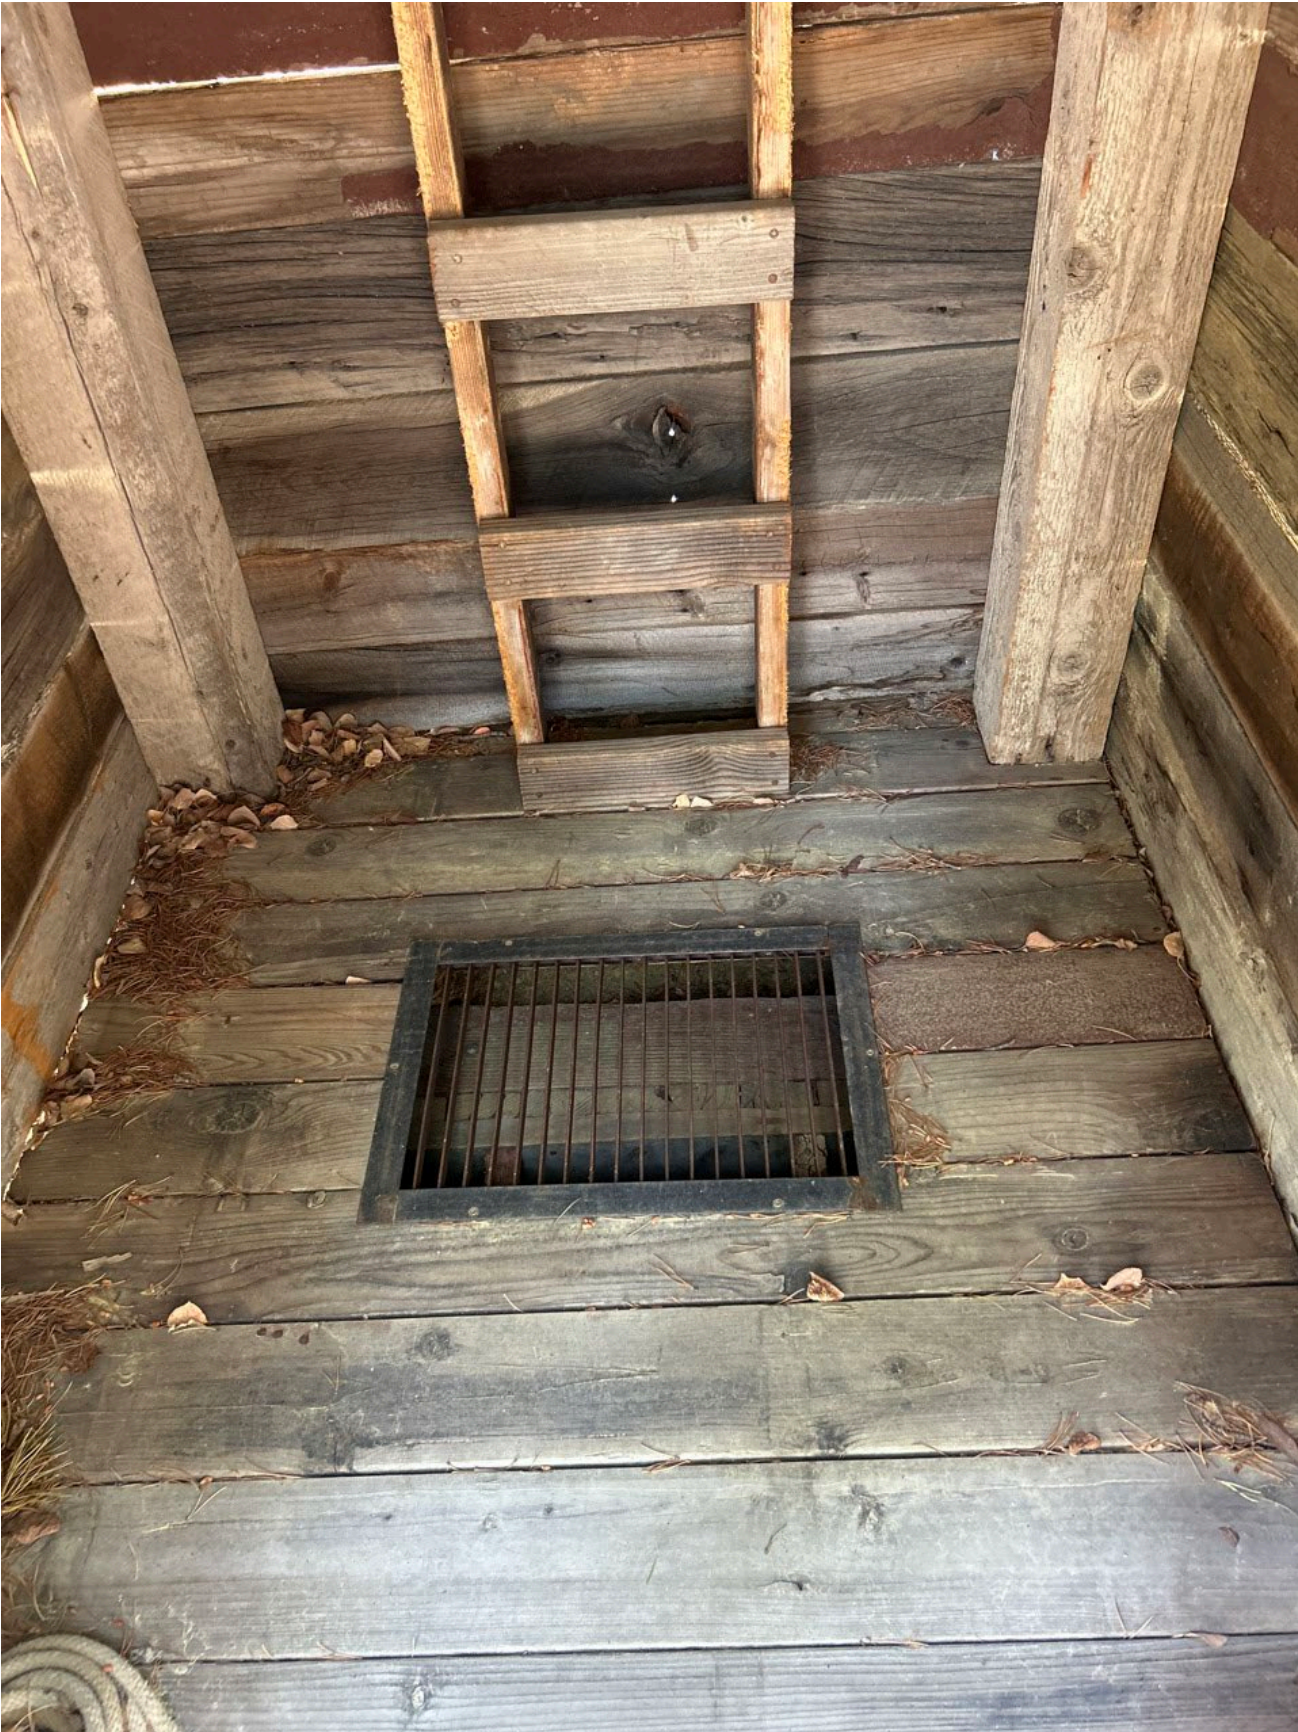
Figure 14: Historic shaft opening, point 650 (1 of 2)

Figure 15: Historic shaft opening, point 650 (2 of 2)

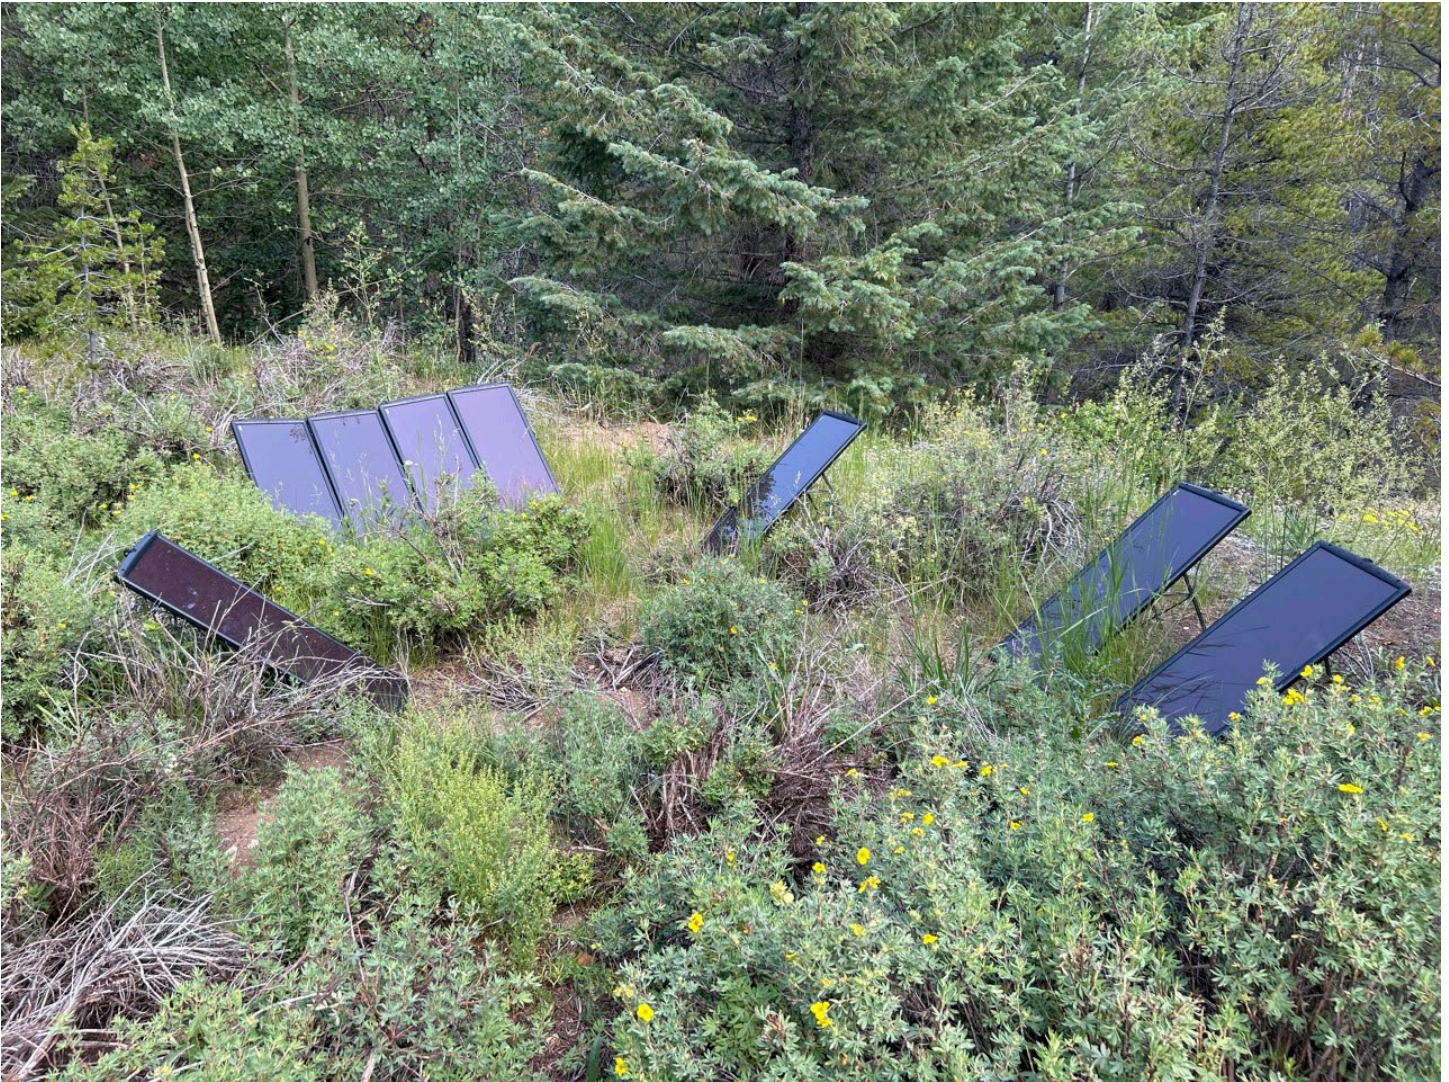
Figure 16: Solar panels inside permit area, point 656

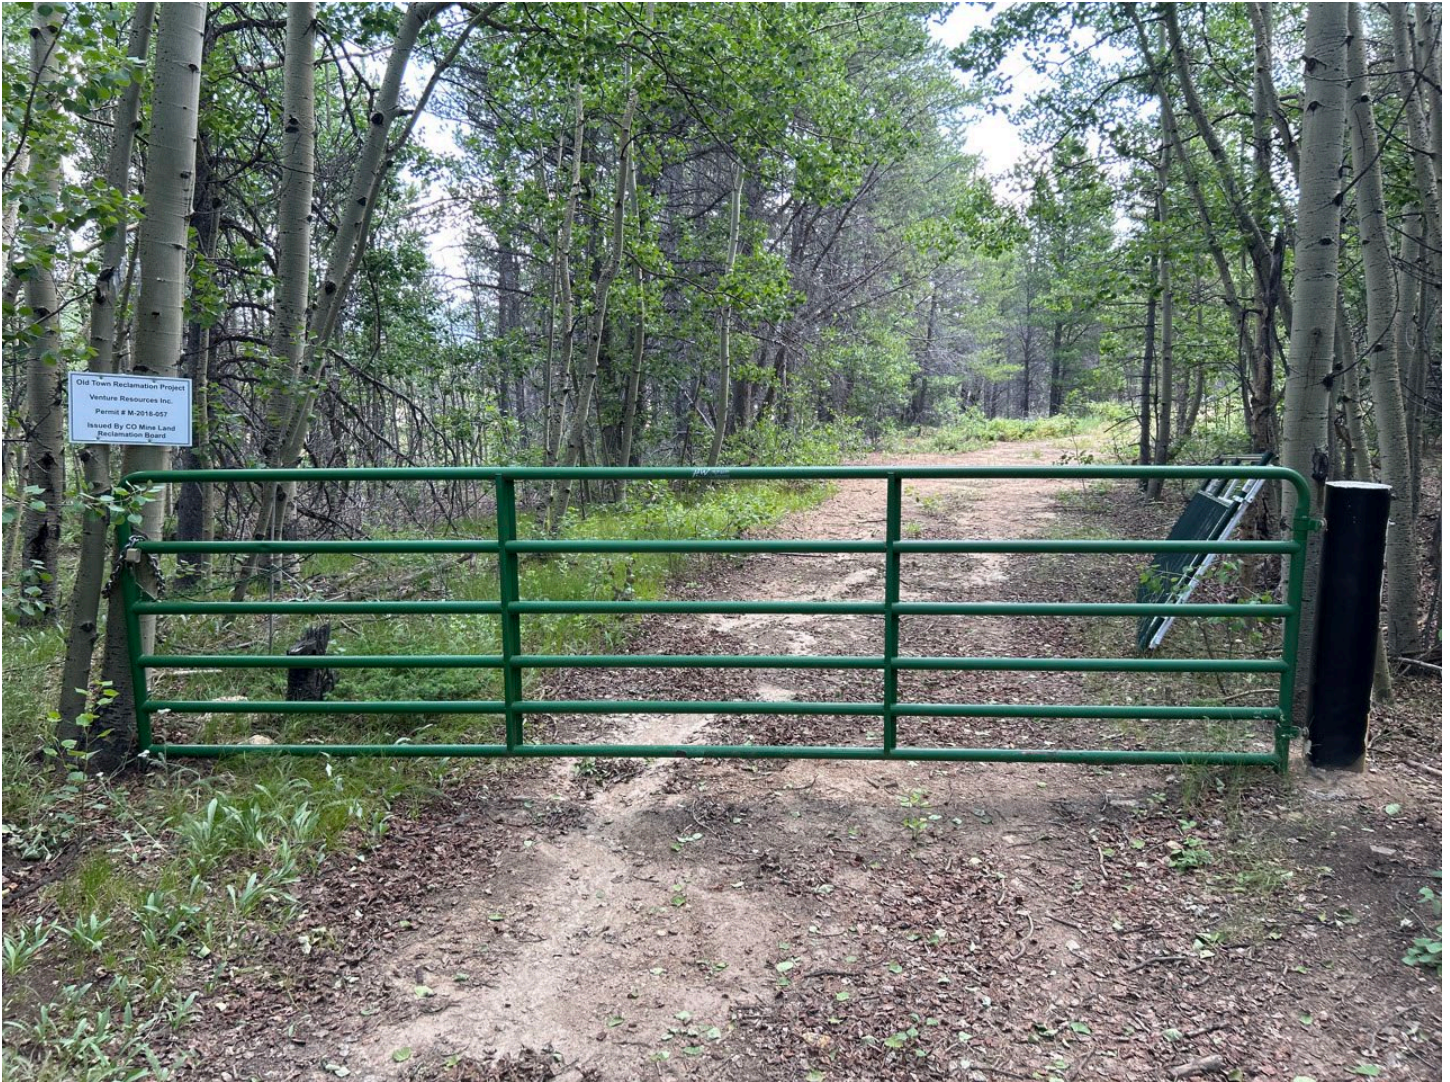
Figure 17: Gate across driveway, point 657

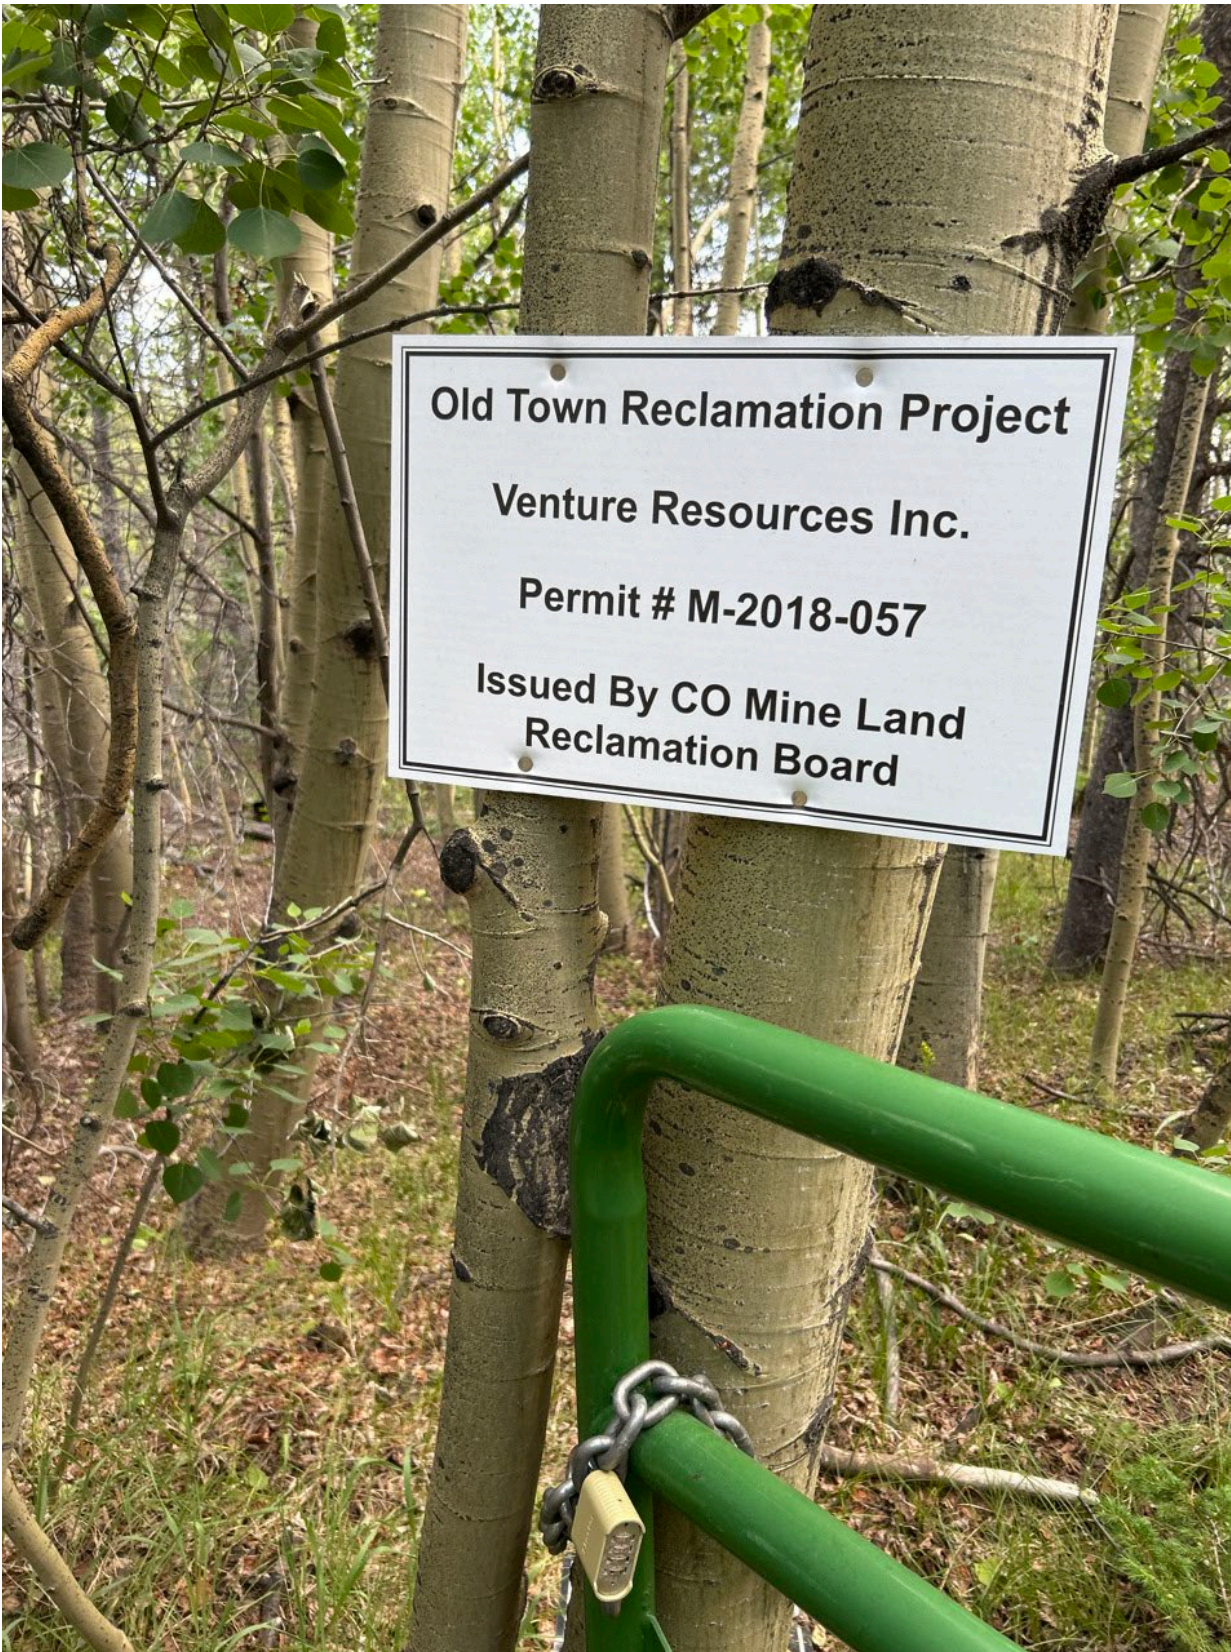
Figure 18: Mine ID sign, point 657
