### MINERALS PROGRAM INSPECTION REPORT

<b>MINE NAME:</b> 120th Estates Partners	<b>MINE/PROSPECTING ID#:</b> M-2001-085	<b>MINERAL:</b> Sand and gravel	<b>COUNTY:</b> Adams
<b>INSPECTION TYPE:</b> Surety Release Inspection	<b>WEATHER:</b> Clear	<b>INSP. DATE:</b> June 25, 2025	<b>INSP. TIME:</b> 08:30
<b>OPERATOR:</b> 120 85 LLC	<b>OPERATOR REPRESENTATIVE:</b> Adam Schultejaan	<b>TYPE OF OPERATION:</b> 112c - Construction Regular Operation

<b>REASON FOR INSPECTION:</b> Surety Release Requested	<b>BOND CALCULATION TYPE:</b> None	<b>BOND AMOUNT:</b> \$368,590.00
<b>DATE OF COMPLAINT:</b> NA	<b>POST INSP. CONTACTS:</b> None	<b>JOINT INSP. AGENCY:</b> County
<b>INSPECTOR(S):</b> Nikie Gagnon	<b>INSPECTOR'S SIGNATURE:</b>

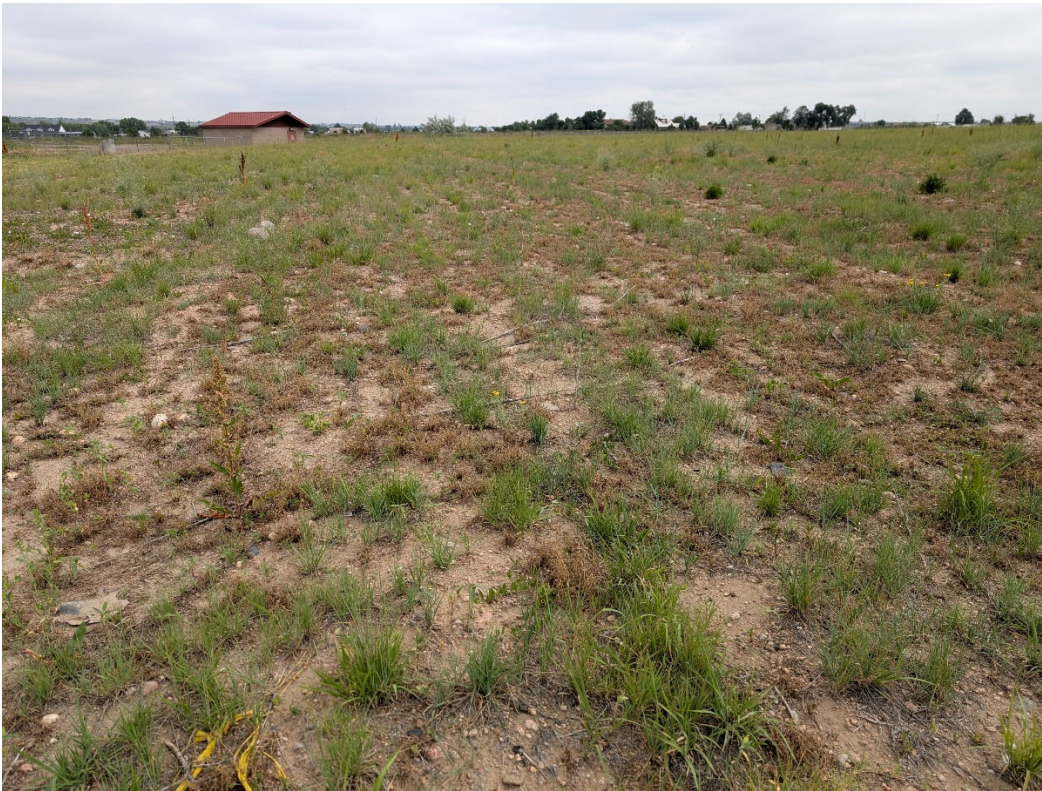
During this inspection, the Division observed native grasses reestablished in the stockpile area, along the former access road, and at the ditch crossing. Annual weeds are interspersed with grass species in the reclaimed area. The vegetation in the release areas is consistent with the surrounding land on the parcel.

Photo 1: Looking north across the revegetated stockpile area on the adjacent parcel.

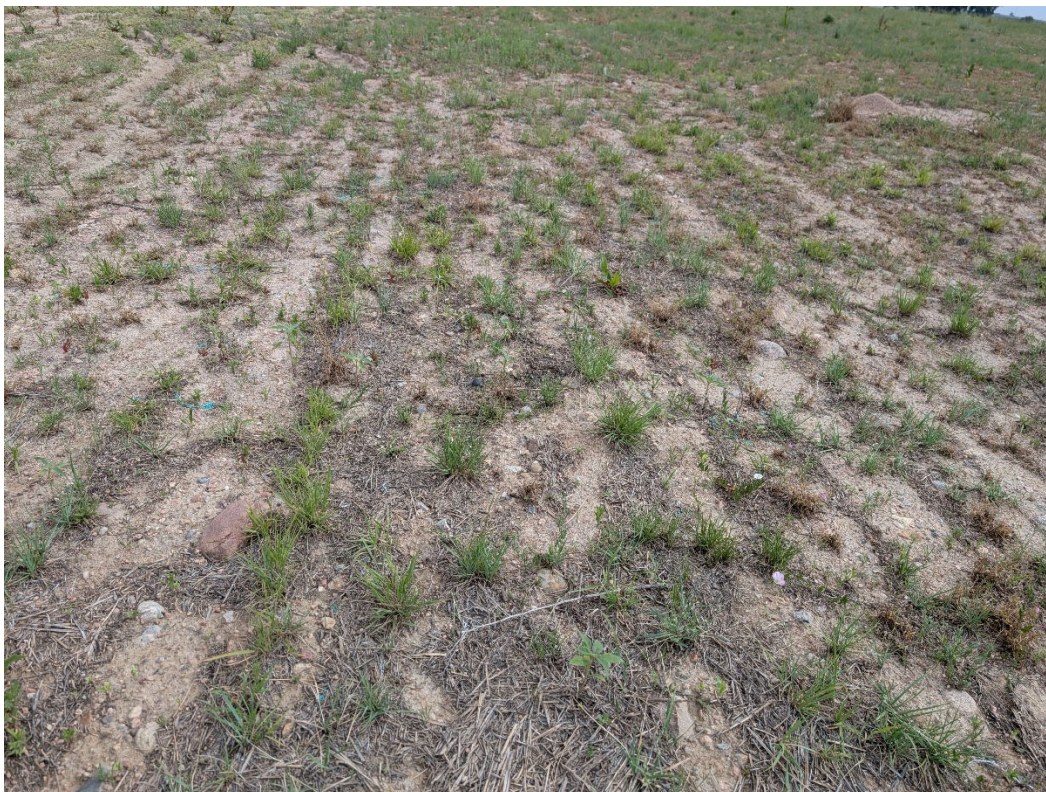
Photo 2: Grasses observed growing in the area of the former access road on the adjacent parcel.

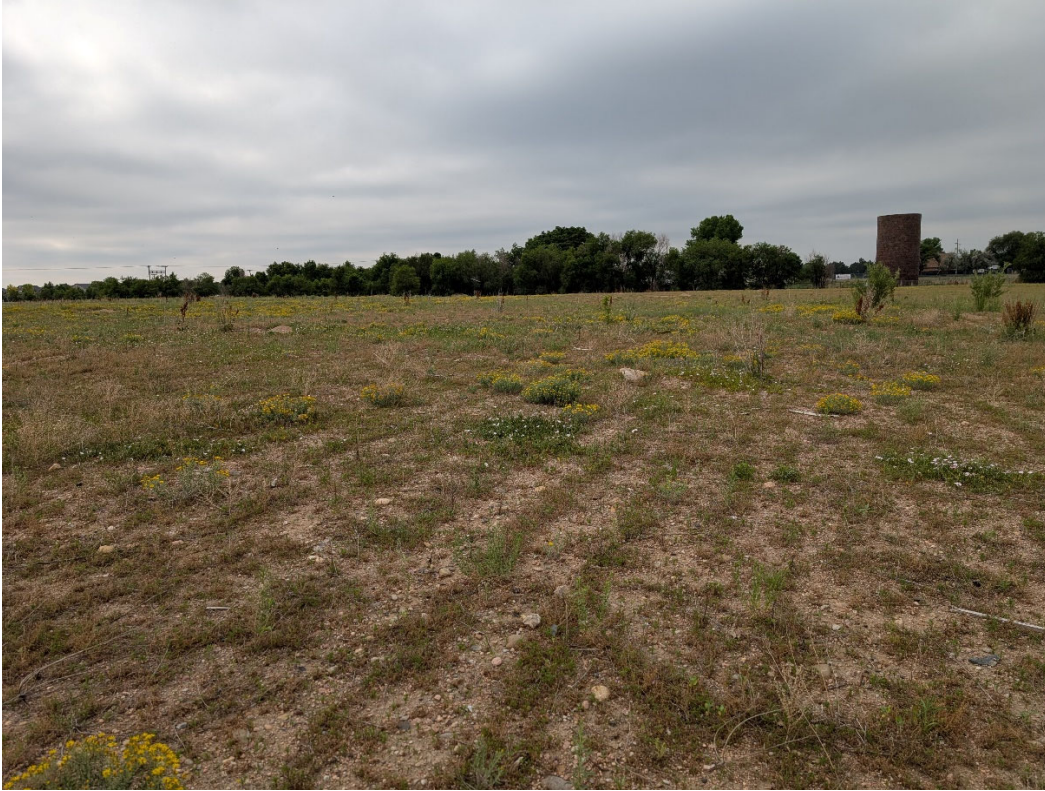
Photo 3: Looking south across the adjacent parcel in the area of the former access road.

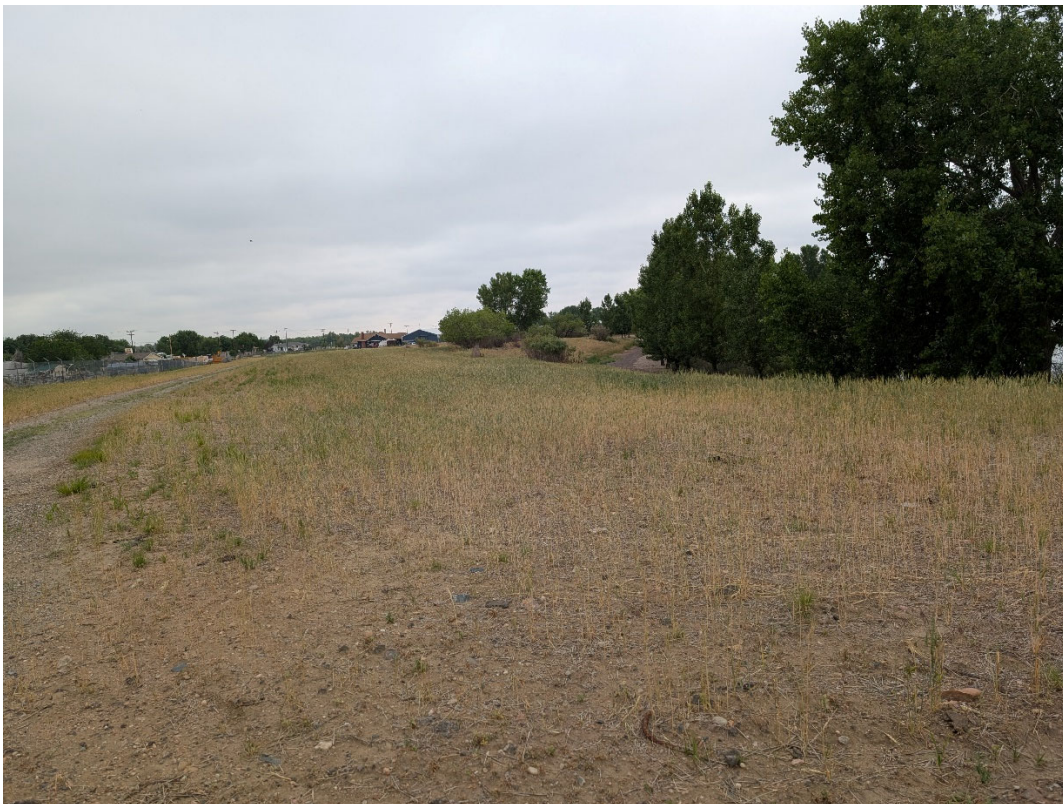
In 2003, the Division approved Amendment 3 which added 5 acres to dredge a portion of an adjacent ski lake, north of the mining area. Additionally, a 0.4 acre crossing of the Fulton Ditch and 2.2 acres of an access road left over from Permit No. M-2002-113, was incorporated into the permit area. Reclamation work was completed years ago in these areas. The ski lake was never mined or dredged, and the operator stated the shores were revegetated and is currently for water storage.

Photo 4: Looking north from the northwest corner of the permit area. The shoreline of the adjacent ski lake, north of the mining area has been reclaimed and the lake is currently used for water storage.

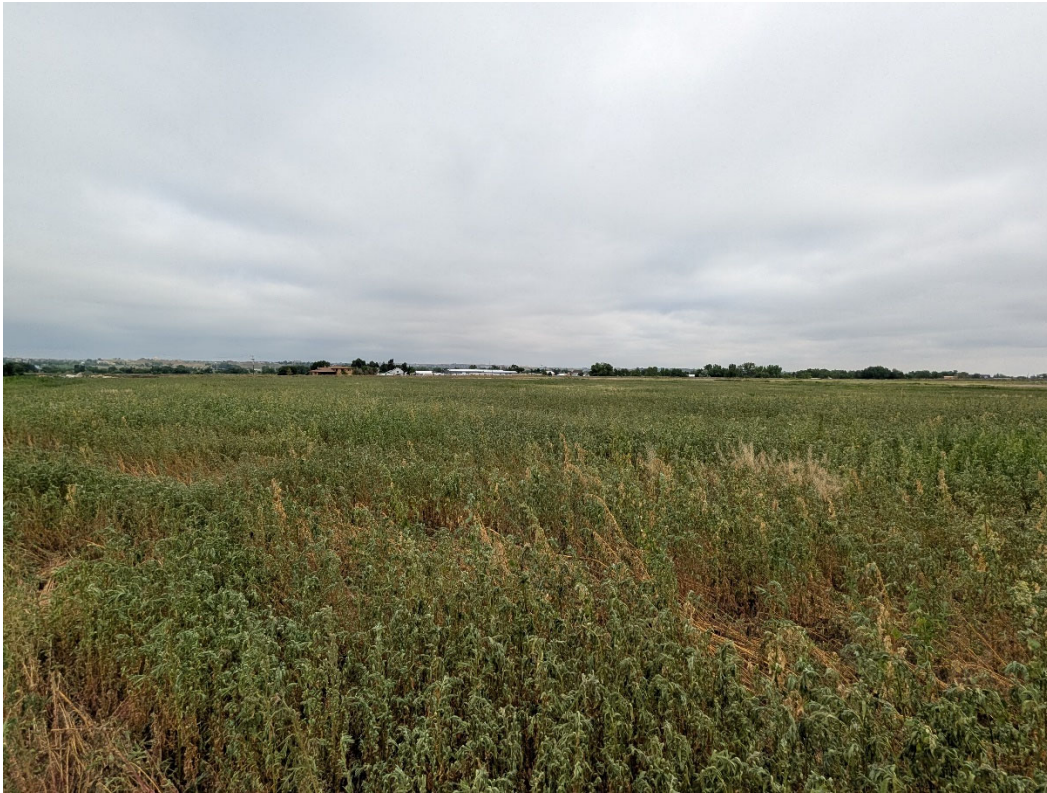
During this inspection, the Division observed the backfilled pit. Topsoil berms surround the mining area, and Mr. Schultejan confirmed the topsoil has not been placed across the site. Annual weeds, primarily kochia, dominate large sections and portions of the site are bare ground. Noxious weeds were observed across the site including, thistle, bindweed, and downy brome (cheatgrass). **As stated in Problem #1 above, the Operator shall develop a weed control and management plan in accordance with Section 3.1.10 (6) of the Rule. This plan should be developed in consultation with the county extension agency or weed control district office and should include specific control measures to be applied, a schedule for when control measures will be applied and a post-treatment monitoring plan. This weed control plan shall be submitted to the Division as a Technical Revision to the approved plan with the appropriate Technical Revision fee of \$216.00 by the corrective action date.**

Photo 5: Looking northwest across the backfilled pit. Annual weeds (kochia) observed covering this area.

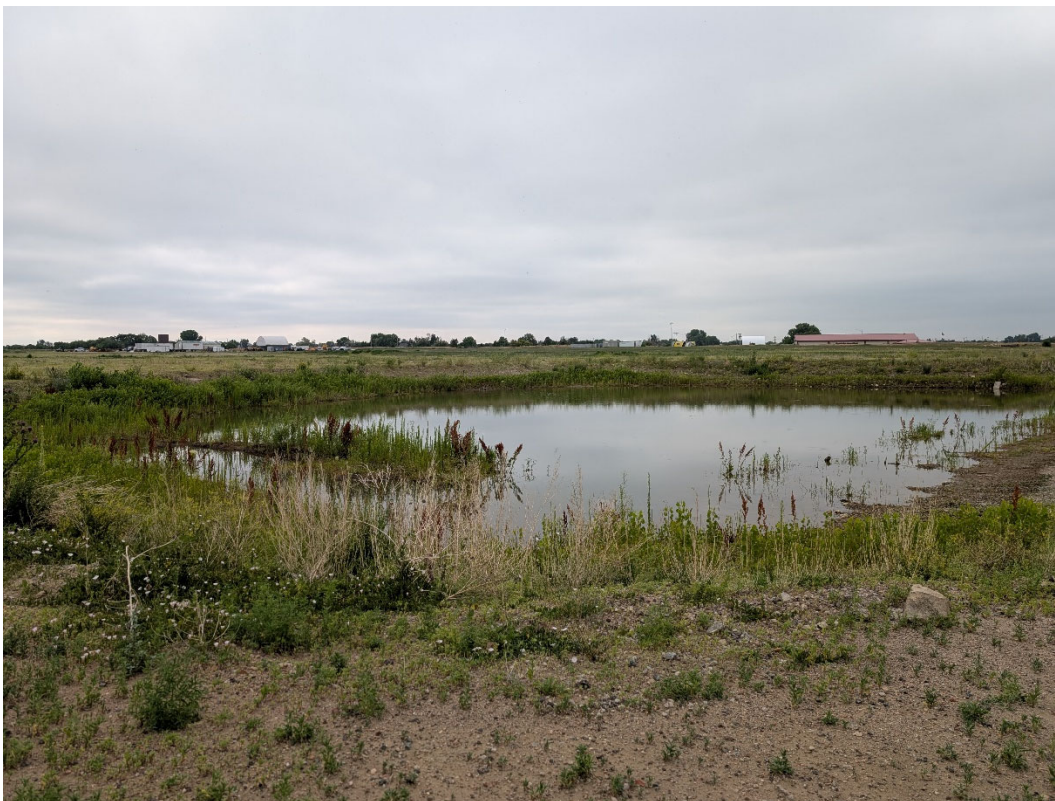
A small pond, approximately 0.6 acre, was observed in the northwest corner of the permit area. The Operator has a current Substitute Water Supply Plan to cover the exposed groundwater surface. The approved reclamation plan depicts a shallow channel with gently sloping sides that directs water along the western perimeter to a swale in the northwest corner that will be seeded with a facultative seed mix.

Photo 6: Small pond in the northwest corner of the permit area.

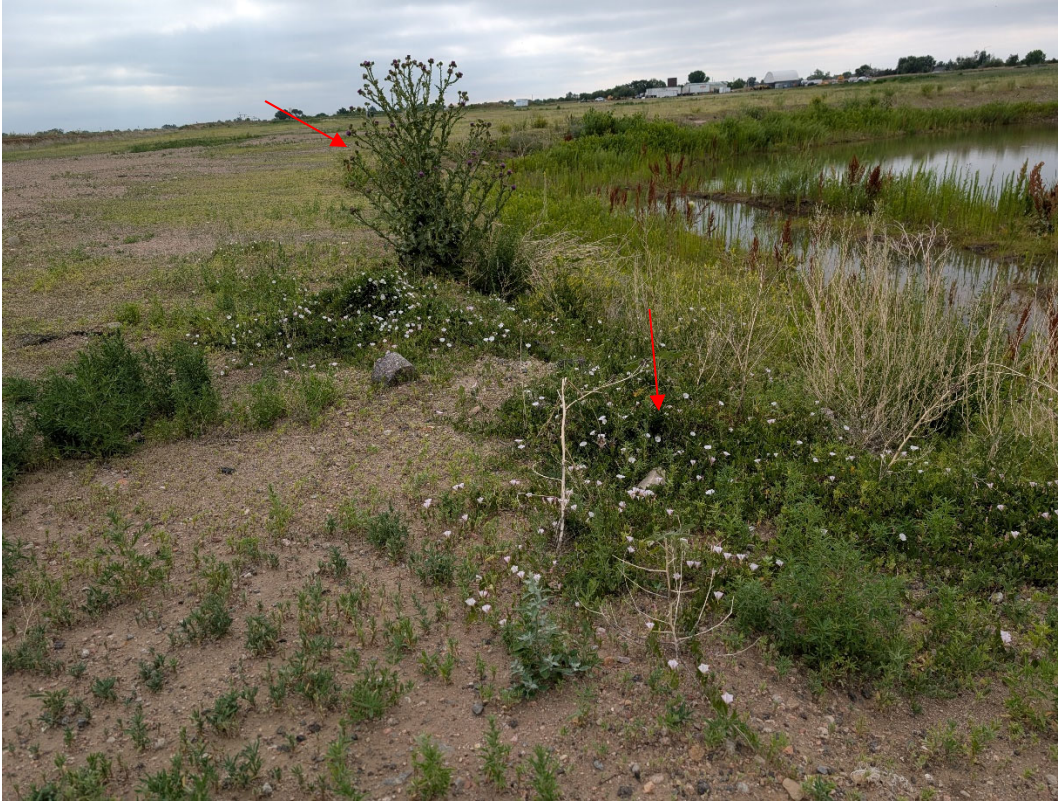
**PROBLEM #1:** There are state-listed noxious weeds present on site. This is a problem for failure to employ weed control methods for state listed noxious weed species within the permitted area, and to reduce the spread of weeds to nearby areas as required by Section 3.1.10 (6) of the rule.

Photo 7: Noxious weeds observed on the north side of the pond. Red arrows point to thistle and bindweed plants.

**CORRECTIVE ACTIONS:** The Operator shall develop a weed control and management plan in accordance with Section 3.1.10 (6) of the Rule. This plan should be developed in consultation with the county extension agency or weed control district office and should include specific control measures to be applied, a schedule for when control measures will be applied and a post-treatment monitoring plan. This weed control plan shall be submitted to the Division as a Technical Revision to the approved plan with the appropriate Technical Revision fee of \$216.00 by the corrective action date.

**CORRECTIVE ACTION DUE DATE:** 8/22/25

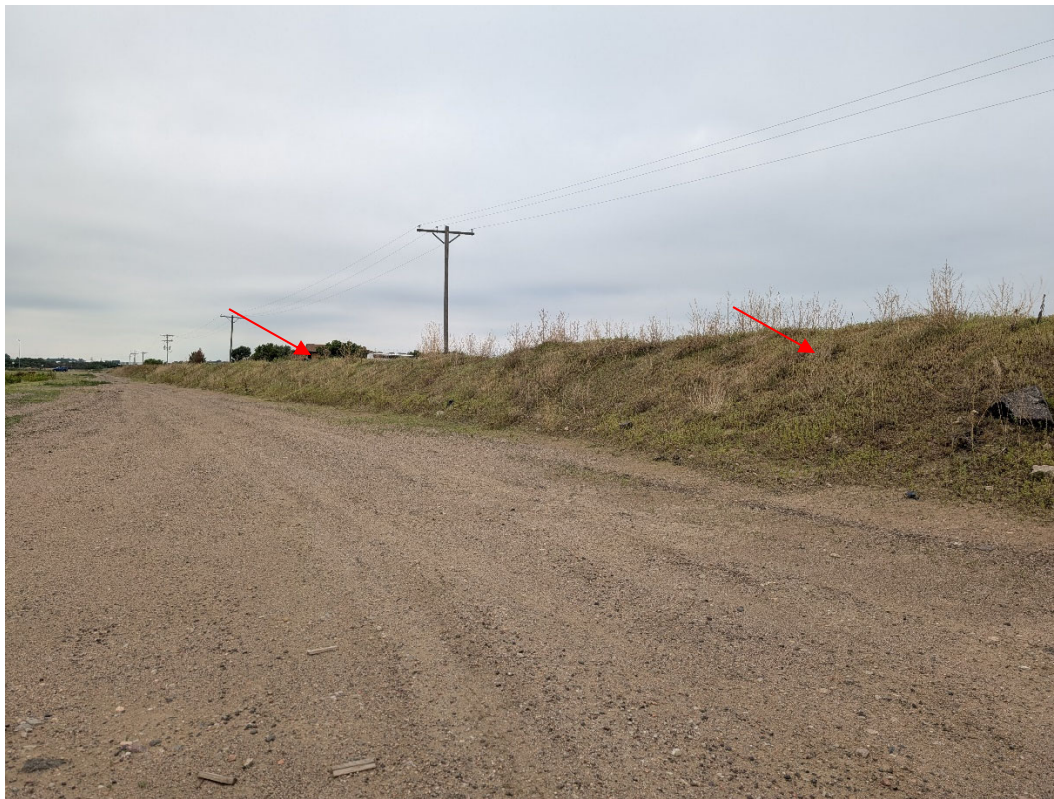
Topsoil was observed in berms around the perimeter of the former mining area. The operator will need to utilize the topsoil and seed the site. An access road was observed, which will remain for future use by the landowner.

Photo 8: Gravel road that will remain in the permit area. Topsoil berms observed around the perimeter of the mined area (red arrows).

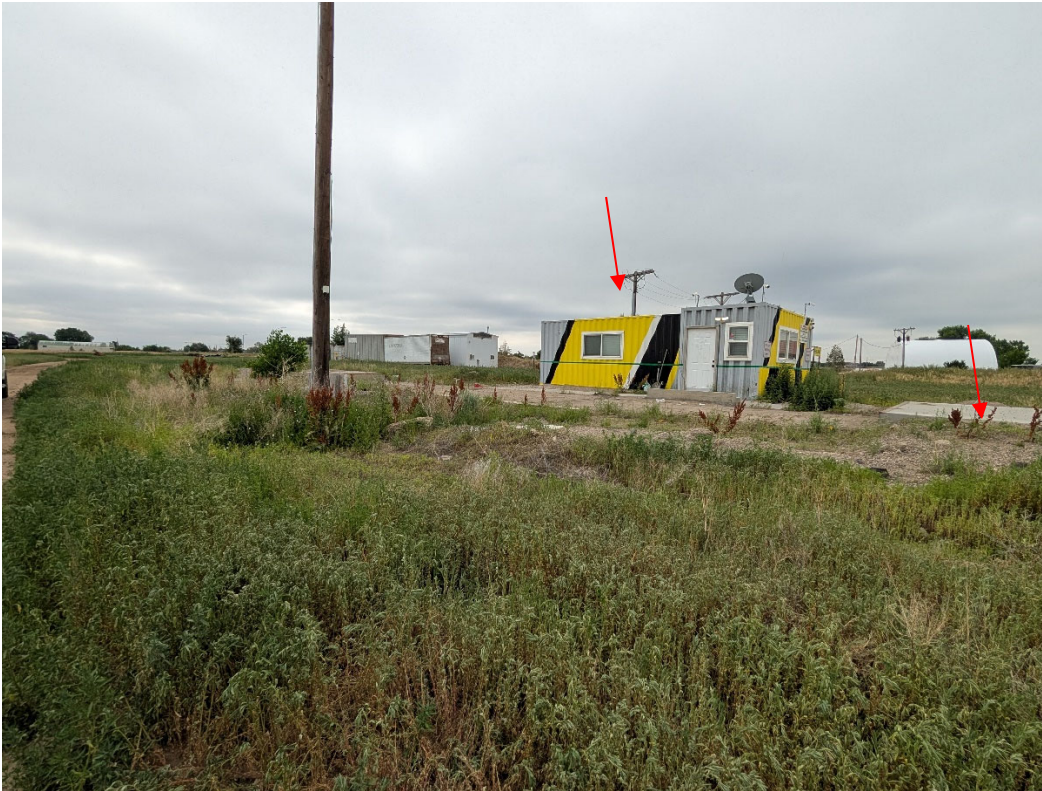
On the south side of the permit area, the Division observed an office/trailer and truck scale on site. Per the approved reclamation plan, the office and scale need to be removed.

Photo 9: Office trailer and scale on the south side of the permit area (red arrows).  
Cheatgrass noted here.

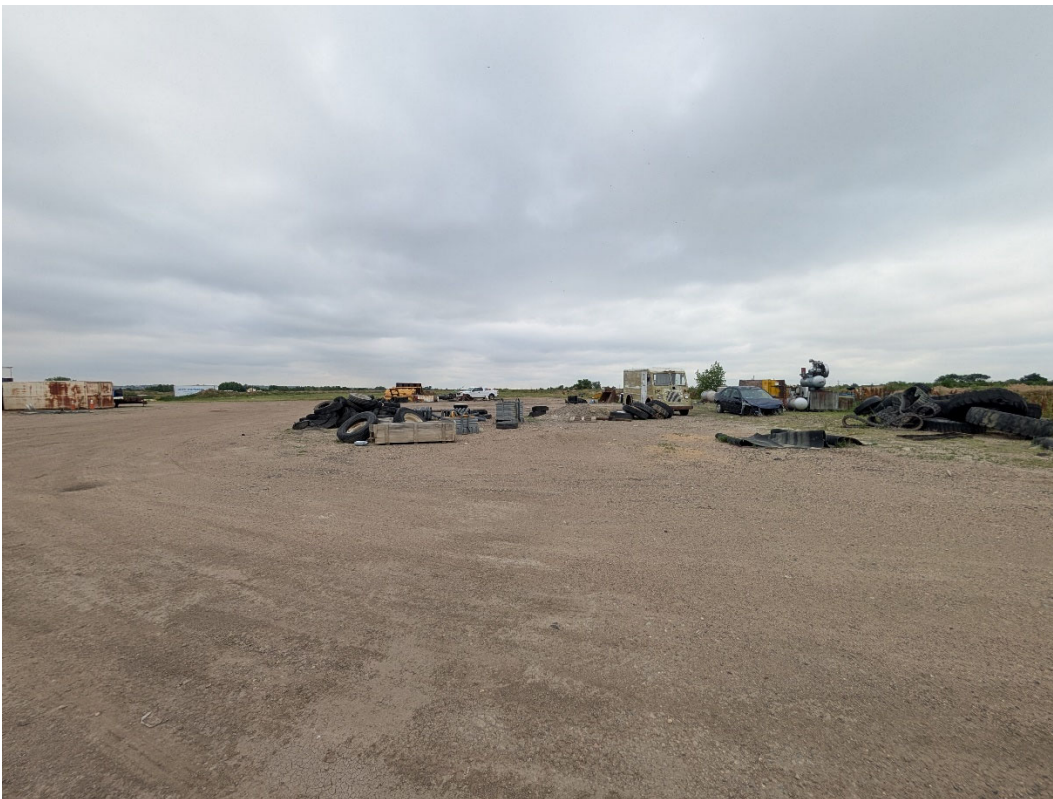
**PROBLEM #2:** The operator is storing abandoned equipment, trailers, and trash within the permit area. This is a problem for failure to dispose of refuse in a manner that controls unsightliness or deleterious effects of such refuse pursuant to C.R.S. 34-32.5-116(4)(e)

Photo 10: Looking north across a storage area on the east end of the permit area.  
Tires, cars and trash were observed here.

**CORRECTIVE ACTIONS:** The operator shall submit a written notice to the Division with photo documentation that the abandoned equipment, vehicles and trash have been removed from the mine site by the corrective action date. Additionally, if the landowner intends to keep the building on site for future agriculture use, the operator will need to submit a Technical Revision to revise the Reclamation Plan along with the revision fee of \$216.00 and obtain approval for structures that will remain on site.

**CORRECTIVE ACTION DUE DATE:** 8/22/25

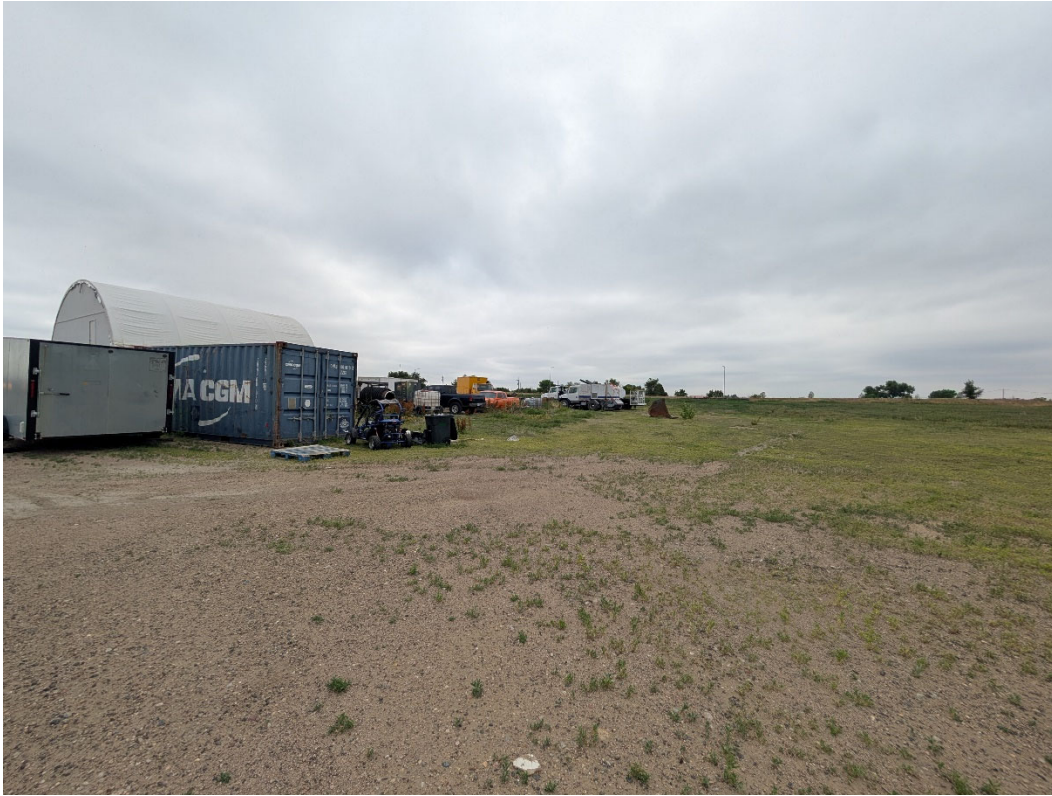
Photo 11: East end of the permit area. Trailers and vehicles stored on site.

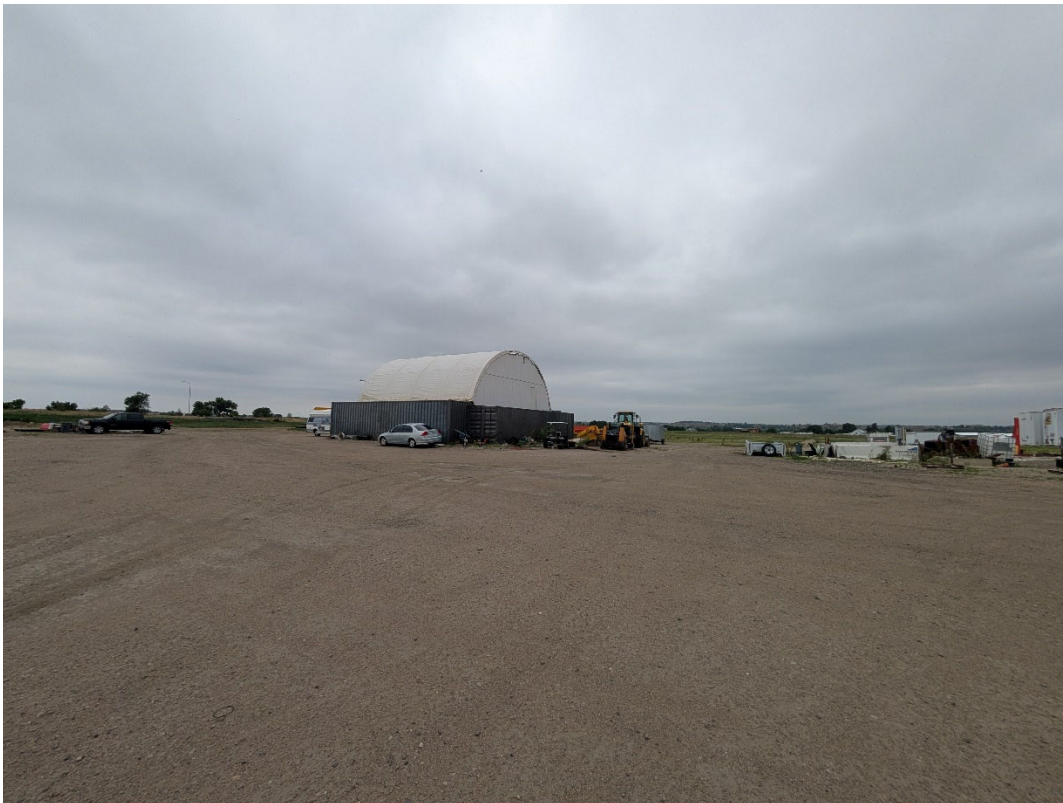
On the east side of the mining area, the landowner is storing used equipment, tires, cars and trailers. Additionally, a large canvas building surrounded by Conex boxes was observed. The post mining land use is agriculture. Ms. Gomez with Adams County, and the Division discussed with Mr. Schultejan the requirements to remove all trash, vehicles, and trailers from the mine site. **As stated in Problem #2 above, the operator shall submit a written notice to the Division with photo documentation that the abandoned equipment, tires, trailers, vehicles and trash has been removed from the mine site by the corrective action date.** If the landowner intends to keep the building on site for future agriculture use, the operator will need to submit Technical Revision to the Division to obtain approval for a work area or any structures to remain on site.

Photo 12: Canvas structure observed in a storage area on the east side of the permit area.
