MINERALS PROGRAM INSPECTION REPORT
PHONE: (303) 866-3567

MINE NAME: 32 Road Pit	MINE/PROSPECTING ID#: M-1985-219	MINERAL: Sand and gravel	COUNTY: Mesa
INSPECTION TYPE: Monitoring	WEATHER: Clear	INSP. DATE: July 8, 2025	INSP. TIME: 10:00
OPERATOR: Parkerson Construction, Inc.	OPERATOR REPRESENTATIVE: Eric Valdez	TYPE OF OPERATION: 112c - Construction Regular Operation	
REASON FOR INSPECTION: Normal I&E Program	BOND CALCULATION TYPE: Complete Bond	BOND AMOUNT: \$351,038.00	
DATE OF COMPLAINT: NA	POST INSP. CONTACTS: None	JOINT INSP. AGENCY: None	
INSPECTOR(S): Amy Yeldell	INSPECTOR'S SIGNATURE:

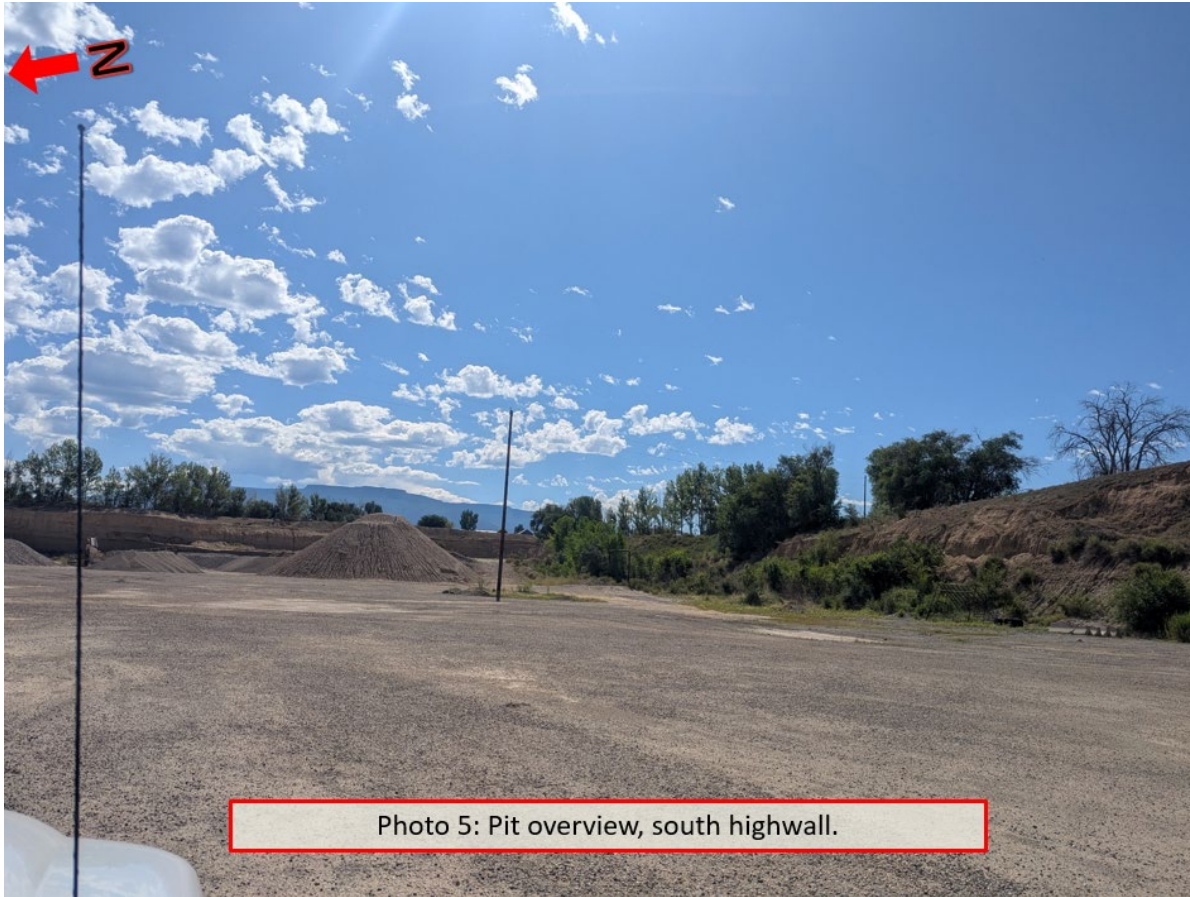
330 LF of highwall on the west side of the agricultural field remains. Additionally, the southern permit boundary highwall remains unchanged

Photo 5: Pit overview, south highwall.

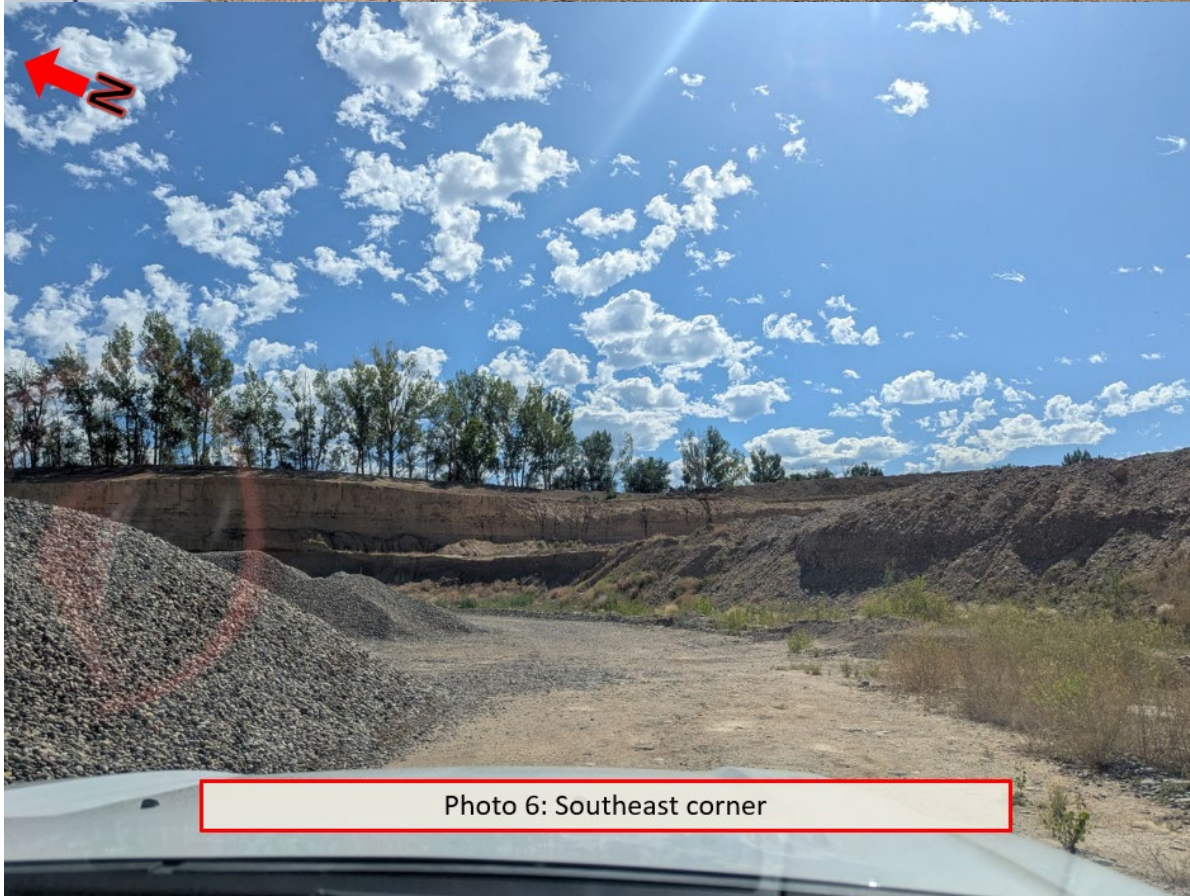
Within the stripped southeast corner approx. 1,000 LF requires backfill. An additional 400 LF of interstitial benching between stripped and mined out area is present. This can be cut/fill contoured. Within the northeast corner approximately 400 yards of grading remains. A small eastern portion (200 LF) along the adjacent property required backfill. The remainder of grading throughout the site is cut fill grading.

Active mining is taking place in the southeast corner (Area 1). The previously stripped bench is being pushed back. It consists of stripped overburden (10-20 ft thick) and the gravel layer (15-25 ft thick). The entirety of Area 1 has been stripped, and a narrow strip remains unmined.

Photo 6: Southeast corner

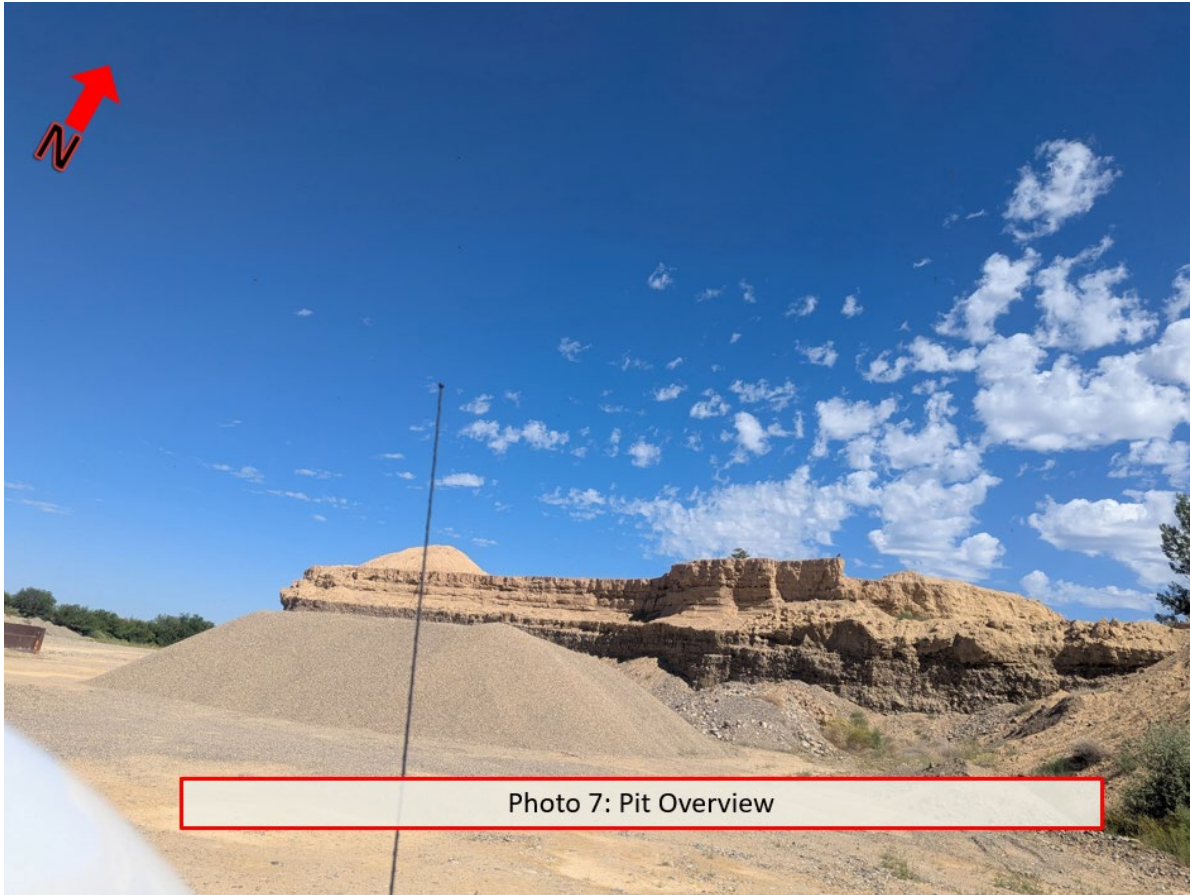
Photo 7: Pit Overview

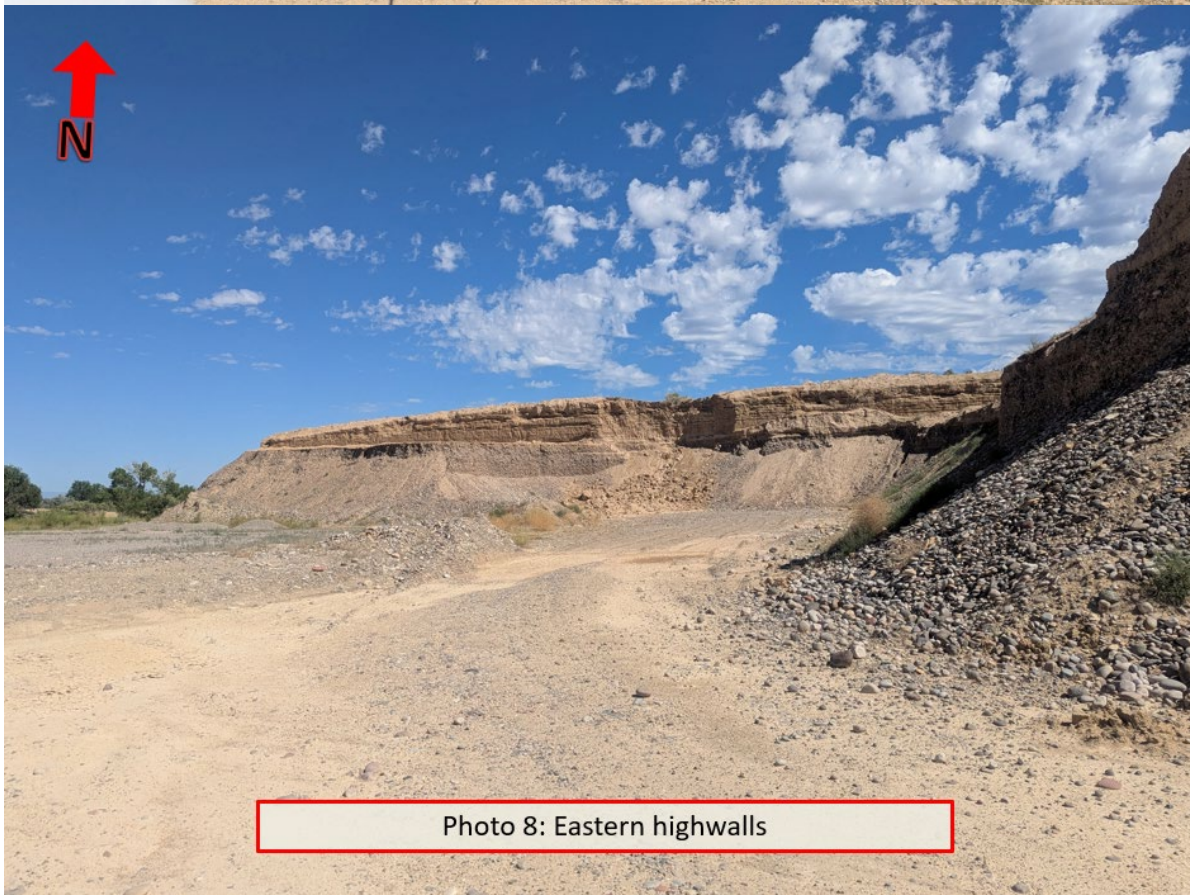
The highwalls along the northeast side surrounding remain near vertical, averaging 20 ft high. The highwalls around the house will require backfilling (600 LF). The other northern slopes are cut fill as they will eventually daylight out (approx. 900 LF).

Photo 8: Eastern highwalls
