C-1981-035 King Mine July Partial Inspection Report

Permit Number: C-1981-035 Mine Name: King Coal Mine Operator: GCC Energy, LLC Operator Address: Mr Jordan McCourt 6473 County Road 120 Hesperus, CO 81326	County: La Plata Operation Type: Underground Permit Status: Active Ownership: Private
	Operator Representative Present: Wade Wymore
Operator Representative Signature: (Field Issuance Only)

Inspection Start Date: July 16, 2025 Inspection Start Time: 13:20 Inspection End Date: July 16, 2025 Inspection End Time: 15:00	Inspection Type: Coal Partial Inspection Inspection Reason: Normal I&E Program Weather: Clear
Joint Inspection Agency: None	Joint Inspection Contacts:
Post Inspection Agency: None	Post Inspection Contacts:
Inspector(s): Lucas West	Inspector's Signature:

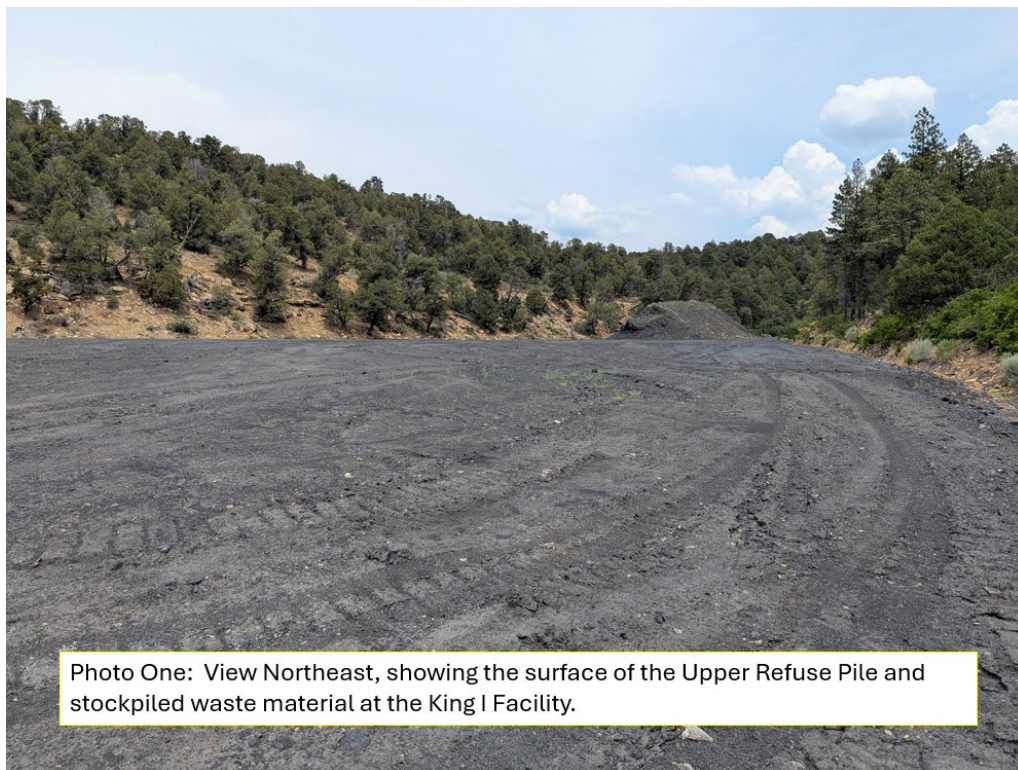
At the King I facility both the Upper and the Lower Refuse Piles were observed. The Upper Refuse Pile (URP) remains in similar condition to the Division's previous inspections. The stockpile of material at the East end of refuse pile shows no signs of recent placement, nor signs of erosion or sediment transport. The face of the pile is well compacted, and no evidence of erosion was noted. The surface of the pad as well as the stockpile of waste material can be seen in Photo One. The out slopes of the refuse pile were well compacted and no rilling was noted.

Photo One: View Northeast, showing the surface of the Upper Refuse Pile and stockpiled waste material at the King I Facility.

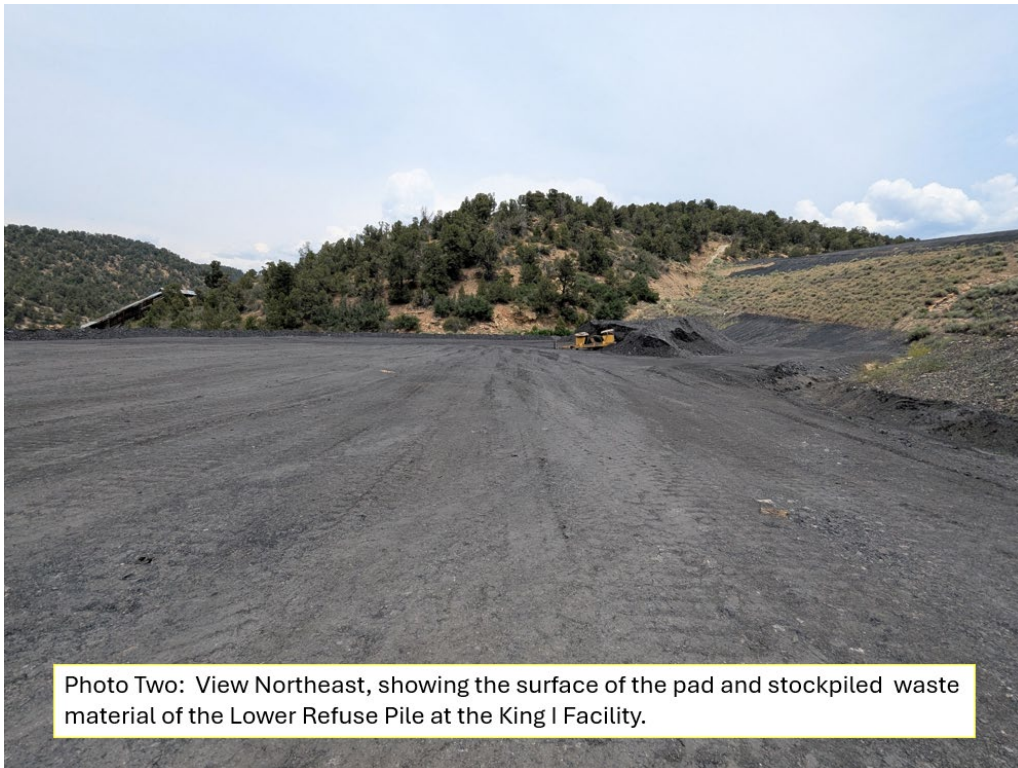
The Lower Refuse Pile (LRP) was also observed to be in excellent condition. Recent lifts of material have been placed and compacted. According to onsite discussions a compaction test of the material will be performed soon. All material sizing and grading of the surface of the pile appear to be within design specifications. No evidence of settling, slumping or erosion was noted and no impounded stormwater was observed. A small stockpile of material remains on the surface of the LRP. The stockpile appeared stable at the time of the inspection. The surface of the pile and stockpile can be seen in Photo Two. The out slopes of the Refuse Pile also appeared stable during the inspection. No evidence of erosion was noted.

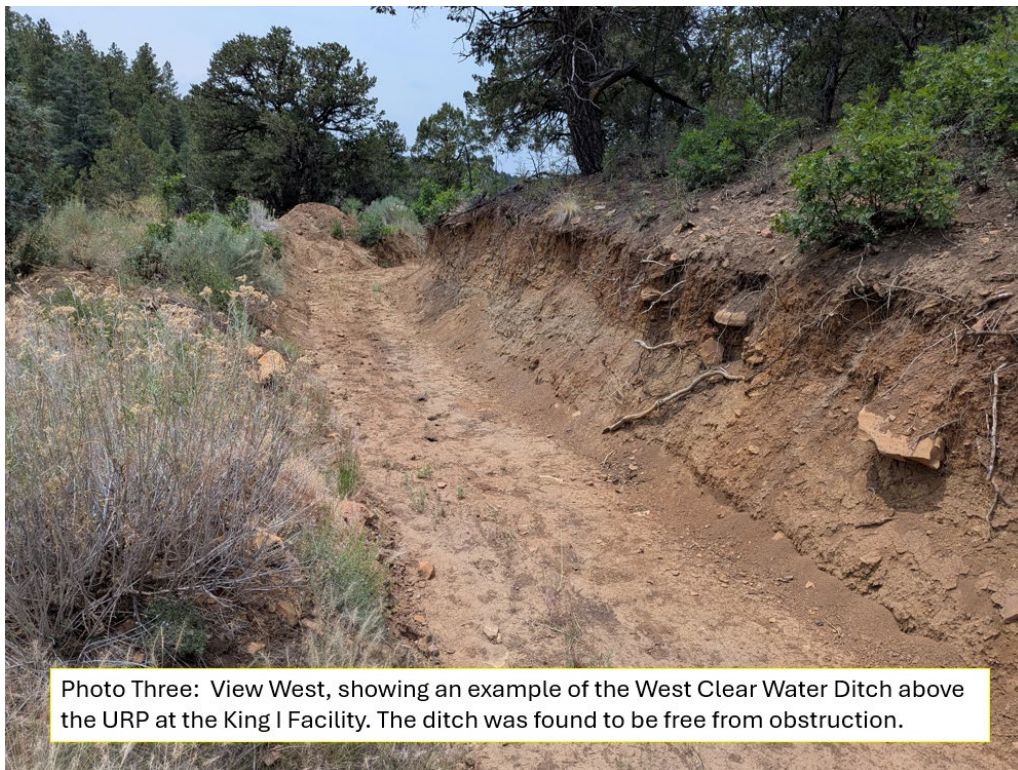
At both the King I and II areas both sets of the Clear Water Ditches were observed. At the King I Facility, the East Clear Water Ditch was found to be in excellent condition. The entire length of the CWD was free from obstruction and appears to be able to function as designed. The West CWD was found to be in similar condition. No significant obstructions were noted and the ditch appeared to be able to flow freely. Photos Three and Four show examples of the ditches.

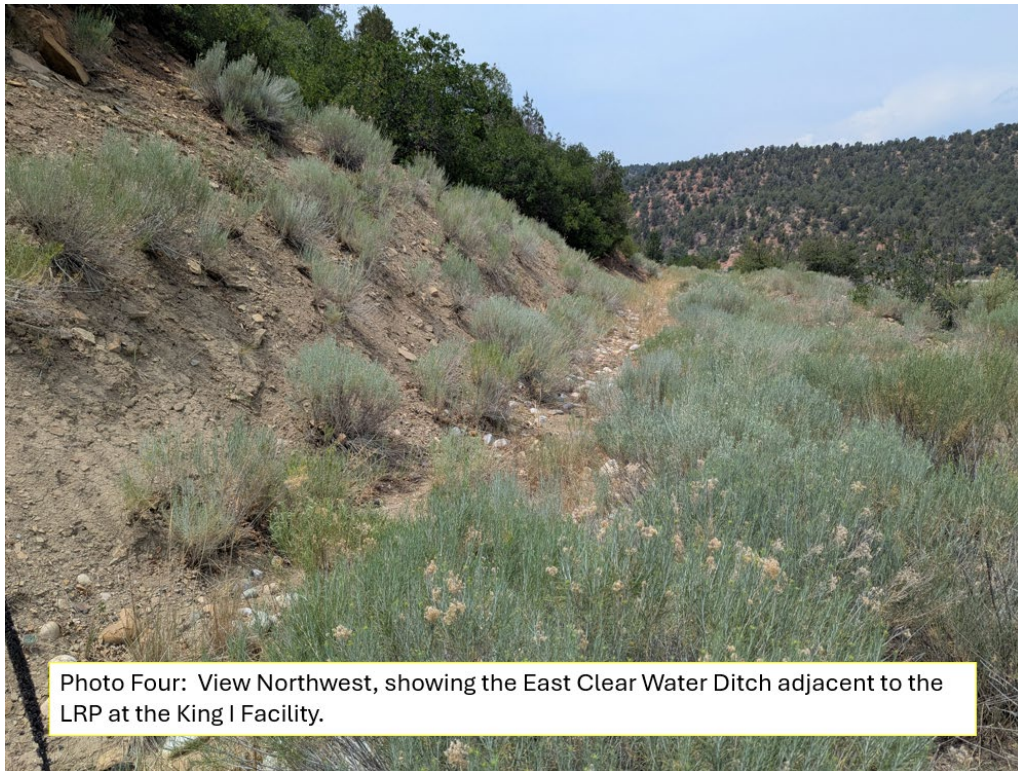
Photo Four: View Northwest, showing the East Clear Water Ditch adjacent to the LRP at the King I Facility.

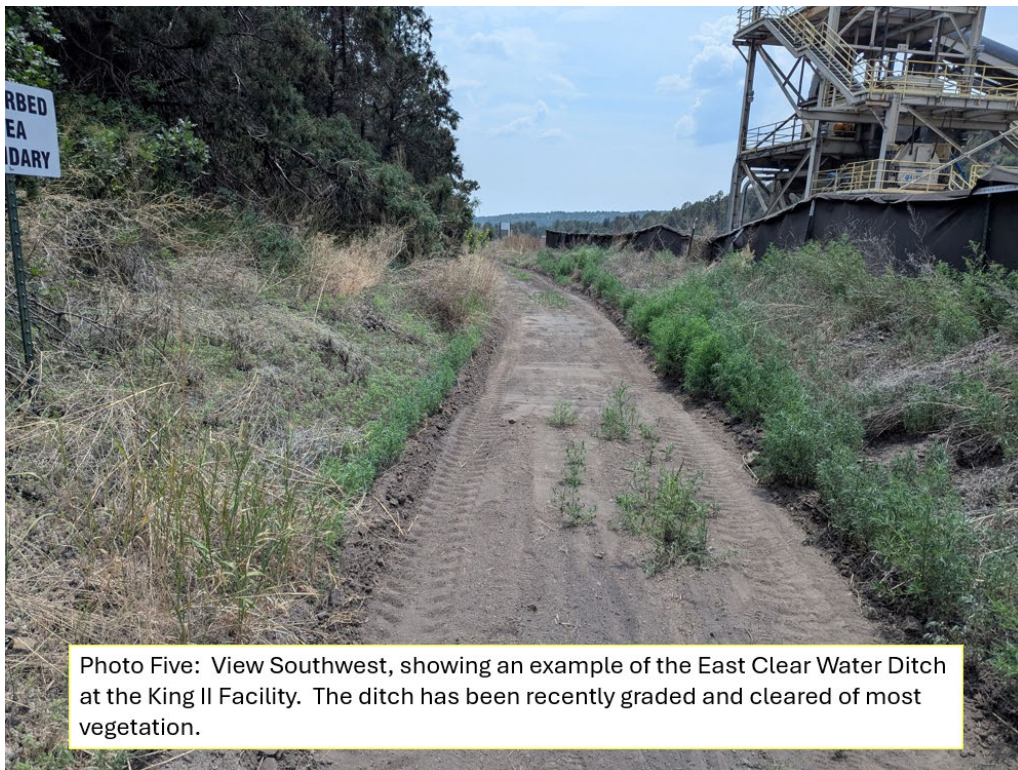
At the King II Facility, the East CWD was found to have been recently cleared of vegetation and graded to ensure proper flow. The East ditch is in good condition and an example of such can be seen in Photo Five. The West CWD was noted to be free from obstruction and able to function as designed. An example of the West ditch can be seen in Photo Six. The entire length of both CWD's was walked to ensure proper functionality.

Photo Five: View Southwest, showing an example of the East Clear Water Ditch at the King II Facility. The ditch has been recently graded and cleared of most vegetation.

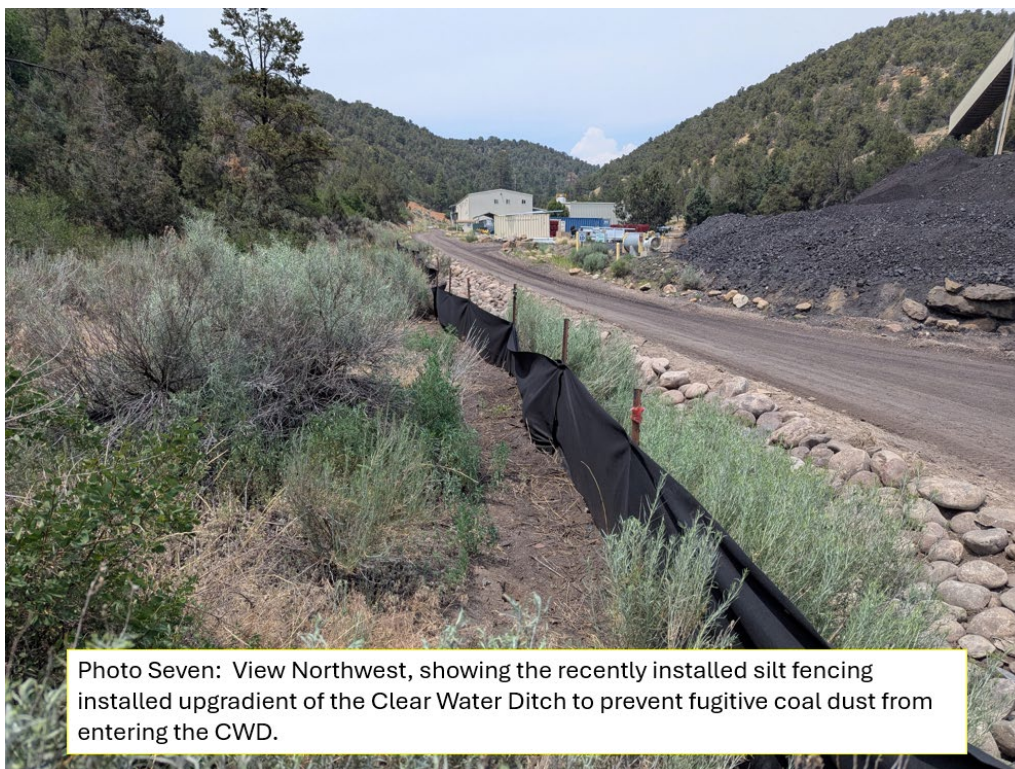
Additionally, the recently installed silt fencing installed just upgradient of the West CWD at the King II facility was observed. The silt fence was installed to prevent minor amounts of fugitive coal dust from entering the West CWD. The silt fence itself was found to be in tact and functioning as intended. Photo Seven shows the fencing. The entire upgradient side was inspected for any accumulated material and no material was observed as seen in Photo Eight.
