## C-1981-008 July Partial Inspection Report

**PERMIT INFORMATION**

| <b>Permit Number:</b> C-1981-008<br><b>Mine Name:</b> New Horizon Mine<br><b>Operator:</b> Elk Ridge Mining and Reclamation, LLC<br><b>Operator Address:</b><br>Mr Tony Tennyson<br>P.O. Box 628<br>27646 West 5th Avenue<br>Nucla, CO 81424 | <b>County:</b> Montrose<br><b>Operation Type:</b> Surface<br><b>Permit Status:</b> Active<br><b>Ownership:</b> Private |

| <b>Inspection Start Date:</b> July 17, 2025<br><b>Inspection Start Time:</b> 11:20<br><b>Inspection End Date:</b> July 17, 2025<br><b>Inspection End Time:</b> 11:53 | <b>Inspection Type:</b> Coal Partial Inspection<br><b>Inspection Reason:</b> Normal I&E Program<br><b>Weather:</b> Cloudy |

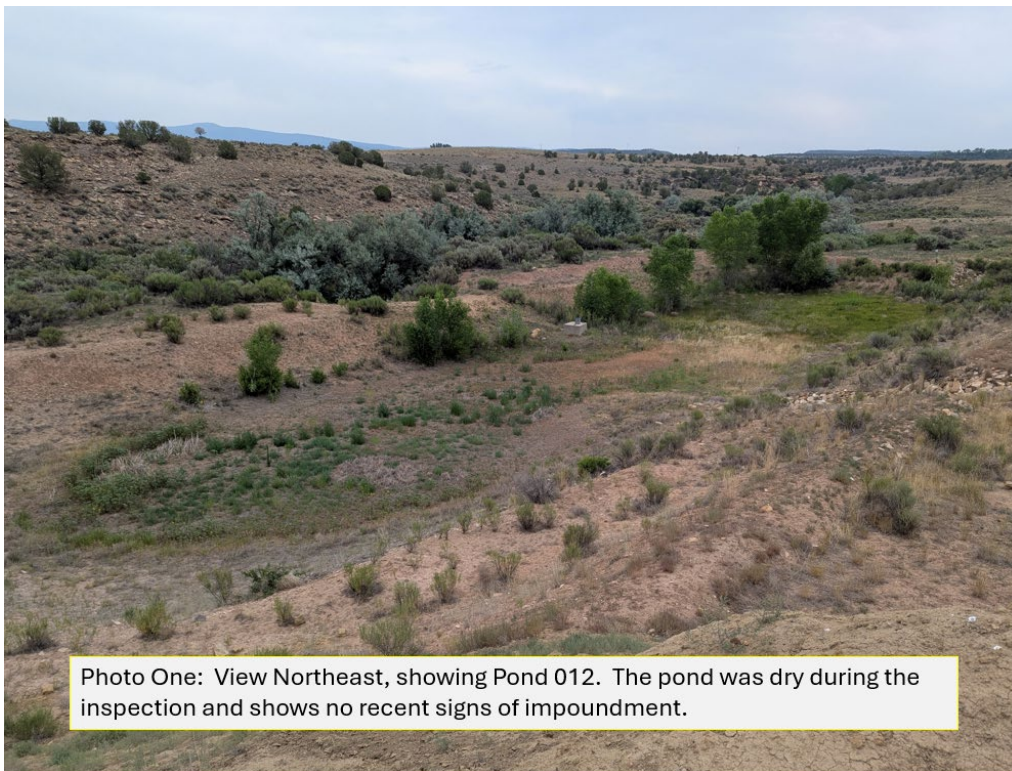
During this inspection, Ponds 012, 013 and 016 were observed. Pond 012, as seen in Photo One was in good condition, contained no standing water and showed no signs of recent impoundment. The banks appeared stable at the time of the inspection and the discharge structure appeared to be able to function as designed. No evidence of discharge was noted. Pond 013, appeared to contain the normal amount of water, with water actively flowing in through the aeration structure. Pond 013 can be seen in Photo Two. Adjacent to Pond 013, the rock lined drop structure was observed. No signs of recent flows were noted. The banks of the pond, as well as the baffle curtains all appeared stable and in good condition. Pond 016 was dry as seen in Photo Three, with no signs of recent impoundment. The banks of both ponds appeared to be stable at the time of the inspection and in good condition.

Photo One: View Northeast, showing Pond 012. The pond was dry during the inspection and shows no recent signs of impoundment.

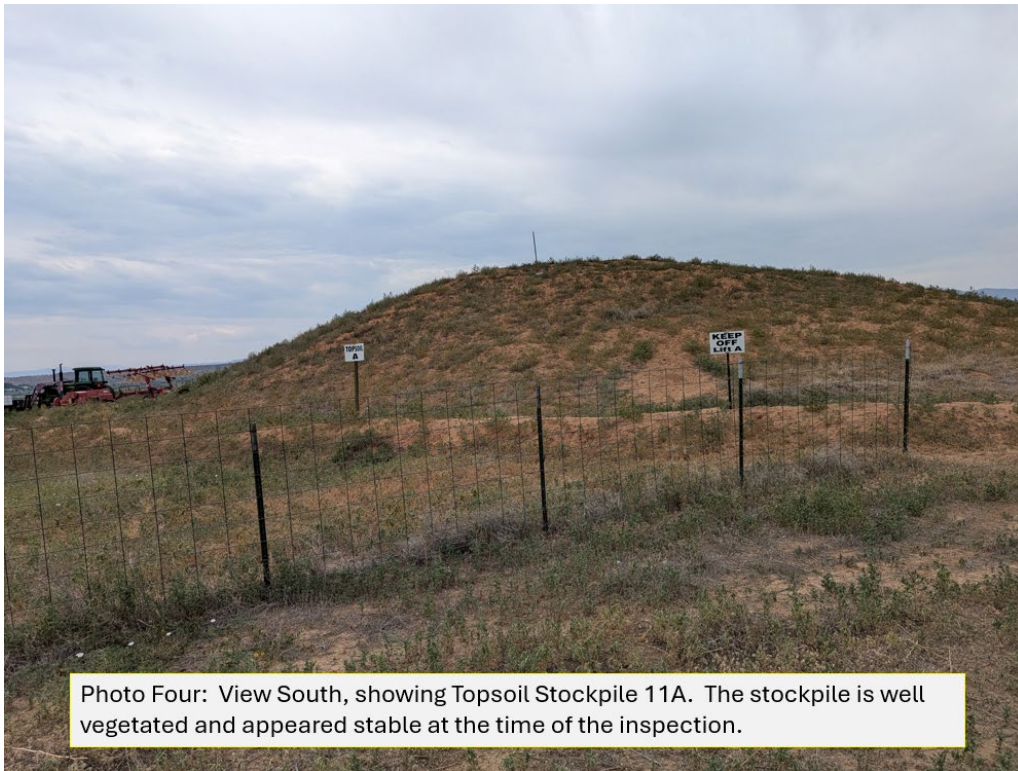
Morgan Property. Both stockpiles in this area are well vegetated and appeared stable at the time of the inspection. The ring berms around the piles are functioning as designed and no evidence of erosion or sediment transport was noted. The stockpiles can be seen in Photos Four and Five respectively.

Photo Four: View South, showing Topsoil Stockpile 11A. The stockpile is well vegetated and appeared stable at the time of the inspection.

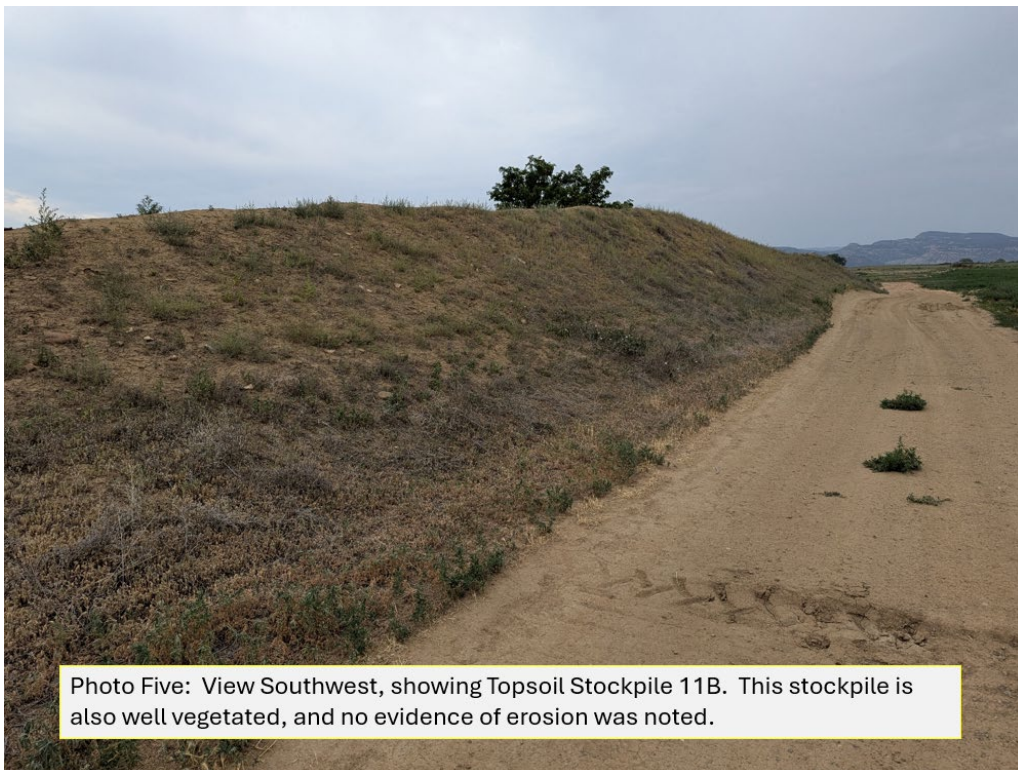
Photo Five: View Southwest, showing Topsoil Stockpile 11B. This stockpile is also well vegetated, and no evidence of erosion was noted.

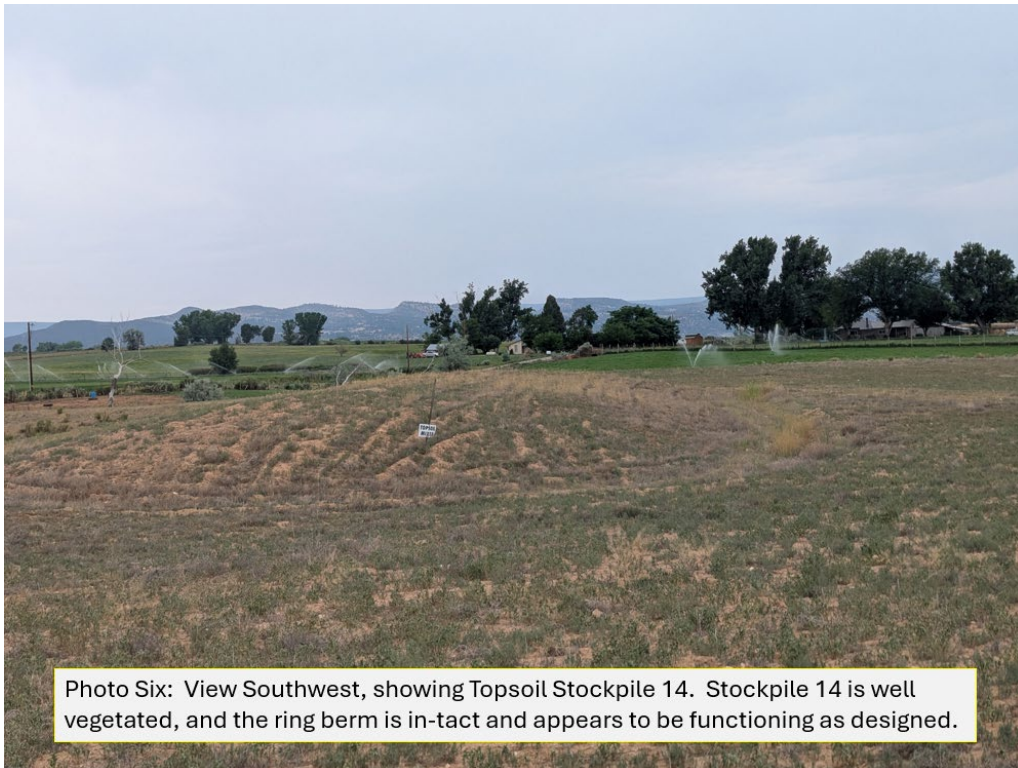
Topsoil Stockpiles 14 and 15 are located adjacent to Pond 016 on the Johnson Property Area. Both stockpiles are well vegetated, with in-tact ring berms and show no signs of erosion. These stockpiles can be seen in Photos Six and Seven. The Bench 1 stockpile in the area appeared to be stable with no signs of significant erosion. The Bench 1 stockpile is also vegetated for stability.

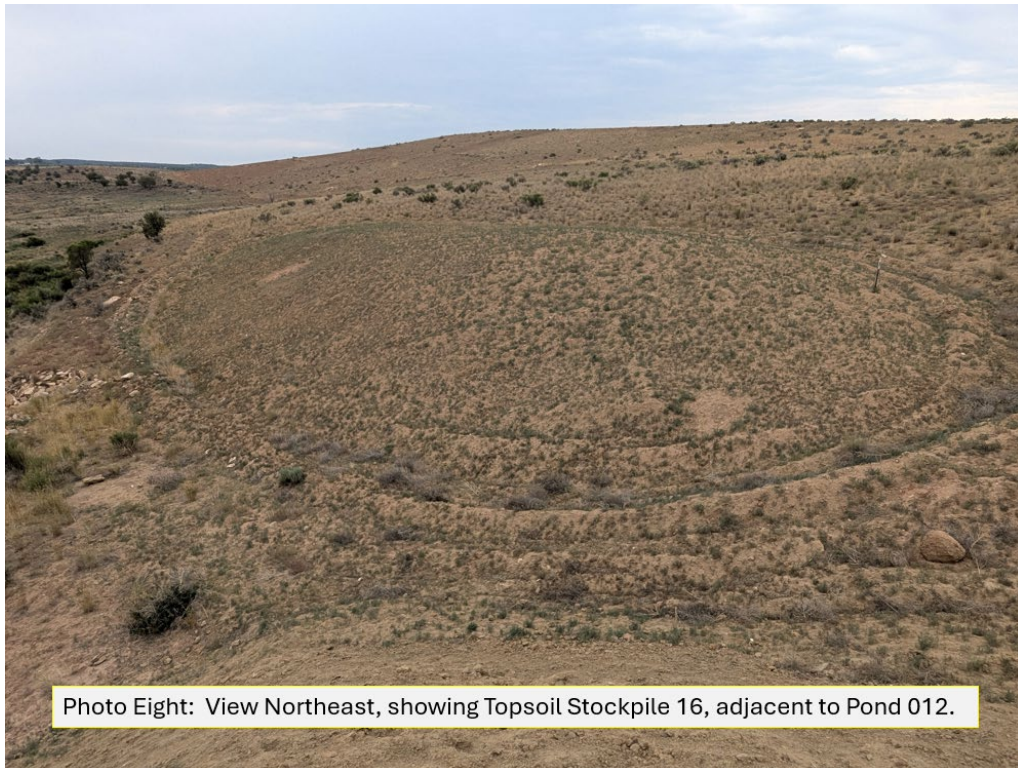
Topsoil Stockpile 16 is also in good condition, and well vegetated for stability as seen in Photo Eight. The ring berm around the stockpile appears to be functioning as designed. The adjacent Bench 1 stockpile, as seen in Photo Nine shows no signs of sloughing or erosion and no evidence of recent hauling was noted. All observed stockpiles are in excellent condition.
