Phase I, II and III Bond Release Inspection Request (SL-25), Colwyo Coal Mine, C1981019

PERMIT INFORMATION

Permit Number: C-1981-019 Mine Name: Colowyo Coal Mine Operator: Colowyo Coal Company L.P. Operator Address: Mr Tony Tennyson	County: Moffat, Rio Blanco Operation Type: Surface Permit Status: Active Ownership: Private	
5731 State Highway 13	Operator Representative Present:	
Meeker, CO 81641	operator representative resents	
WICCKCI, CO 61041	Tony Tennyson	
Operator Representative Signature: (Field Issuance Only)

Inspection Start Date: July 17, 2 Inspection Start Time: 07:30 Inspection End Date: July 17, 20 Inspection End Time: 11:00			Inspection Type: Coal Partial Inspection Inspection Reason: Surety Release Requested Weather: Clear
Joint Inspection Agency:		Joint	Inspection Contacts:
OSM			
Post Inspection Agency: Po		Post	Inspection Contacts:
OSM			
Inspector(s):	Inspector's Signature: Signature Date:		
Hunter Ridley	Hunter Ridley July 22, 2025

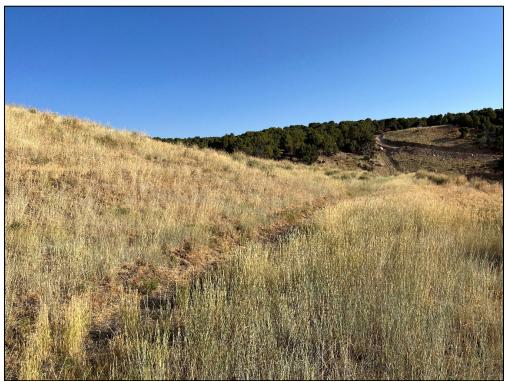
Visual inspection of the ditch also included inspection of ditch design such as channel depth, channel type, side slopes and channel material for comparison to approved design criteria for Streeter South Side Ditch. No erosional issues were noted within the requested release area, suggesting that grading and channel establishment has been constructed to encourage proper storm drainage as required. No areas were identified that would suggest stormwater has flowed or could flow outside of the approved channel area. Elevational GPS data will be post-processed and further compared to the data provided by Colowyo to verify the approved post-mining topography has been achieved. In depth analysis of these data points will be provided as part of the Division's Proposed Decisions and Findings of Compliance Document for SL-25.

Photo 1: View north looking towards the northern end of Streeter South Side Ditch.

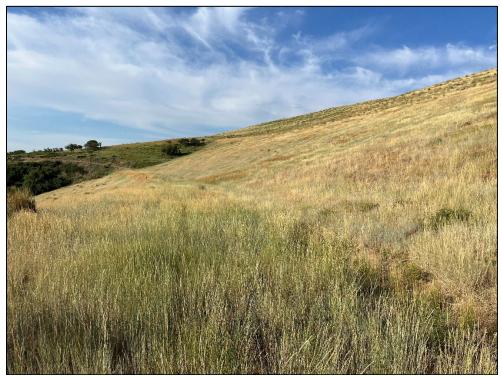
Photo 2: Looking south across Streeter Fill and towards Streeter South Side Ditch.

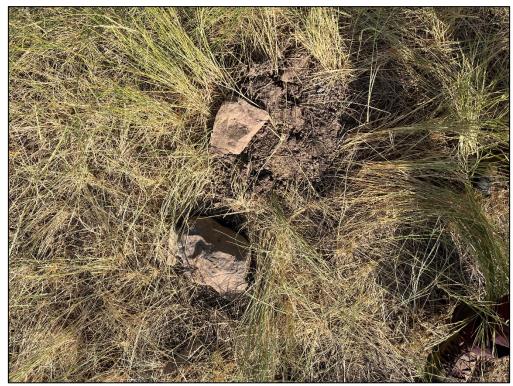
Prior to the SL-25 inspection, four unused water monitoring wells were discovered adjacent to the northern end of Streeter South Side Ditch (Example Photo 3). These were originally used for water monitoring of the Streeter Valley Fill area, which has since been Phase III released and removed from Colowyo's permit boundary. All four wells were abandoned in the days before the SL-25 inspection.

Photo 3: Example of one of four wells along the edge of Streeter South Side Ditch that were abandoned.

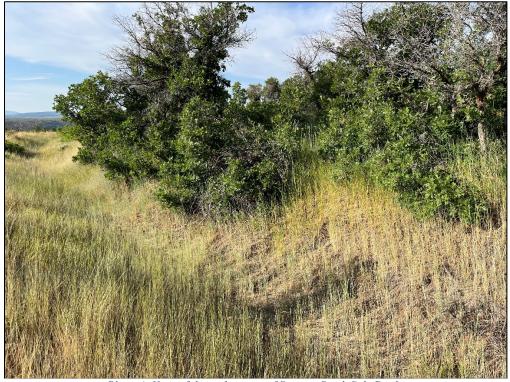
Photo 4: View of the mid section of Streeter South Side Ditch.

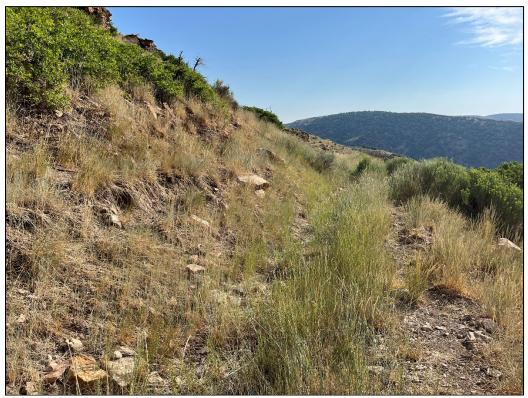
Photo 5: View north of the southern end of Streeter South Side Ditch.

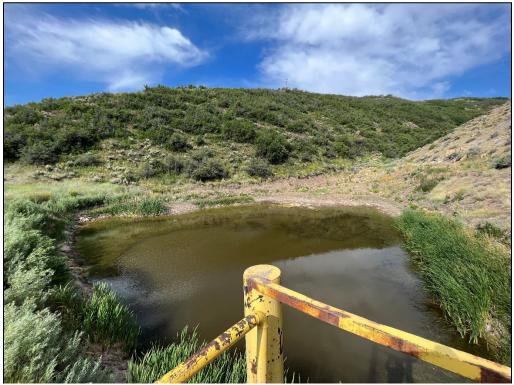
Other areas observed as part of this partial inspection but not related to SL-25 include Prospect Pond, Section 28 Pond, EP1, EP2, EP3 and Final East Pit Ditch (Photos 6-12). All areas were free of erosional issues, had stable embankments, inlet/outlet areas were free of obstruction and were holding water as designed.

Photo 6: Prospect Pond.

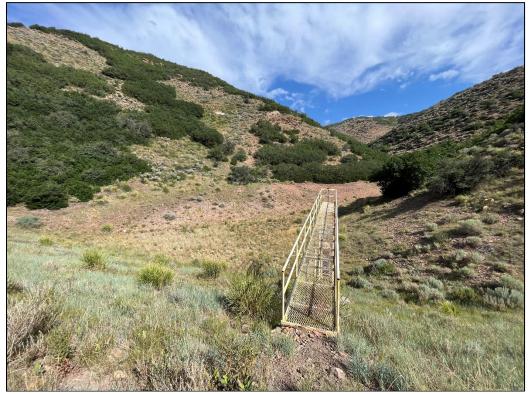
Photo 7: View north of Section 28 Pond.

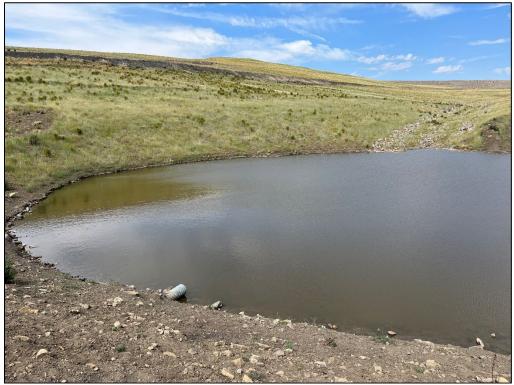
Photo 8: View southwest of EP2.

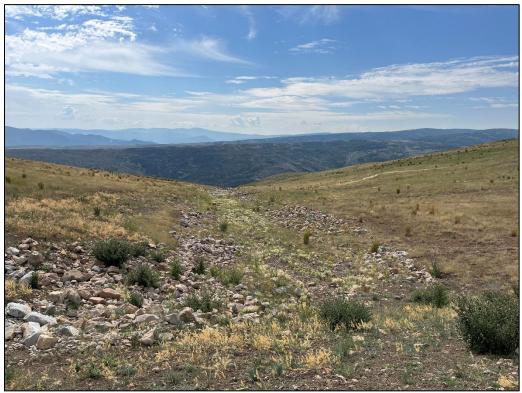
Photo 9: View east of Reach 2 of Final East Pit Ditch.

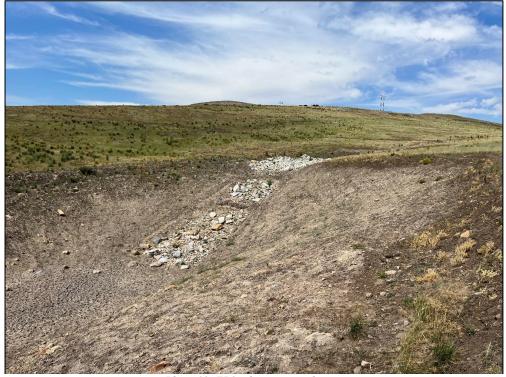
Photo 10: EP2 inlet, view southwest.

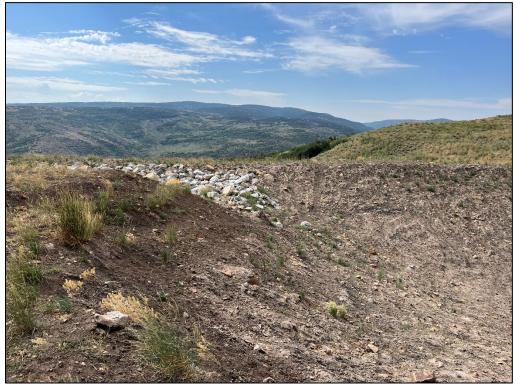
Photo 11: EP2 outlet, view south.

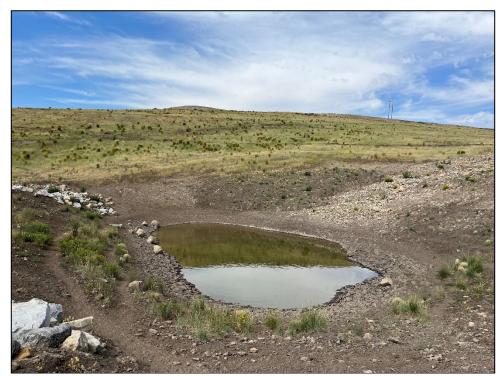
Photo 12: EP3, view south.

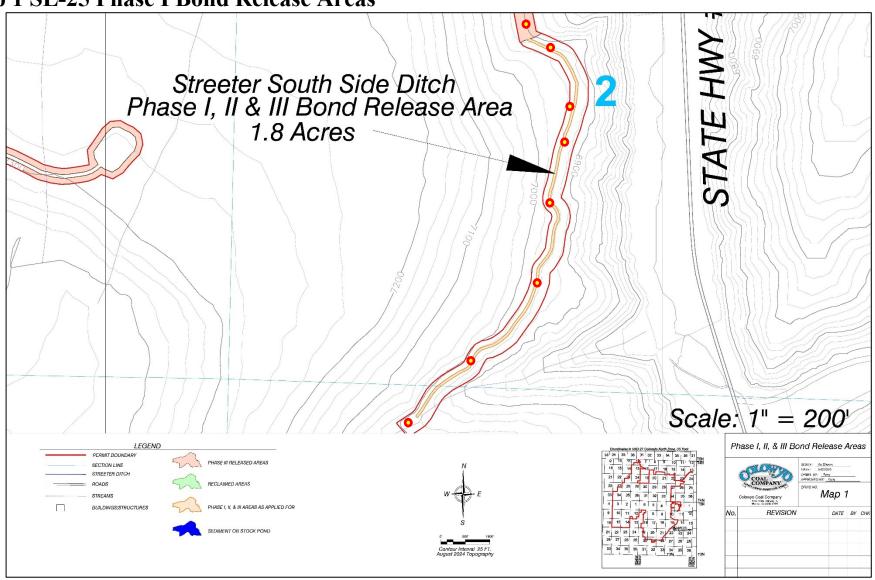
Map 1 SL-25 Phase I Bond Release Areas

Rule 3.03.1(2)(a) states, "Up to sixty percent of the applicable bond amount shall be released when the permittee successfully completes backfilling, regrading, and drainage control in accordance with the approved reclamation plan." The Division inspected the SL-25 requested areas in the East Pit to ensure Colowyo has met the drainage control establishment requirements outlined in Colowyo's PAP. The total acreage being requested for Phase I bond release is 1.8 acres and consists entirely of the Streeter South Side Ditch, an approved permanent conveyance structure. The ditch was walked in its entirety (Photos 1-5), and elevational GPS points were collected at eight different locations along the ditch. Data point locations were determined using a georeferenced image of 'Map 1 SL-25 Phase I Bond Release Areas', provided with the SL-25 application and are shown below on Map 1.

Table 1: Eight elevation points collected along Streeter South Side Ditch, locations shown below in Map 1 and follow location points chronologically north to south.
