**MINERALS PROGRAM INSPECTION REPORT**  
**PHONE: (303) 866-3567**

<b>MINE NAME:</b> Dellacroce Pit	<b>MINE/PROSPECTING ID#:</b> M-1993-050	<b>MINERAL:</b> Gravel	<b>COUNTY:</b> El Paso
<b>INSPECTION TYPE:</b> Surety Release Inspection	<b>WEATHER:</b> Clear	<b>INSP. DATE:</b> July 21, 2025	<b>INSP. TIME:</b> 09:30
<b>OPERATOR:</b> Raymond F. & Robert W. Dellacroce	<b>OPERATOR REPRESENTATIVE:</b> Dr. Angela Bellantoni	<b>TYPE OF OPERATION:</b> 112c - Construction Regular Operation	
<b>REASON FOR INSPECTION:</b> Surety Release Requested	<b>BOND CALCULATION TYPE:</b> None	<b>BOND AMOUNT:</b> \$37,112.00	
<b>DATE OF COMPLAINT:</b> NA	<b>POST INSP. CONTACTS:</b> None	<b>JOINT INSP. AGENCY:</b> None	
<b>INSPECTOR(S):</b> Hunter Ridley	<b>INSPECTOR'S SIGNATURE:</b>

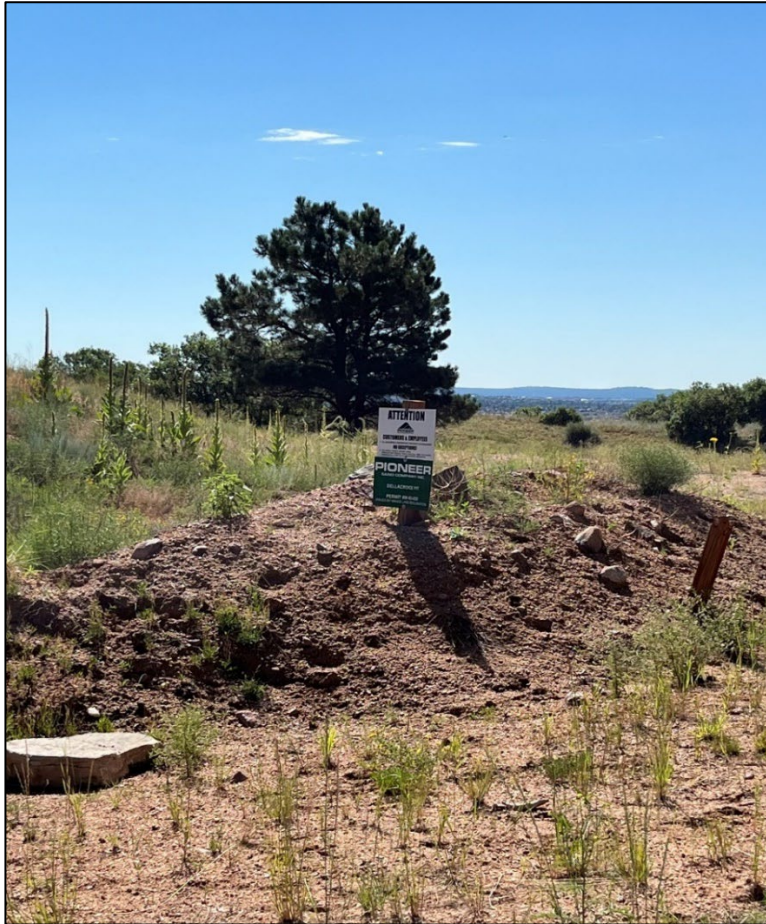
**Signs and Markers:** The permit sign was posted at the access road entrance (Photo 1). The affected area boundary had been marked using the perimeter visual berms, which have since been regraded (Photos 7 and 8). No accessory markers (e.g., t-posts) require removal for final release. However, the sign will be removed following final release.

**Photo 1: Permit sign posted at the site entrance.**

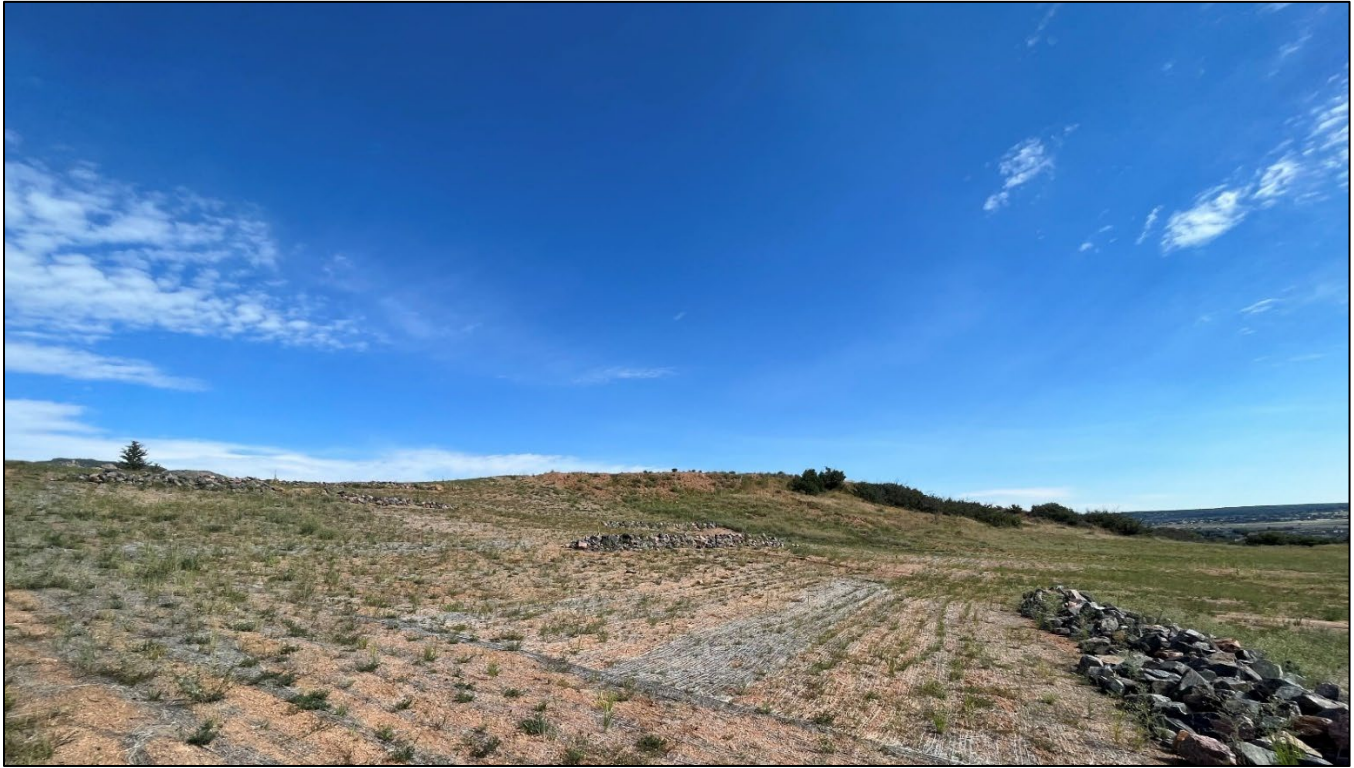
**Backfilling and Grading:** Site grading remains complete as observed at the Division's last inspection in 2023 and conforms to the Division's backfilling and grading requirements outlined in Rule 3 of the Construction Materials Rules and Regulations and outlined in the permit's approved Reclamation Plan (Photos 5 and 8). Slopes appeared to be 3H:1V or gentler throughout the site. No leftover overburden or topsoil piles were observed on site.

**Sediment Control:** This site has struggled with erosional features in the past, especially on the main, east facing slope between the upper and lower mine areas. However, significant work has been done to prevent erosion and sedimentation while this hillside revegetates. For example, erosion control rock check dams have been put in place along the troublesome slope and erosion control matting was also installed (Photo 2). These interventions appeared to have been successful, as this slope did not exhibit any signs of erosion and vegetation was successfully establishing across the entirety of the slope.

**Photo 2: View north of the reclaimed slope between the upper and lower mine areas, rock check dams are in place.**

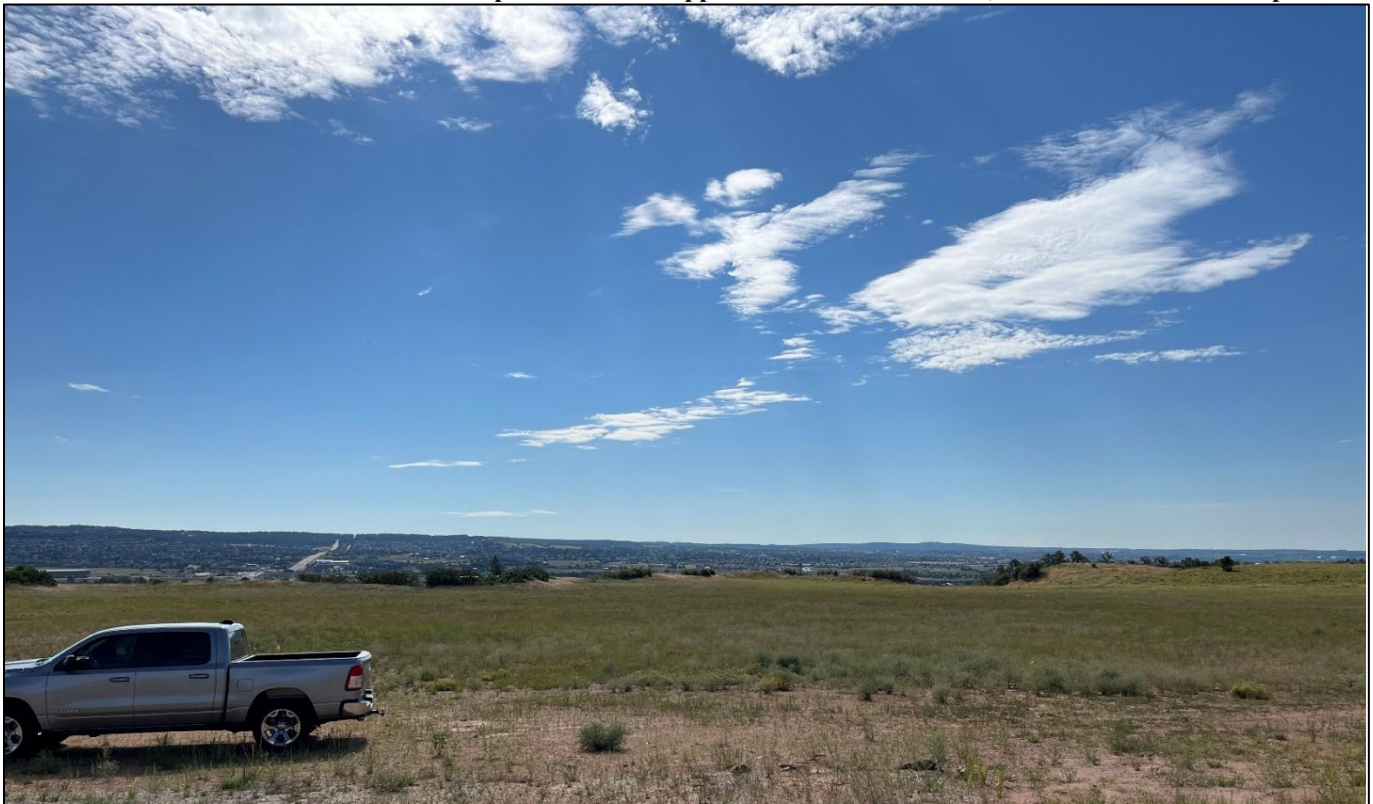
Two Surety Reductions (SR1 & SR2) were approved in 2022 and 2023 for grading and topsoiling of acreage in the lower mining area (Photo 3).

**Reclamation Success:** Revegetation efforts across the site took the form of hydro mulching, drill seeding, and or laying of erosion control blankets. Seeding efforts occurred in both 2022 and 2023. The SR1 and SR2 acreage areas were observed to have full and mature vegetation, made up of predominantly native and desirable

vegetation such as wheatgrasses, bromes, sunflowers, alfalfa and clover (Photo 3). All other areas of the site showed significant growth of bunch grass species, including more than two types of wheatgrasses (Photos 5, 6, and 9). Forb species such as alfalfa, sweet clover, and small woody shrubs were also observed to be established across the reclaimed site.

**Photo 3: View east of the lower mine site acreage.**

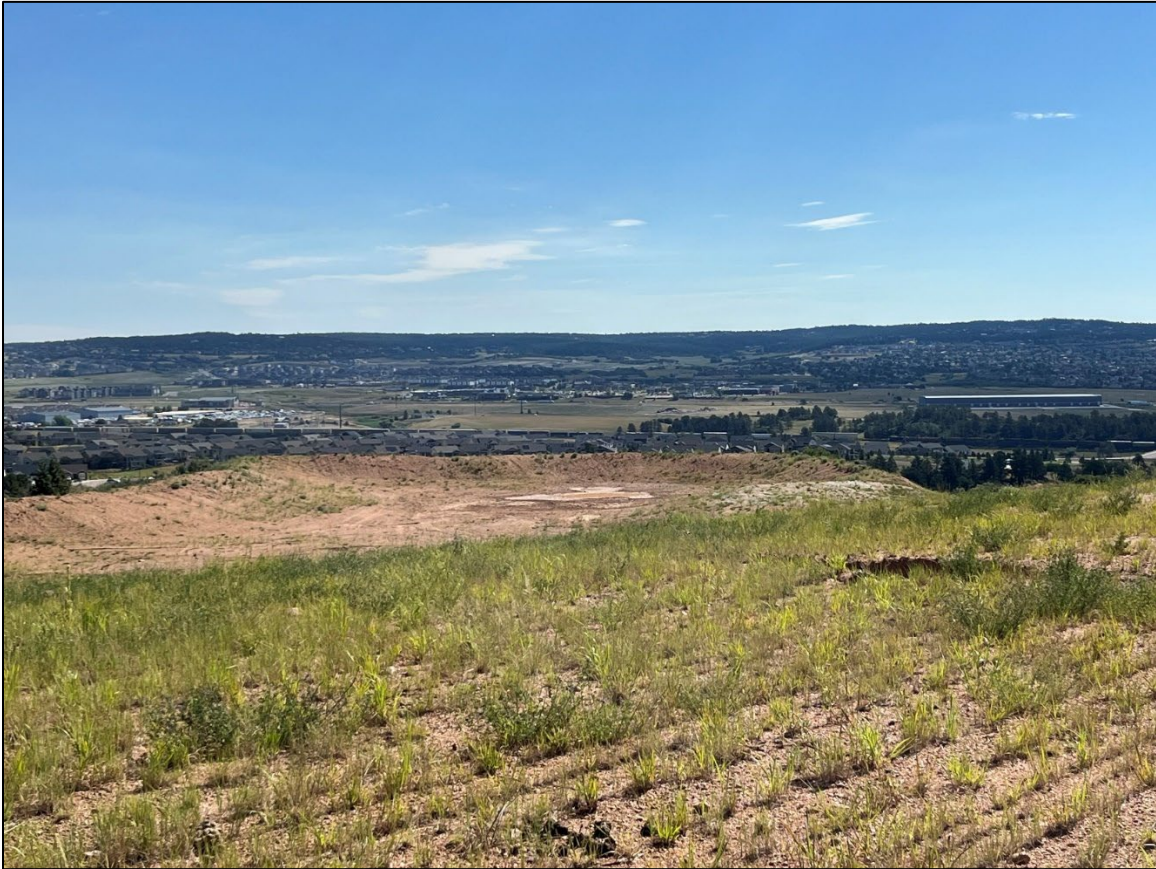
**Hydrologic Balance:** Two sediment ponds, one in the northwest corner (Photo 4) and one in the southeast corner are approved to remain in place at the site. The upper pond was constructed to help prevent erosion of the regraded area between the upper mine area and the lower/east mine area. The slopes of these ponds have been seeded and graded to allow stormwater to infiltrate back into the natural flow of groundwater. The area had experienced heavy rainfall in the recent weeks, so a small amount of stormwater was observed in the upper pond. The lower pond, however, was dry. No exposed groundwater was observed onsite.

Minor erosion rills were present near the upper sediment pond area; however, these did not appear to be affecting the integrity of the slope nor were they contributing to offsite sediment deposition (Photo 4). Therefore, the Division is not concerned with the presence of these minor features and no BMPs were determined to be needed at the time of the inspection.

**Photo 4: View of the upper sediment pond.**

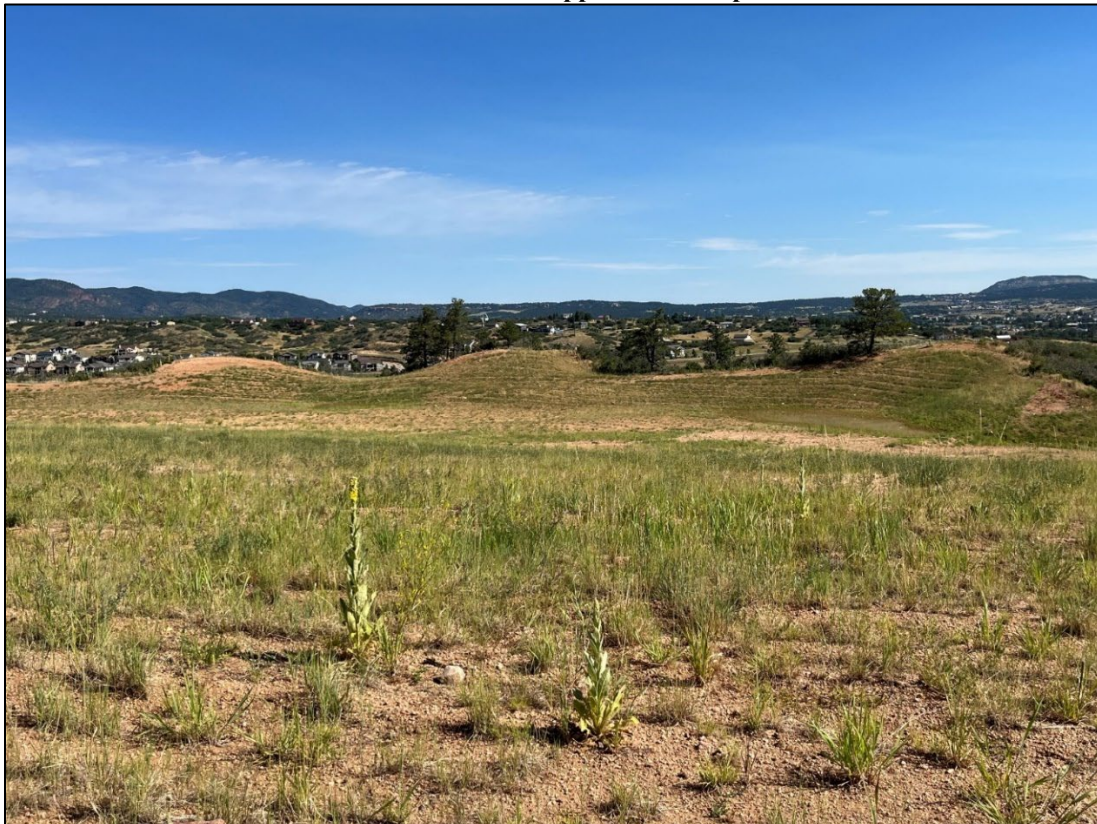
**Photo 5: View north of regraded and reseeded hillslopes in the upper mine area.**

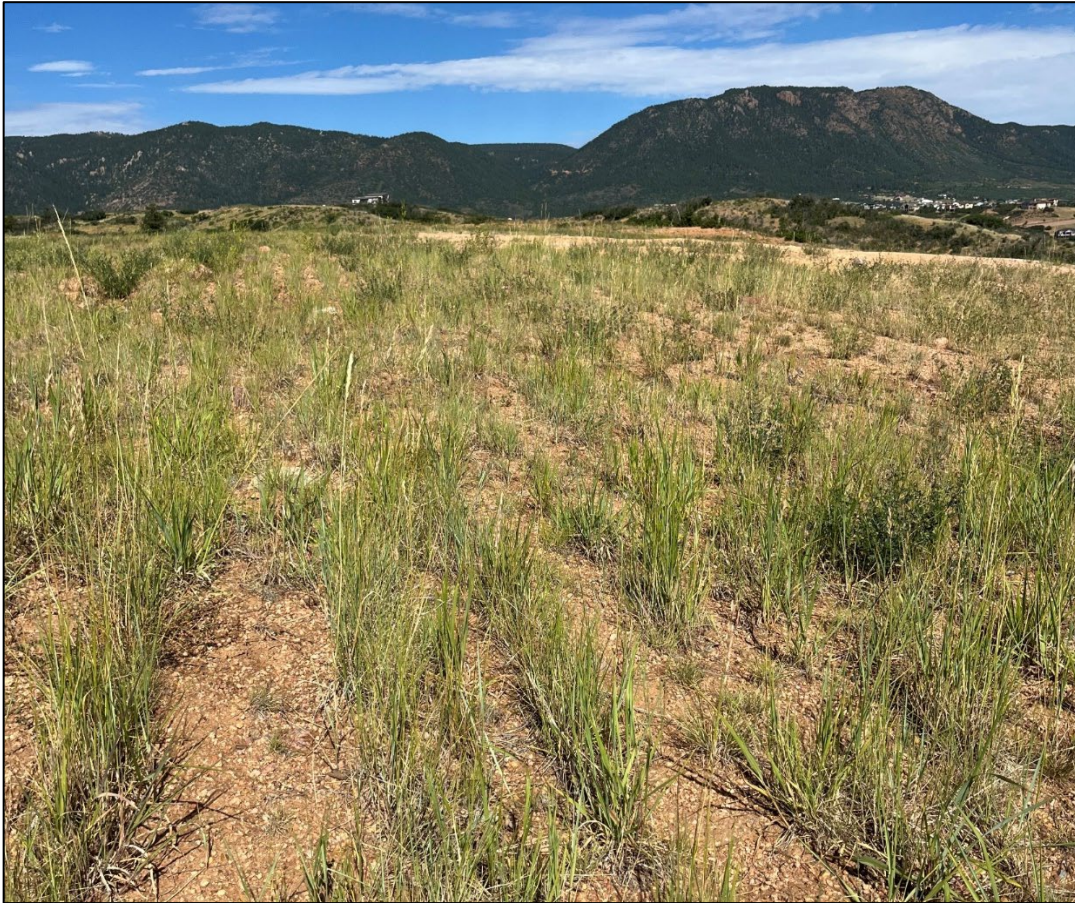
**Photo 6: Example of mature and native vegetation present across the reclaimed site.**

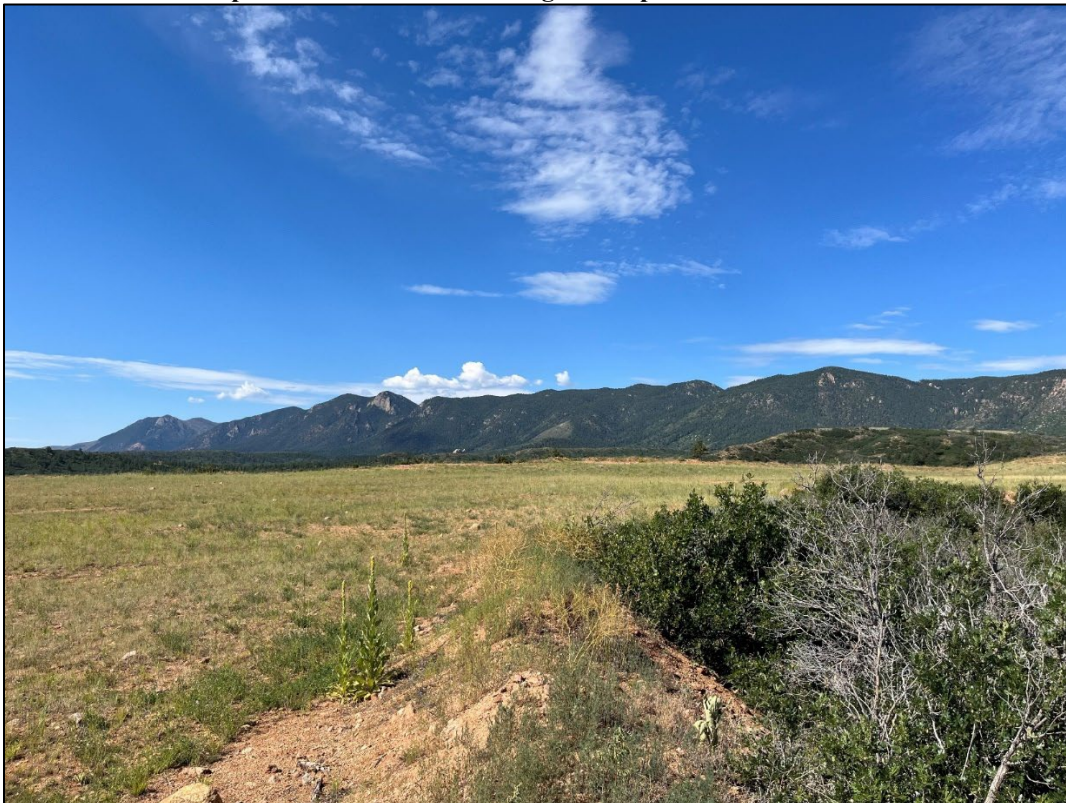
**Photo 7: View south of the regraded perimeter berm and the southern half of the upper mine area.**

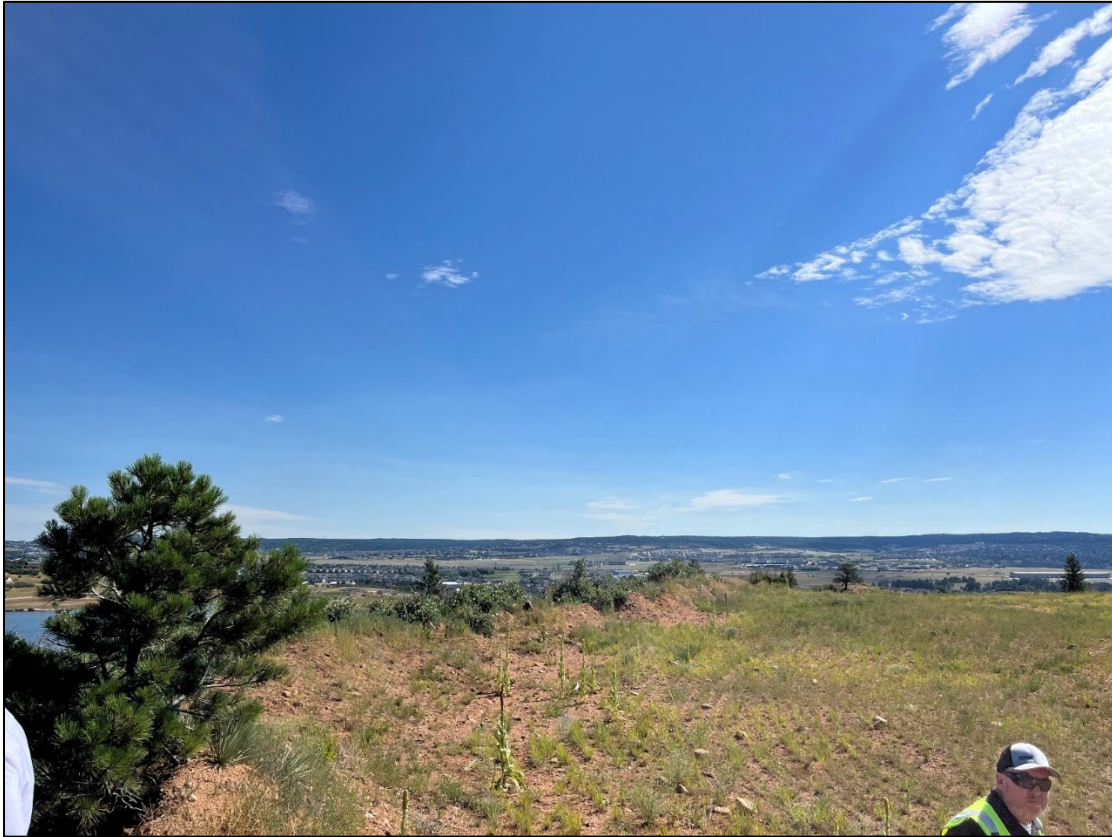
**Photo 8: View north of the regraded perimeter berm and revegetated upper mine slopes.**

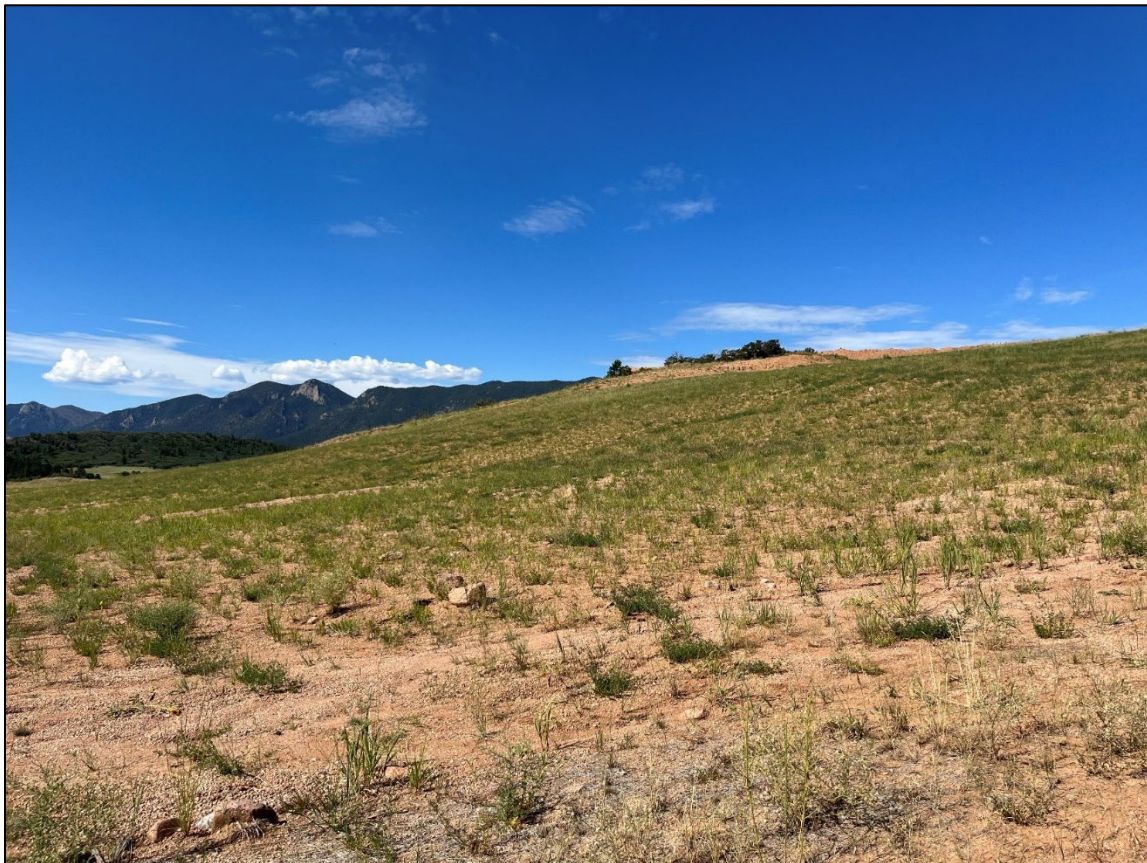
**Photo 9: View across the southwestern corner of the upper mine area.**
