July Inspection Report

Division of Reclamation,
Mining and Safety

Permit Number: C-1981-018 Mine Name: Deserado Mine Operator: Blue Mountain Energy, Inc Operator Address: Mr Kurtis Blunt 3607 County Road 65 Rangely, CO, 81648	County: Moffat, Rio Blanco Operation Type: Underground Permit Status: Active Ownership: Private
	Operator Representative Present: Kurt Blunt
Operator Representative Signature: (Field Issuance Only)

Inspection Start Date: July 16, 2025 Inspection Start Time: 11:00 Inspection End Date: July 16, 2025 Inspection End Time: 13:30		Inspection Type: Coal Partial Inspection Inspection Reason: Normal I&E Program Weather: Clear	
Joint Inspection Agency: None		Joint Inspection Contacts: NA	
Post Inspection Agency: None		Post Inspection Contacts: NA	
Inspector(s): Todd Jesse	Inspector's Signature:

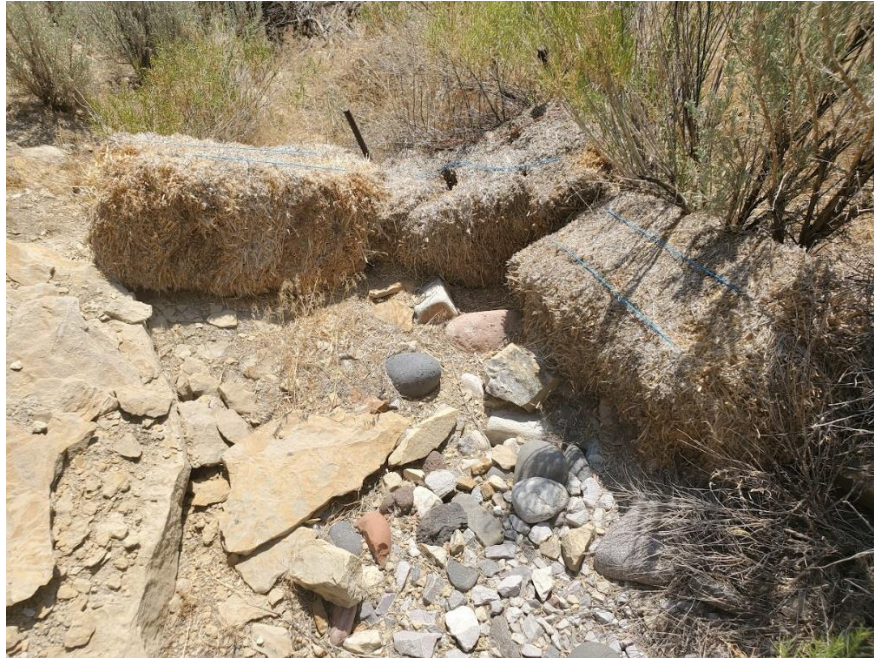
The explosives storage area for the Deserado Mine is located at the southern end of the main facilities area. The storage consists of a pad with a storage bunker for the explosives. The cut and fill slope of the pad was stable with no erosional features. Runoff from the pad is directed to an outlet at the southern end of the pad and passes down a channel through straw bales. The bales appear to be in good condition and functioning as designed (Photo 1)

Photo 1: View to the east of straw bales at explosive pad drainage.

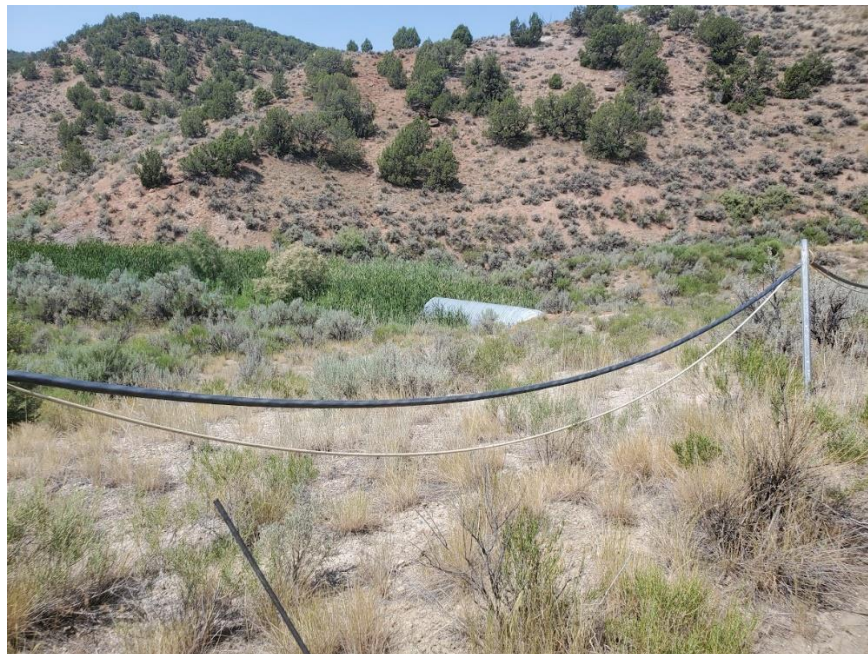
There are three ponds located in the main facilities area: the DP-1 Pond, the PP-1 Pond and the PP-2 Pond. The DP-1 Pond is located on the southern part of the lower facilities bench. DP-1 collects all runoff from the three facilities benches. The outlet structure was clear of debris and the pond was discharging at the time of inspection. The embankments appear stable with well-established vegetative cover (Photo 2). The emergency spillway has minor amounts of vegetation but still appears to be able to convey water and is well armored. There were no erosional concerns identified. The PP-1 Pond is located on the middle bench of the facilities area near the prep plant. The pond was holding water and was well below the discharge level (Photo 3). There were no erosion or stability issues identified in the PP-1 Pond. The PP-2 Pond is located on the upper facilities bench. The outlet structure was in good condition with no vegetation obscuring the outlet (Photo 4). The pond had a large amount of duck weed and was a green color. No erosional concerns were identified on the outer embankments of the pond. Water diversion ditches throughout the main facilities area were unobstructed and stable.

Photo 2: View to the southwest of the DP-1 embankment.

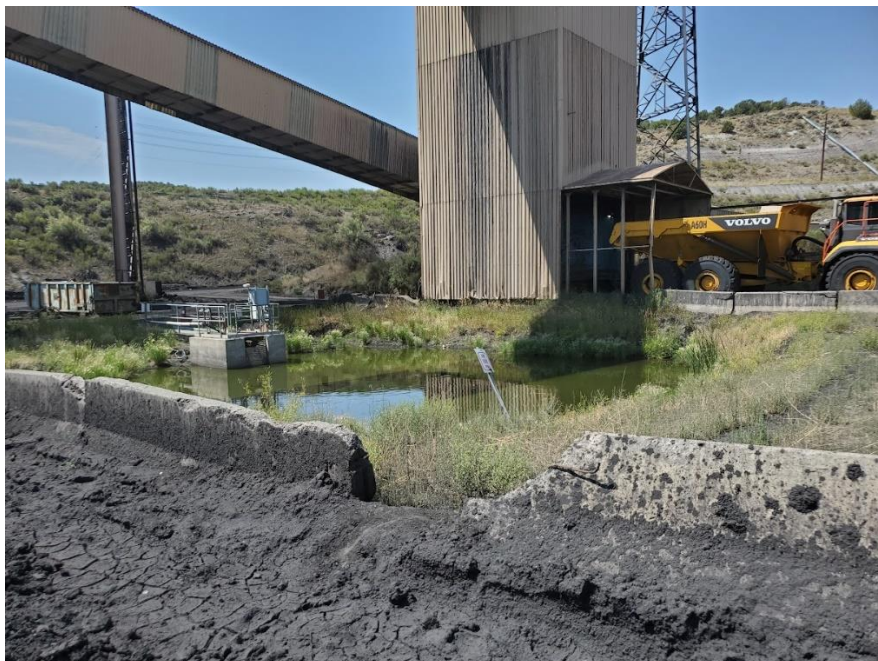
Photo 3: View to the southwest of the PP-1 pond.

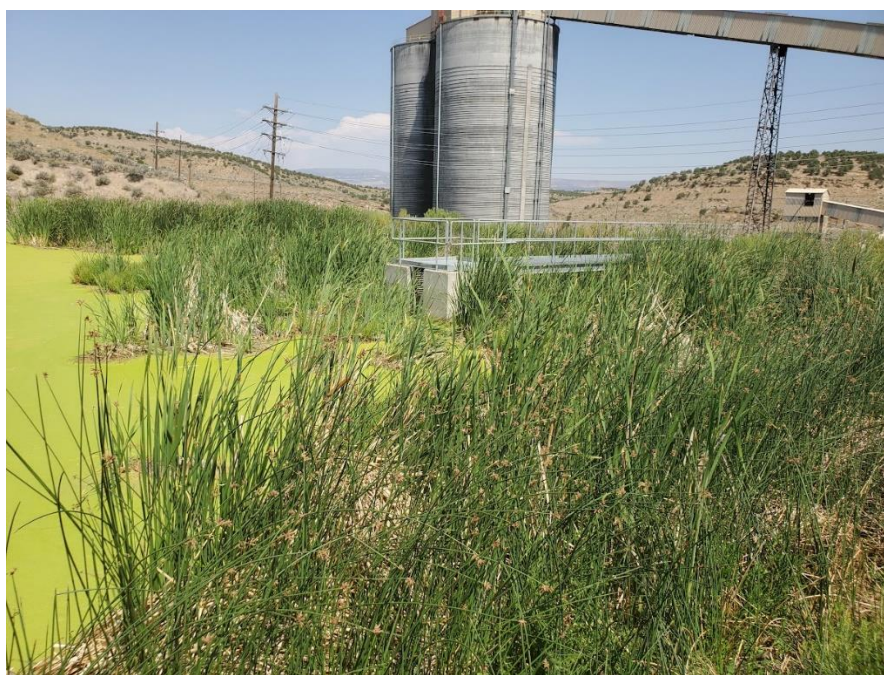
Photo 4: View to the northwest of outlet of the PP-2 pond.

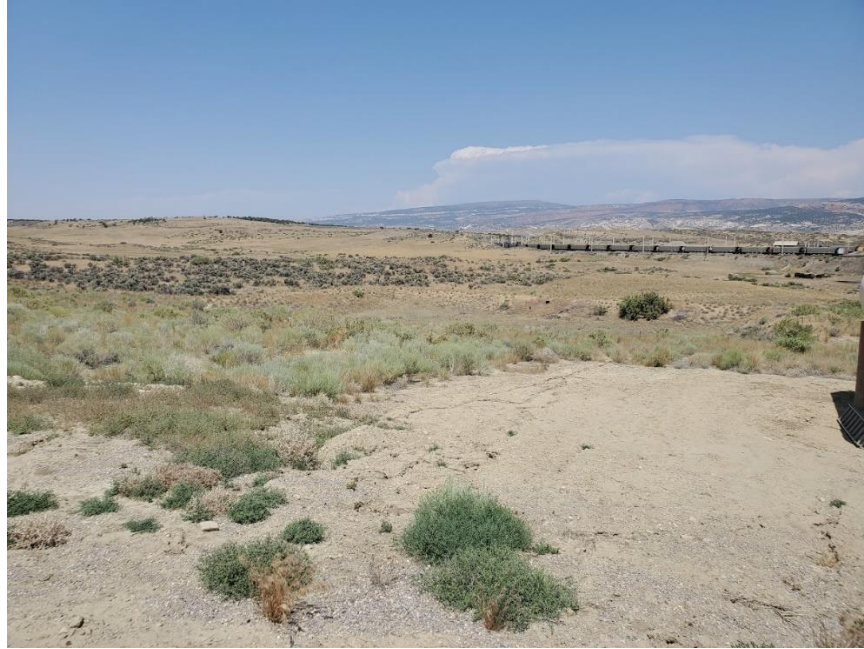
The SS-2 Pond is located at the northwestern base of the Slot Storage Facility. The pond was dry at the time of the inspection. The embankments of the pond were well vegetated and stable with no indications of erosion (Photo 5).

Photo 5: View to the north of the SS-2 Pond

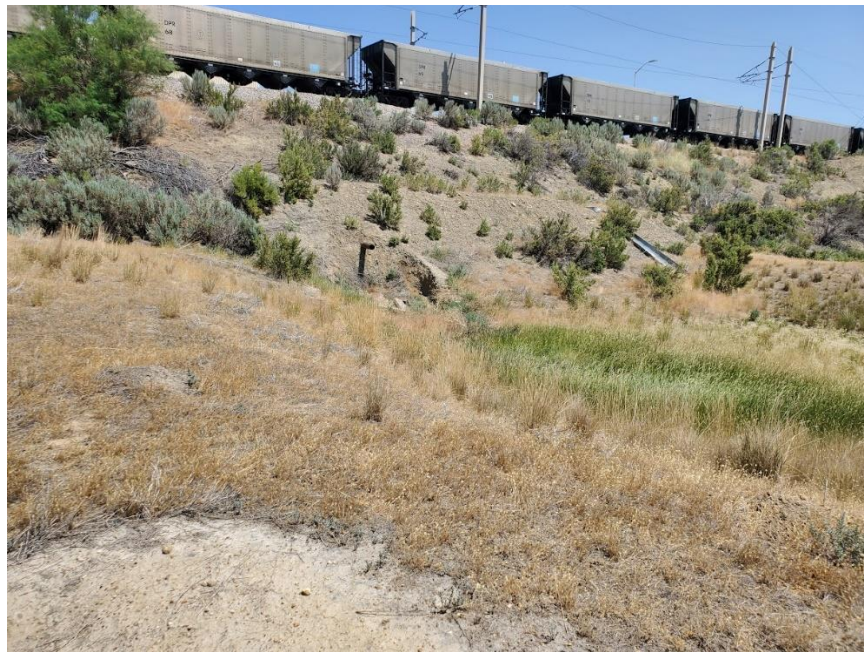
The RS-1 Sump and the RR-1 Pond are located at the south side of the Rail Loadout. The RS-1 Sump was dry. There were no indications of erosion. The RR-1 Pond was dry. The embankments of the pond seem stable. The erosion feature on the northern embankment that has been noted in previous inspection reports does not appear to have grown in size (Photo 6). The Rail Loadout Storage South Ditch has minor amounts of vegetative debris but does not appear obstructed and is able to convey water.

Photo 6: View to the north of erosion scar on RR-1 pond.

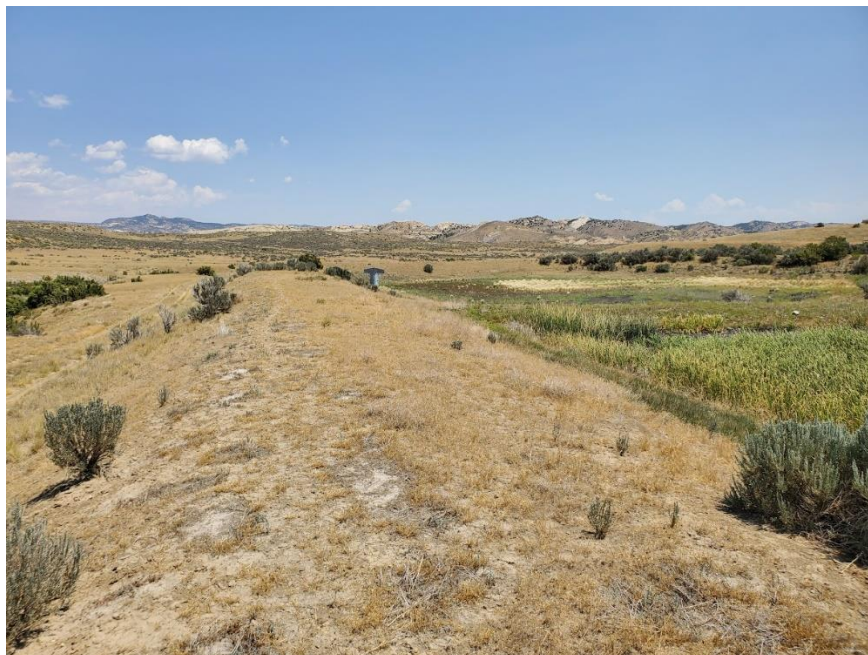
Two ponds are located at the northern base of Refuse Pile RP-2/3/4. The RP -2/3 Pond is located on the pile's northeast corner. The Pond consists of three cells, all of which were dry at the time of the inspection (Photo 7). The channels above the ponds appear clear of debris. No erosional features were noted on the embankments of the conveyance ditches. The trash rack was clear of debris. The RP-4 Pond is located at the northwest base of the pile. The pond was dry during the inspection. The outlet for the RP-4 Pond is capped with a trash rack. The outlet was clear of debris. Multiple animal burrows were noted in the embankments of the RP-4 Pond and were filled during the inspection (Photo 8).

Photo 7: View to the northeast of embankment to Pond RP-2/3

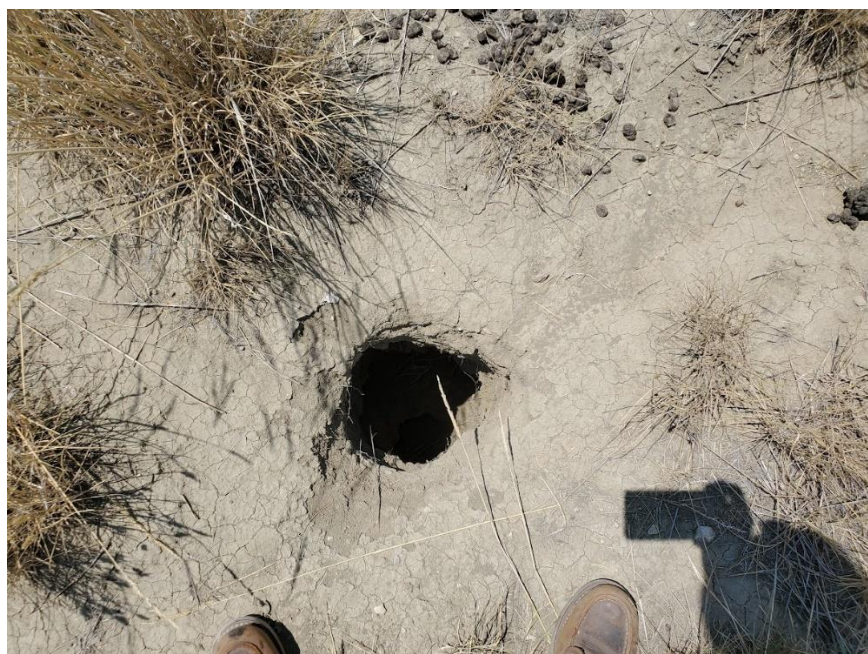
Photo 8: View to the north of animal burrow that was filled on RP-4 Pond embankment.

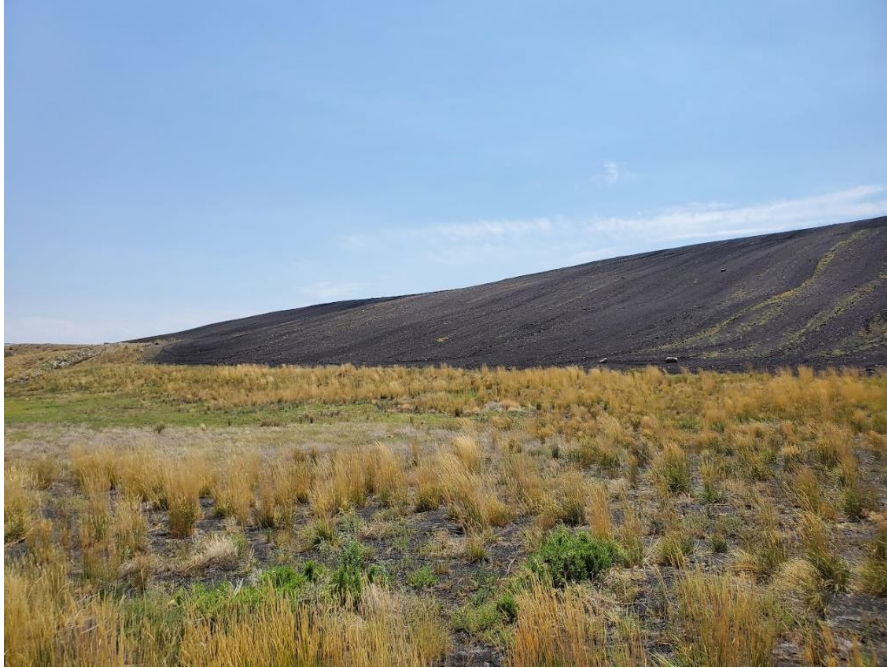
During the inspection the RP-2/3/4 Refuse Pile, the RP-5a Refuse Pile and the RP-A Refuse Pile were observed. The RP-2/3/4 Refuse Pile was stable. The stack has been graded to remove minor erosion rills on the

slopes of the pile which have been noted in previous Division inspection. (Photo 9) There was no signs of displacement or slumping.

Photo 9: View to the southeast of grading on the embankment of Refuse Pile RP-2/3/4.

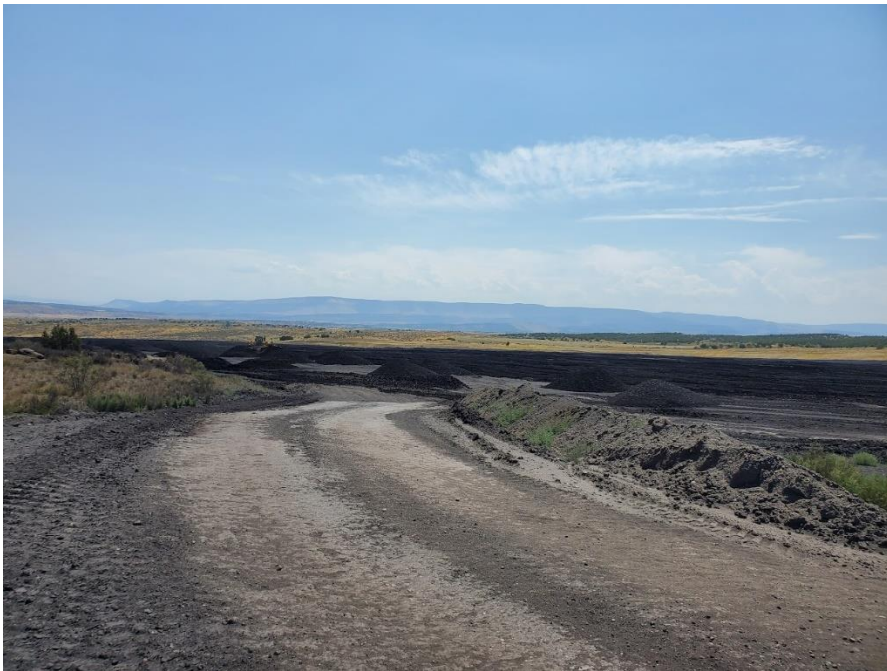
The RP-A Pile was also observed to be stable. Coal that was stacked in windrows was being spread during the inspection (Photo 10).

Photo 10: View to the east of Refuse Pile RP-A and the windrows being spread.

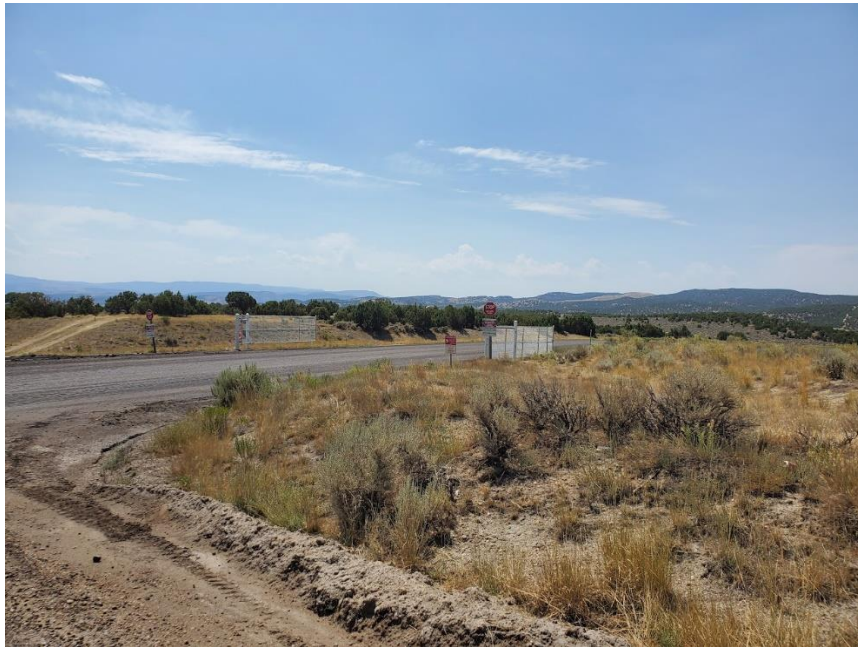
The Haul Road was clear and well maintained. There were no sections with ruts or other road damage. The road surface was treated for dust, and no noticeable amount of dust was generated by haul trucks. The ditches that parallel the roads are clear of debris and haybales used to control sediment are functioning as designed. The operator installed a gate along the main haul road at the intersection of CR-65 to prevent unauthorized entry (Photo 11).

Photo 11: View to the southeast of gate installed along the haul road.

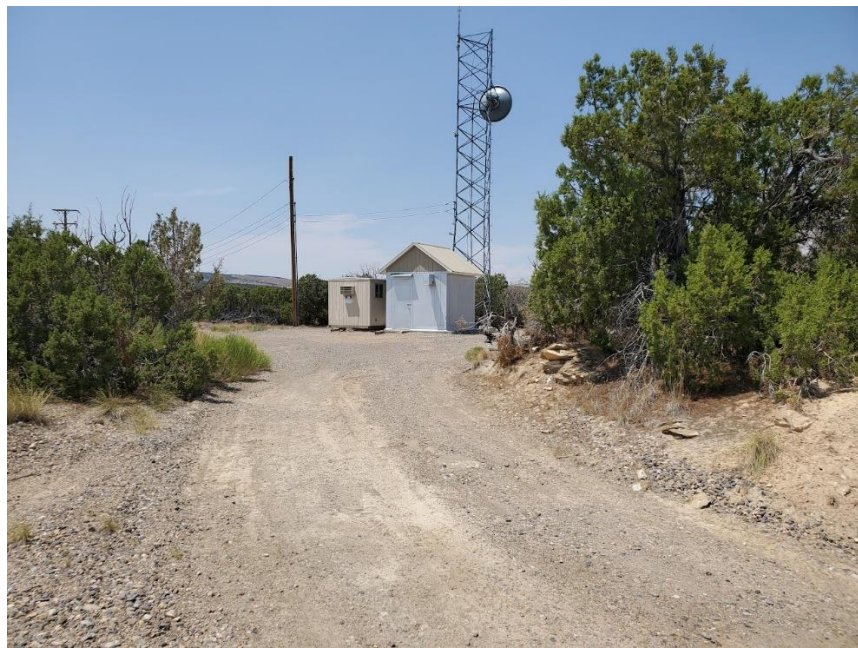
The pad for radio tower is located to the north of the Main facilities. The pad for the tower was stable with no indications of erosion (Photo 12).

Photo 12: View to the southwest of the radio tower pad. .
