MINERALS PROGRAM INSPECTION REPORT

MINE NAME: Pit 29	MINE/PROSPECTING ID#: M-1980-183	MINERAL: Sand and gravel	COUNTY: Adams
INSPECTION TYPE: Monitoring	WEATHER: Clear	INSP. DATE: July 10, 2025	INSP. TIME: 10:00
OPERATOR: Brannan Sand and Gravel Company, L.L.C.	OPERATOR REPRESENTATIVE: Alex Schatz and Steve Kelton	TYPE OF OPERATION: 112c - Construction Regular Operation

The Van Cleave Pit was inspected by Nikie Gagnon representing the Division of Reclamation, Mining and Safety (Division) as part of the Division's normal monitoring inspection program. Colby Van Cleave, the landowner and representative of VCA Aggregates, (Operator) accompanied the Division during the inspection. The site is located 13 miles northeast of New Raymer, on County Road 104 west of County Road 139 in Weld County.

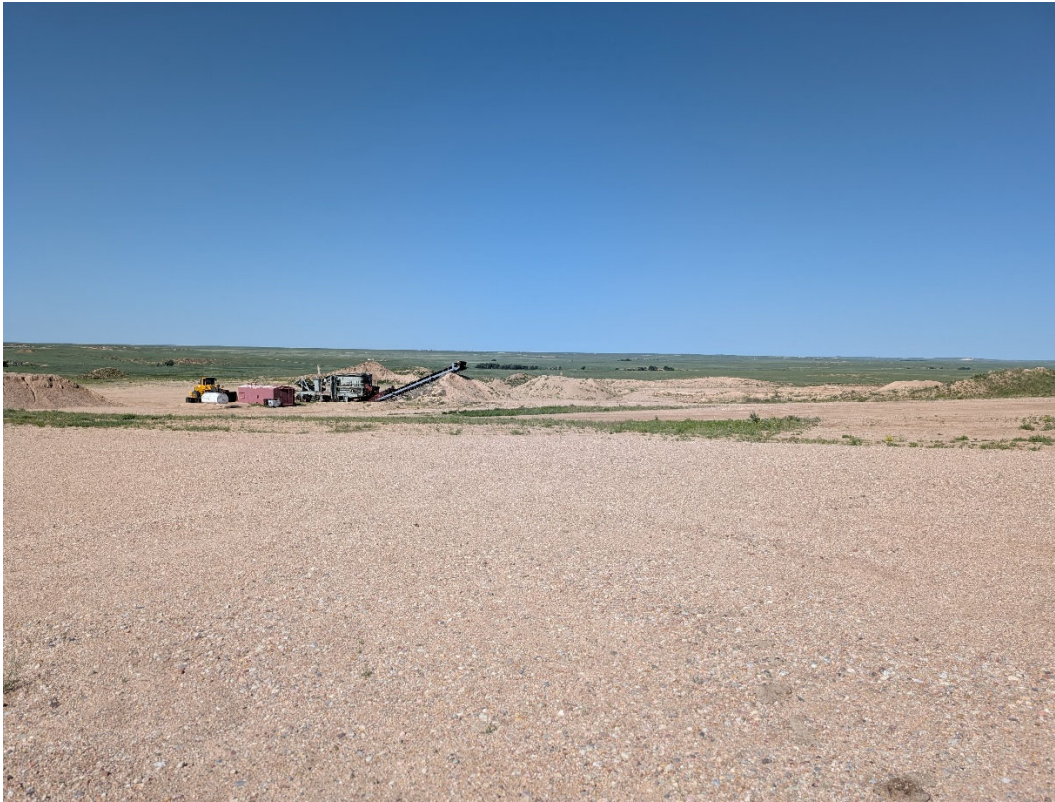
Photo 1: Looking south across the floor of the mining pit.

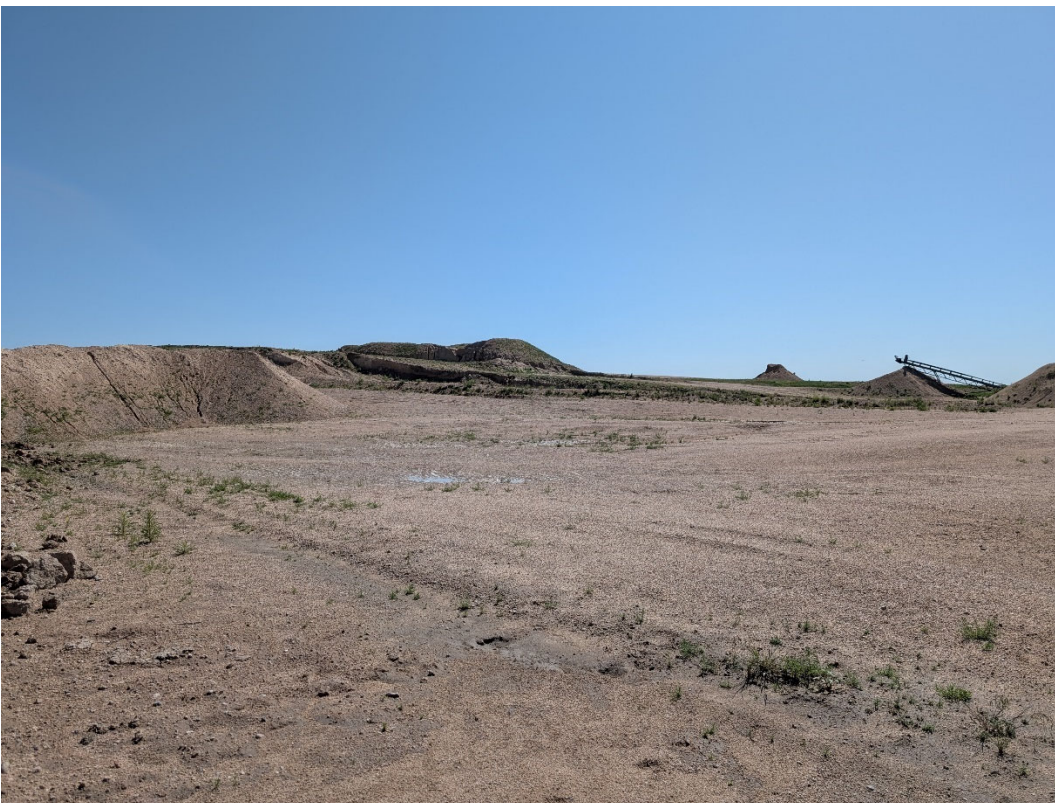
Photo 2: Looking east across the mined pit area from the west side.

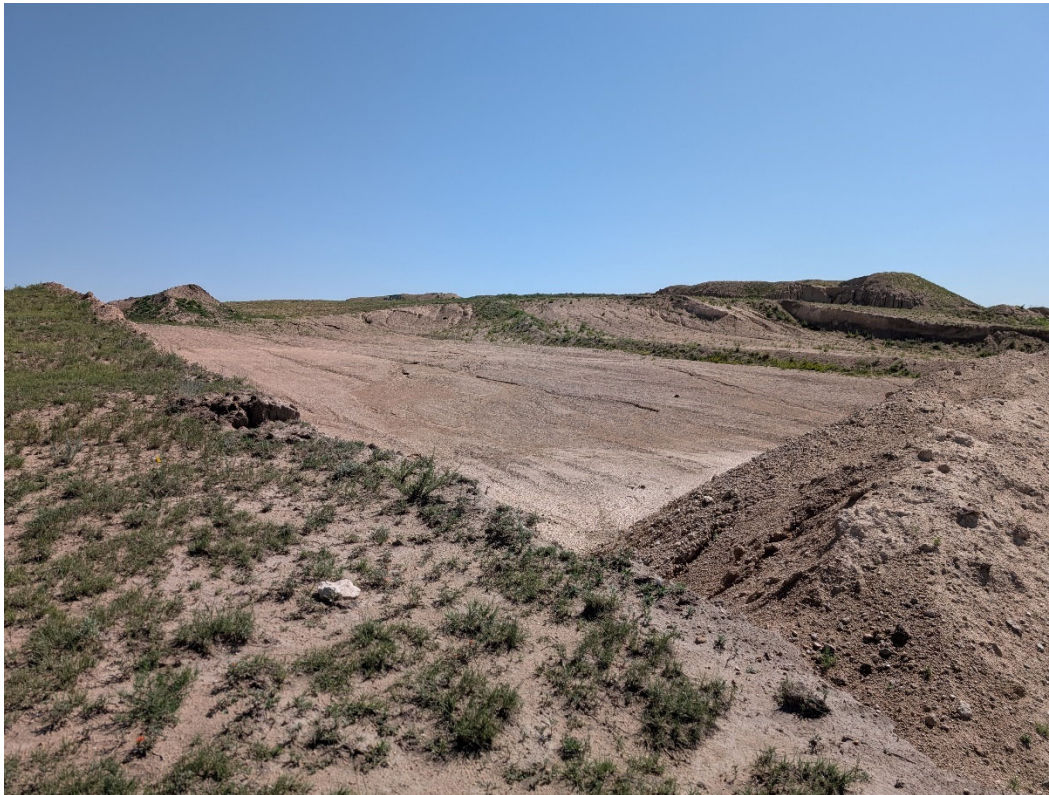
Photo 3: Looking northeast across the mined pit area from the western boundary of disturbance.

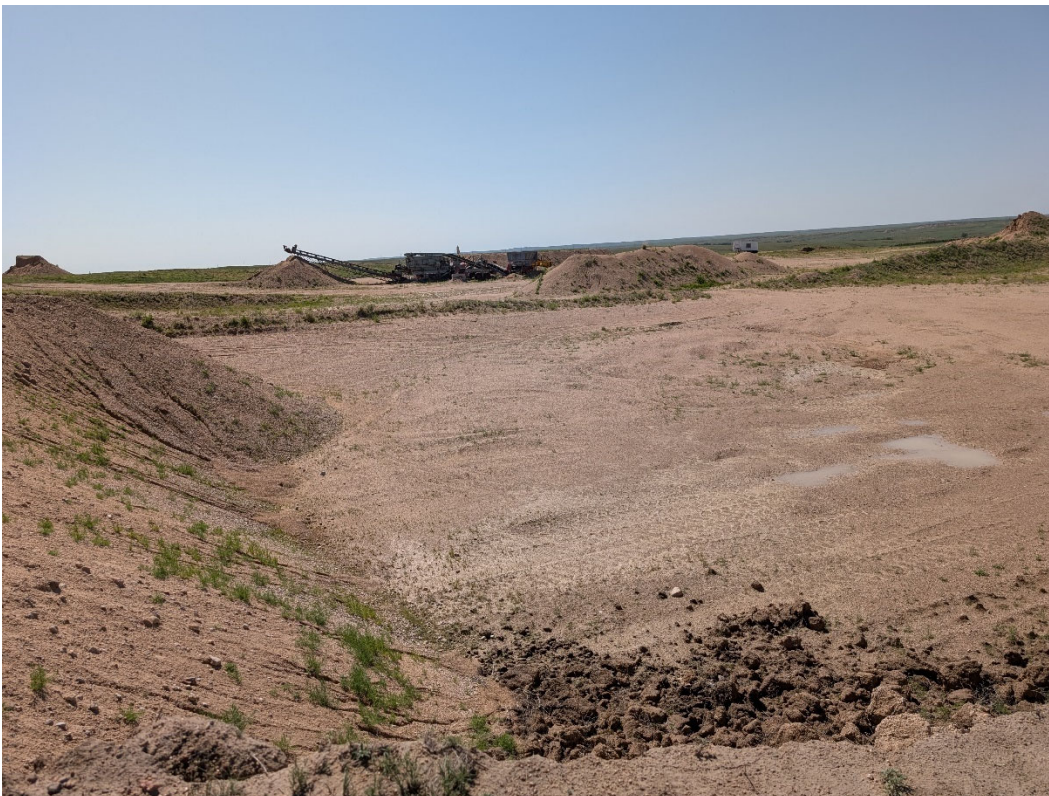
Photo 4: Looking southeast across the pit. Processing equipment observed in the middle of the pit floor. Slopes are 3H:1V here.

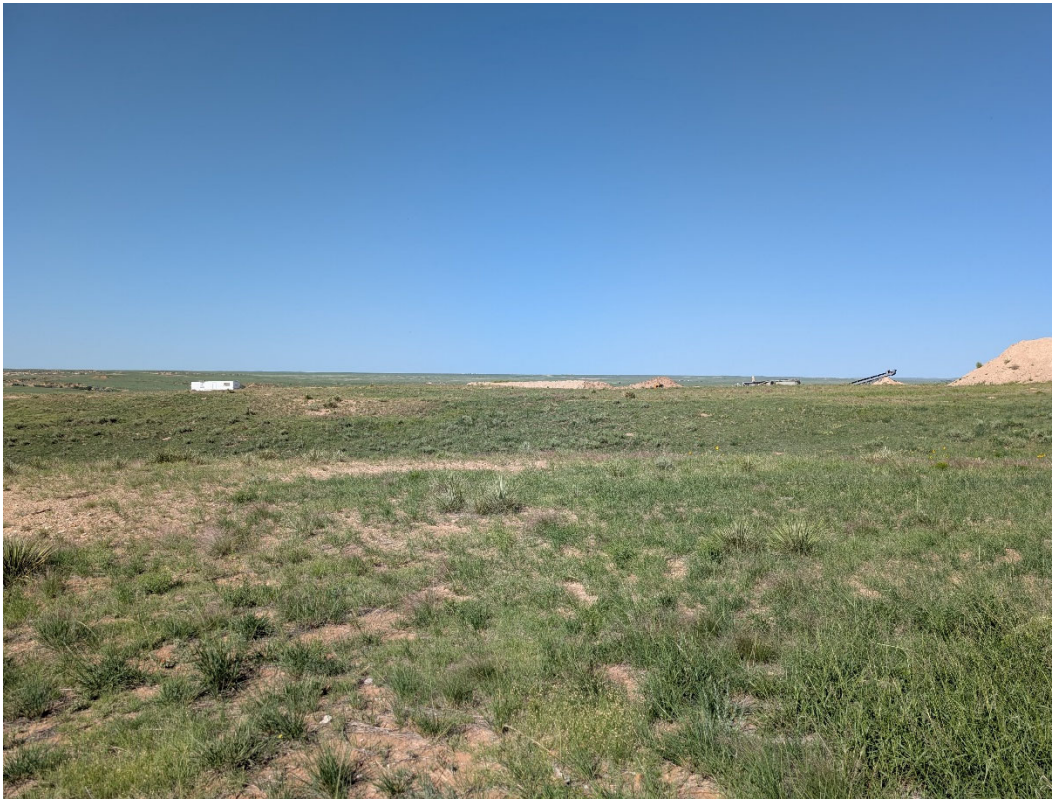
Photo 5: Looking west from the eastern side of the pit, outside the affected area.

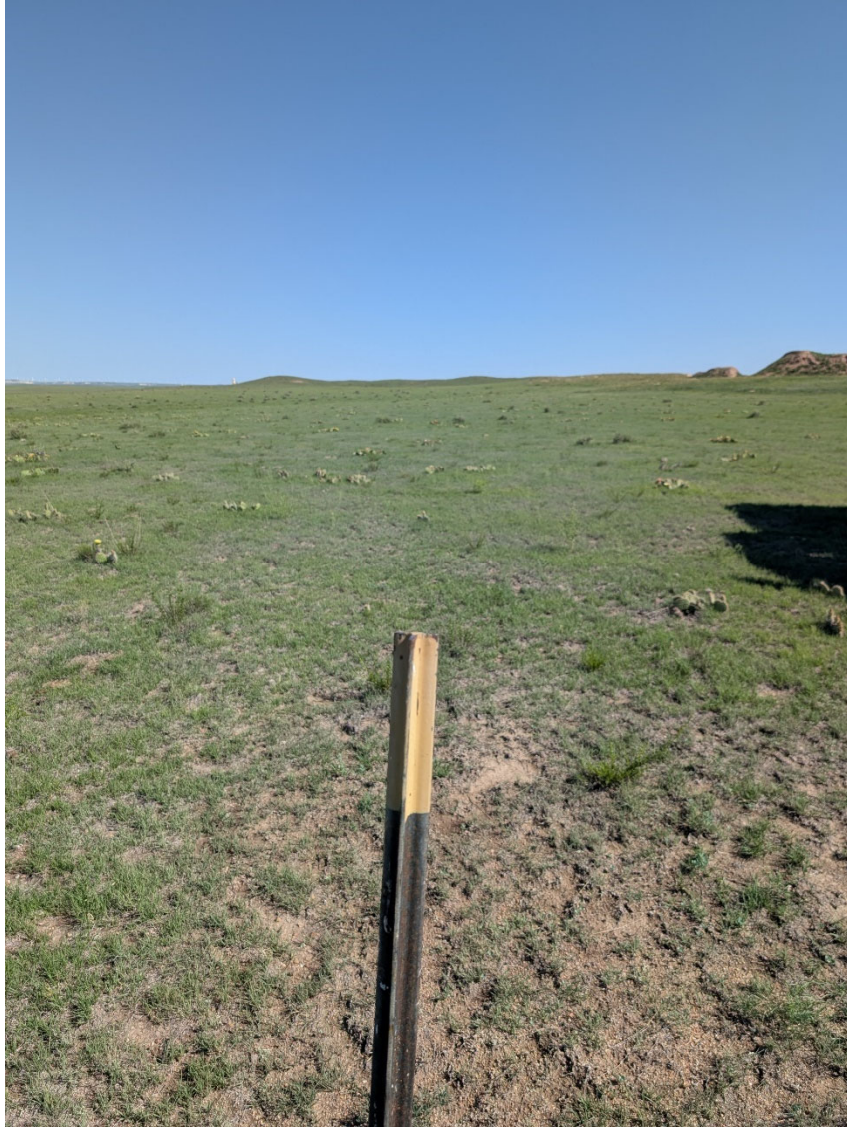
Photo 6: Looking north towards the mining area from the permit boundary located in the southwest corner of the permit area.

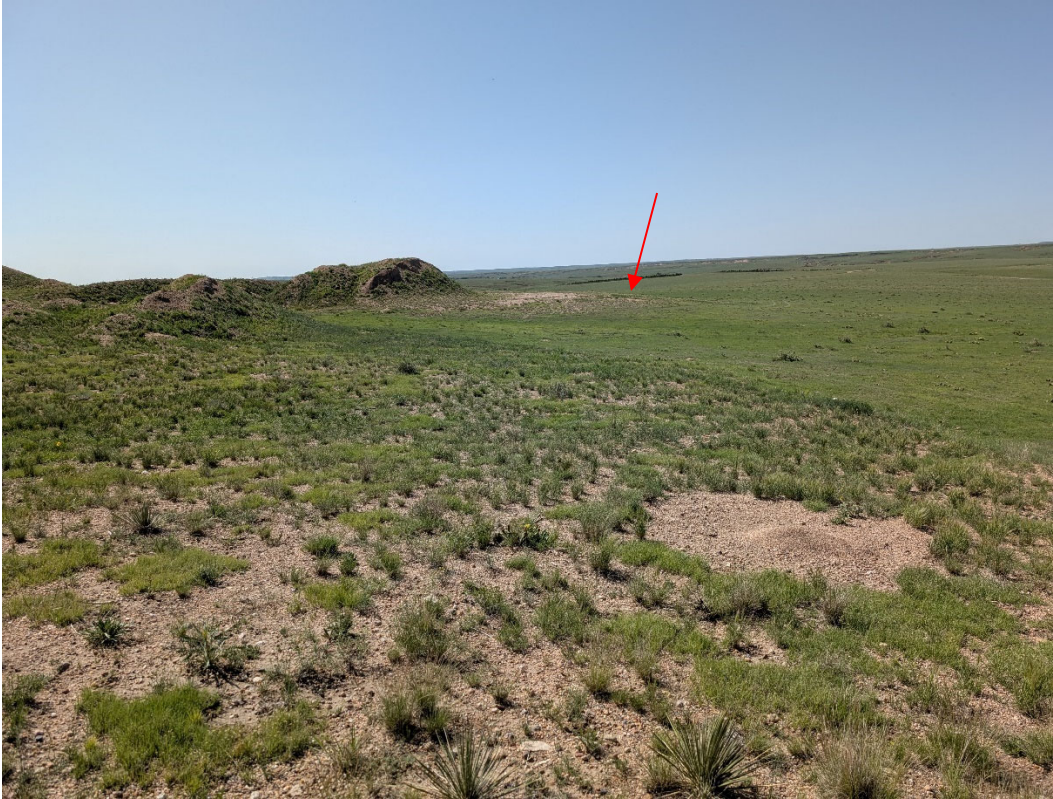
PROBLEM #1: The affected area boundary markers were not observed per the requirements of Rule 3.1.12 which states that the boundaries of the affected area must be marked by monuments or other markers that are clearly visible and adequate to delineate such boundaries.

In accordance with Rule 3.1.12, the Division observed the appropriate mine sign at the entrance to the site. However, some permit boundaries delineating the affected area could not be located. Although a metal permit stake was observed at the southwest corner of the permit area, the permit boundary is irregularly shaped along the western perimeter. Therefore, boundary markers should be placed at every corner to ensure the operation remains within the approved boundaries. As stated in Problem 1 above, the operator must conduct a survey and replace the boundary markers around the affected area to clearly define the existing approved permit area. Photographic evidence of the installed markers must be submitted to the Division. Additionally, the operator must provide a map with the photos, showing the permit markers with their latitude and longitude locations, to assist the Division in locating the boundaries in the future, especially since grazing cattle frequently dislodge them.

Photo 7: Looking south across at the area on the west side that has been revegetated. The permit boundary marker observed in the southwest corner is marked by the red arrow.

CORRECTIVE ACTIONS: The operator shall conduct a survey and replace the boundaries around the affected area and submit photographic evidence of the boundaries in place. Additionally, the Division requests that the operator submit a map showing the location of the boundaries and include the lat/long locations for each marker.

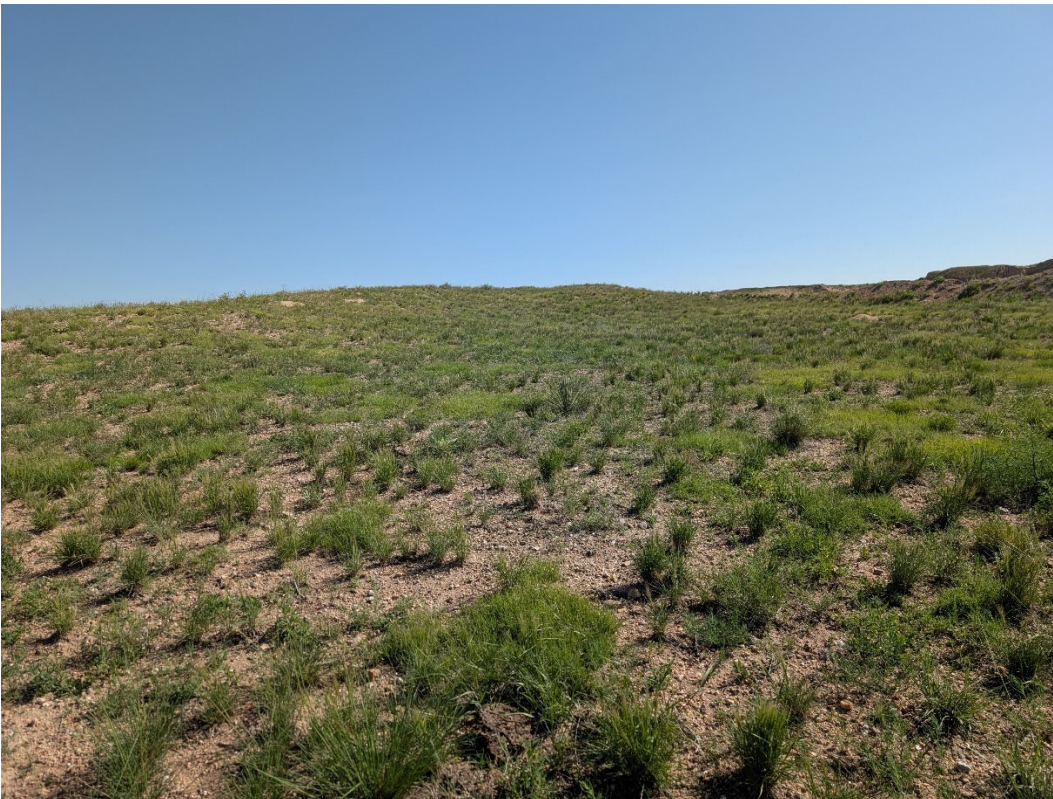
The Division observed a reclaimed area adjacent to the western side of the mining pit. During a previous inspection, the Division was concerned that the topsoil and overburden stockpiles were placed outside the permit boundary. The Operator moved the stockpiles east and reseeded an area on the west side. Native grasses are reestablished in this area.

Photo 8: Looking north across area on the west side that was revegetated.

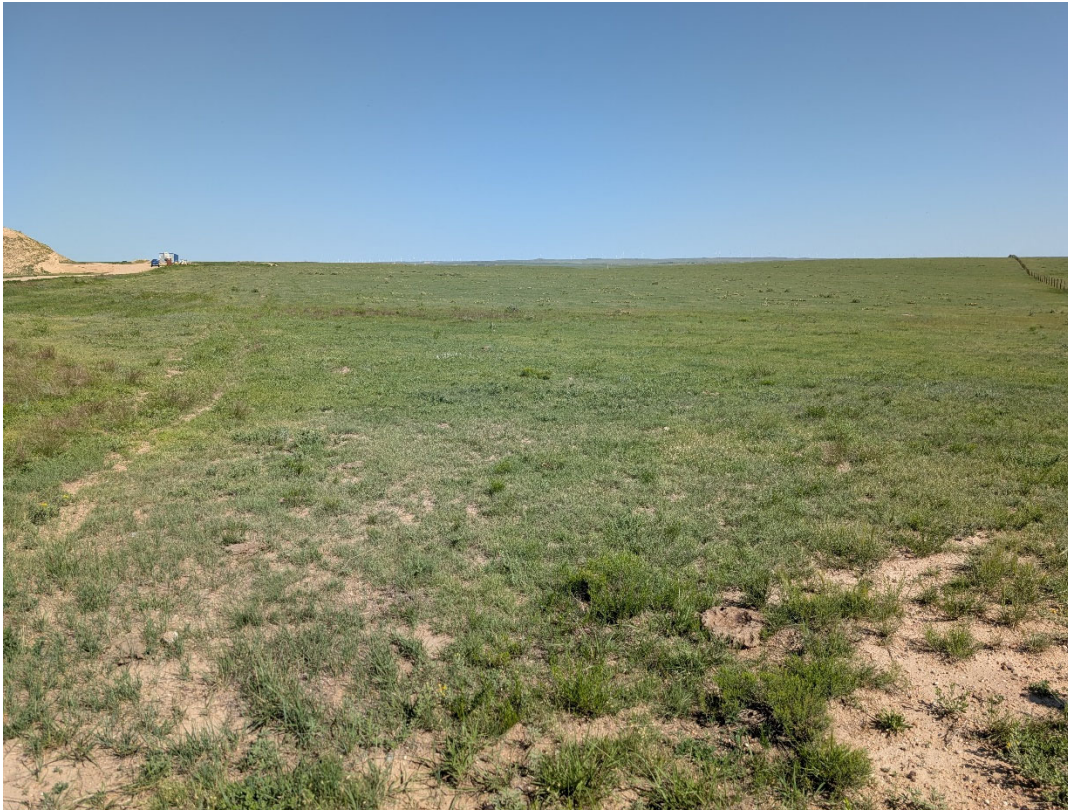
Photo 9: Area near the entrance to the site on the north side of the farm road that has not been disturbed. The northern permit boundary runs through here.

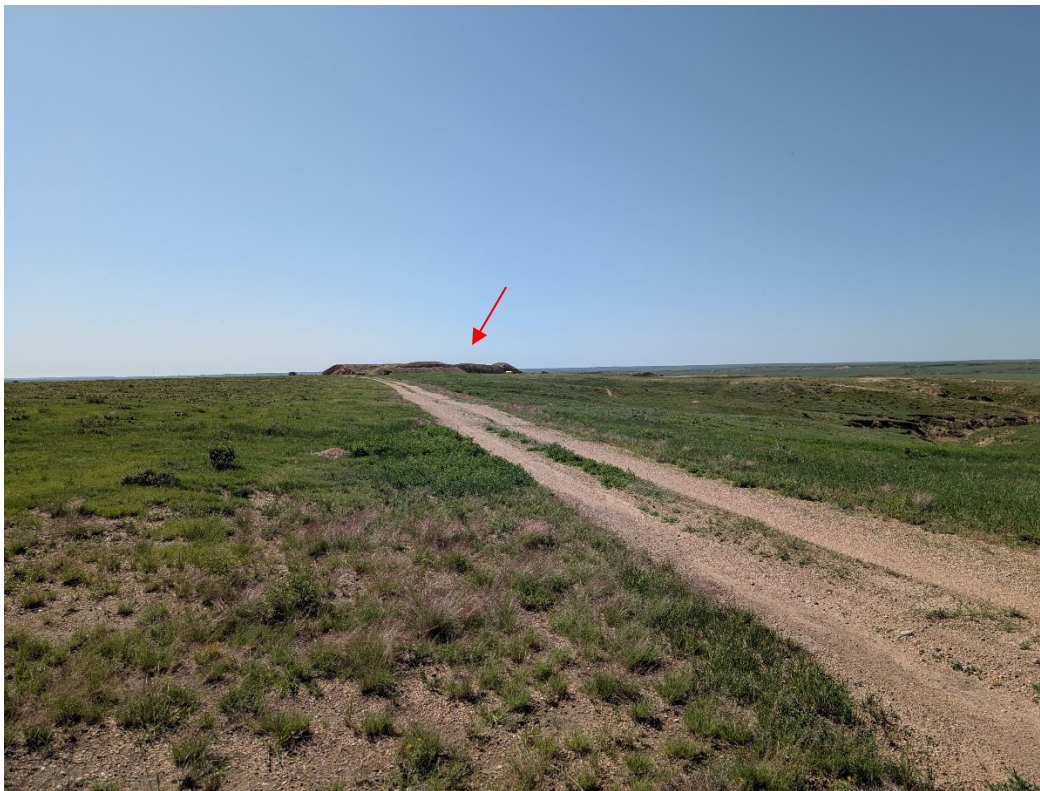
Photo 10: Looking east at the farm road that runs through the middle of the permit area. This area has not been disturbed by mining. The red arrow points to the mining area.

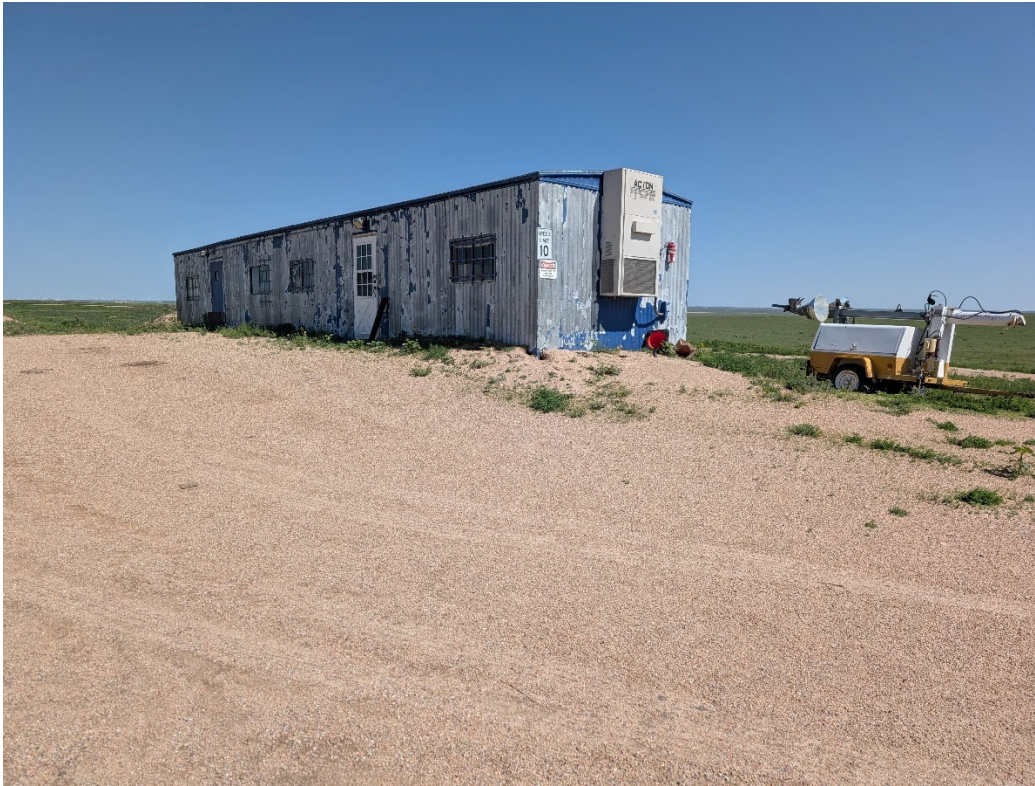
Photo 11: Looking at the office at the north end of the mining area.

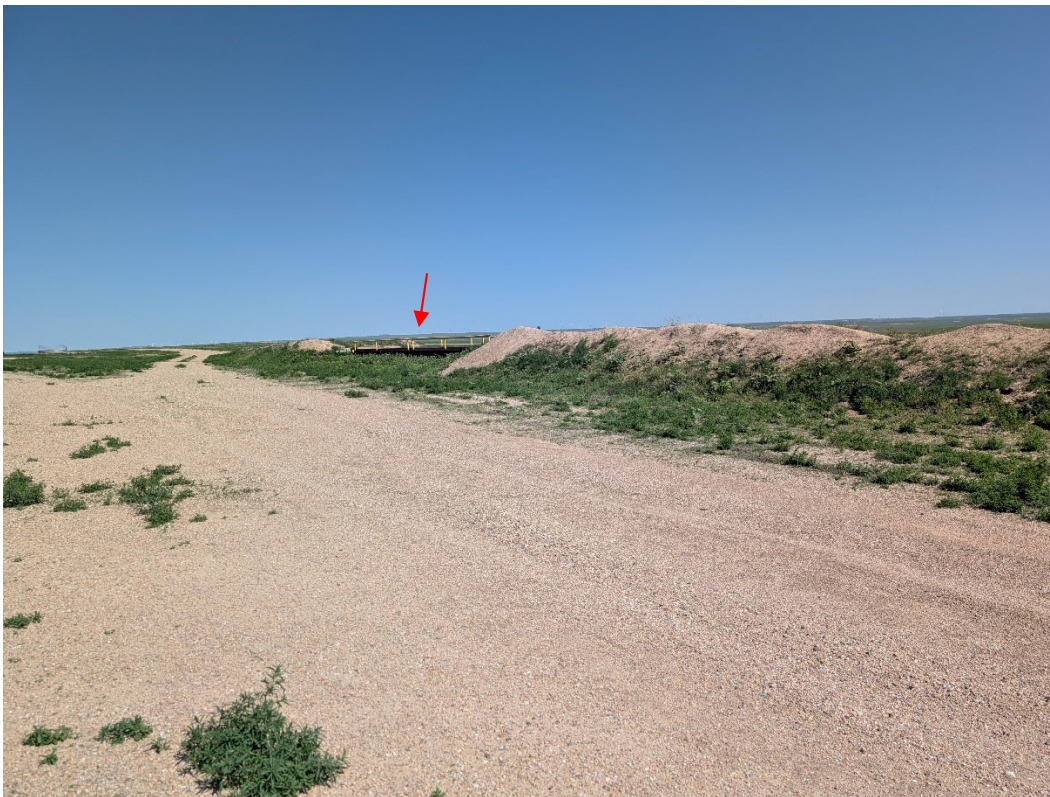
Photo 12: Looking at the truck scale at the north end of the mining area.
