MINERALS PROGRAM INSPECTION REPORT
PHONE: (303) 866-3567

MINE NAME: Pikeview Quarry	MINE/PROSPECTING ID#: M-1977-211	MINERAL: Limestone (general), granite gneiss and do	COUNTY: El Paso
INSPECTION TYPE: Monitoring	WEATHER: Clear	INSP. DATE: July 15, 2025	INSP. TIME: 10:00
OPERATOR: Riverbend Industries Inc.	OPERATOR REPRESENTATIVE: Jerry Schnabel	TYPE OF OPERATION: 112c - Construction Regular Operation	
REASON FOR INSPECTION: Normal I&E Program	BOND CALCULATION TYPE:	BOND AMOUNT: \$1,789,451.00	
DATE OF COMPLAINT: NA	POST INSP. CONTACTS: None	JOINT INSP. AGENCY: None	
INSPECTOR(S): Hunter Ridley	INSPECTOR'S SIGNATURE:

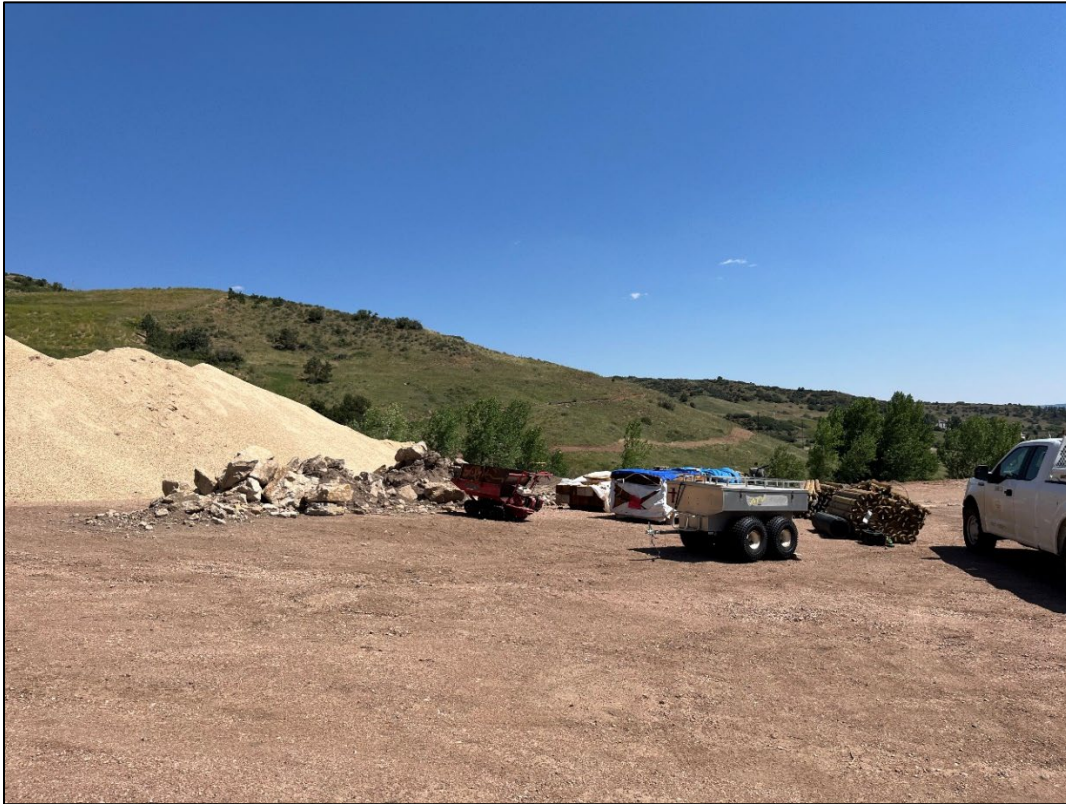
At the time of inspection, the partial landowner, the City of Colorado Springs, had begun work on a trail system in the Blodgett Open Space adjacent to the Pikeview Quarry Site (Photo 1). Trail creation is within the Pikeview permit boundary but is outside of the site's disturbance boundary. Prior to release, Pikeview will be required to submit a Technical Revision to update site maps to show the addition of these minor trails.

Photo 1: Equipment and stockpiles onsite for use in the City of Colorado Springs trail work to the east of the site.

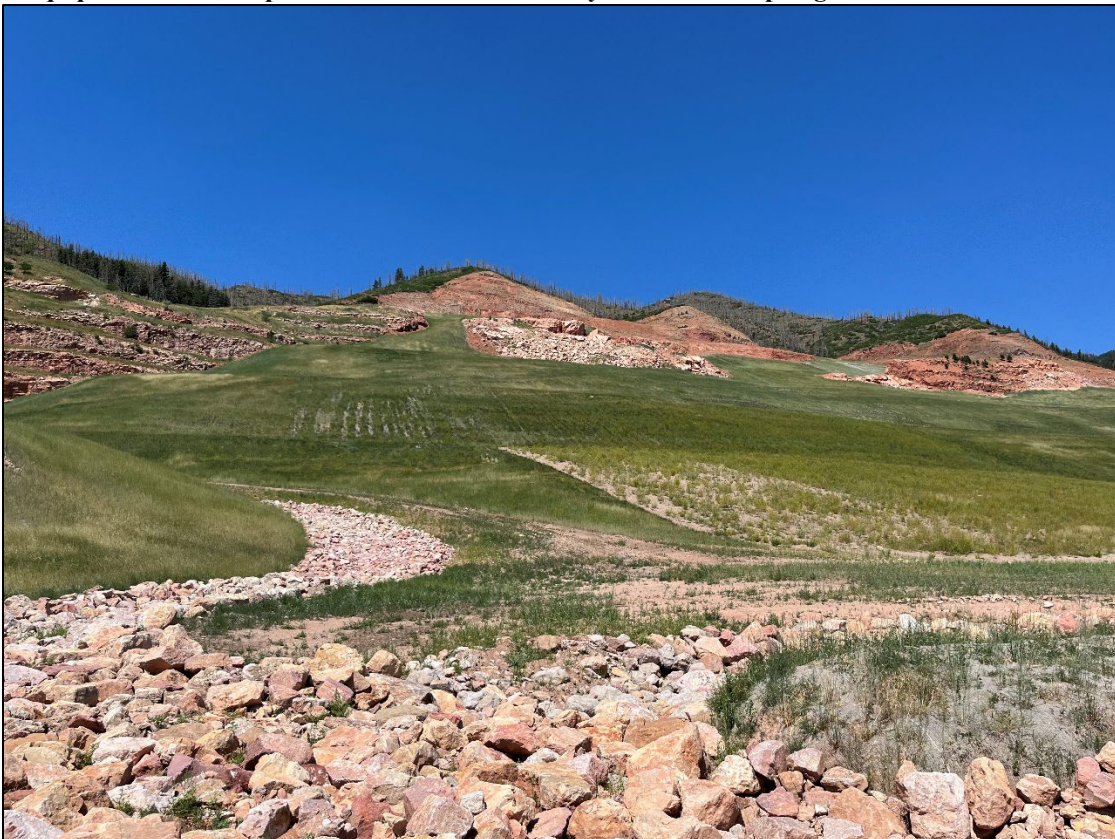
The Leica prism level bench (Photos 2, 4, and 10), was seeded in a similar fashion to the northern City and USFS slopes discussed above but has not been drill seeded a second time. Consequently, this section of the slope shows less favorable growth of vegetation in terms of both species and diversity of cover. This section is predominantly made up of yellow and white clover (Photo 7). While some small batches of bunch grasses are popping up between larger clover plants (Photo 8), there is still a clear and visible delineation of vegetative growth between where matting was placed and where only one round of drill seeding occurred (Photo 10). While the decision is ultimately up to the Operator, for long-term survival and flourish of native species on this slope, the Division would recommend re-drill seeding of the area if this can be done without major damage to the preexisting vegetation.

Photo 2: View west of reclaimed main slope from the Leica prism level.

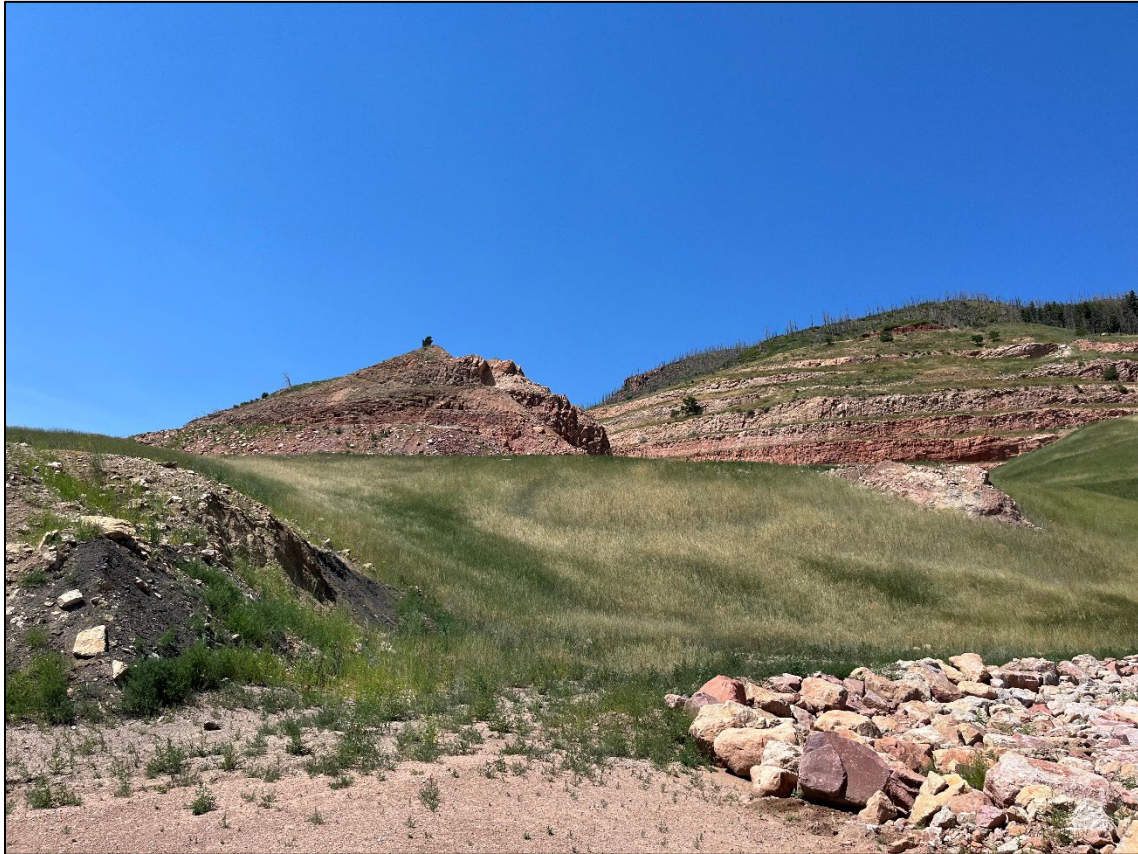
The south borrow area and USFS land to the south are both looking lush and well vegetated (Photo 3). The obliterated road area on USFS land was walked in its entirety during the inspection and was growing thick and mature vegetation, similar to the main backfilled slope area. Slopes to the north, owned by both the City of Colorado Springs and USFS have improved greatly in terms of vegetation. Slopes in these areas have supported vegetation in the past, but the diversity of vegetation was lacking, the slope being mainly made up of alfalfa and clover. This has been discussed during past inspections as not being a desirable condition for revegetated slopes, as Rule 3.1.10(1) of the Construction Materials Rules and Regulations requires final release areas to have 'diverse and long-lasting cover'. These areas have since been reseeded and have shown improved growth of diversity of species, with wheatgrasses and other forbs popping up among the preexisting alfalfa and clover plants (Photos 5 and 11).

Photo 3: View southwest of the south borrow area slope.

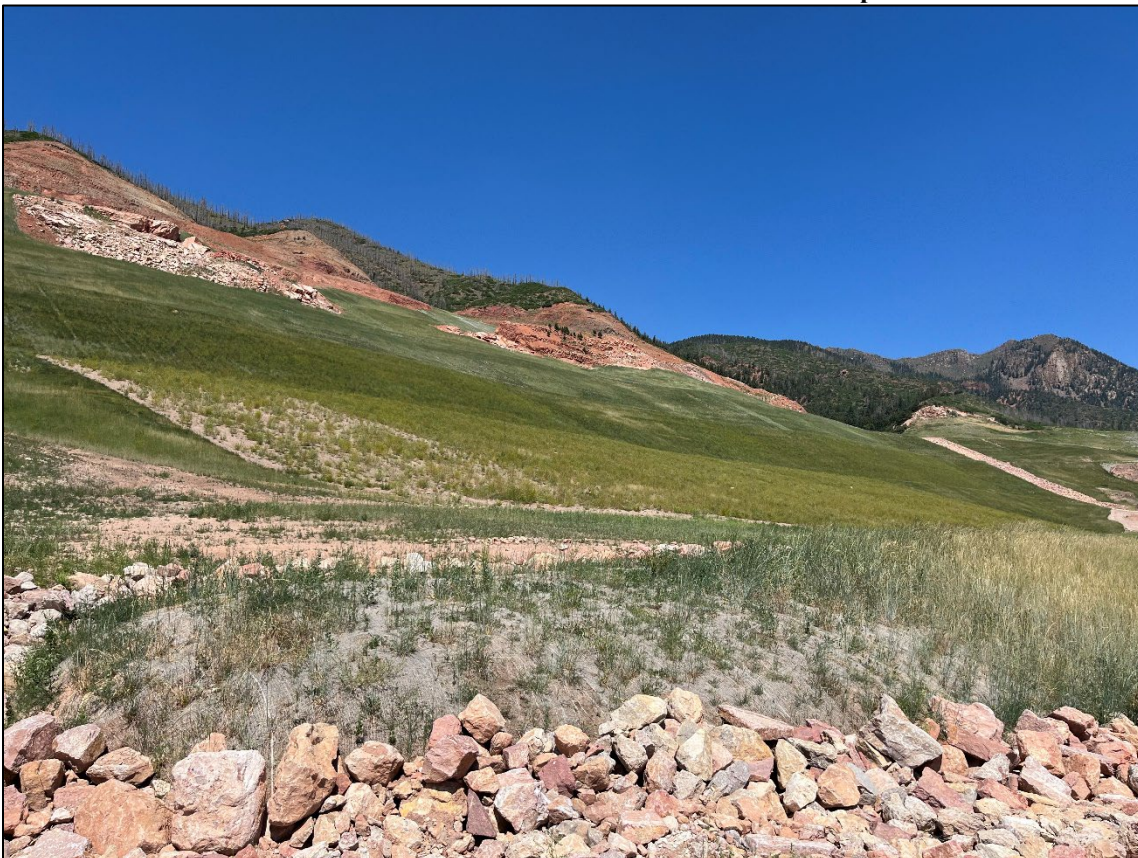
Photo 4: View northwest of the main reclaimed slope.

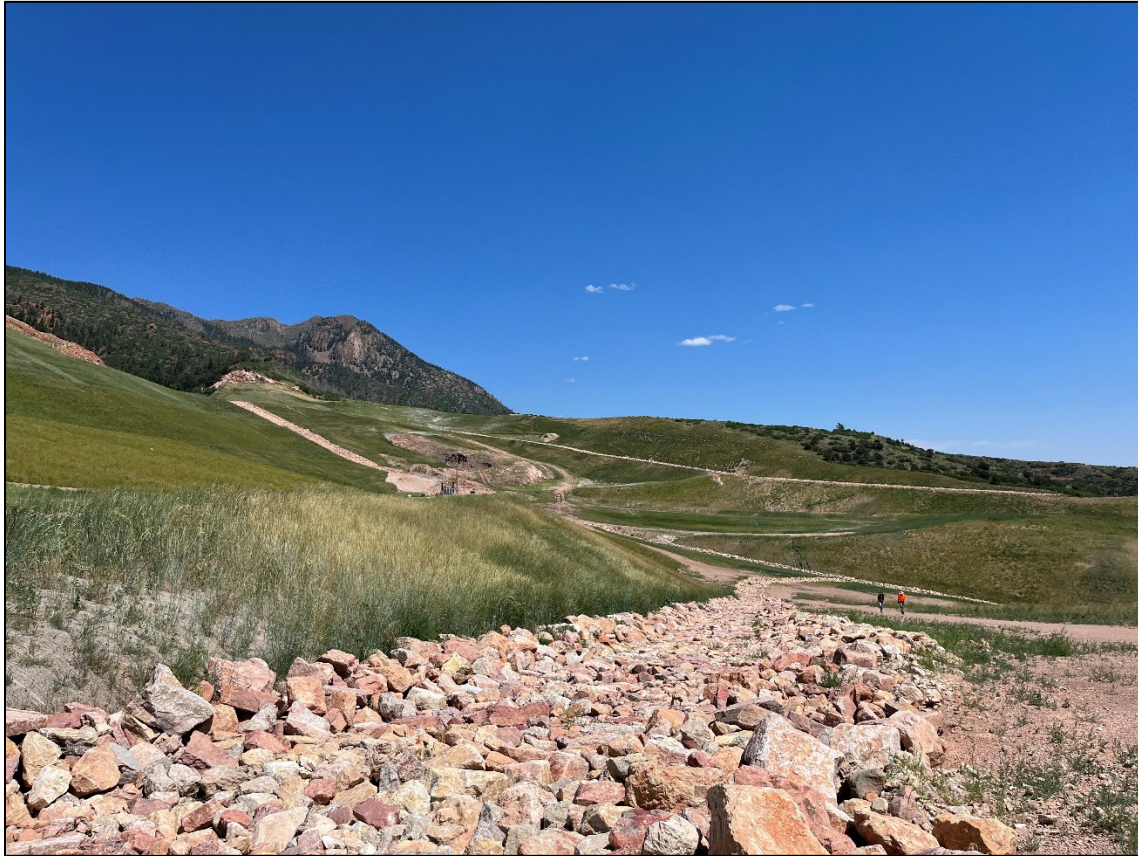
Photo 5: View north of the Dragons Back area and reclaimed City and USFS lands.

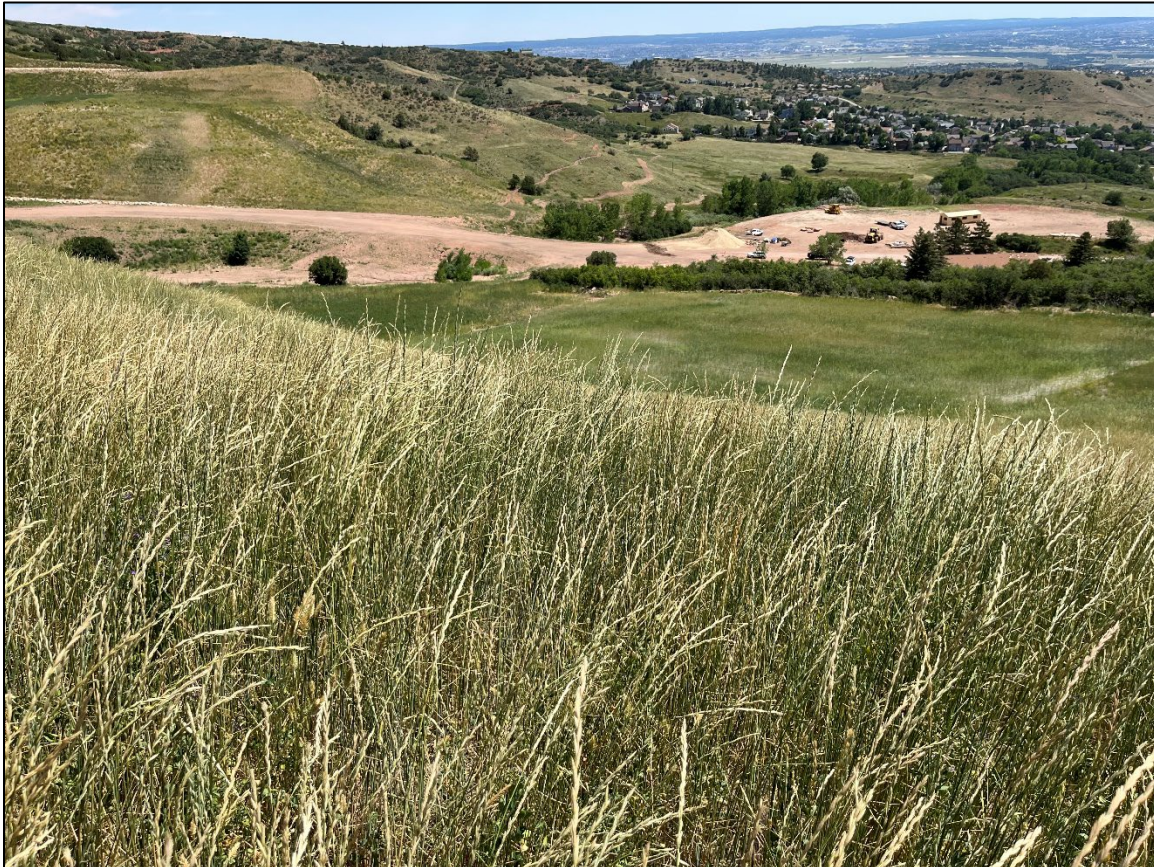
Photo 6: Example vegetation on slopes reclaimed with revegetation matting.

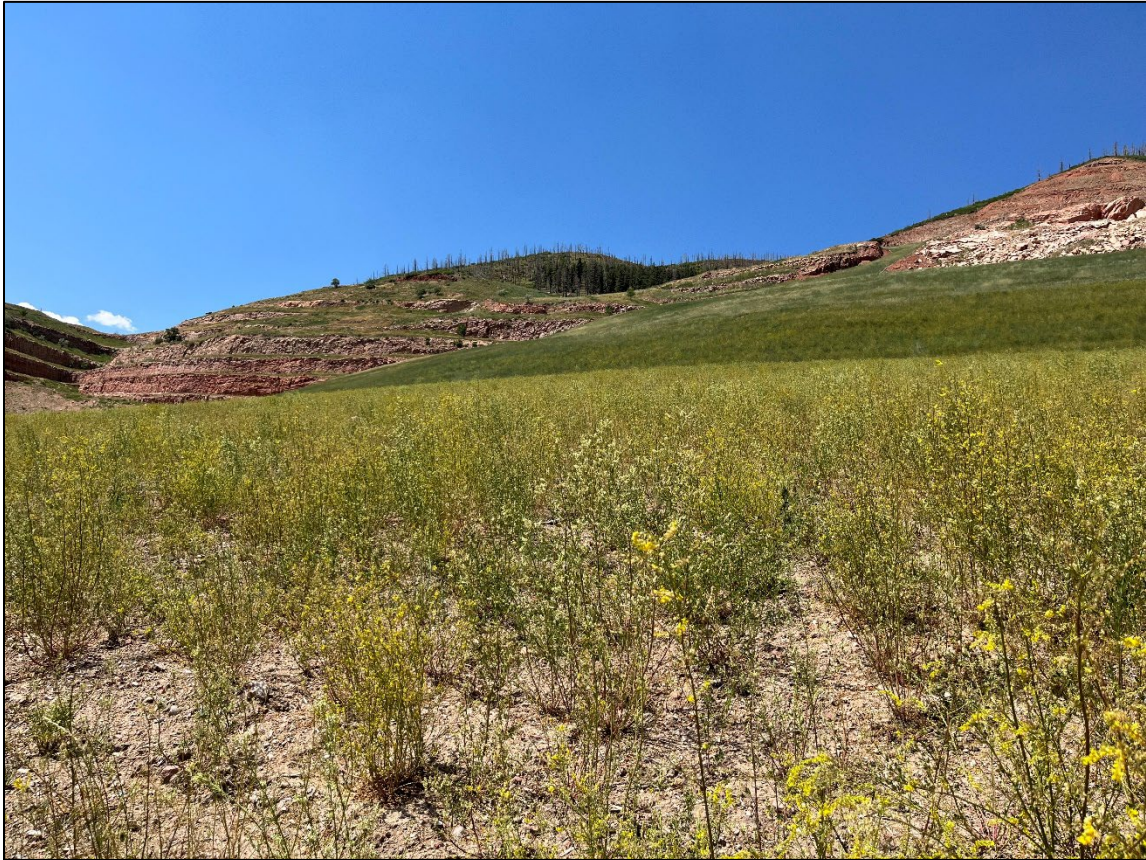
Photo 7: Example vegetation found on the bottom bench of the main slope, mainly clover species.

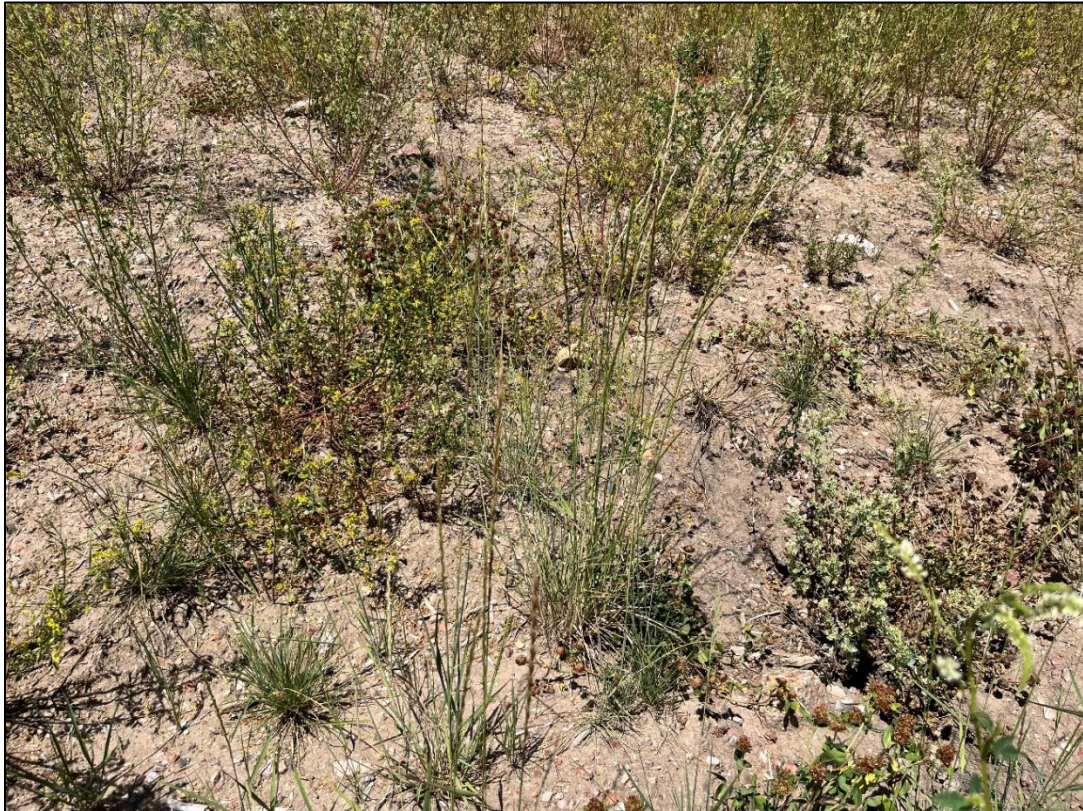
Photo 8: Example of native grass bunches growing on hillslope pictured in Photo 7.

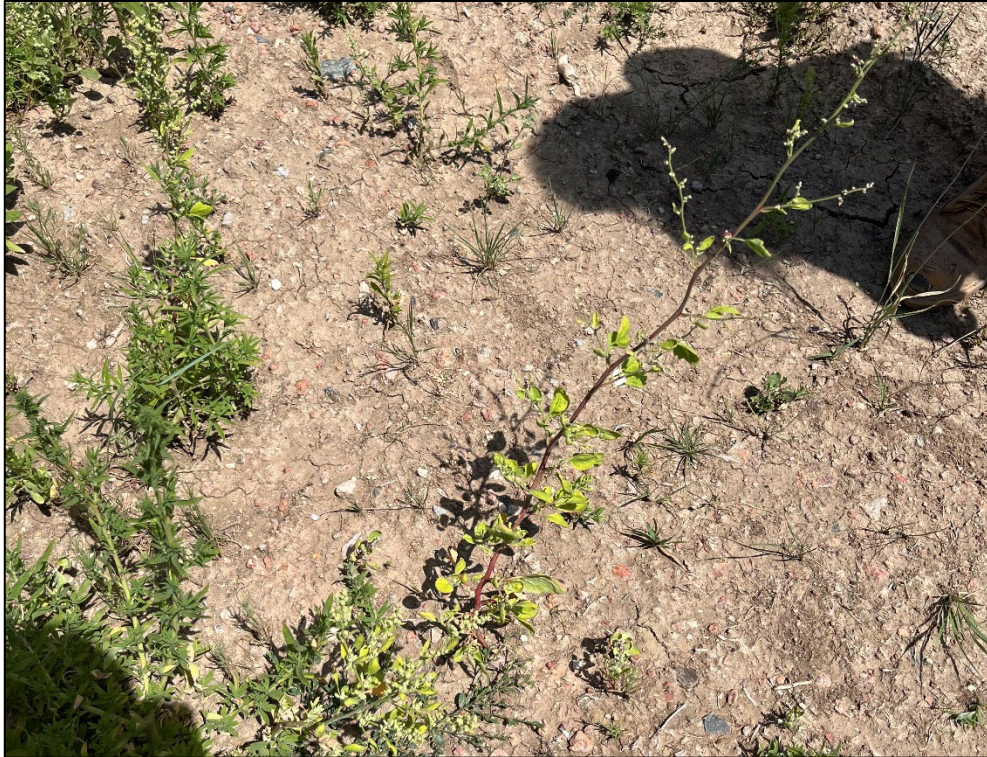
Photo 9: Evidence of shrub survival and growth on revegetated slopes.

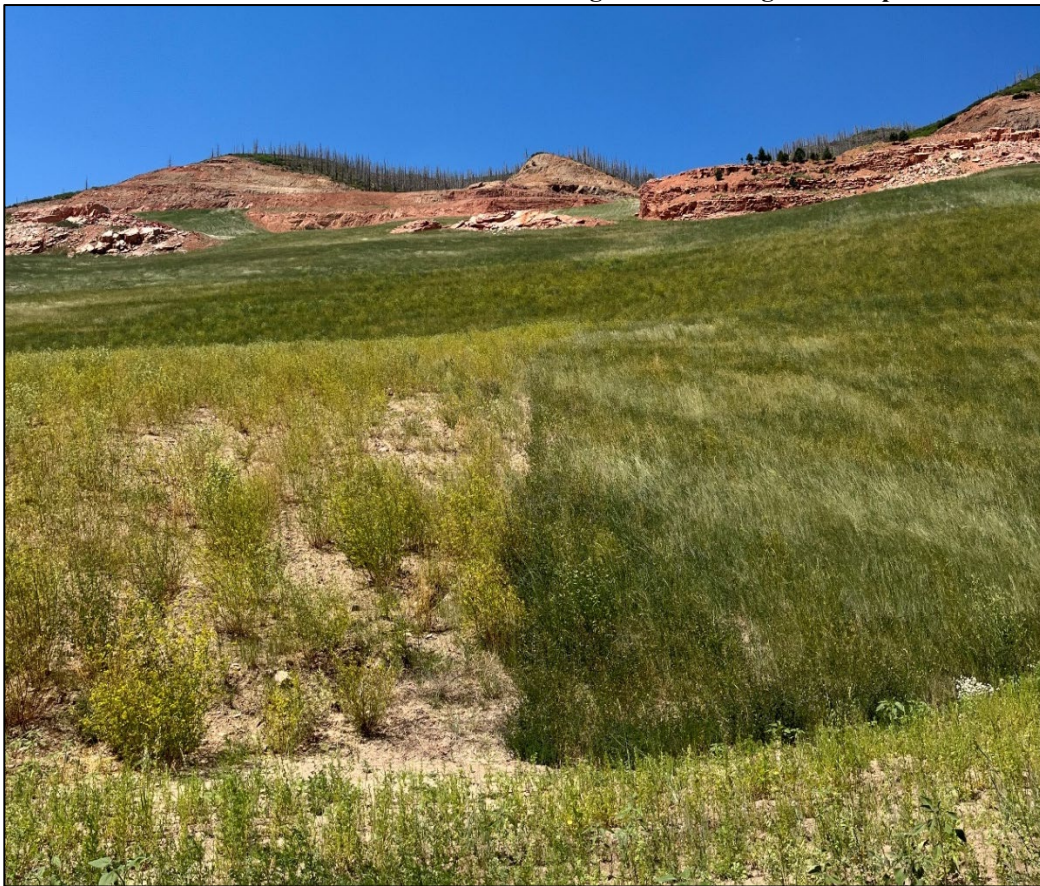
Photo 10: View west, depicts difference between hillslopes revegetated with matting versus drill seeding alone.

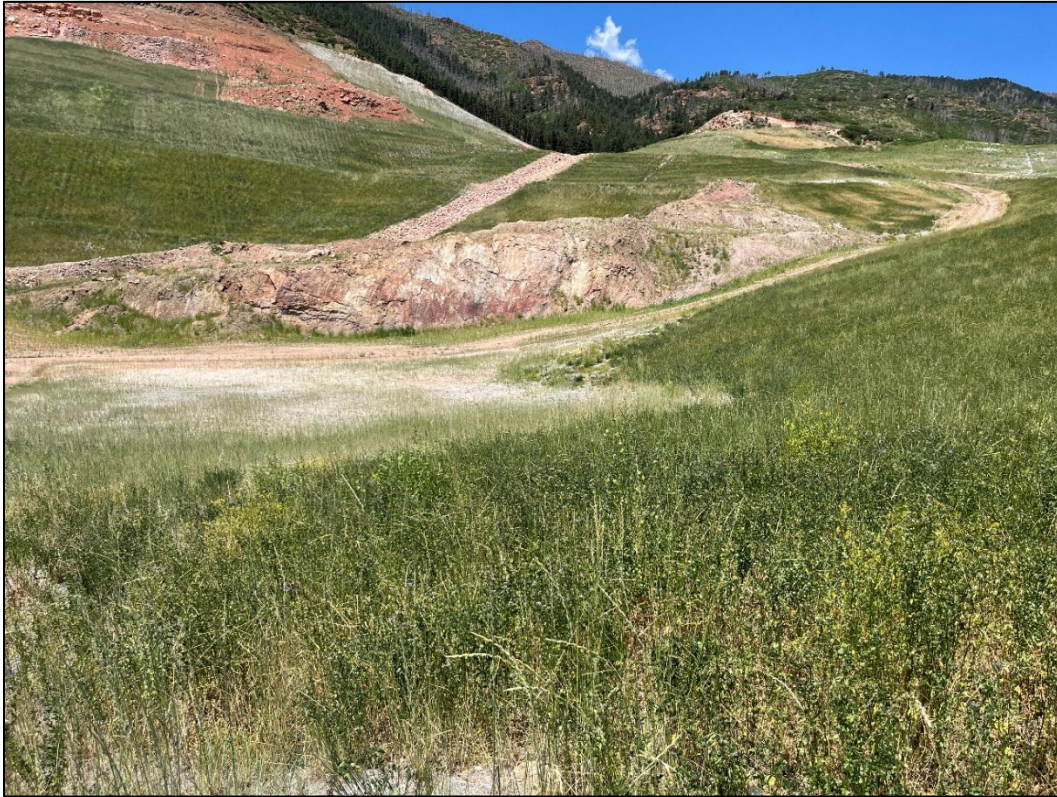
Photo 11: View northwest of the Dragons Back area and revegetated 'shop area'.

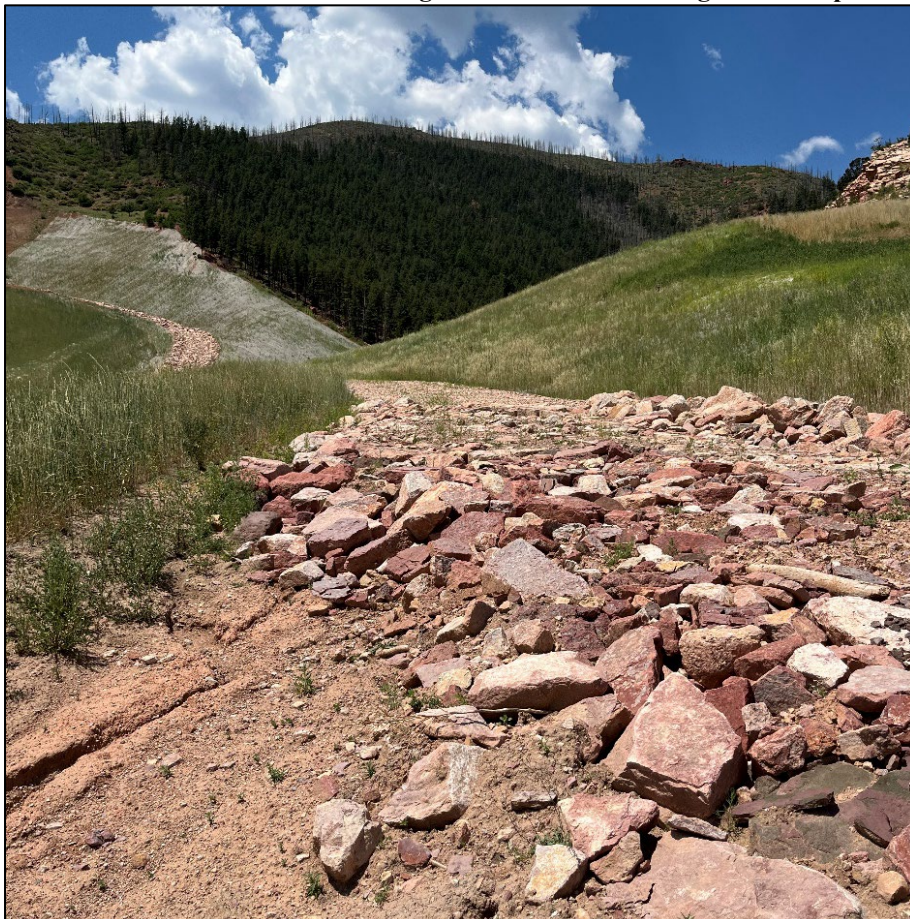
The first area is a section of 3-4 erosion gullies which were forming along the reseeded northern haul road (Photo 13). The gullies were approaching 2 feet deep in some areas. The Division and inspection participants hiked further up the slope and determined that water was likely leaving the constructed channel (C4) and creating gullies downslopes at the point where rip rap sizing changes (Photo 12). The Division and site personnel agreed that the gullies should be regraded and that the C4 channel could be slightly expanded and the transition between larger boulders and gravel could be reworked to be more gradual in an effort to keep water flowing within the designed channel. These improvements will likely solve the downslope erosional issues while vegetation is still being established on the old haul road slope.

Photo 12: View east of the north channel, this area was observed to be the source of a few downslope erosional issues shown in

Photo 13.

CORRECTIVE ACTIONS: The operator shall provide photo documentation to the Division verifying erosion gullies and ruts have been repaired, and that the site has have been reconstructed and stabilized to prevent erosion damage by the corrective action date.

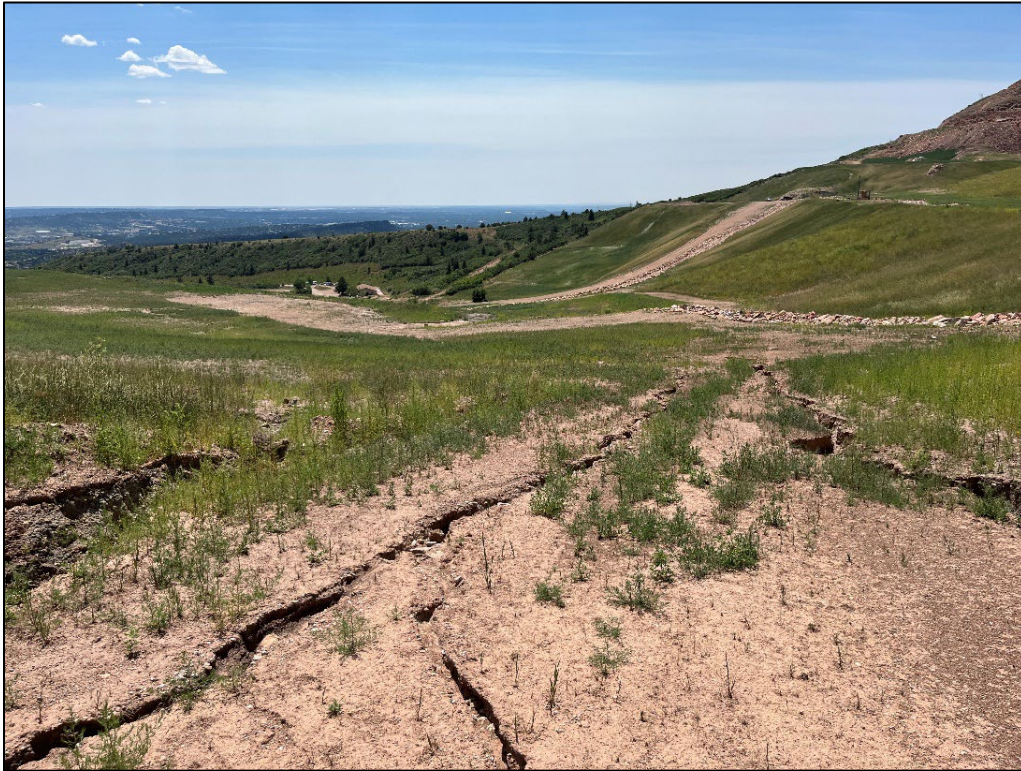
PROBLEM/POSSIBLE VIOLATION: Problem: Erosion gullies and ruts were observed on-site. This is a problem at this time for failure to protect the affected land from erosion pursuant to C.R.S. 34-32.5-116 (4) (j).

Photo 13: Erosional issues on old haul road, source of erosion shown in Photo 12.

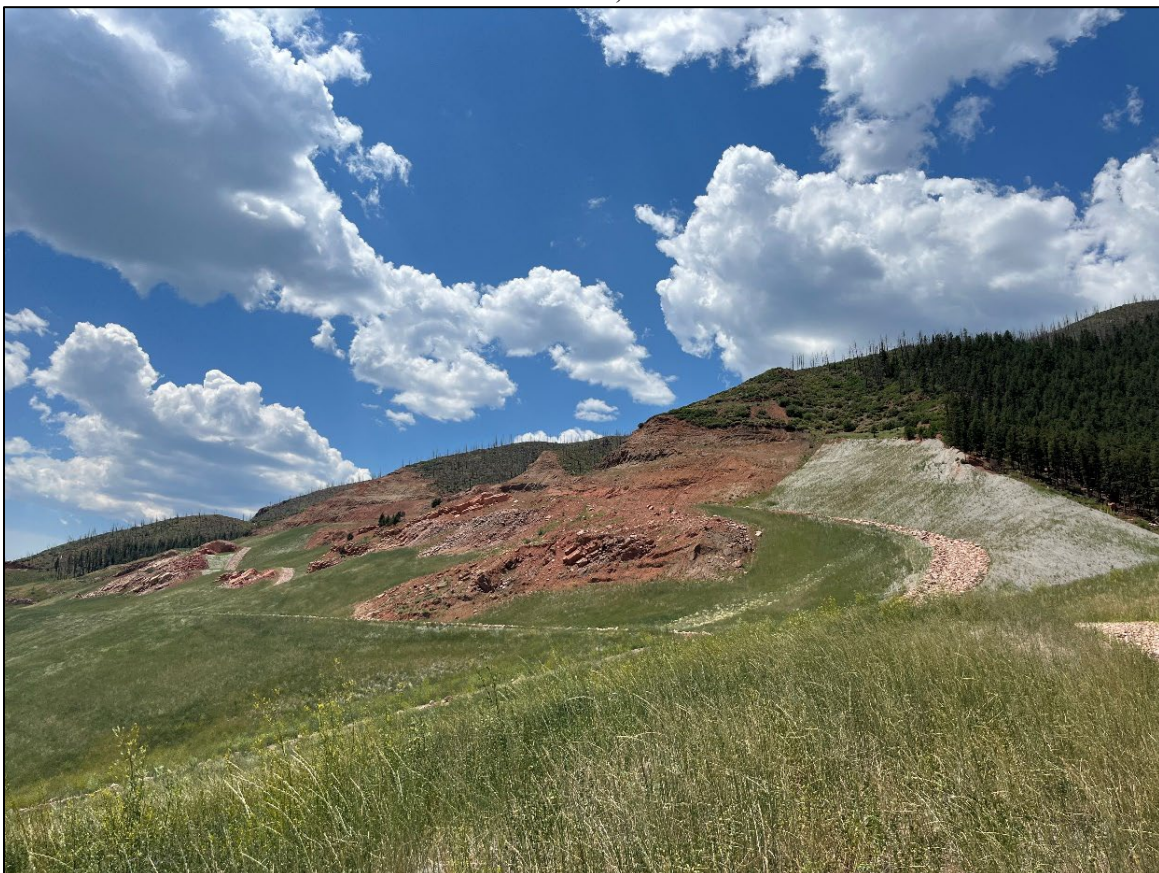
The three peak areas, which were hydro mulched in early 2024 are showing signs of growth (Photo 14 and 18). The Division would like to point out that growth in the peaks area is not intended to resemble the lush growth of the bottom slope areas. Rather, the hydro mulching of these areas allowed seeds to stick and settle into pockets in the rocky slope where small clusters of vegetative growth could form.

Photo 14: View southwest of upper vegetated slopes and three peaks areas.

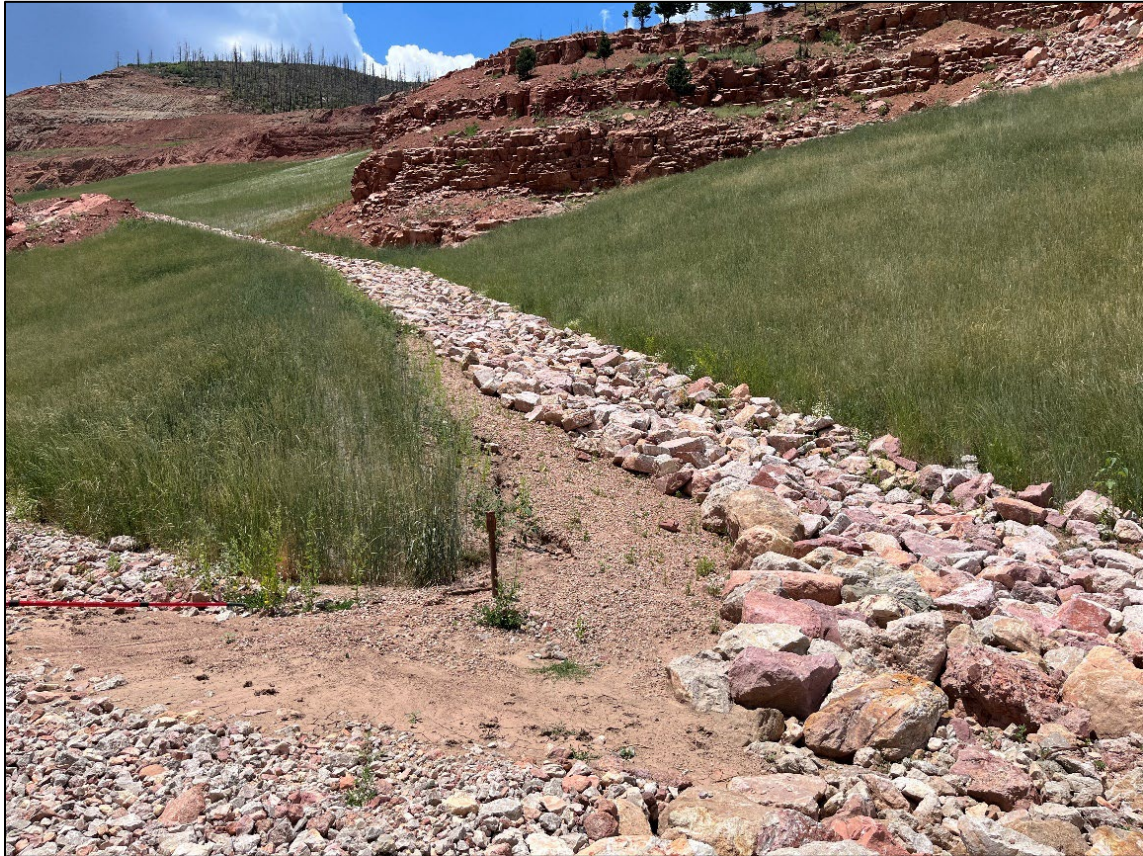
The second area of concern is located at the tie in area of Channels T7 and T8 on the upper slopes (Photo 15). Sedimentation occurs at this tie in area and if left unaddressed could hinder functionality of the drainage channel. Site personnel committed to reworking this area to extend the channel out slightly and redirect water back into the rip rap channel.

Photo 15: Sedimentation observed at the tie in on Channels T7 and T8.

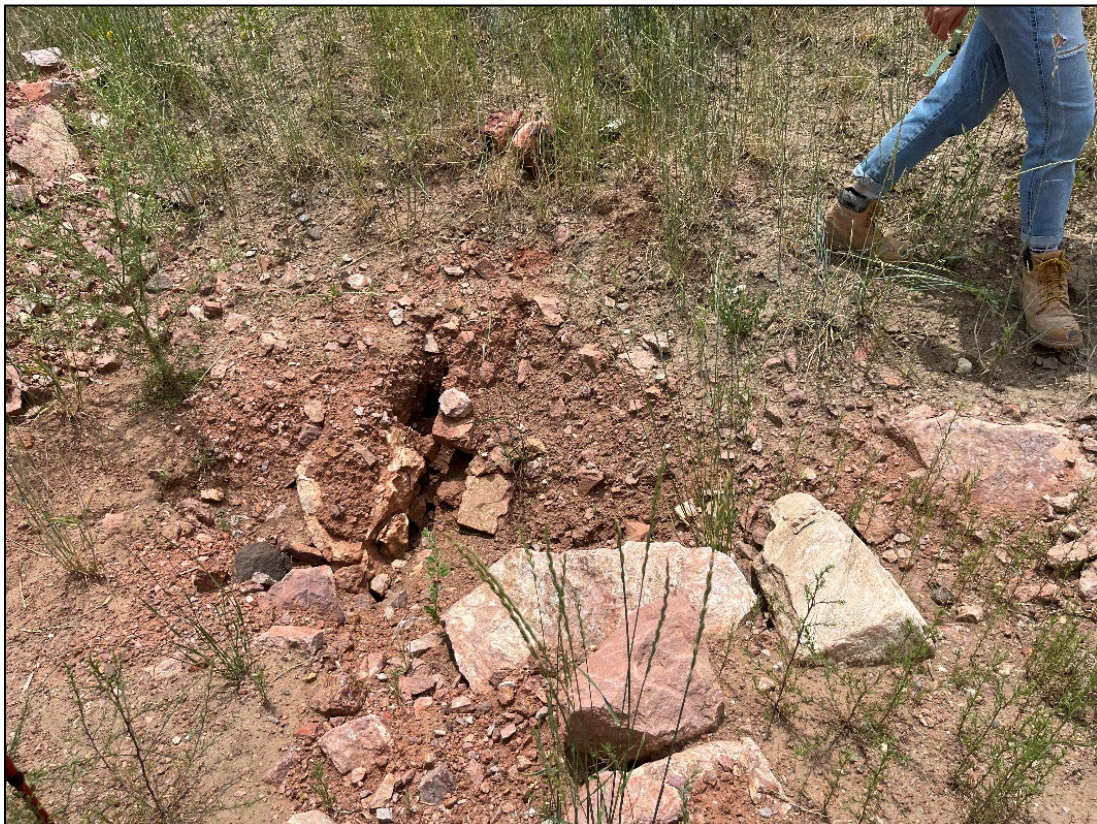
The third and final area is shown in Photos 16 and 17. Two small holes have formed just above a small, natural rock outcropping of bedrock on the upper slopes. Site personnel explained that these had been silting in over the previous weeks and decreased in size. However, it was discussed that these holes should be more formally filled in with larger material. This would ensure stability of the slope above the outcropping and hinder stormwater flow into these holes and under the outcropping, with the aim of avoiding any future slope stability concerns. Loose, mid-sized bedrock material from atop the rock outcropping is available for filling these holes. With these holes filled, stormwater will be directed down and off the rock outcropping, rather than under and behind it.

Photo 16: Hole observed near the western edge of a natural outcrop feature along the upper slopes.

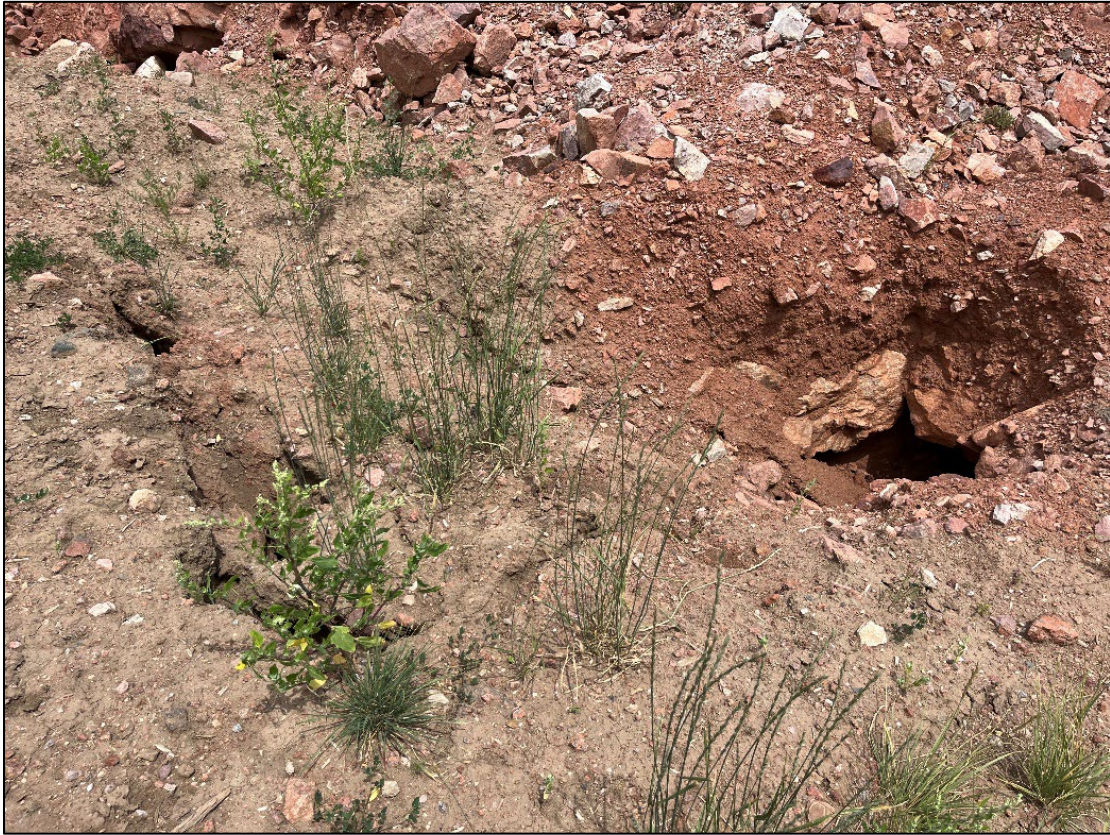
Photo 17: Hole observed near the western edge of a natural outcrop feature along the upper slopes.

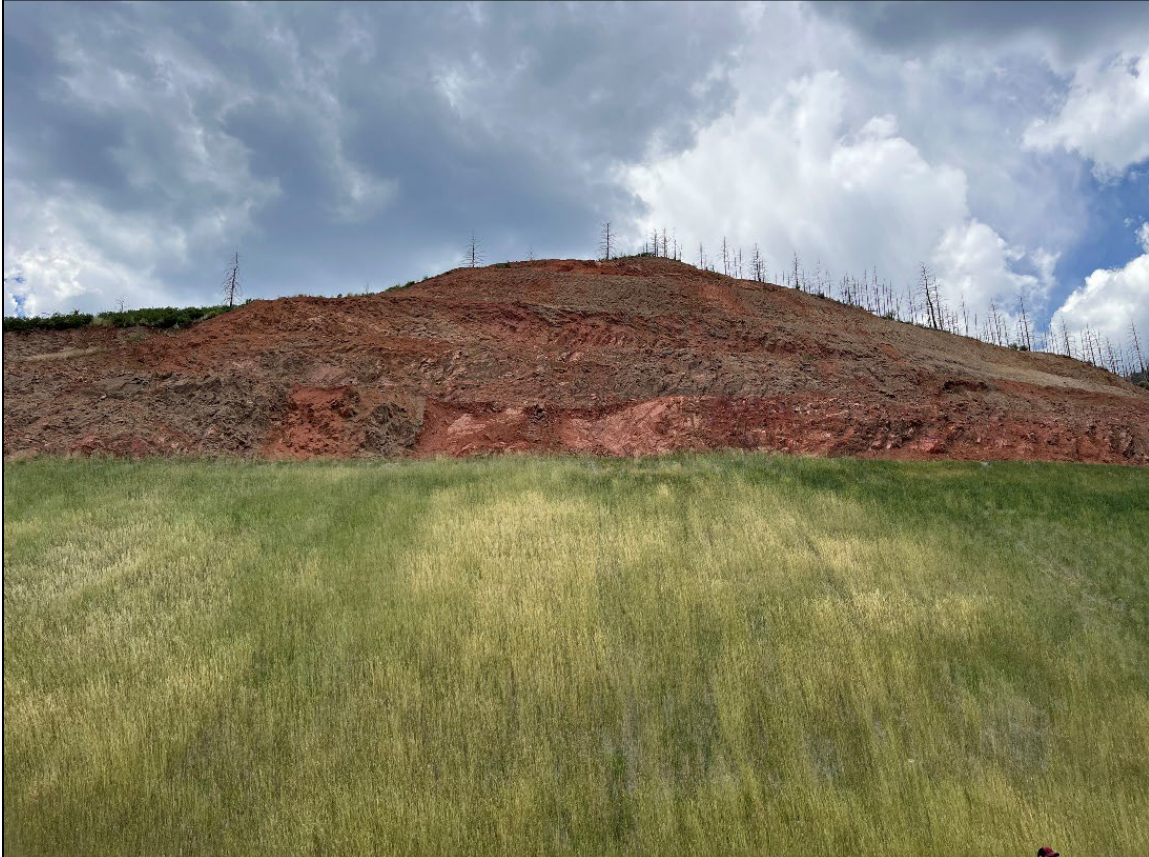
Photo 18: View west of example vegetation on the south peak.
