Inspection report for Bowie No. 1 Mine

PERMIT INFORMATION

Permit Number: C-1981-038 Mine Name: Bowie No. 1 Mine Operator: Bowie Resources, LLC Operator Address: Mr. Art Etter P.O. Box 1488 Paonia, CO 81428	County: Delta Operation Type: Underground Permit Status: Active Ownership: Private
	Operator Representative Present: None
Operator Representative Signature: (Field Issuance Only)

Inspection Start Date: July 24, 2025 Inspection Start Time: 07:00 Inspection End Date: July 24, 2025 Inspection End Time: 09:00		Inspection Type: Coal Partial Inspection Inspection Reason: Normal I&E Program Weather: Cloudy	
Joint Inspection Agency: None		Joint Inspection Contacts: 	
Post Inspection Agency: None		Post Inspection Contacts: 	
Inspector(s): Robert Zuber, P.E.	Inspector's Signature:

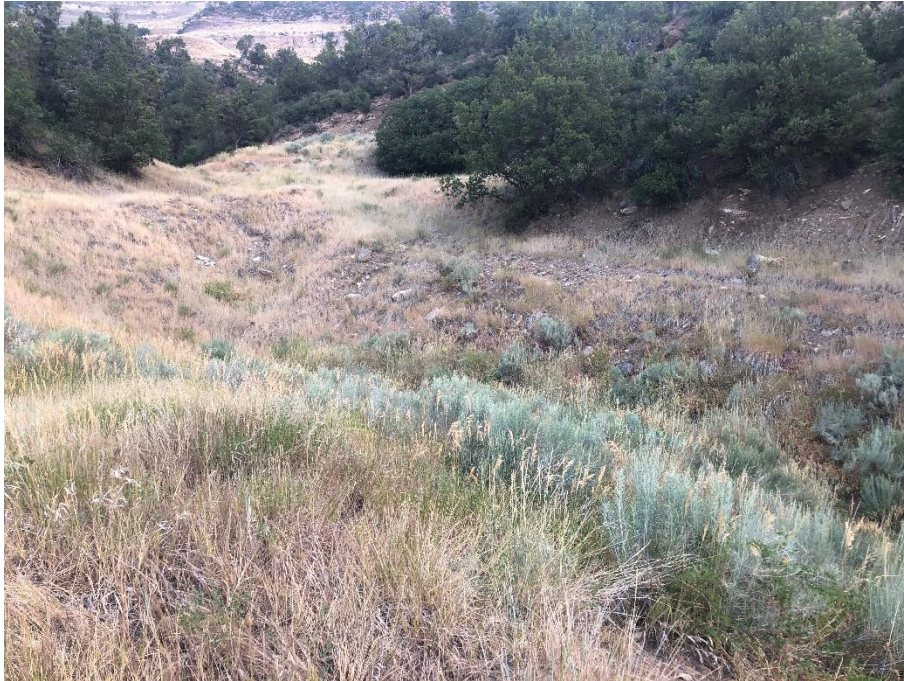
No problems were identified with the reclamation at Ponds 1, 2, 3, and 4 at the East Mine. The vegetation cover is good in this area.

Reclaimed Pond 4 at the East Mine, looking up the drainage

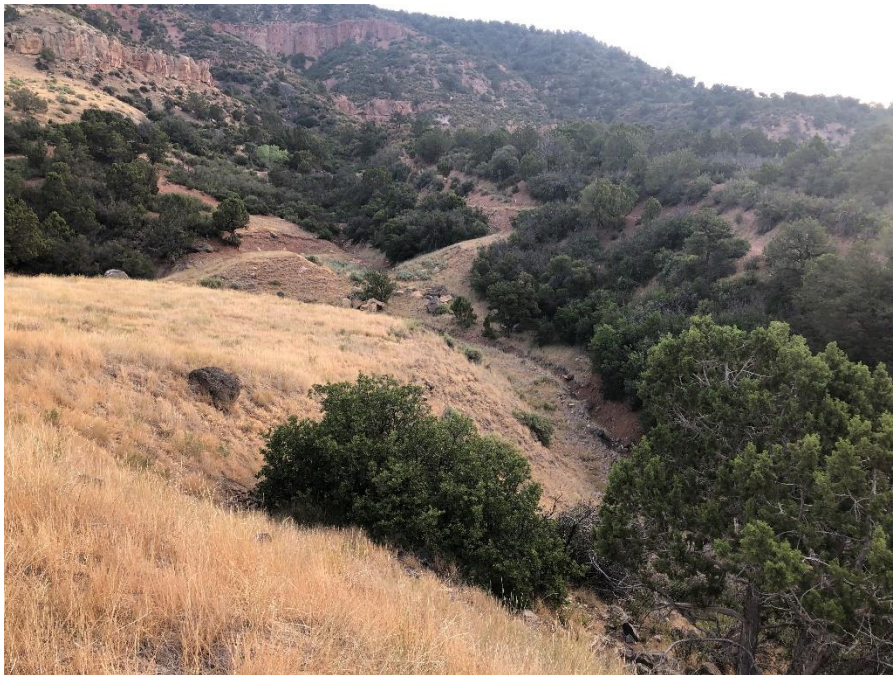
Reclaimed Pond 1 at the East Mine, looking up the drainage

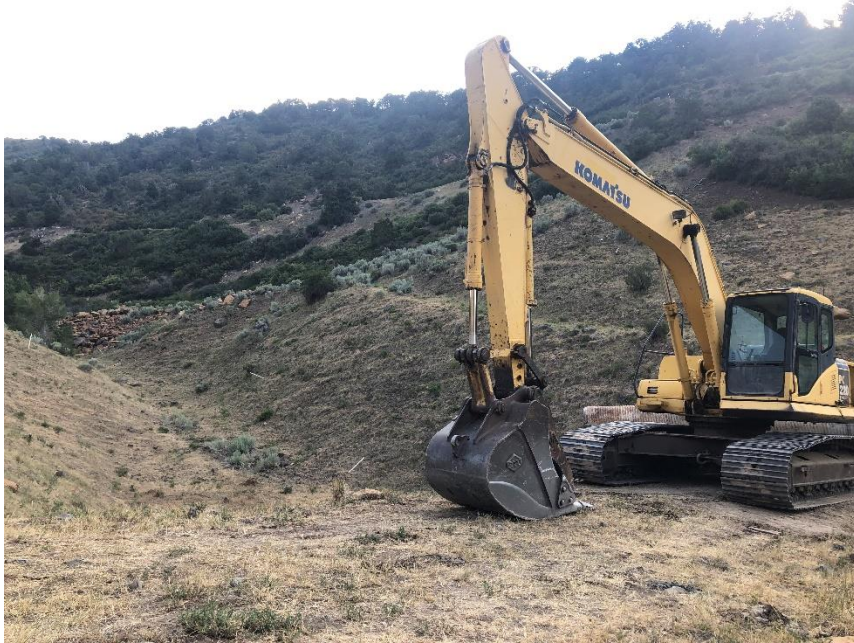
BRL has begun reclamation of East Roatcap Creek at the West Mine. At the time of the inspection, an excavator was sitting idle on the embankment of the upper pond. The lower pond had been removed, several segments of large culvert pipe had been excavated, and approximately 100 feet of riprap channel had been constructed. Generally, the riprap channel looks well-constructed. Some items should be discussed between BRL and the Division as the construction continues:

Excavator at West Mine, looking upstream at the remaining pond

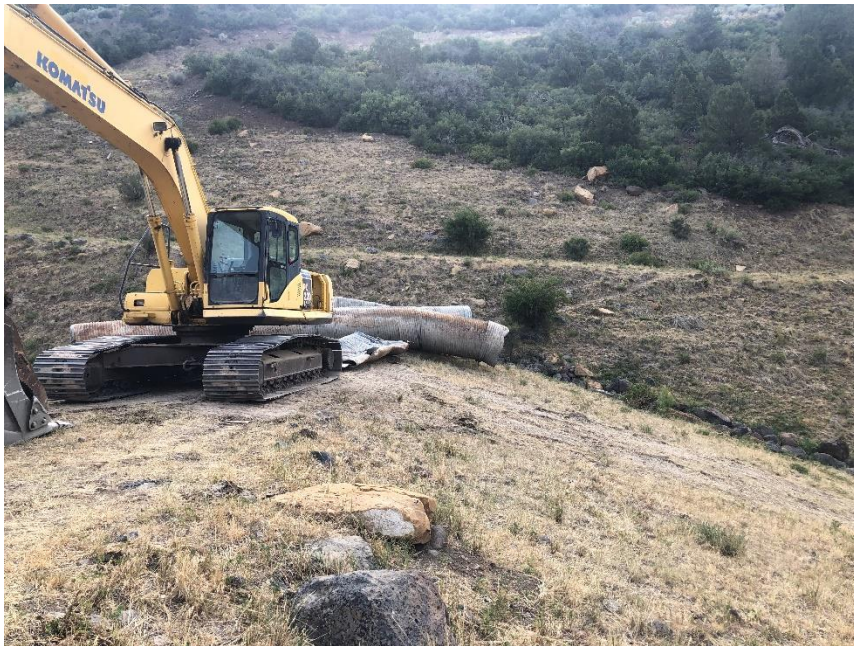
Pipes removed from under the lower pond

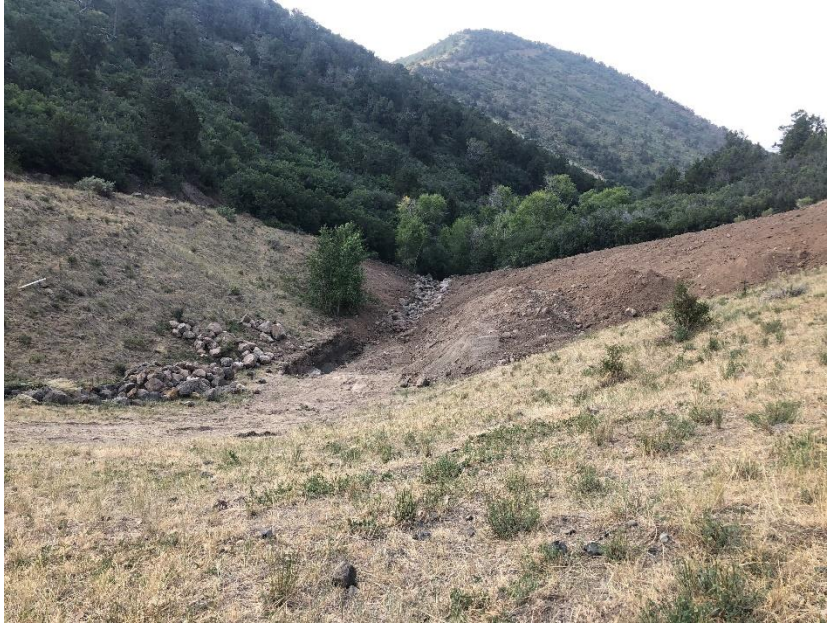
West Mine reclamation, looking downstream

** Per the design in the PAP (Map 8A-19 from TR-64), there will be intermittent boulders rather than a continuous riprap channel.

** The PAP (on page 60-b in Section 2.05) also suggests that it would be beneficial to create pools and drops within this reconstructed portion of East Roatcap Creek.

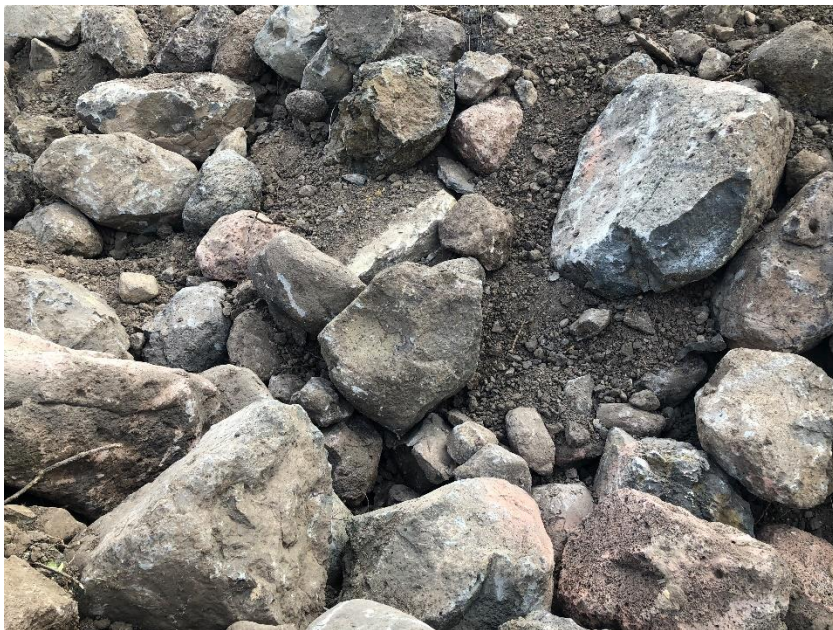
Riprap placed at West Mine reclamation

** If a riprap channel is constructed, it would be beneficial to place more small rocks in the voids between the large boulders to prevent scour.

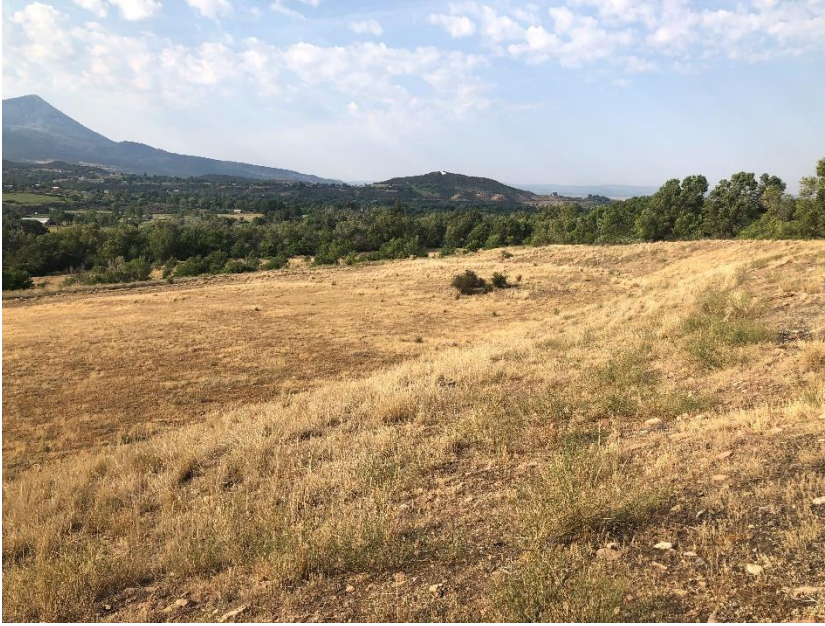
The ponds at the loadout, the coal storage area by Highway 133, and the West Mine contained no water (as noted the lower pond at the West Mine has been removed). No discharges or signs of discharges were observed. No problems were identified with embankments, spillways, or other aspects of these ponds.

Coal storage by Highway 133, west side

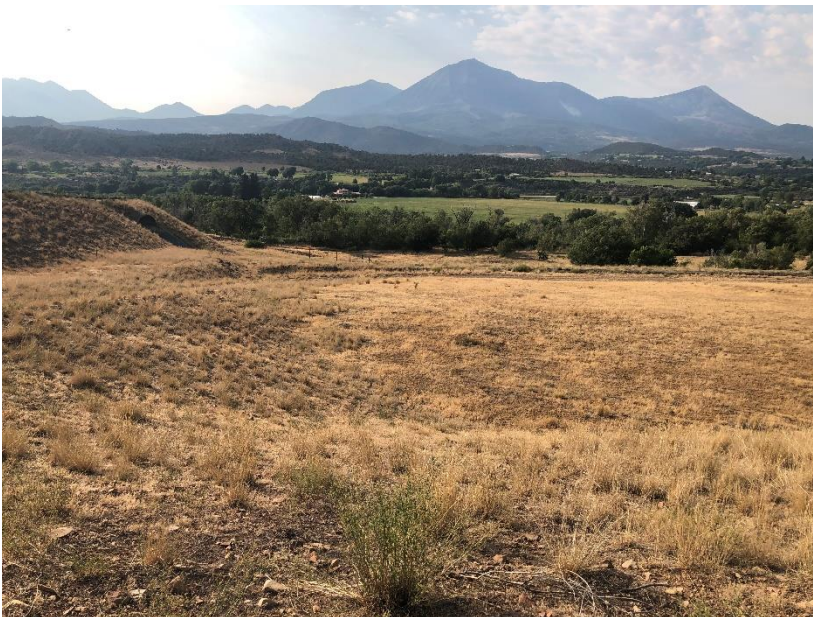
Coal storage by Highway 133, east side
