Re: GCC Energy, LLC, King II Mine
CDRMS Permit # C-1981-035
Sunder, Miller & Associates: Quarterly Inspection: King I 'UbX' = Water Quality
Improvements Inspection 2nd Quarter 2025

RE: King Coal I – Quarterly Water Quality Improvements Inspection

RE: King Coal II – Quarterly Water Quality Improvements Inspection

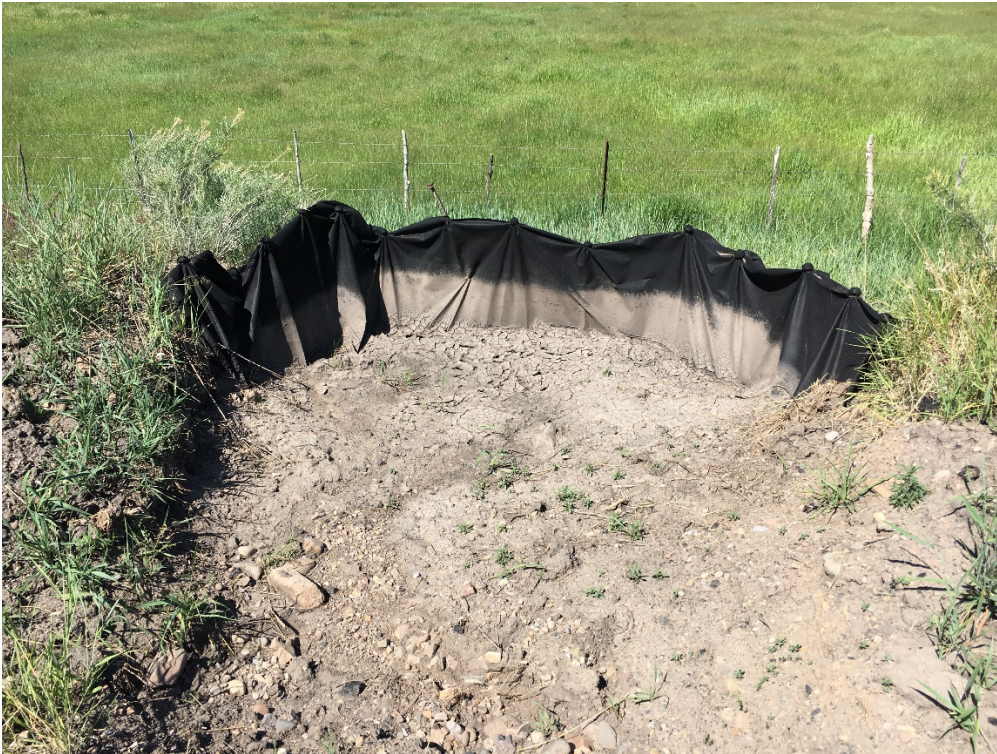
The sedimentation traps at the entrance to the site appear to be in good working condition, anchored below the ground and trapping sediment (Pic. 1). They should continue to be maintained and dredged when sediment levels get high, particularly after rainfall events.

Pic. 1 – Sedimentation trap anchored and catching sediment.

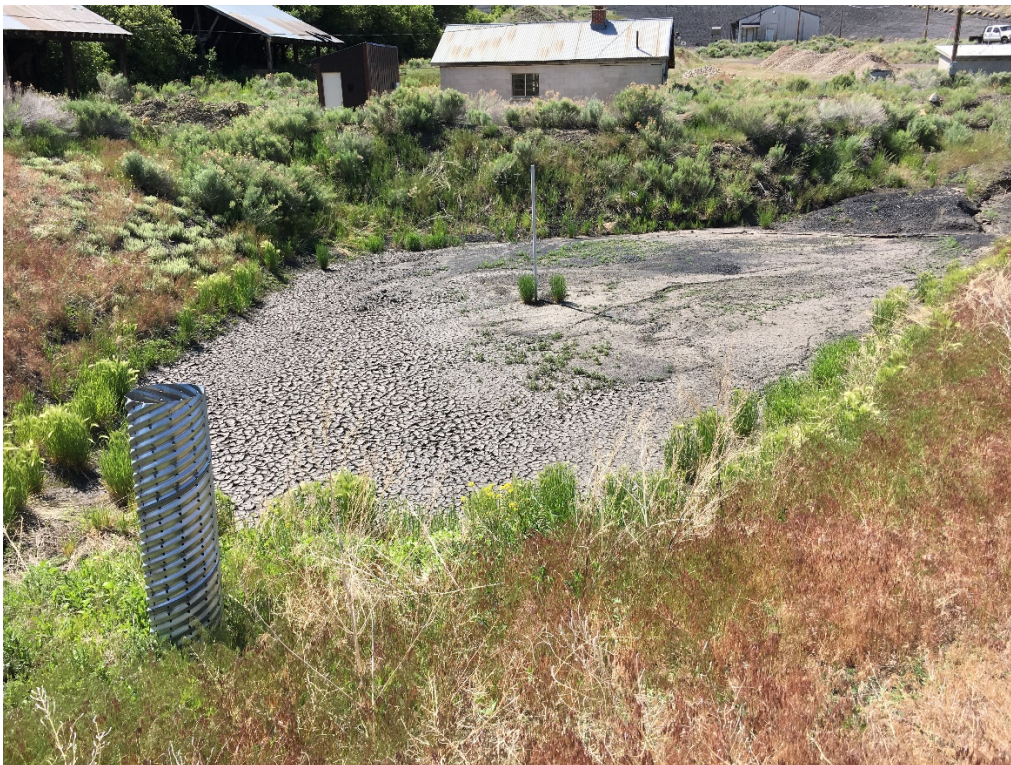
The east pond was dry and the sediment levels within the pond appears to be relatively low (Pic 2). Some sedimentation is evident in the southern inlet portion of the east pond. SMA recommends monitoring this area and dredging should more sedimentation occur, which may impede flow into the main portion of the pond. The west pond was mostly dry and it appears dredging activities were initiated but not complete due to the still wet pond bottom (Pic 3). It is recommended that dredging of the pond resume as soon as conditions allow.

Pic. 2 – East sediment pond.

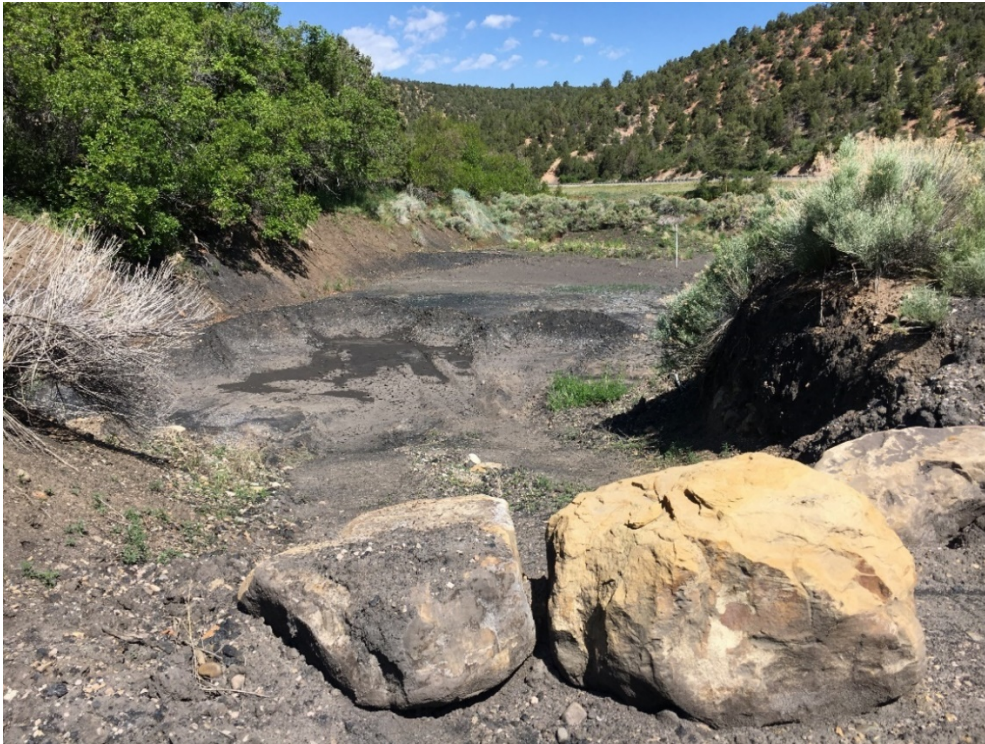
Pic. 3 – View into west pond. Evidence of sediment removal initiated but not complete due to muddy conditions just below the surface.

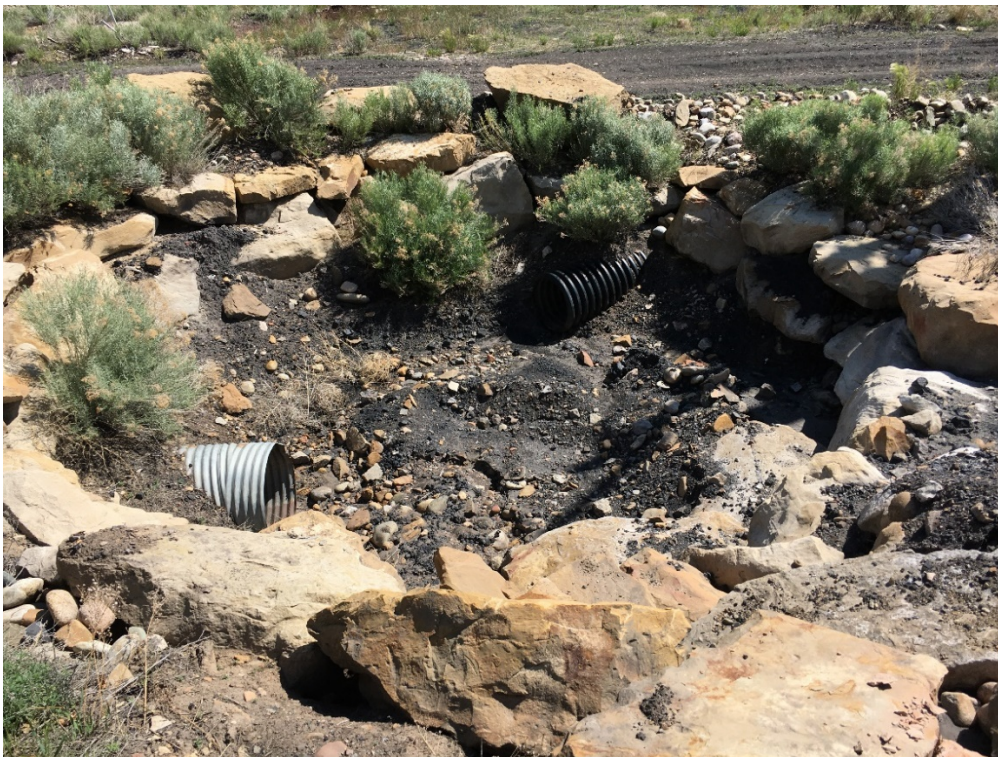
The existing ditches and culverts appear to be generally in good condition at the time of the inspection, including the rock armor and sediment levels (Pic. 4). Voids observed along Reach 9 during the last inspection appear to have been fixed and the reach appears to be in good condition (Pic. 5). The lower and upper portions of Reach 10 also appear in good condition (Pics. 6-7). The undercutting of rock armor from the upper waste pile to the drainage ditch appears in better condition than the previous inspection, and only minor erosion is evident (Pic. 8). SMA recommends monitoring and maintenance of this section to ensure erosion channels do not continue to grow.

Pic. 4 – View of culverts which receive flows from Reach 9 and from below the lower waste pile.

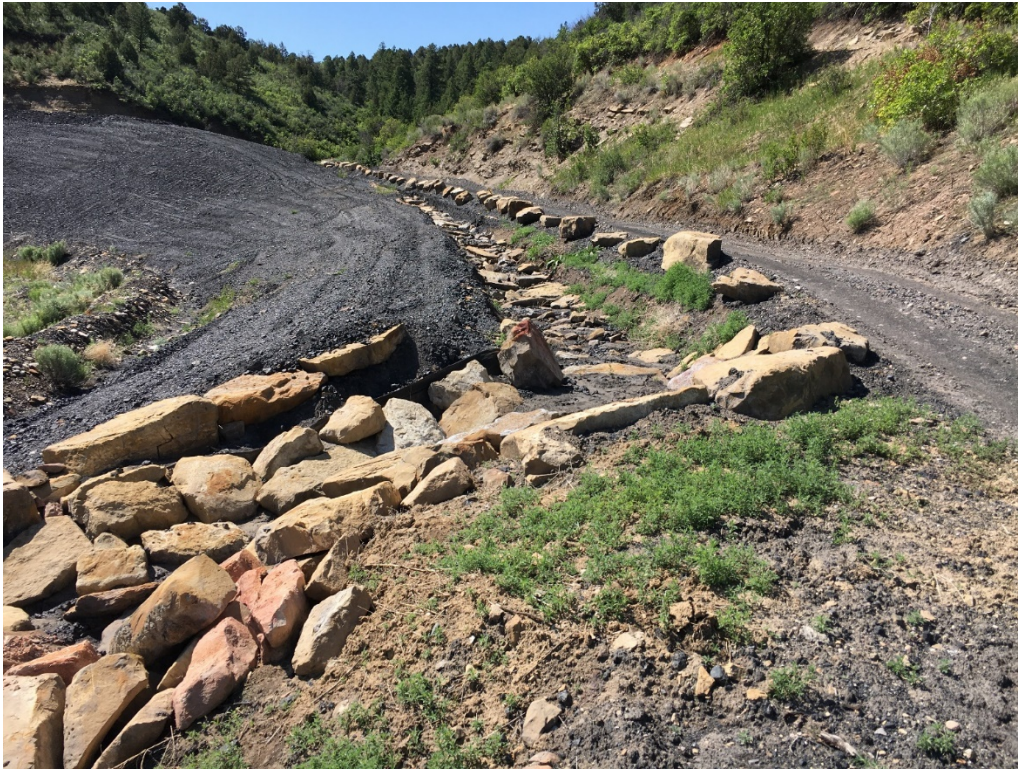
Pic. 5 – Reach 9 conditions.

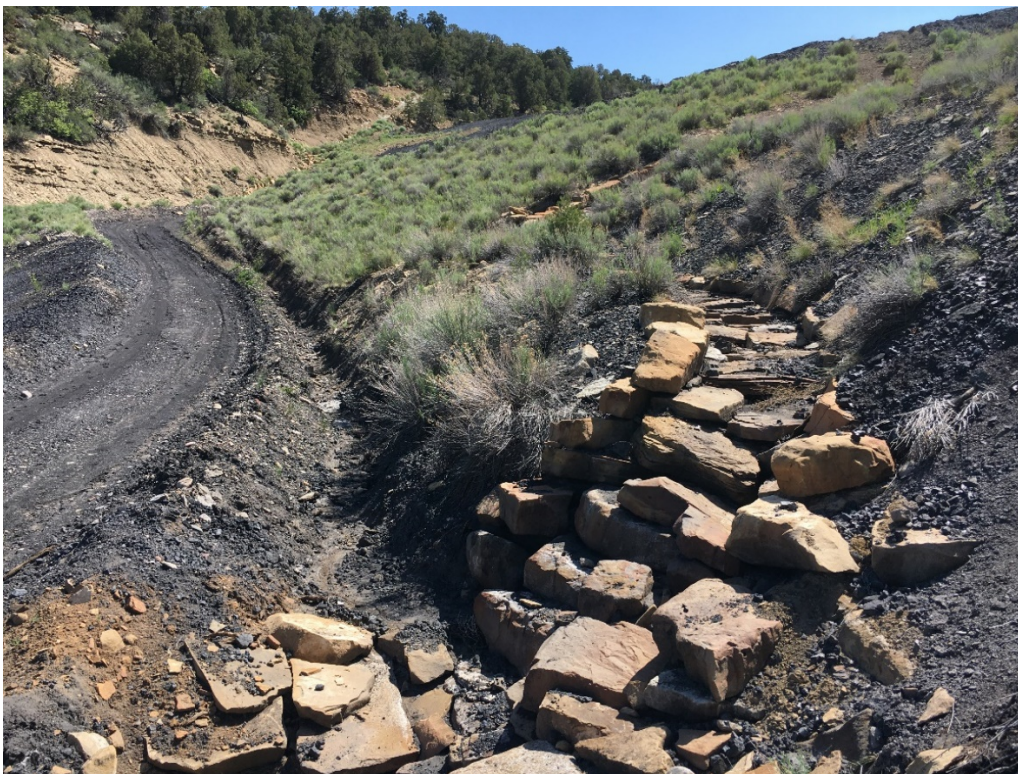
Pic. 6 – Haul road ditch and lower portion of Reach 10 prior to draining towards the lower waste pile area.

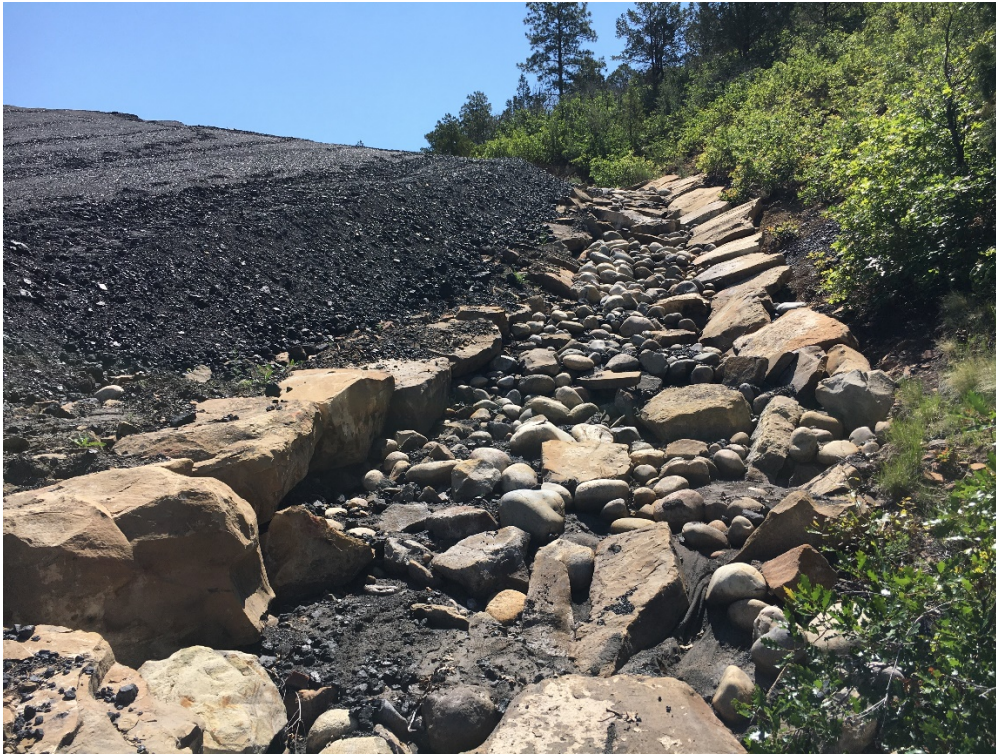
Pic. 7 – Reach 10, armored section between lower and upper waste piles.

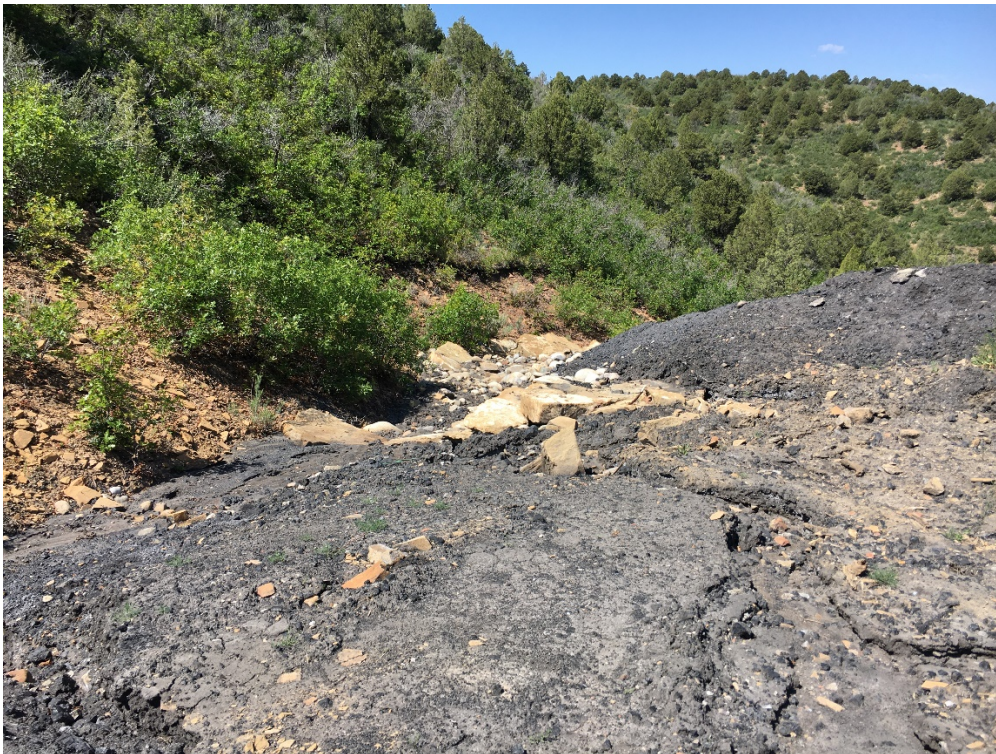
Pic. 8 – Minor erosion evident at the discharge from the upper waste pile to Reach 10. Monitor and maintain so larger, erosional channels do not start forming.

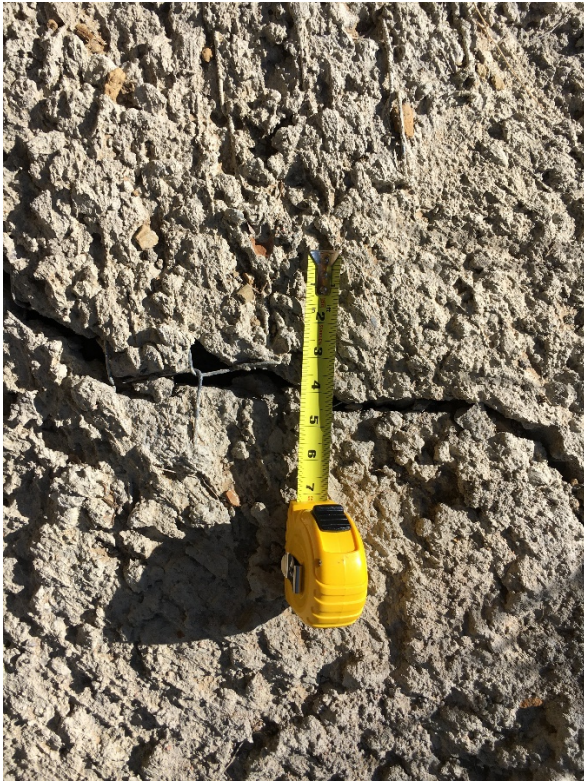
The clear water ditch (Reach 1) was found to be in good condition. The cracks noted in the lower armored section of Reach 1 appear to be about the same size as observed in the previous inspection (Pic. 9). The upper armored section of Reach 1 should be monitored for increased cracking and exposed subsurface and maintained clear of excessive vegetation that may reduce ditch capacity and impede flow. Grout can be installed in the cracks to prevent water infiltration and locations monitored for additional signs of movement.

Pic. 9 – Crack along the armored section of Reach 1.

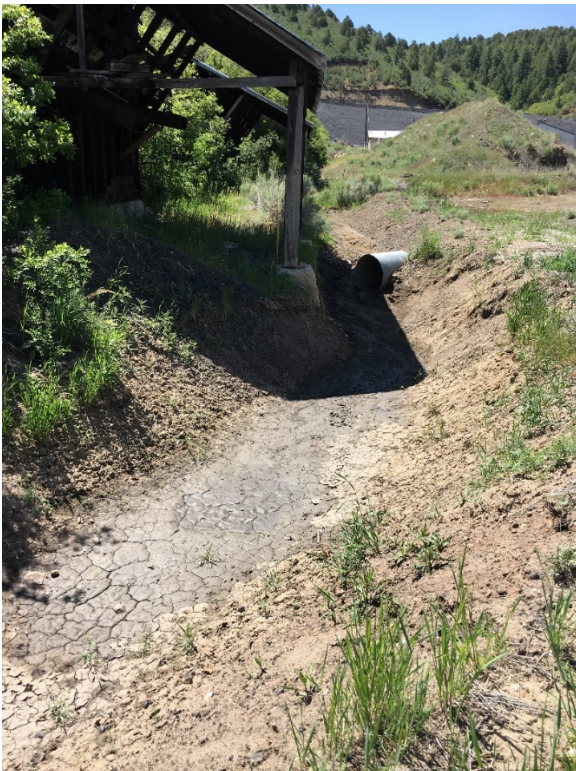
The sediment build-up previously noted during the previous inspection at the culvert outfall near the bottom of Reach 5 appears to have been clean out (Pic. 10). Continue to monitor the sediment load and dredge if the culvert and ditch flow appear to be impeded.

Pic. 10 – Culvert at bottom of Reach 1.

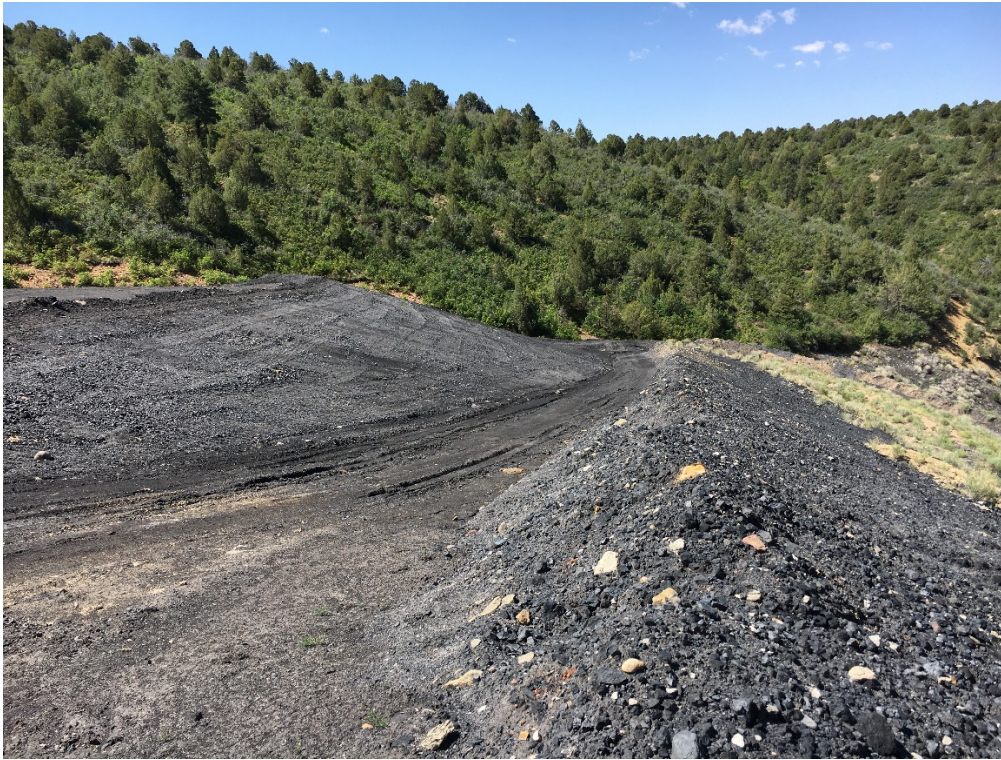
The waste pile areas appear in good condition. Surface grading directs runoff away from the face of both waste piles and the required berming is in place. The banks and slopes of the waste pile areas appear stable and maintained (Pic. 11). Waste material placed on the upper waste pile appears minimal since the previous inspection.

Pic. 11 – Bank stabilization and grading, and berming placed along edges of the upper waste pile.

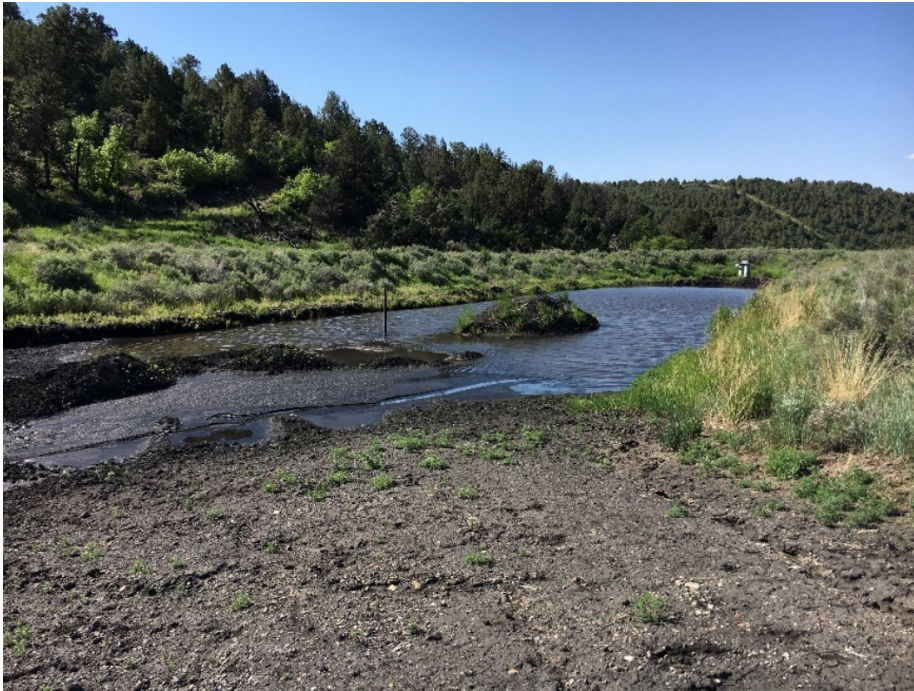
The detention pond held about the same amount of water, maybe slightly less, as compared to the previous inspection (see Pic. 1). The sediment elevation at the bottom of the pond could not be determined due to the water level within the pond, but it appears that the sediment level is at the same point as the previous inspection. When conditions allow, excess sediment should be removed, particularly in the northern portion of the pond.

Pic. 1 – Water level in the detention pond.

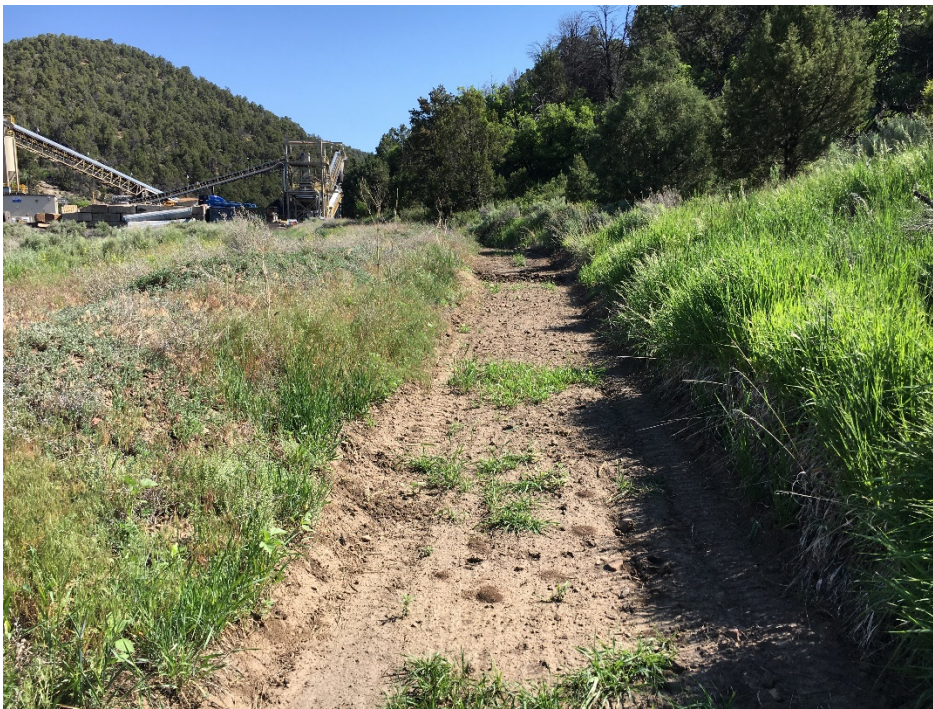
Pic. 2 – East Clear Water Ditch.

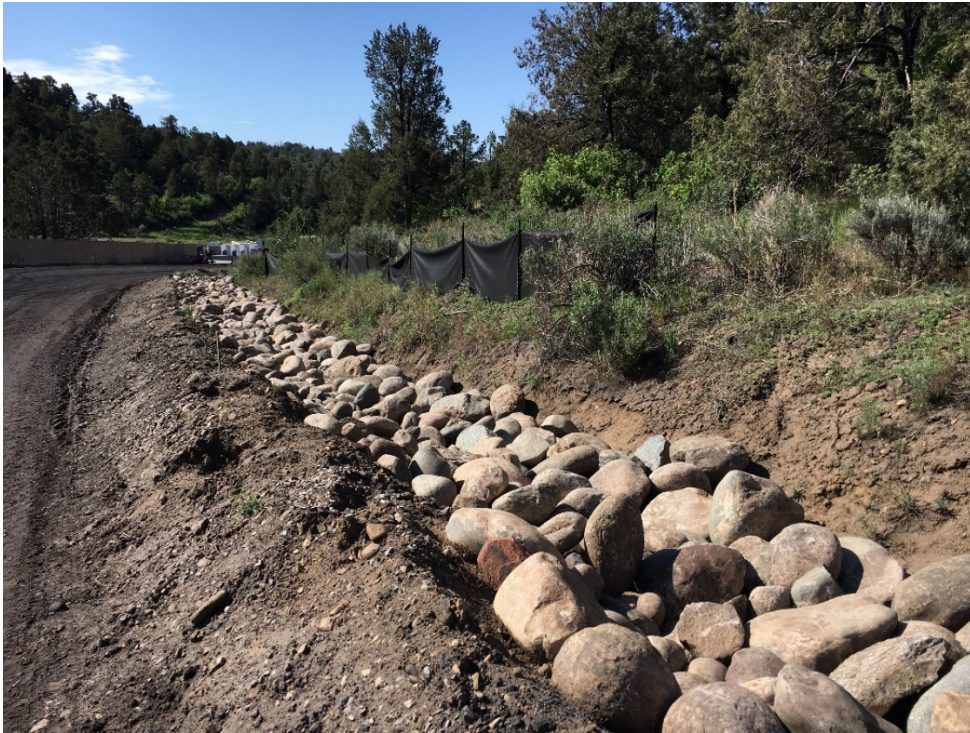
Pic. 3 – West Clear Water Ditch.

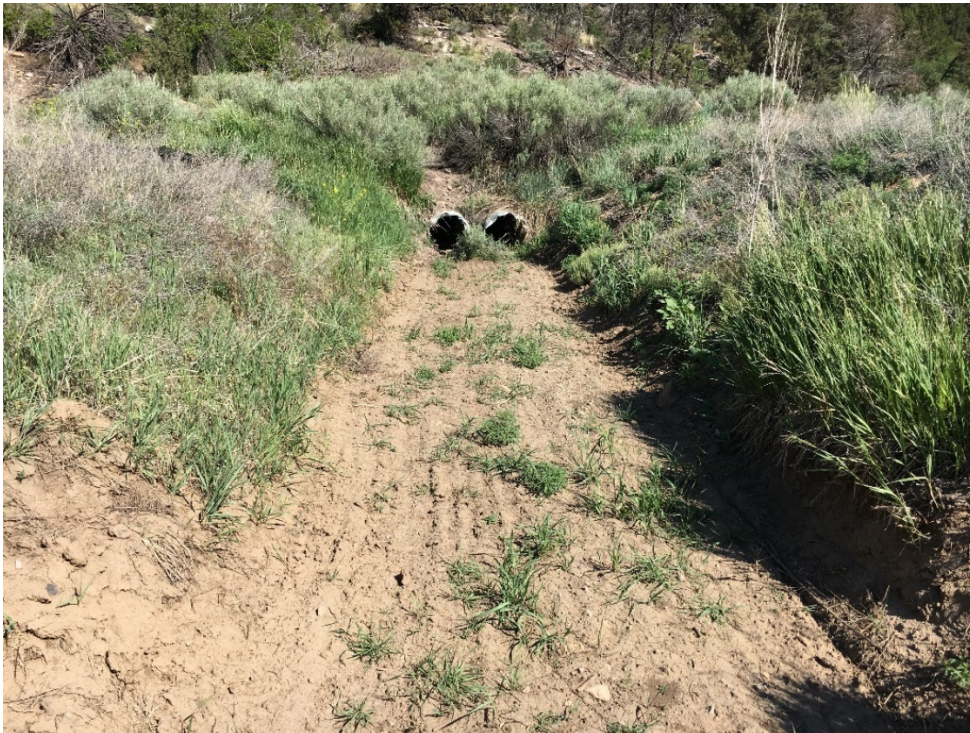
The east clear water ditch (Pic. 2), the west clear water ditch (west of the driveway access) (Pic. 3) and the main drainage ditch (combined clear water ditches) were found to be in good condition and generally clean of debris. Accumulated vegetation noted from the previous inspection has been removed at the culvert outfalls where the west clear water ditch drains towards the main drainage ditch (Pic. 4).

Pic. 4 – Culvert outfalls where the West Clear Water Ditch drains towards the Main Drainage Ditch.

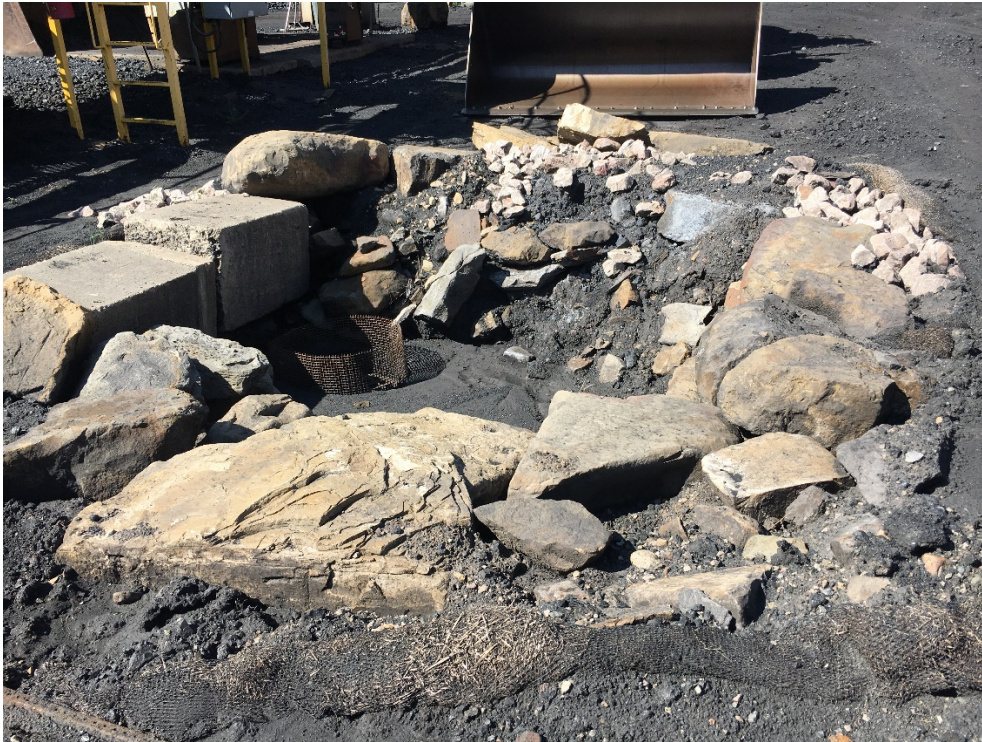
Pic. 5 – Condition of drain near conveyor belt.

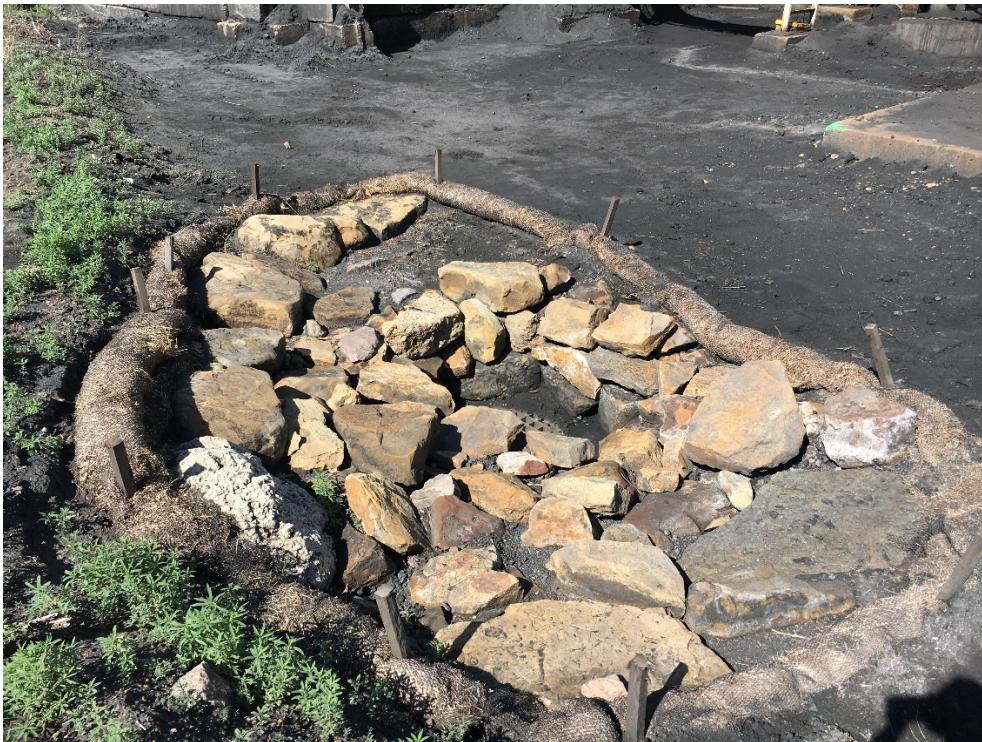
Pic. 6 – Straw wattles and rock armor near the vibratory processing area.

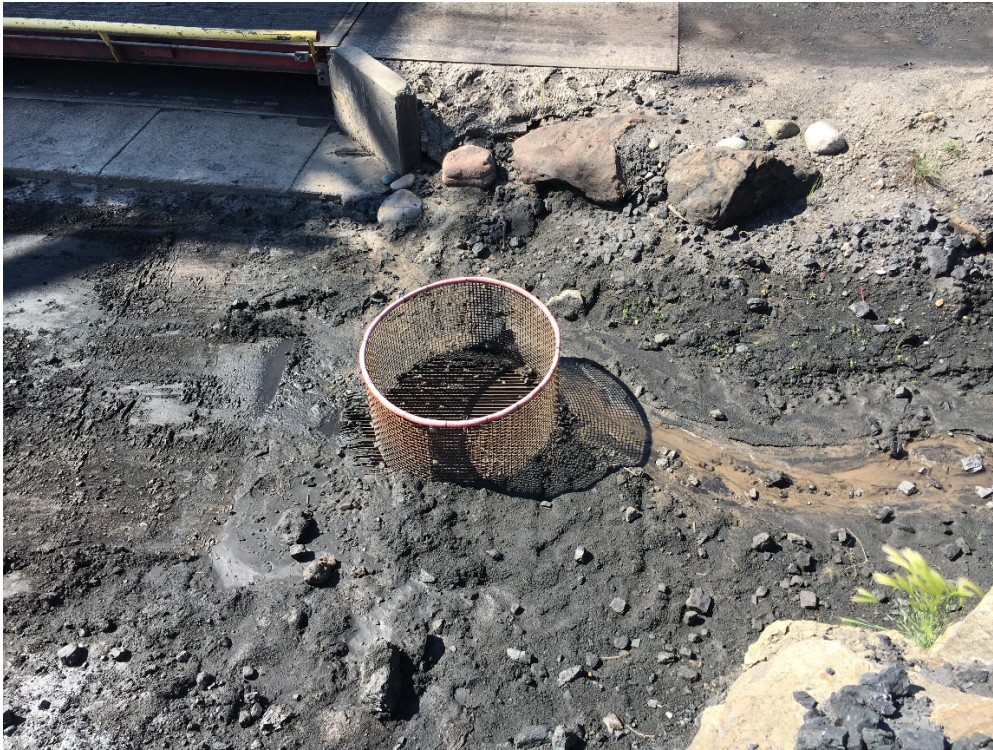
Pic. 7 - Drain located north of scale house building.

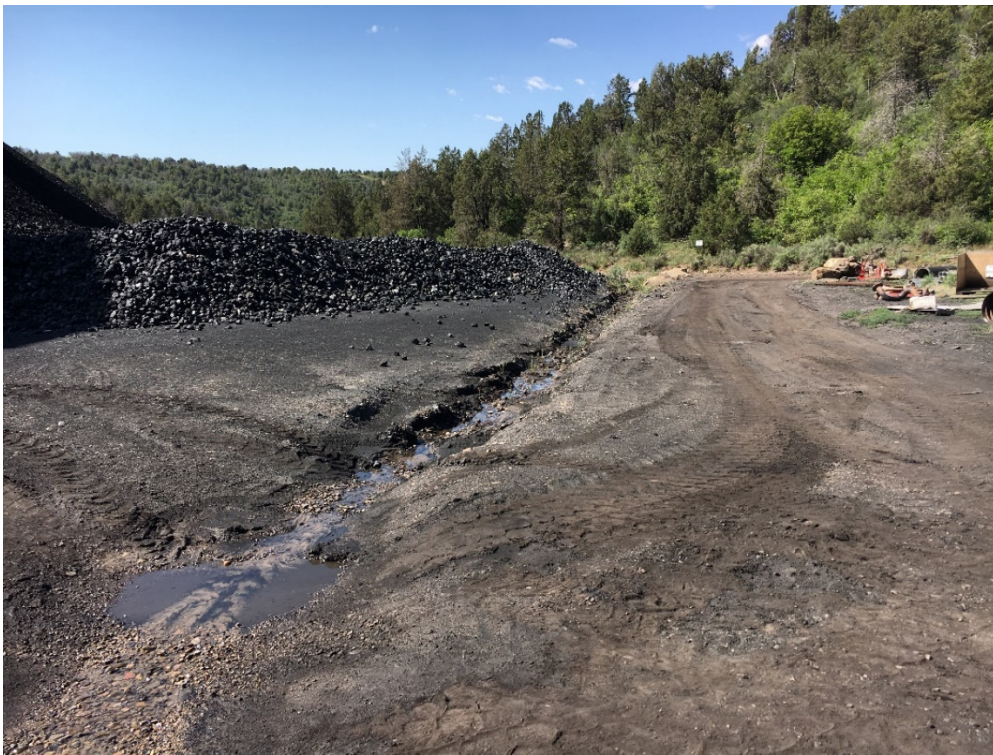
Pic. 8 – Treated water ditch that flows toward drain in Pic. 7.

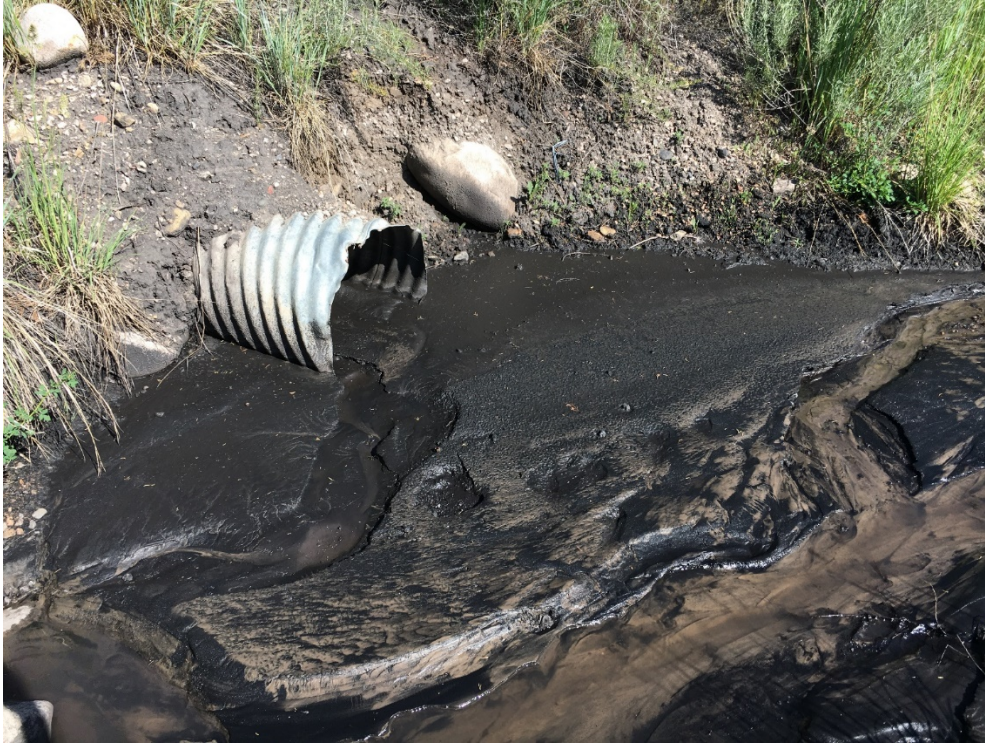
The culvert pipes and ditches on the site were in generally good condition overall. The outlet pipes were free from debris and excessive vegetation, though some sediment accumulation was observed at the outlet pipe from the driveway culvert which discharges south of the scale house (Pic. 9). The culvert pipes and ditches should be monitored after storm events and cleaned out in the event that sedimentation occurs or debris buildup at the culvert inlets or outlets is observed.

Pic. 9 – Some sediment accumulation at the culvert outlet that ultimately drains to the detention pond (south of scale house).
